Effects of Horizontal Seismic Band on Seismic Response in Masonry Structure: Behaviour Depending upon the Material Used

Santosh Yadav, Hala Damerji, Reinold Keco, Yannick Sieffert, Eugénie Créte, F. Vieux-Champagne, Philippe Garnier, Yann Malecot

Effects of Horizontal Seismic Band on Seismic Response in Masonry Structure: Application of DIC technique

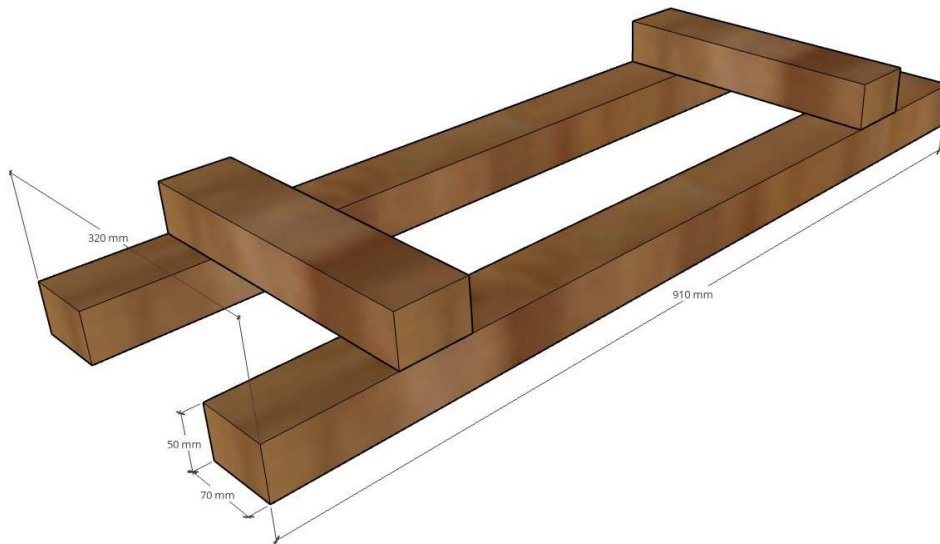
Fig. 4 Dimension of timber seismic band used

A dead load of 9.8 kN is added on the top of the wall, representing that of a roof and any other structure supported by the wall. This dead mass is uniformly applied on the wall creating normal axial stress of 0.03 MPa. A cyclic displacement until a maximum amplitude of 80 mm is applied on the wall, as shown in Fig. 5, at a variable rate of displacement (see Fig. 6).

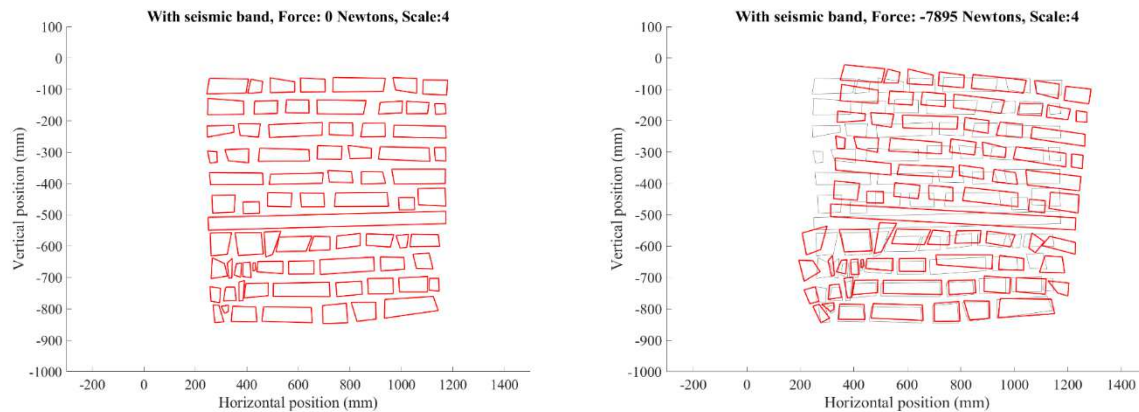
Fig. 9 DIC displacement output field for masonry wall with timber band at zero force (left) and 7.89 kN force (right)

The entire experiment is recorded with a high-resolution camera with images captured at an interval of 10 seconds. These images are later analyzed using the image-correlation software 'Tracker' [38]. The imaging was carried out for the only surface, but the crack propagation on both the surface was verified and observed uniformity regarding crack development. Each brick is associated with four points placed on its corners, forming quadrilateral, and the position of each brick is tracked image by image. The corner of the whole or fragmented brick was manually located by comparing the first image with the last one to avoid the error during DIC due to crack formation or missing part at the measurement point, which is the reason why the shape of the brick looks irregular, as seen in Fig. 9. The horizontal force's value applied on the wall at each stage is associated with the captured image in the analysis. Thus, results obtained with the two walls using DIC can be compared with the corresponding force applied at a particular instant. Fig. 9 shows the DIC output results plotted graphically using MATLAB.
