An uncommon geomorphological crisis — Dominica Coastal system response and adjustments in the aftermath of Hurricane Maria (September 2017 episode)

S. Battut*, T. Rey, S. Defossez & F. Leone - Université Paul Valéry - Montpellier 3 - UMR GRED

1. Objectives

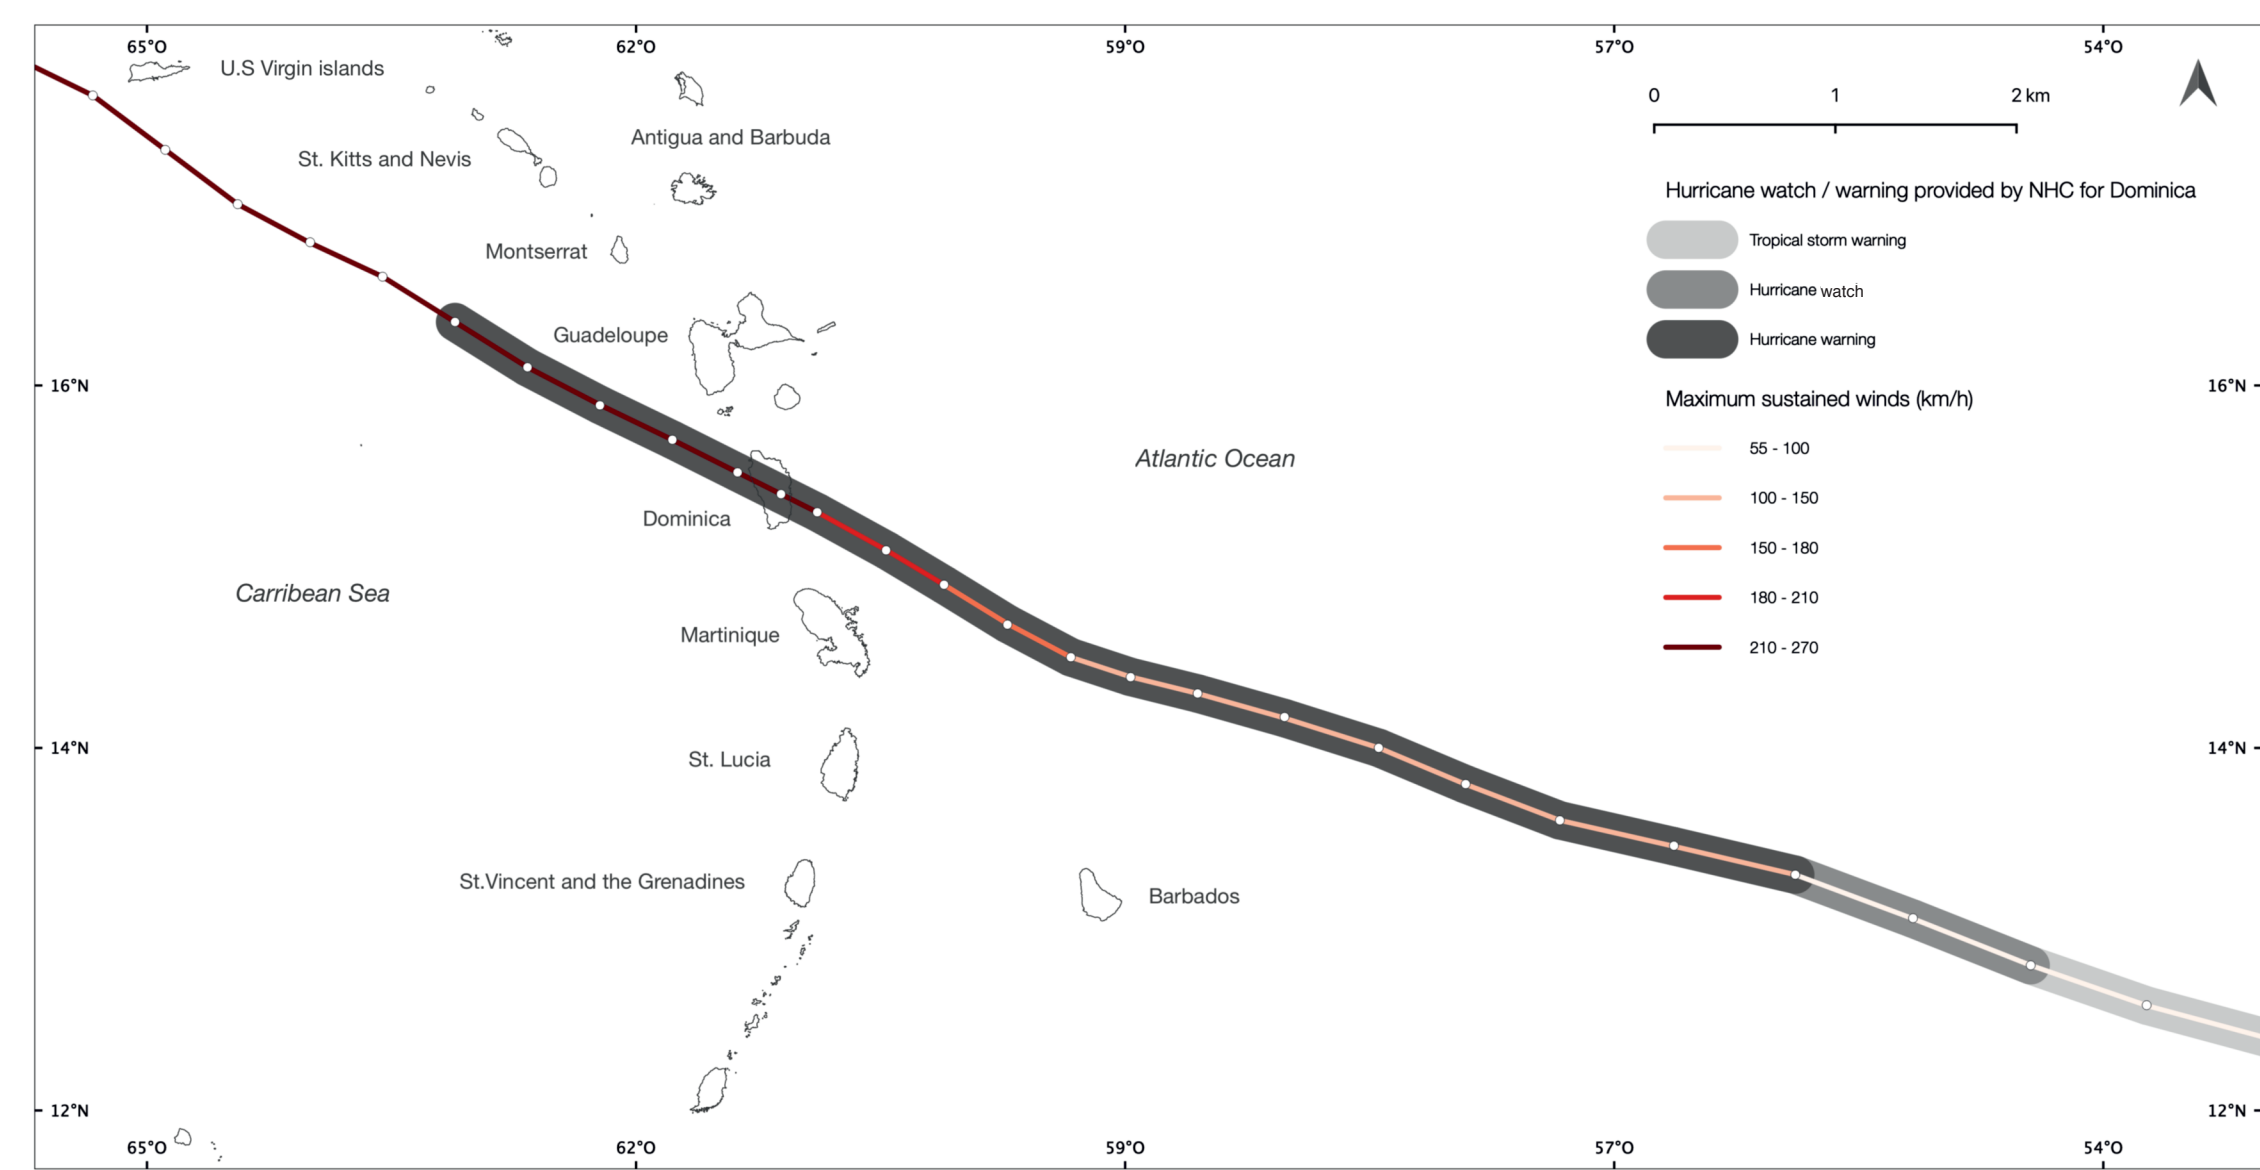
Figure 1 - Maria Hurricane track with winds speed and watch or warning levels for Dominica. Sources : ibtracs /NHC, NOAA, 2018 - GADM, 2019 (BATTUT, 2019)

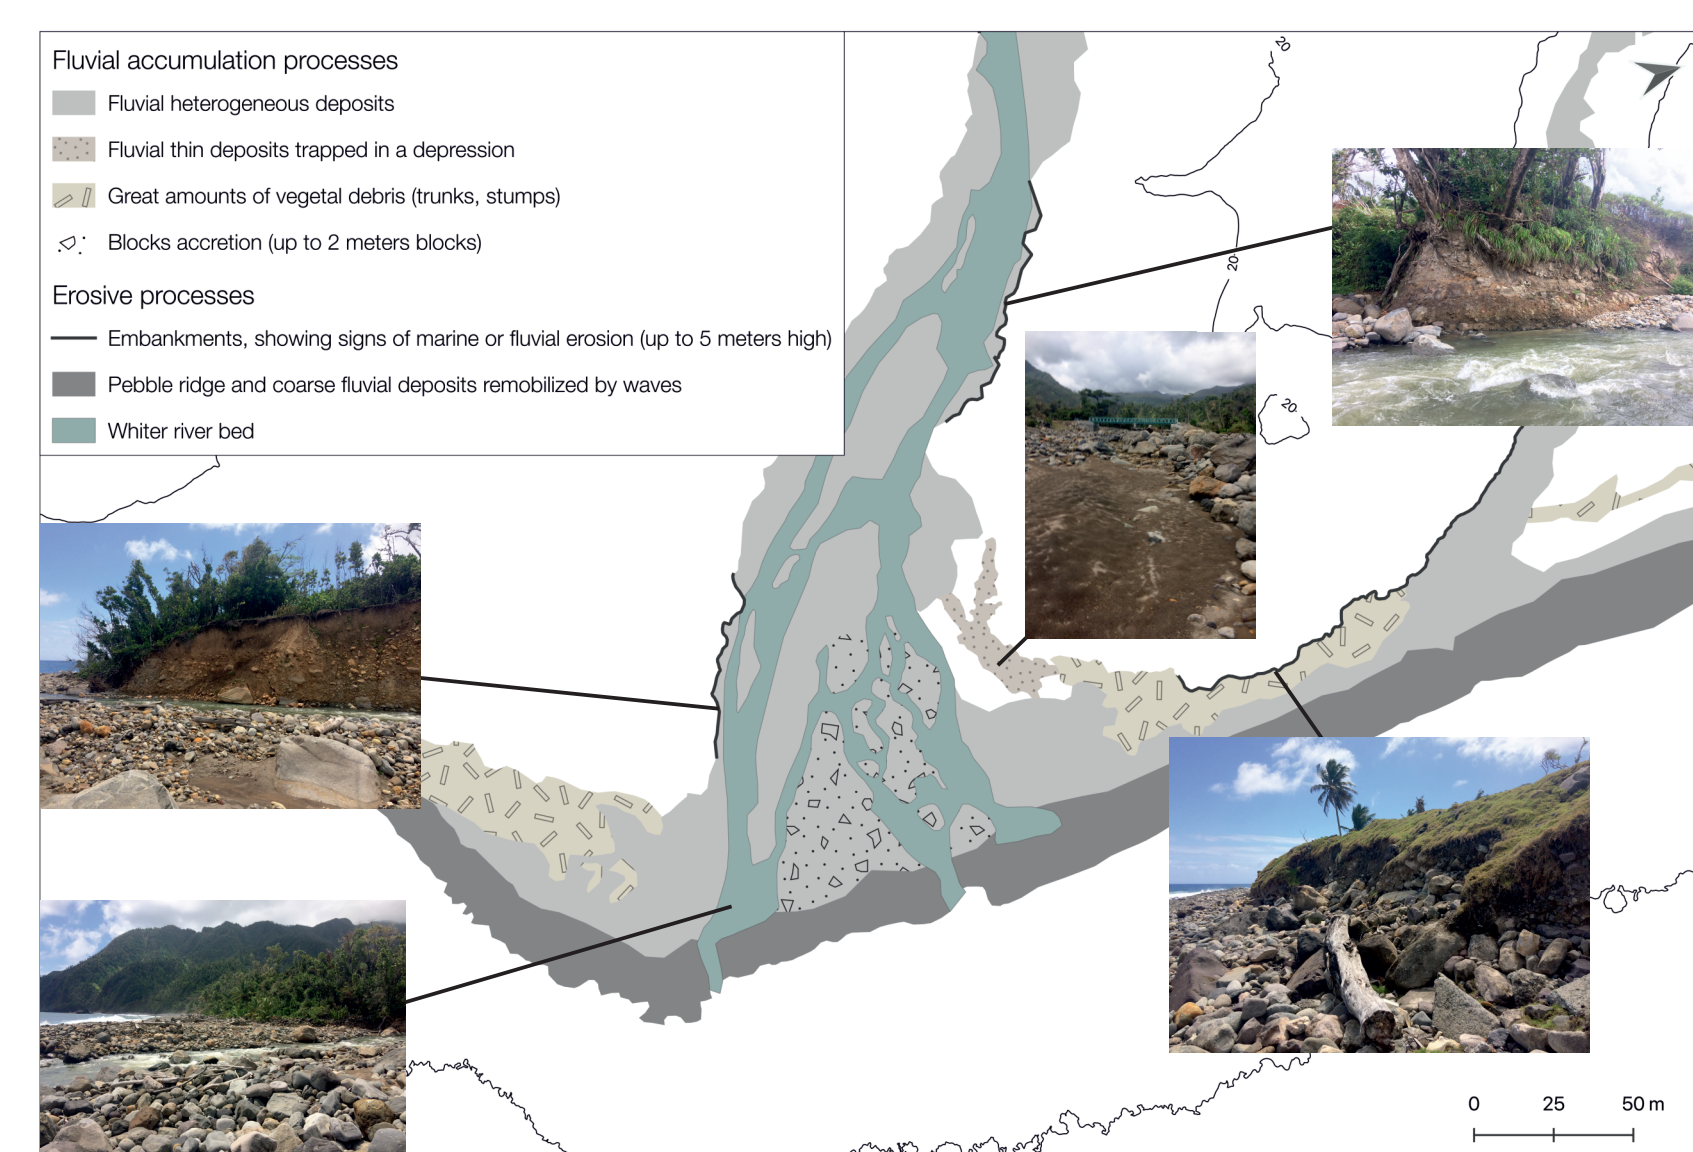
Figure 2 - Geomorphological cartography of Whiter river mouth in Pointe Mulâtre made with field observations and high resolution aerial views (BATTUT, 2019).

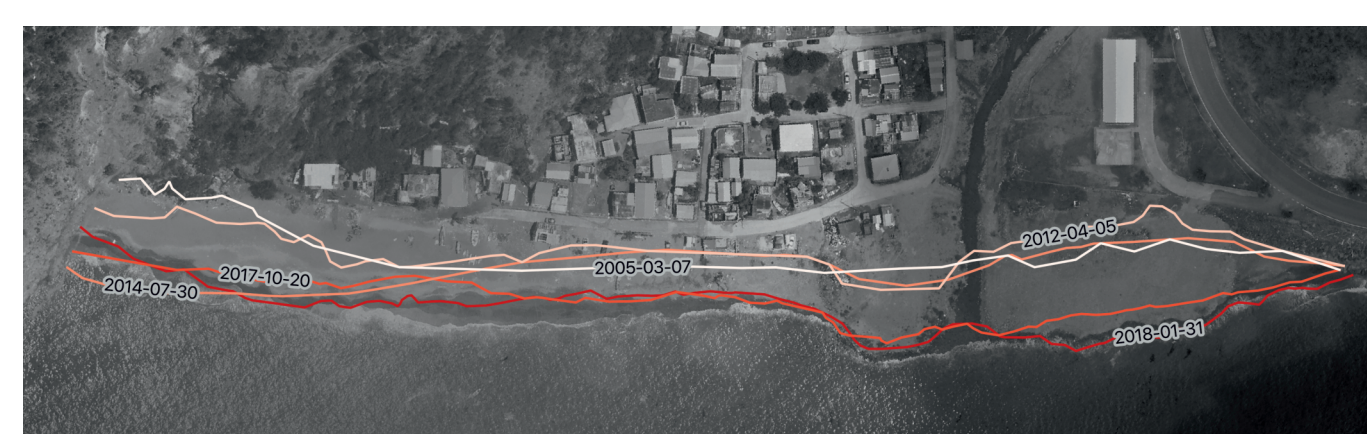
Figure 3 - Coastal evolutions in Colihaut between 2005 and 2018 based on coastline monitoring. (BATTUT, 2019)

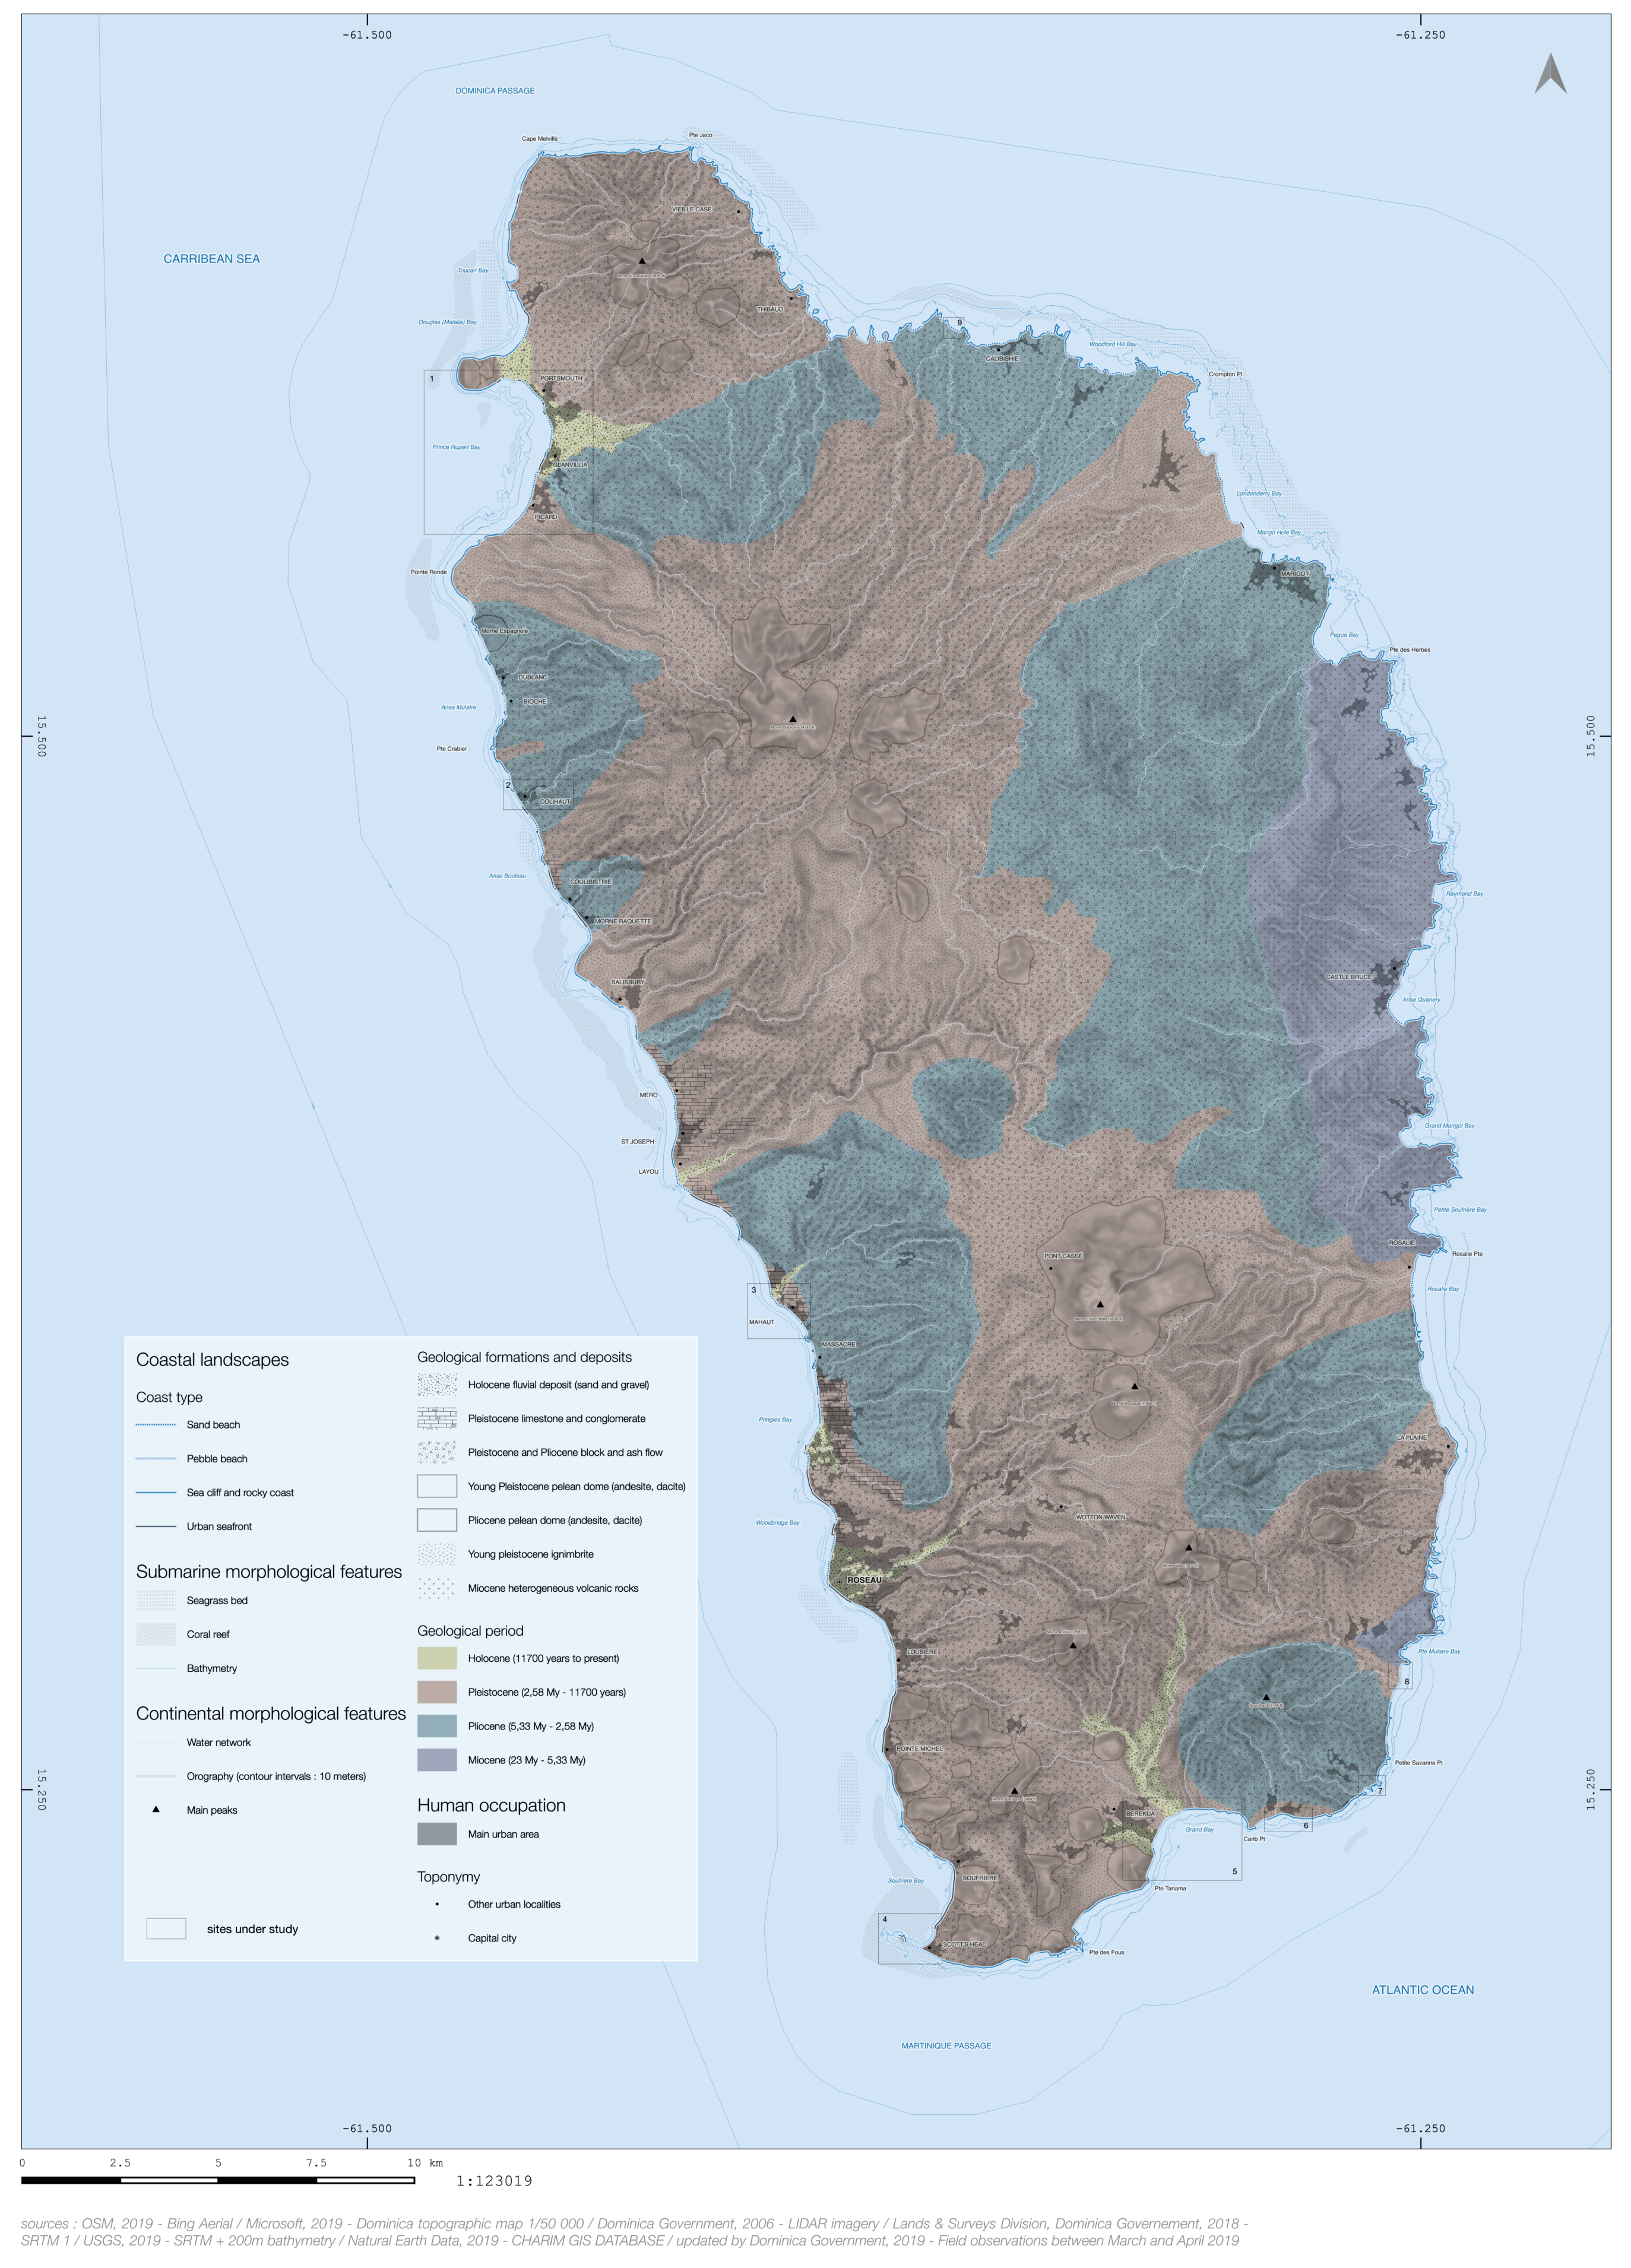
Figure 5 - Geomorphological map of Dominica and sites under study location (BATTUT, 2019). 1 - Portsmouth bay 2 - Colihaut 3 - Mahaut 4 - Scott's Head 5 - Grand bay 6 - Fond Saint Jean 7 - Petite Savanne bay 8 - Pointe Mulâtre 9 - Number one beach.

In Dominica, hurricane Maria impacts have been studied through a comparative and diachronic approach on several sediment cells and watersheds across the island (fig. 5) displaying different signs of anthropisation (fig. 4). Their resilience was assessed a year and a half after the event. The use of aerial footage (fig. 3) and topomorphological data analysis made on field (fig. 2) have been put forward thanks to a cartographic translation in order to emphasize morphosedimentary response at different moments in time.

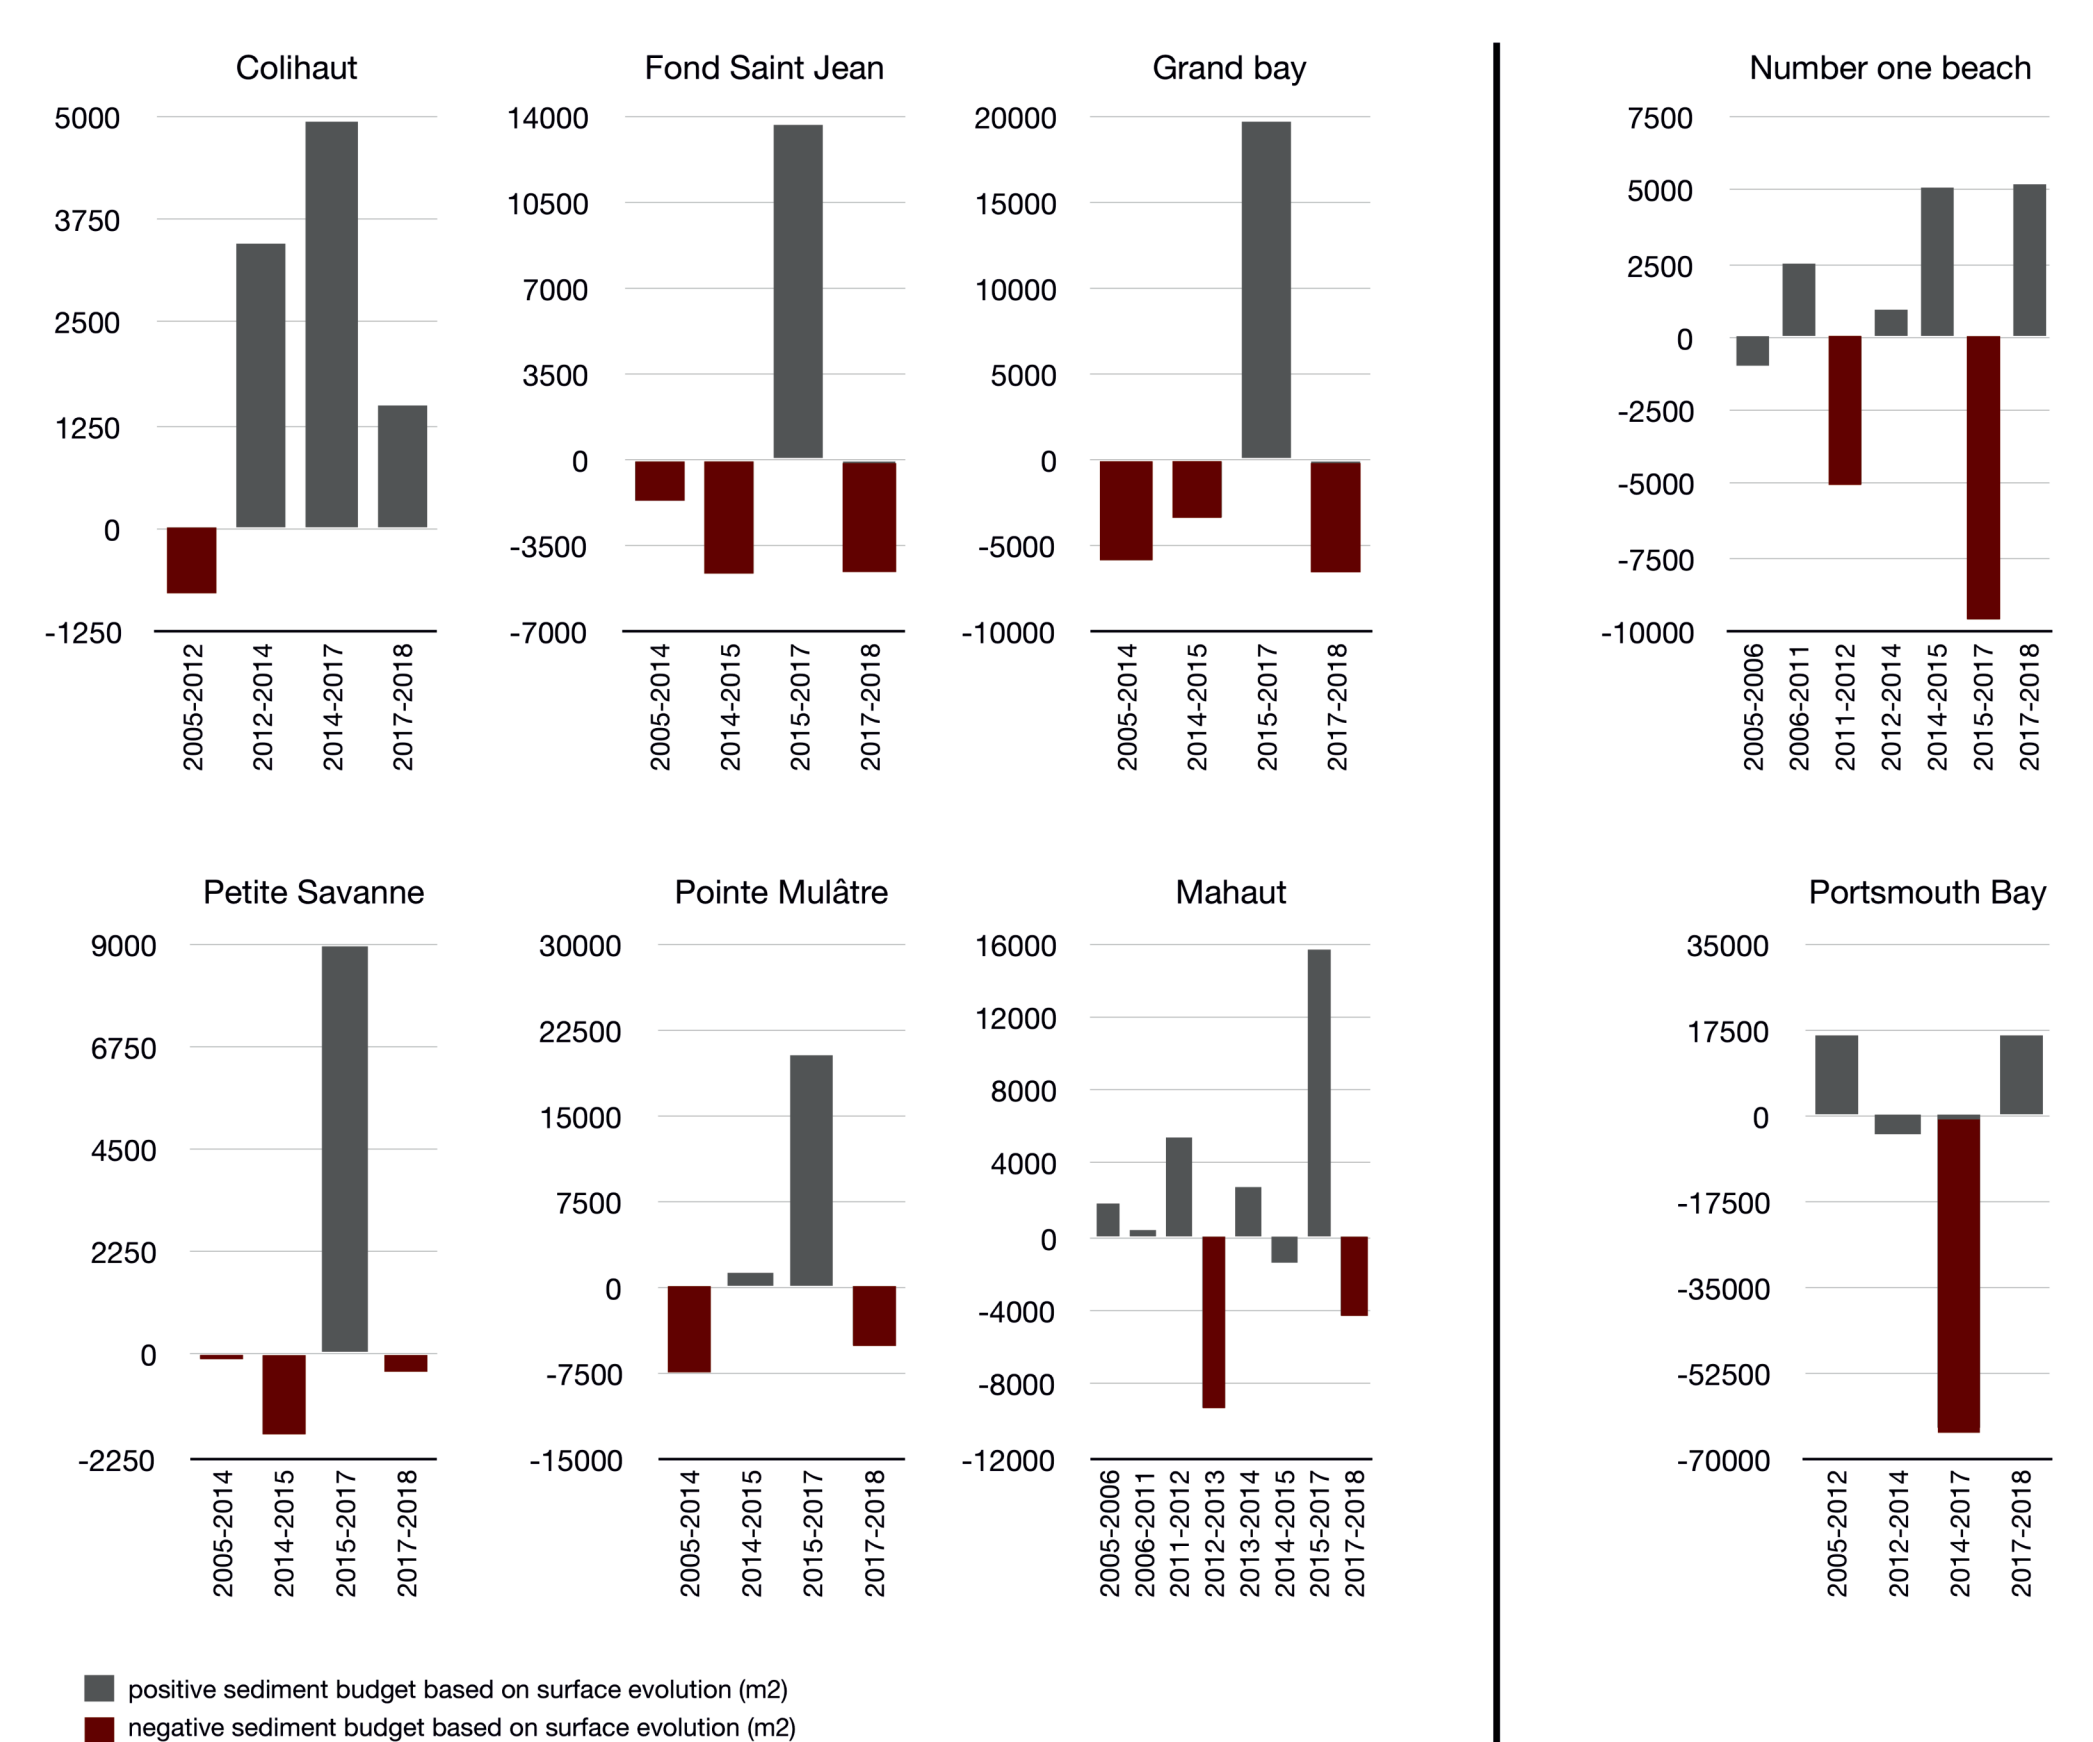
Figure 6 - Sediment balance in 8 different sites between 2005 and 2018 based on evolution surface (m2) (BATTUT, 2019).

Only two studied sites showed erosive processes signs (fig. 6). These locations are low lying sandy beaches with estuaries. Contrary to most of the sites, they include low gradient rivers. Erosion was mainly due to cyclonic waves that transported sediments towards the subtidal zone, causing the beach profile to retreat (fig. 9).

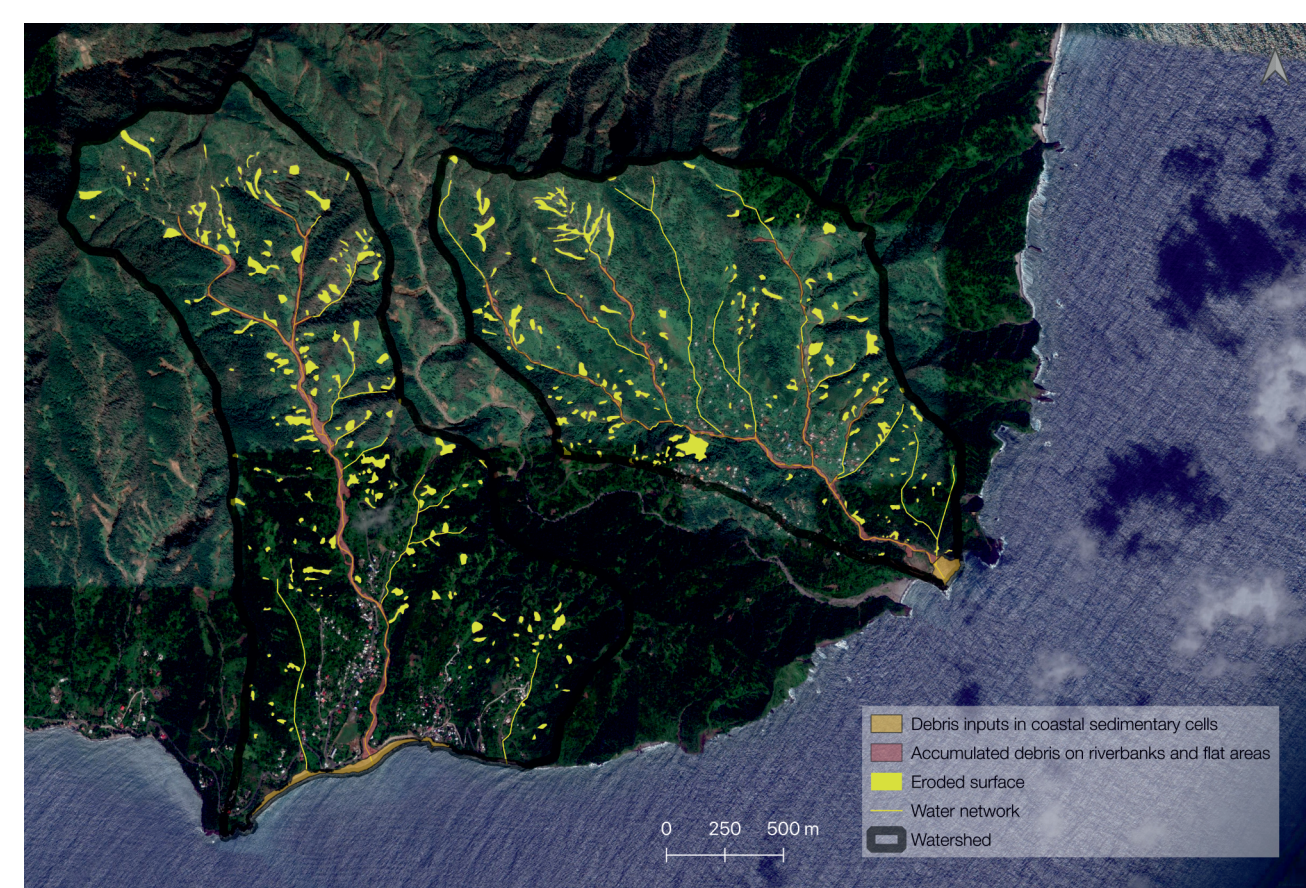
Figure 10 - Sedimentation processes in Fond Saint Jean (west) and Petite Savanne (east) watersheds. (BATTUT, 2019).

The results show that coast evolutions are mainly due to fluvial processes rather than marine dynamics. Heavy rains caused major landslides (fig. 10) and flooding while enabling organic materials and debris to flow downstream towards the mouths. This phenomenon of extreme sedimentation accounts for major morphological alterations such as land elevation, sedimentary progradation, and river avulsion. Contrary to the idea according to which hurricanes generally make coastlines recede, in the case of Dominica island, large amounts of input materials of heterogeneous granulometry have generally contributed to a considerable accretion in sediment cells (fig. 6). Besides, large amounts of wooden debris washed away into the sea and reshaped by the cyclonic swell intensified the impact of the waves on the coastline and accumulated on supratidal parts of beaches.

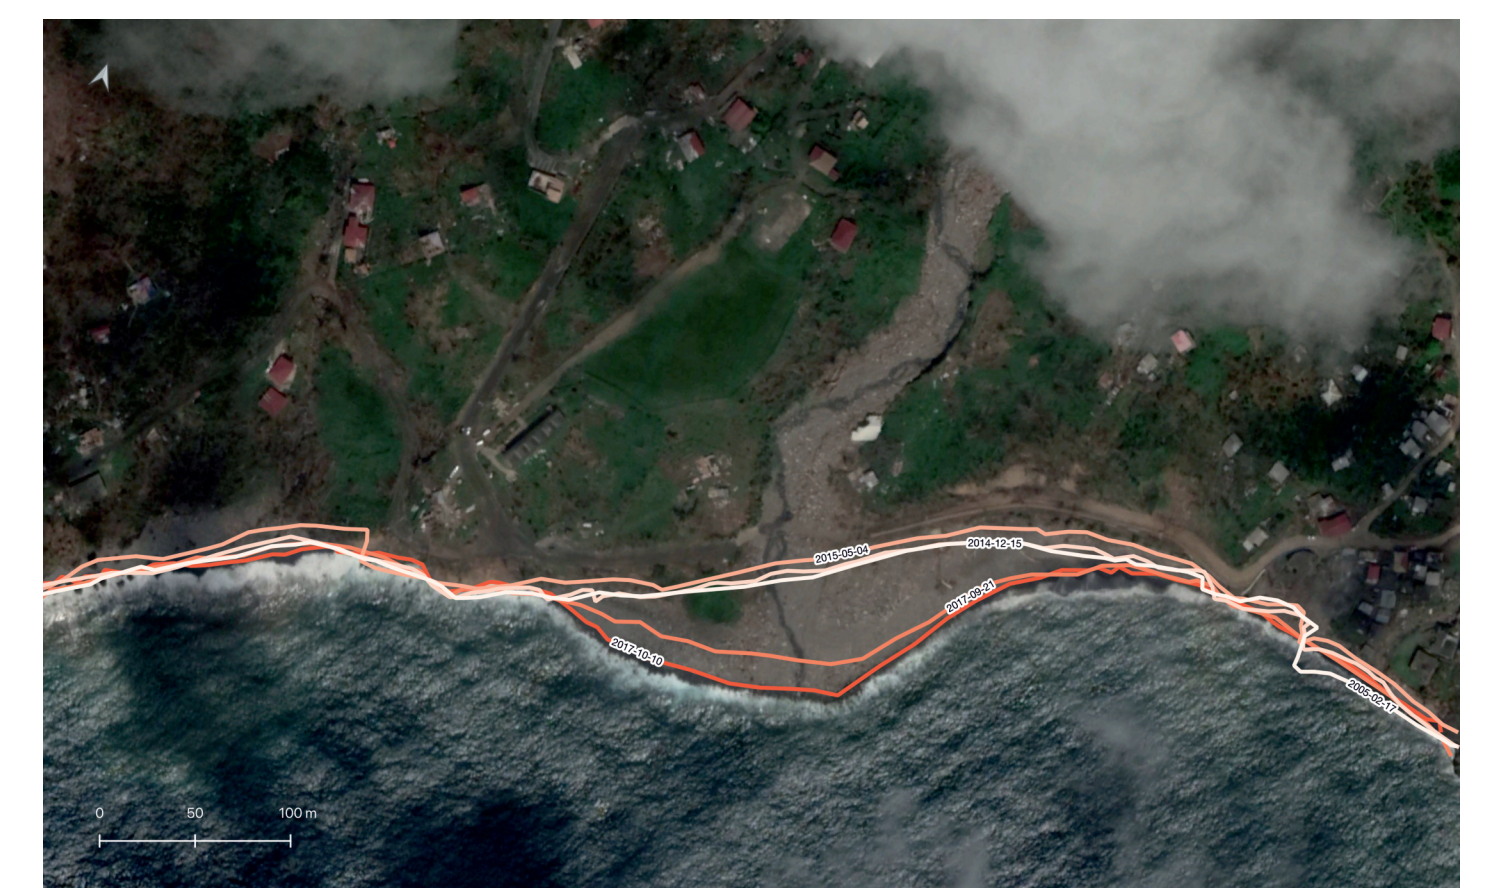
Figure 11 - Morphological evolutions in Fond Saint Jean bay between 2005 and 2017. (BATTUT, 2019).

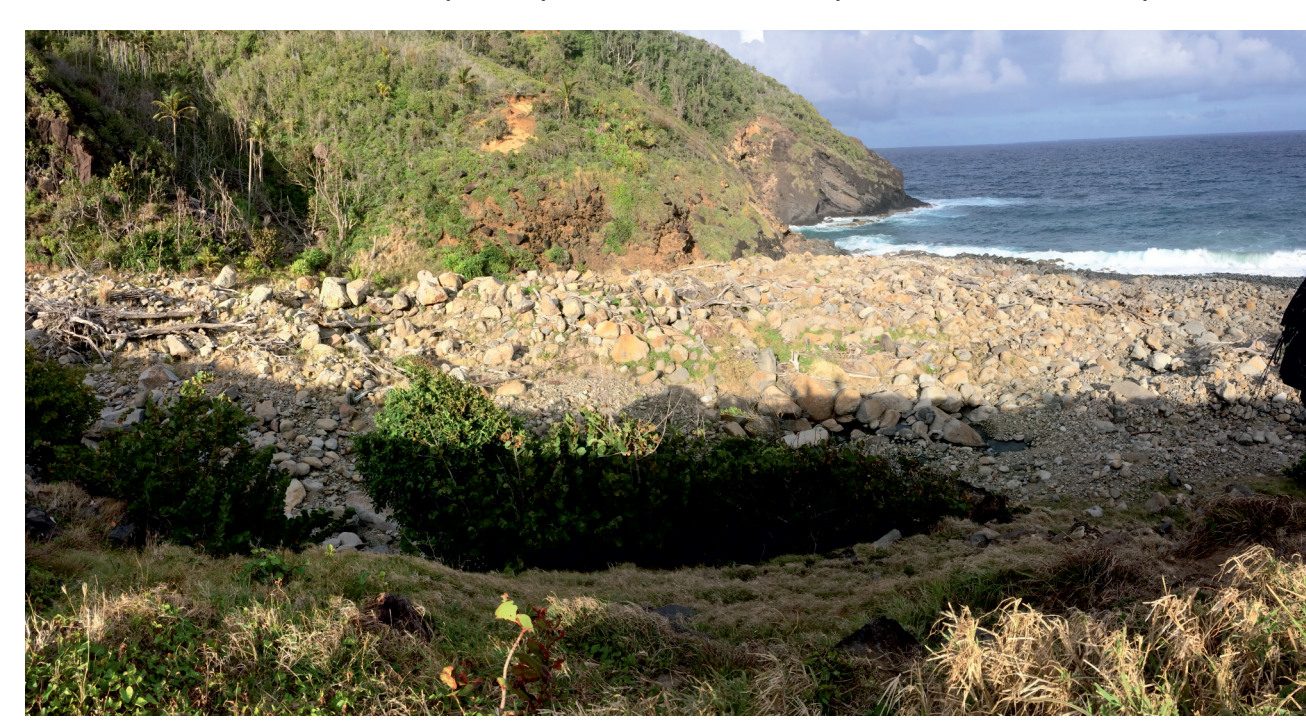
Figure 12 - Coarse deposits in Petite Savanne. (BATTUT, 2019).

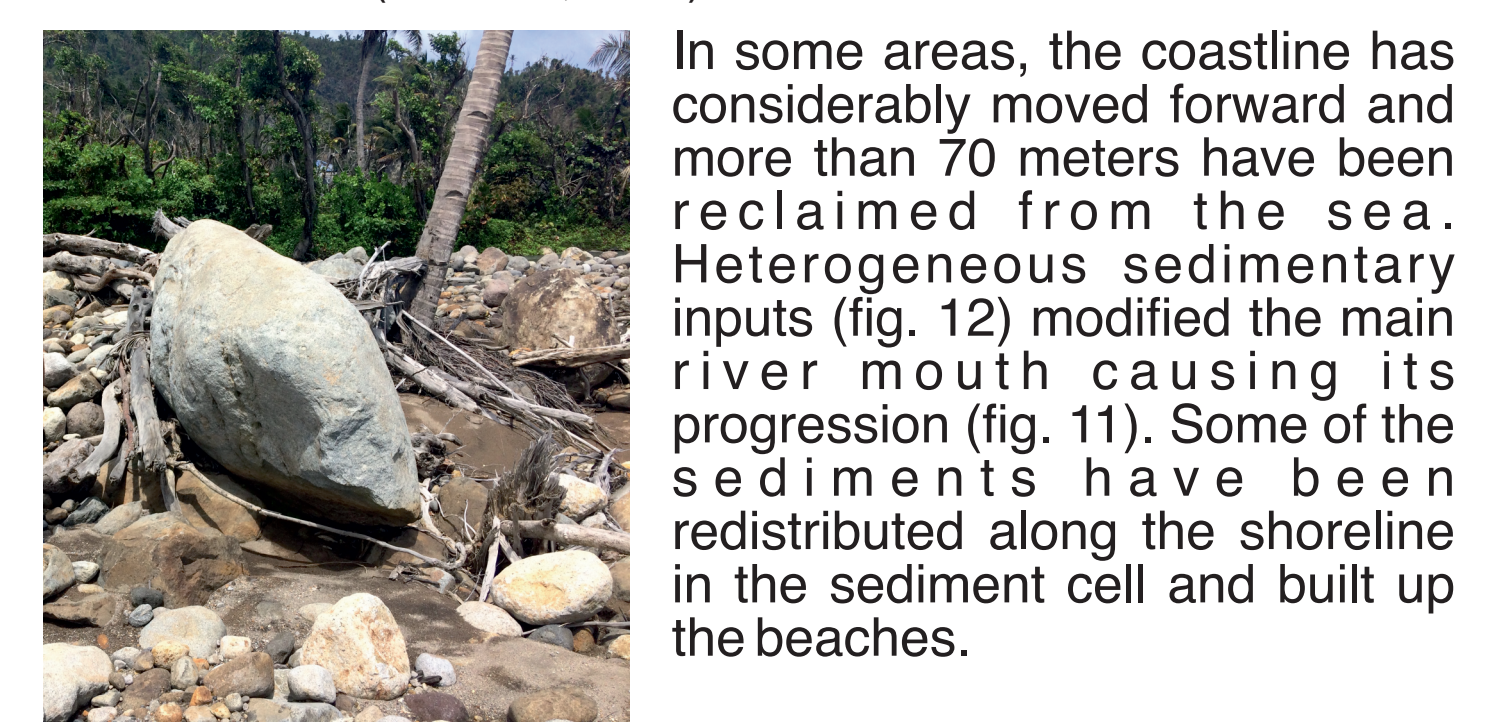
Figure 13 - Large block on Pointe Mulâtre river mouth.

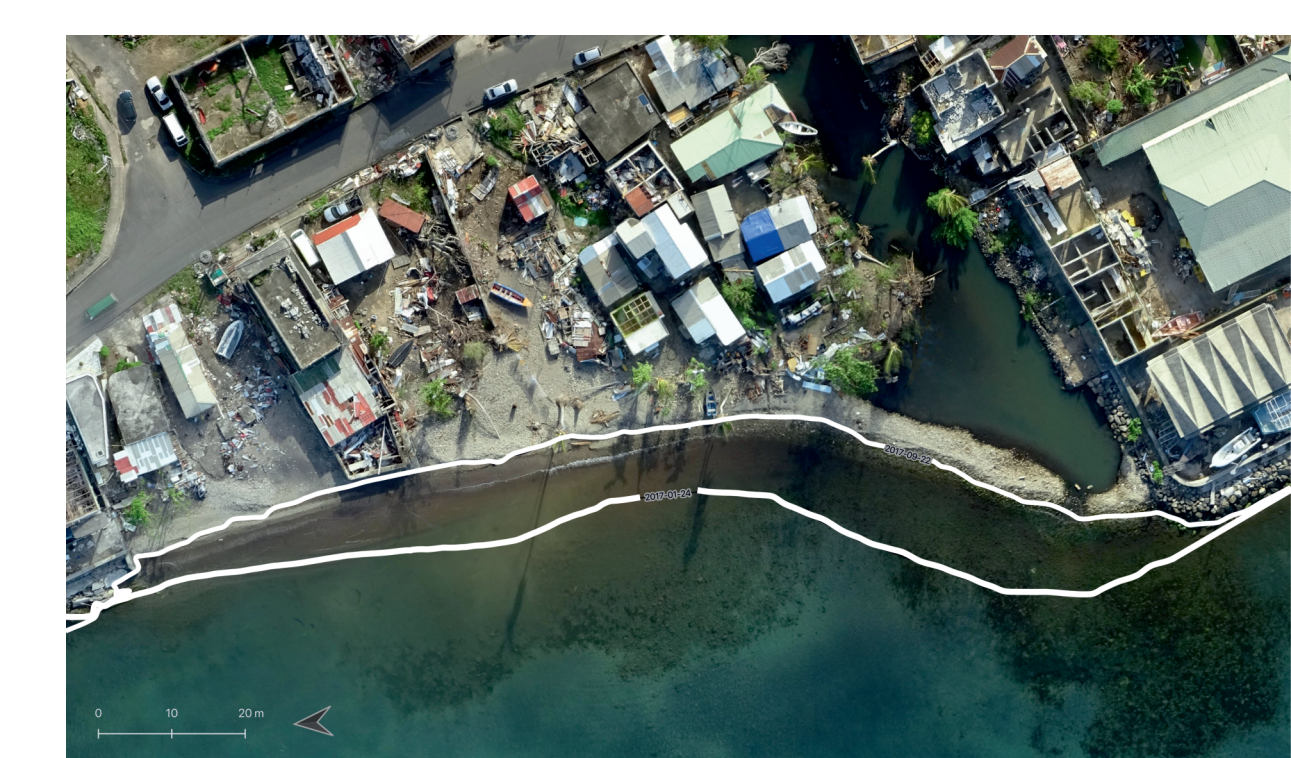
Figure 7 - Erosion induced by Hurricane Maria in Lagoon, Portsmouth (BATTUT, 2019)

Erosive signs were observed in Portsmouth bay and Number one beach (fig. 7 & 8). Their orographic settings are rare on the island of Dominica where slopes are particularly steep, even in coastal areas. Large low plains at the back of the seafloor determine rivers declivity and their sediment load. On these sites, hurricane impacts were mainly induced by marine processes like waves impact and sediment erosion. Urbanized seafronts have suffered very high destructions as reflective erosion damaged sea walls and buildings (fig. 8).

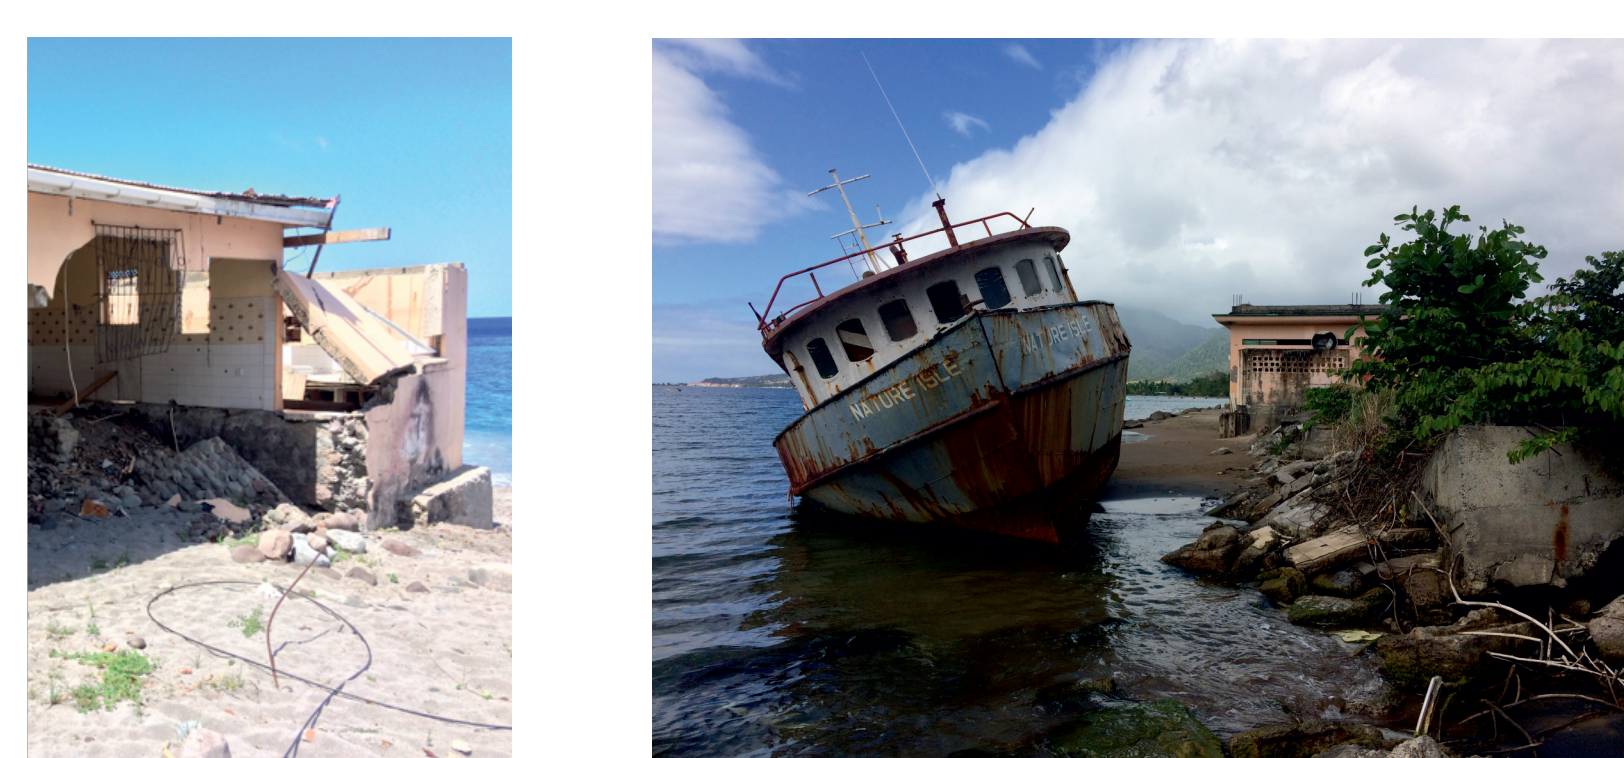
Figure 8 - Erosive processes and damages on seafront urbanization in Scott's Head and Picard (BATTUT, 2019).

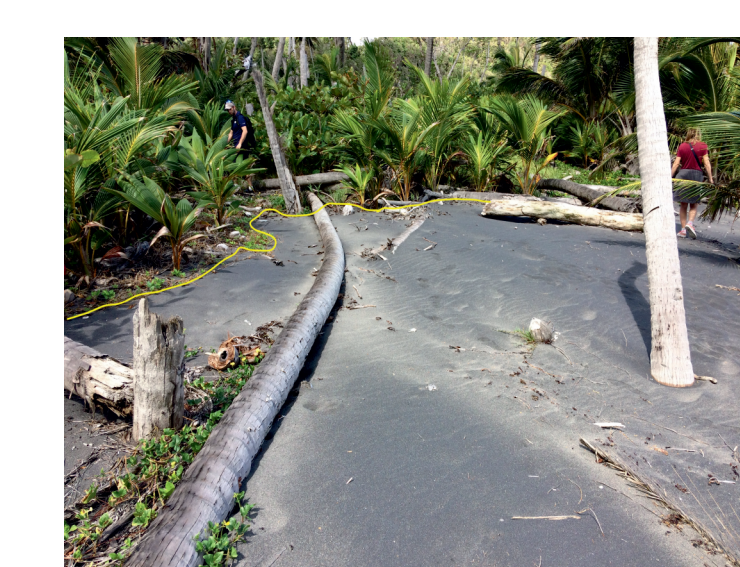
Figure 9 - Washover deposits on Number one beach (BATTUT, 2019).

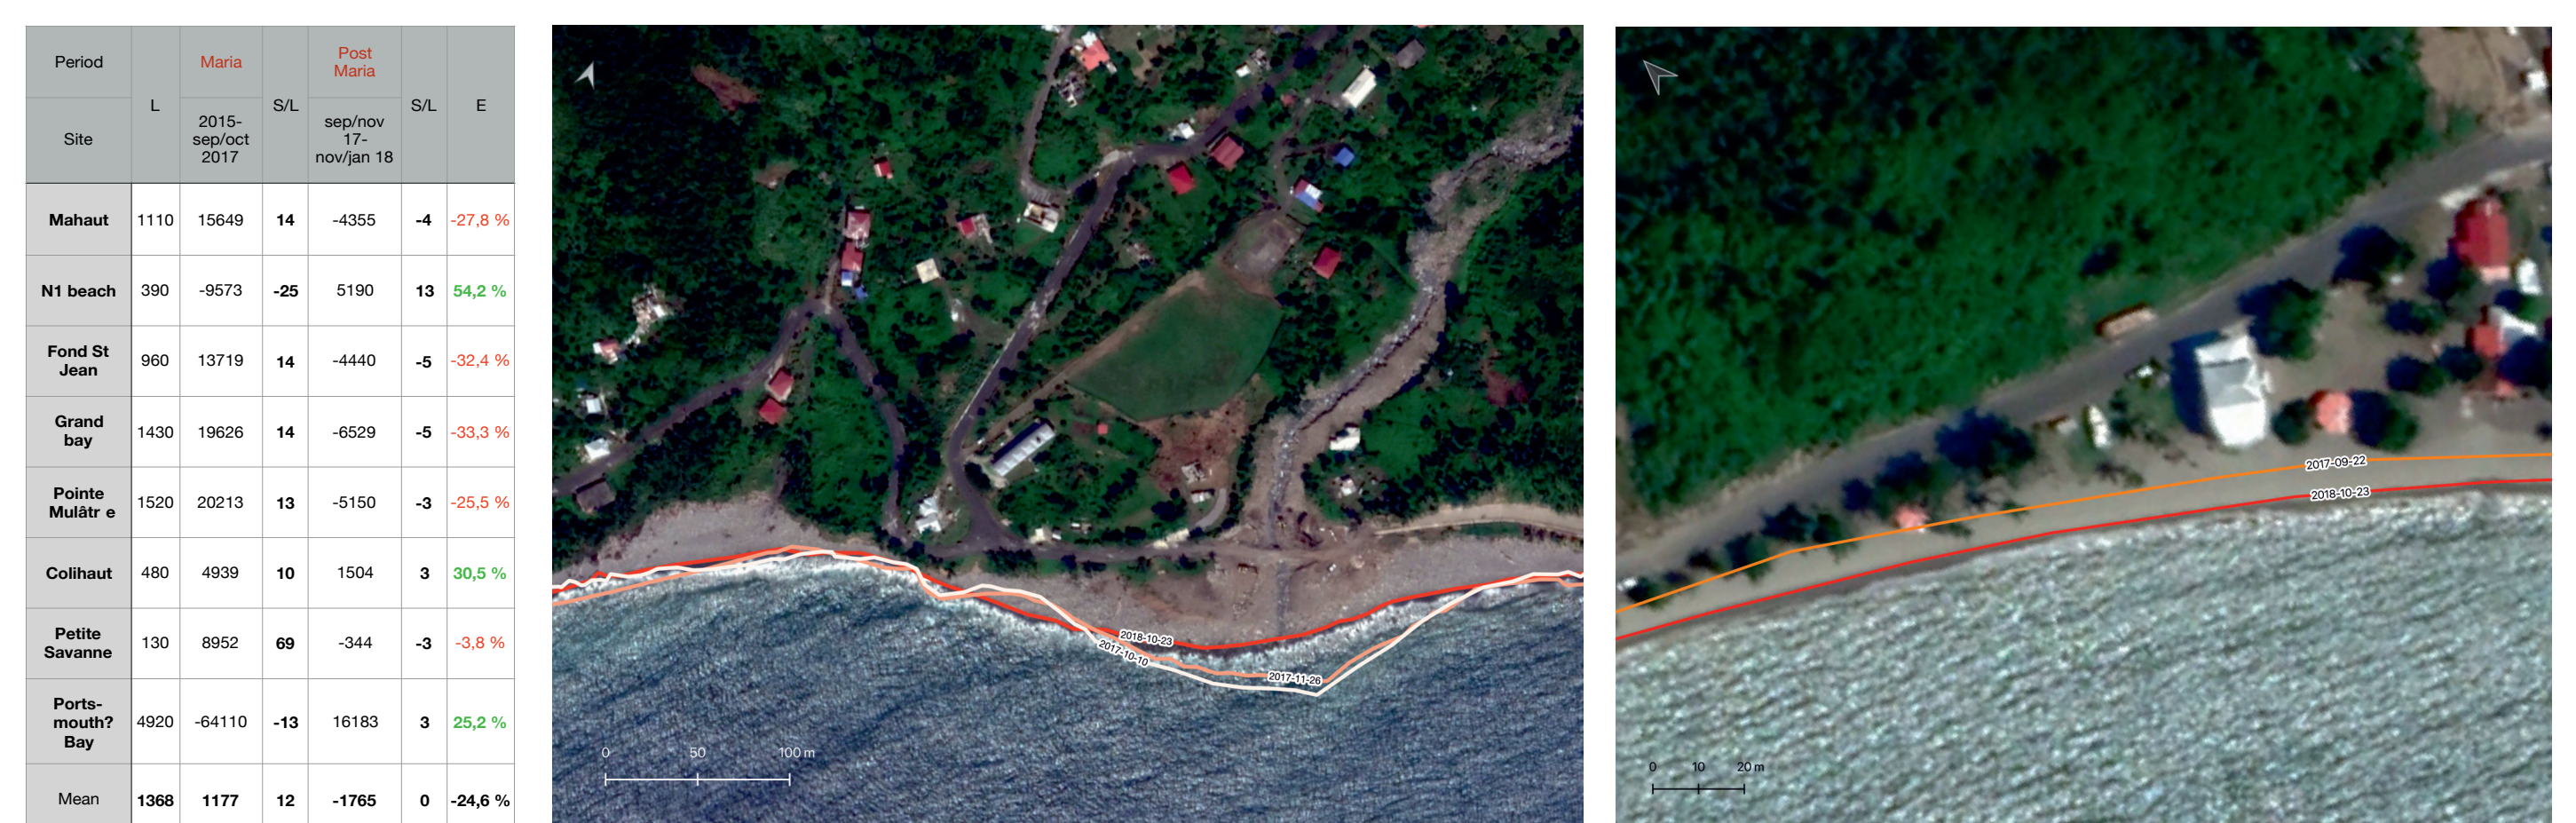
From left to right : Figure 14 - Maria and Post Maria sediment balances in the studied sites (L is the length of the sediment cell, S/L is the evolution surface related to the length of the cell (expressed in m² per linear meter) - Figure 15 - Post Maria coastline adjustments in Fond Saint Jean - Figure 16 - Post Maria adjustments on Lagoon beach, Portsmouth (BATTUT, 2019)
