Kuwaiti-French Expedition in Failaka. The Hellenistic Fortress (Tell Saïd). Preliminary Scientific Report 2009

Mathilde Gelin, Shehab A.H. Shehab, Abdallah Alaeddine, Ahmad Deb,
Jean-Michel Gelin, Shaker Al-Shbib

KUWAITI-FRENCH EXPEDITION IN FAILAKA
THE HELLENISTIC FORTRESS (Tell Saïd)
Preliminary Scientific Report 2009

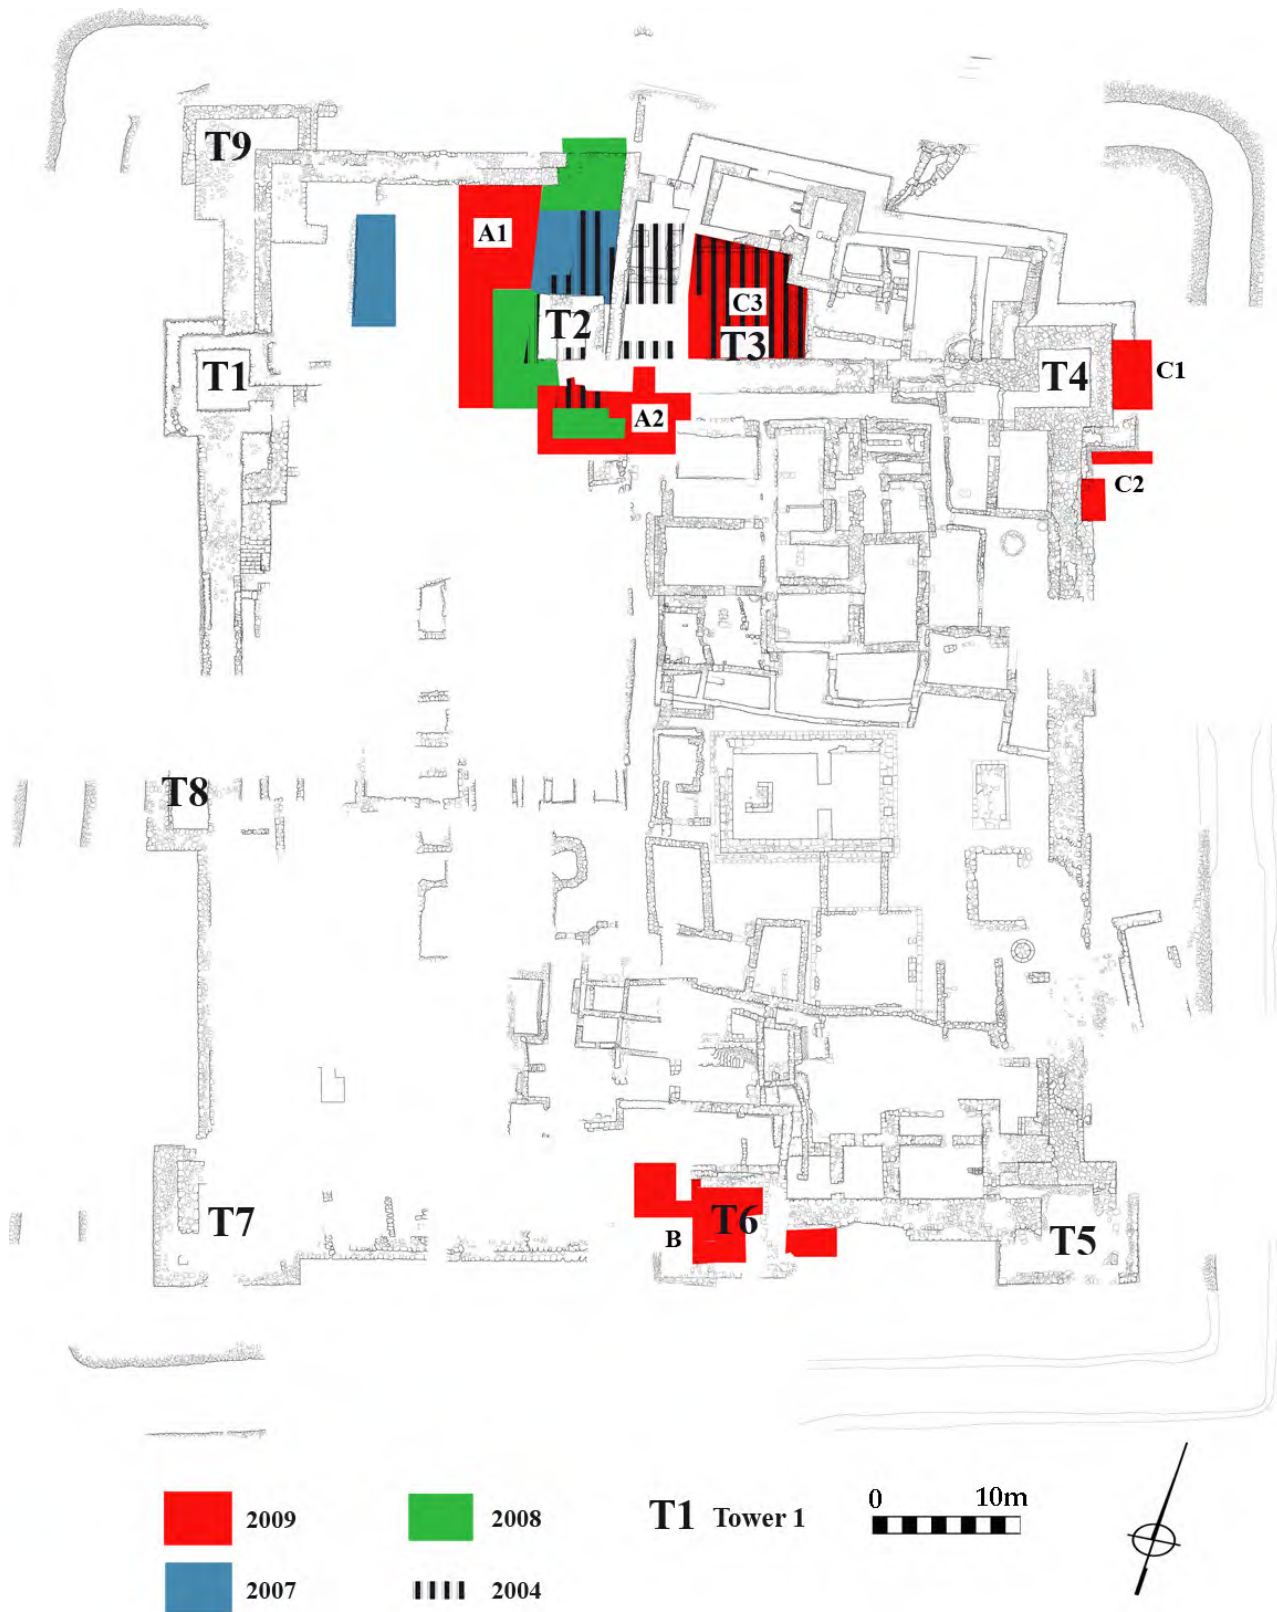
Localization of the fieldworks and towers numbers. After O. Callot.

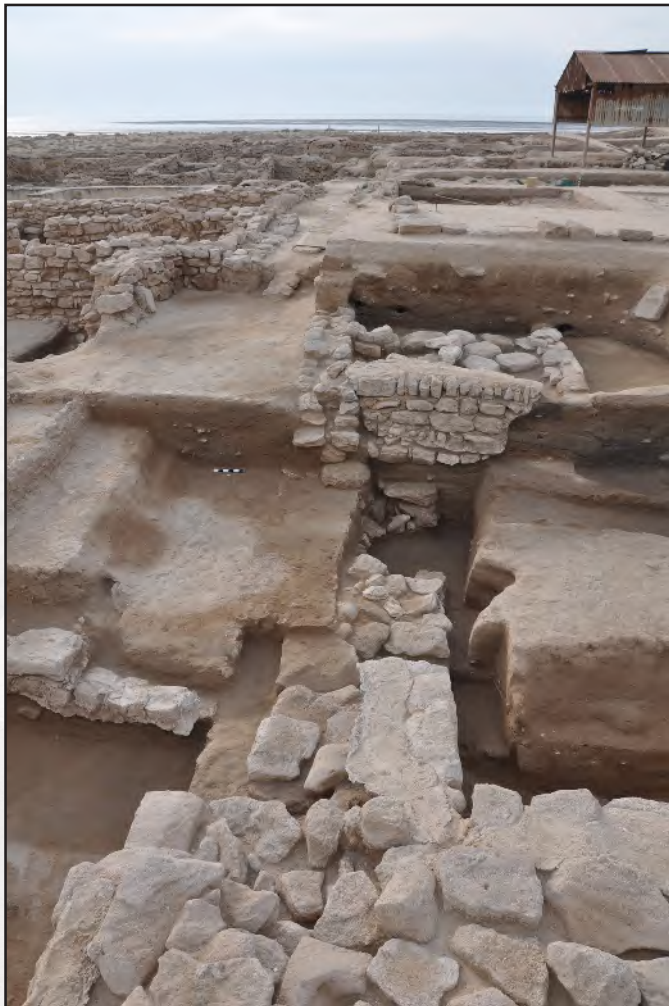
Example of **damages** caused by ancient deep soundings, destroying the links between walls and stratigraphy, view to the south. Here, the wall M320 in A2 sector, surrounded and partly destroyed by ancient soundings. At its south extremity, the baulk has been cemented, creating a modern wall ; at its junction with the rampart (first plan), the top has been cemented.

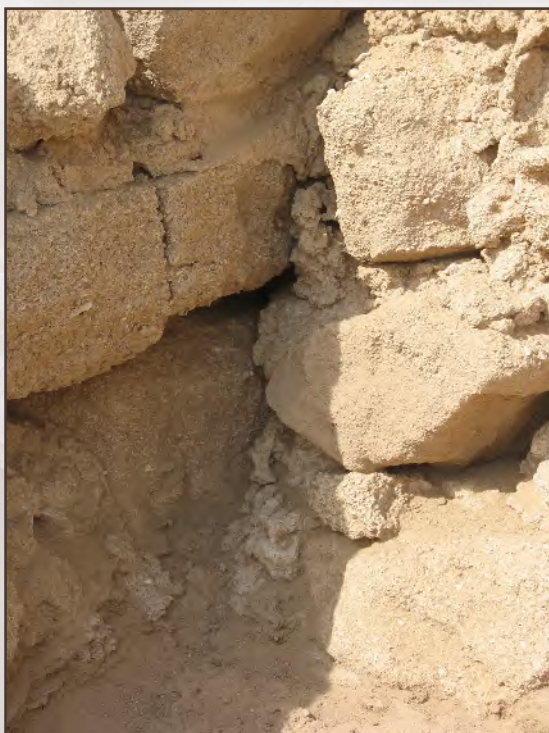
Detail of a junction between two walls. It has been totally **cemented** and the wall on the right has been partly reconstructed. The original link between these walls is now impossible to determine.

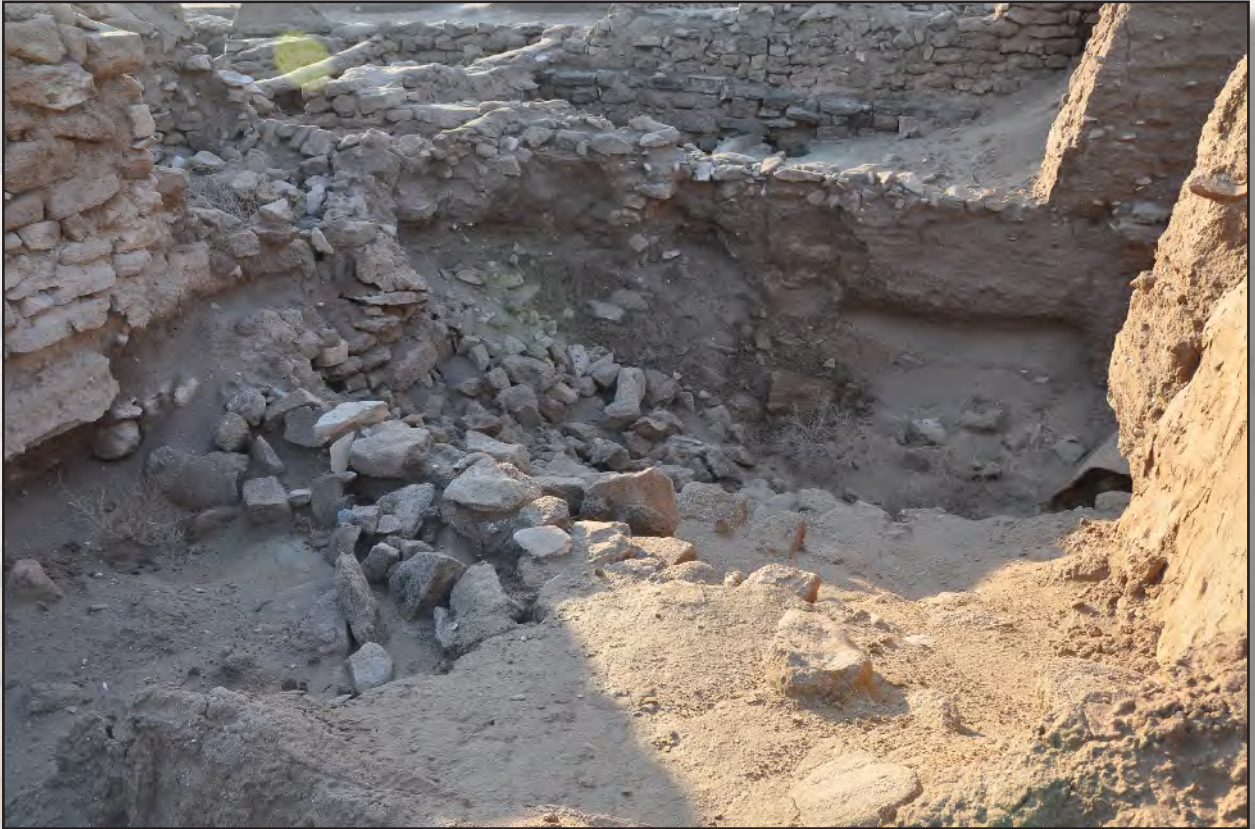
Example of **destructions** due to ancient deep soundings not refilled and humidity. South part of the fortress.

In other places in the site, the ancient trenches, which have not been filled after work, represent a lot of holes where the water and the humidity stagnate. As they have been dug on the bases of the walls and, sometimes, deeper than the walls themselves, the result is that these walls are now destabilized and may fall down.

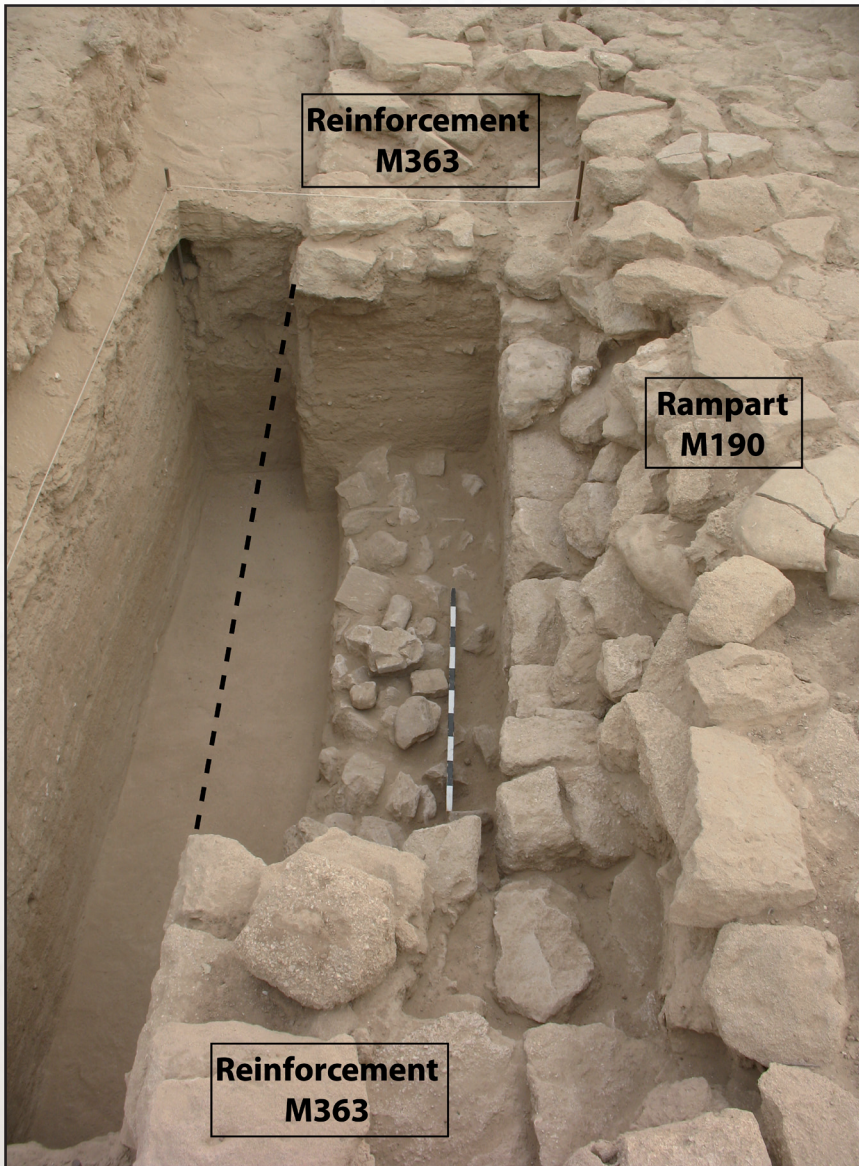
The rubble preparation layer under the rampart. Left, under the east rampart (outer face) in C22, view to the south. The broken wall above is a later embankment (M363). Below, under the north rampart (outer face) in C3, view to the south.

So, to understand what was exactly the rule of this rubble layer, we took several levels in all the fieldworks and discovered that it has, in all the places we uncovered it, a regular altitude at its base : a difference of 18 cm maximum has been noticed. But the most remarkable is for the fortifications of the first rampart : the levels of the walls and towers bases are the same (a difference up to 7 cm only), even for points distant until ≈ 60 m¹⁵. This means that the sand layer is very important, because it sustains the fortifications and plays the rule of adjustment (or foundation course). Filling the irregularities of the soil and of the rubble layer, it erases them and regulates the level, to offer a horizontal surface for the construction of the wall. It also distributes the weight and pressure of the wall. Then, the rubble layer has been installed in order to maintain the sand layer under the construction, to avoid it to move under the pressure of the upper structures.

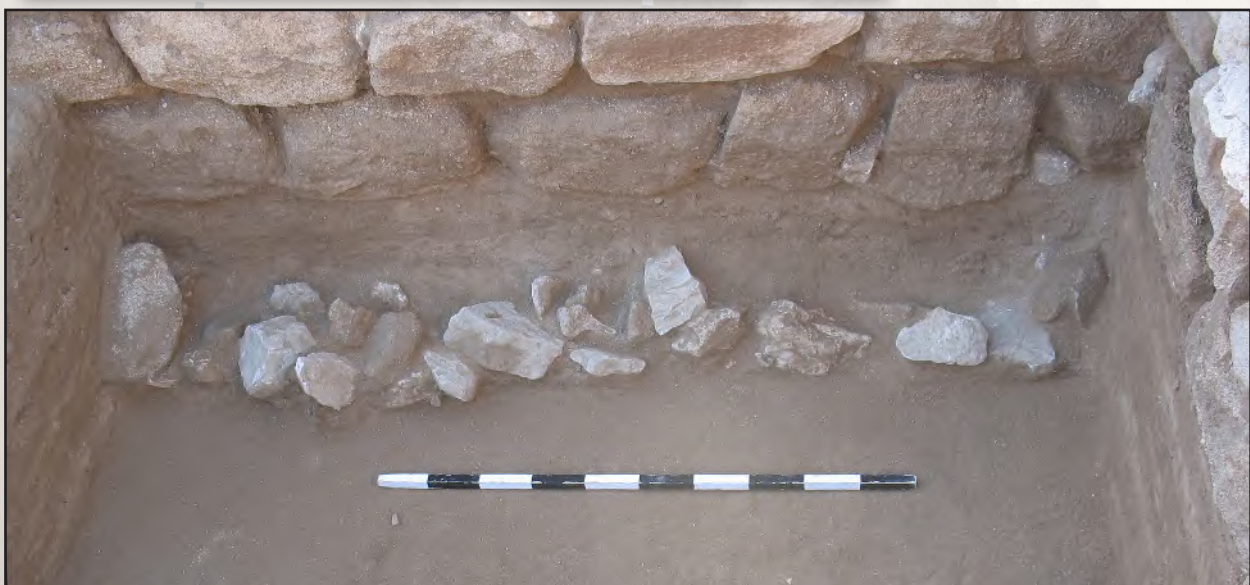
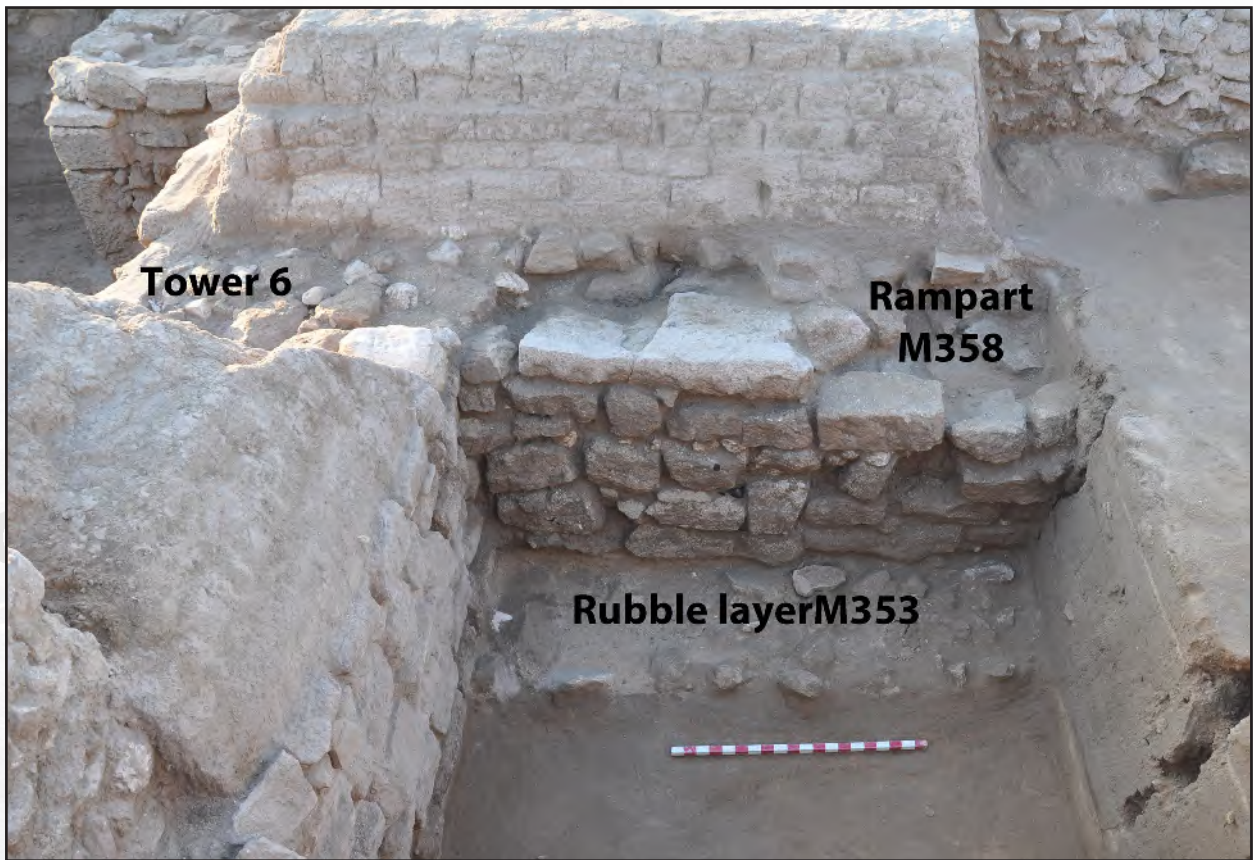
The rubble preparation layer under the rampart. **Above**, under the south wall (inner face) in B2, view to the south. **Below**, under the south rampart (outer face) in B1, view to the north.

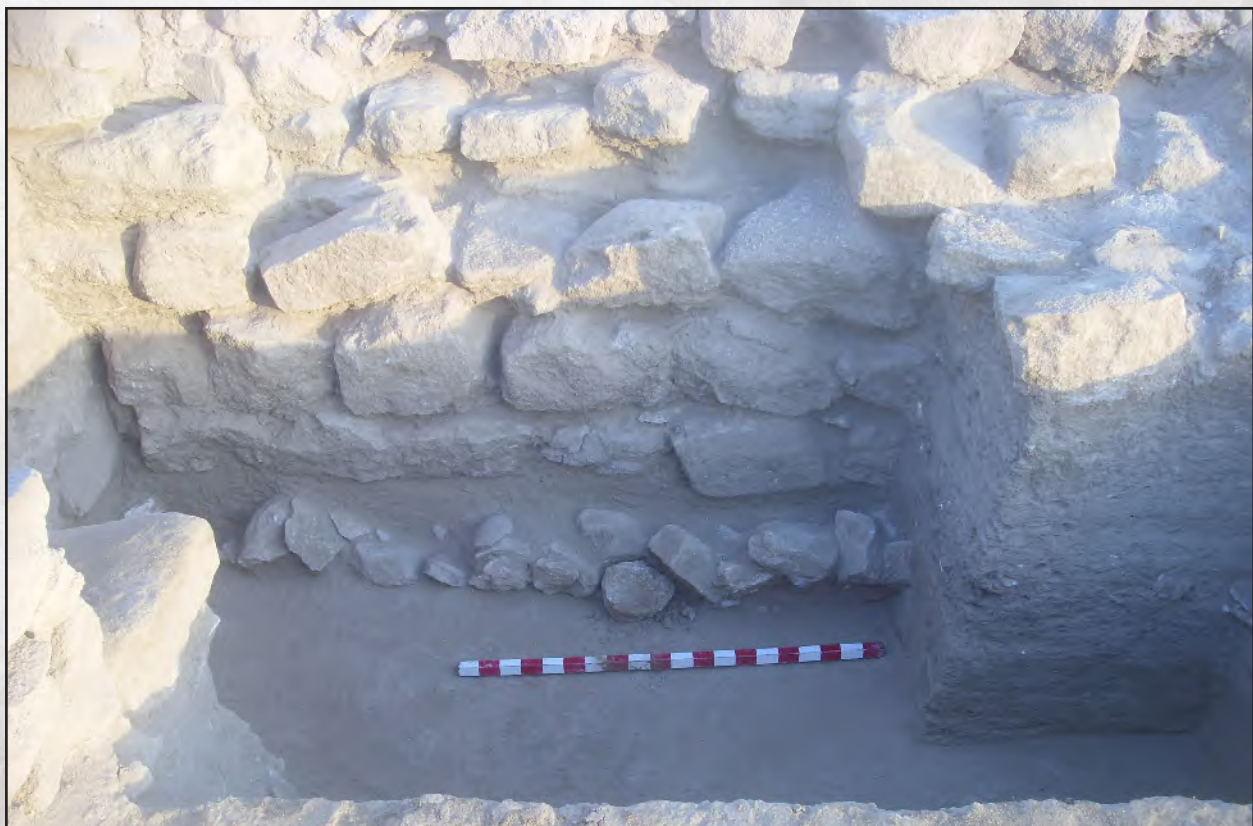
The rubble preparation layer under the towers. **Above**, under the tower 2 (inner face) in A2, view to the north. **Below**, under the tower 4 (outer face) in C12, view to the west. Here, the previous excavations destroyed part of it.

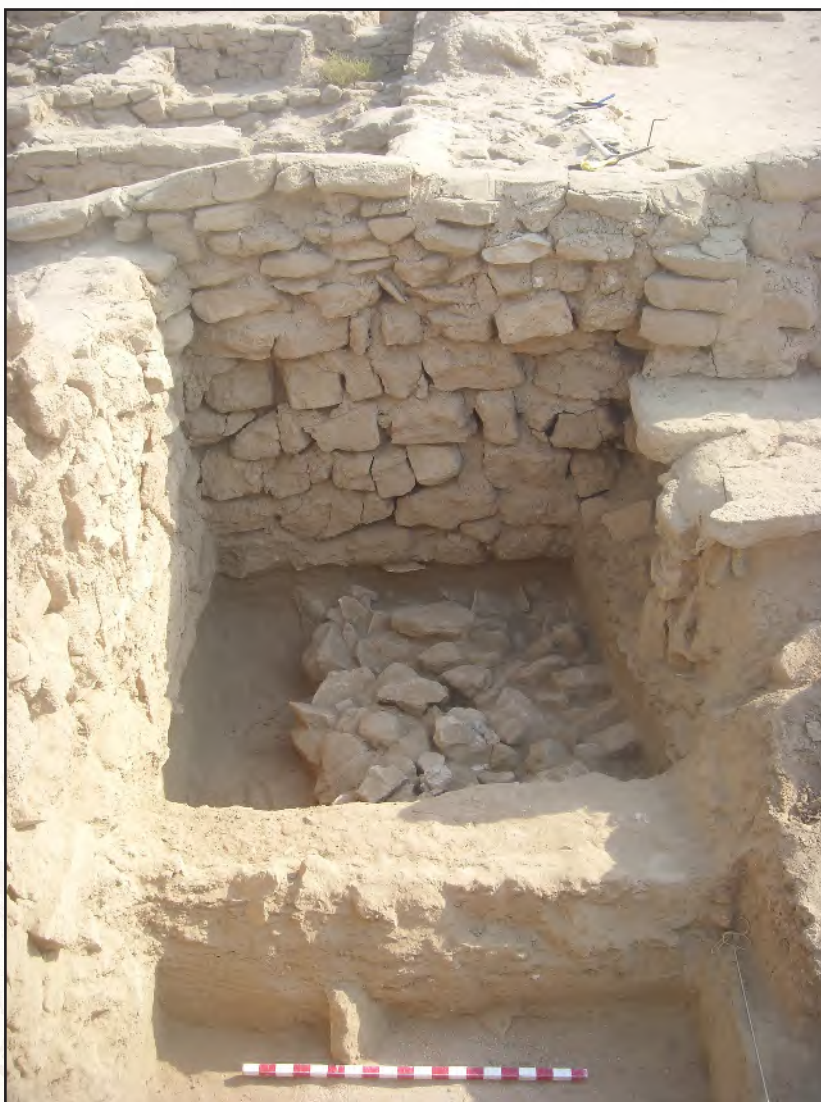
Tower 6, the rubble preparation layer under the south rampart, penetrating inside the tower. In the west half of the tower (below in the picture), it doesn't exist. View to the east.

from the east, it goes directly through the south gate (tower 6), following the line of the rampart without considering the east wall of the tower. Does this mean that the original plan of the fortress included the tower 4, but that the tower 6 was not planned, or planned to be on a western location ? In C3 sector, we also observed that the rubble layer doesn't exist under the west wall of the tower 3 or under east and west walls of tower 2. Does this signify that these towers have been planned after the rampart construction ?

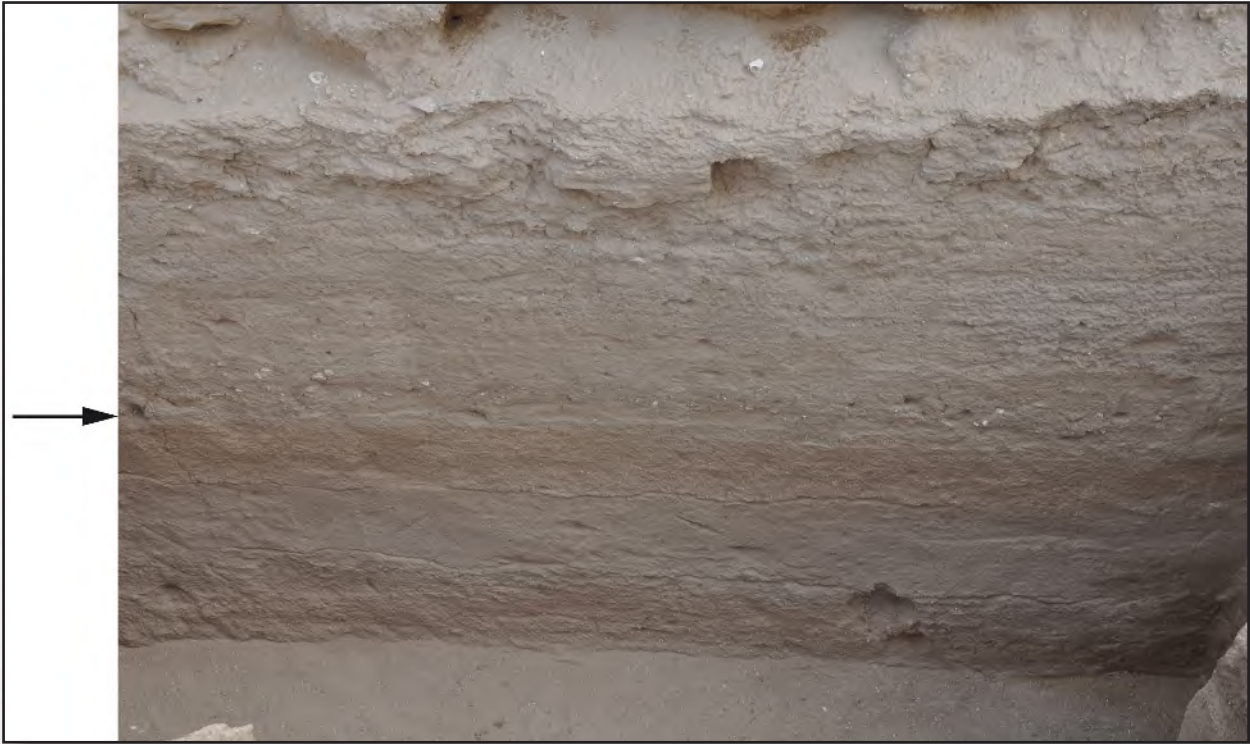
The nearly horizontal sand layer, inside which the **rubble layer** has been put. C22 east baulk.

The use of a sand layer in foundations of a building appears to be a usual practice in antic constructions from Arabian Peninsula, as in Shabwa in Yemen, and generally in sandy areas, as in Egypt¹⁶. It takes the appearance of a unique layer, thick or not, specially put for this purpose. But the combination of the rubble layer with the sand one, in the limits of my knowledge, has not been seen before : either the sand layer exists, alone, or a rubble layer exists directly under the wall, alone. It seems that this could be a particularity in Failaka. And another particularity is that here, this sand layer is naturally present, probably put by the sea, and seems to have been exploited just because it was naturally thick and with a regular horizontal level, as it is seen in the east part of the site¹⁷.

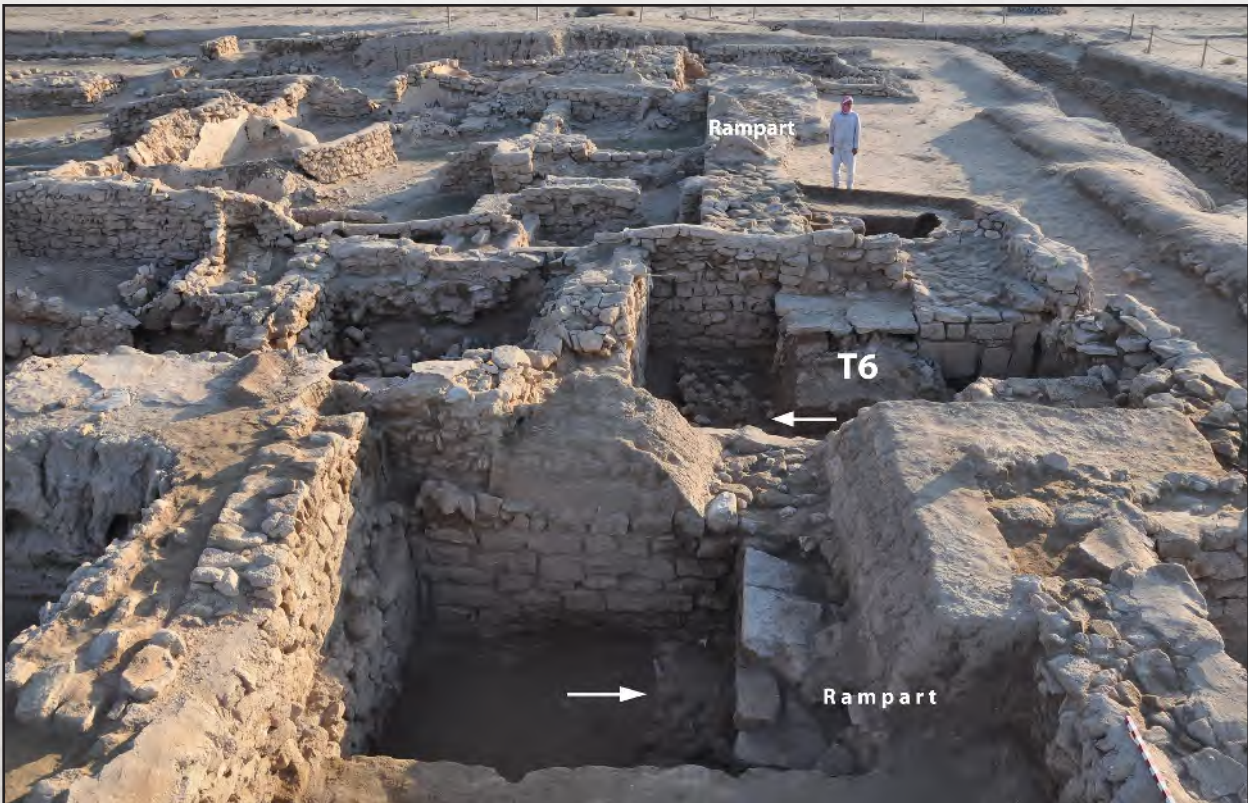
General view of the south rampart, showing the **rubble layer** under the line of the wall (white arrows). On the first plan, the mud bricks elevation of the rampart has been partly destroyed by ancient excavations. View to the east.

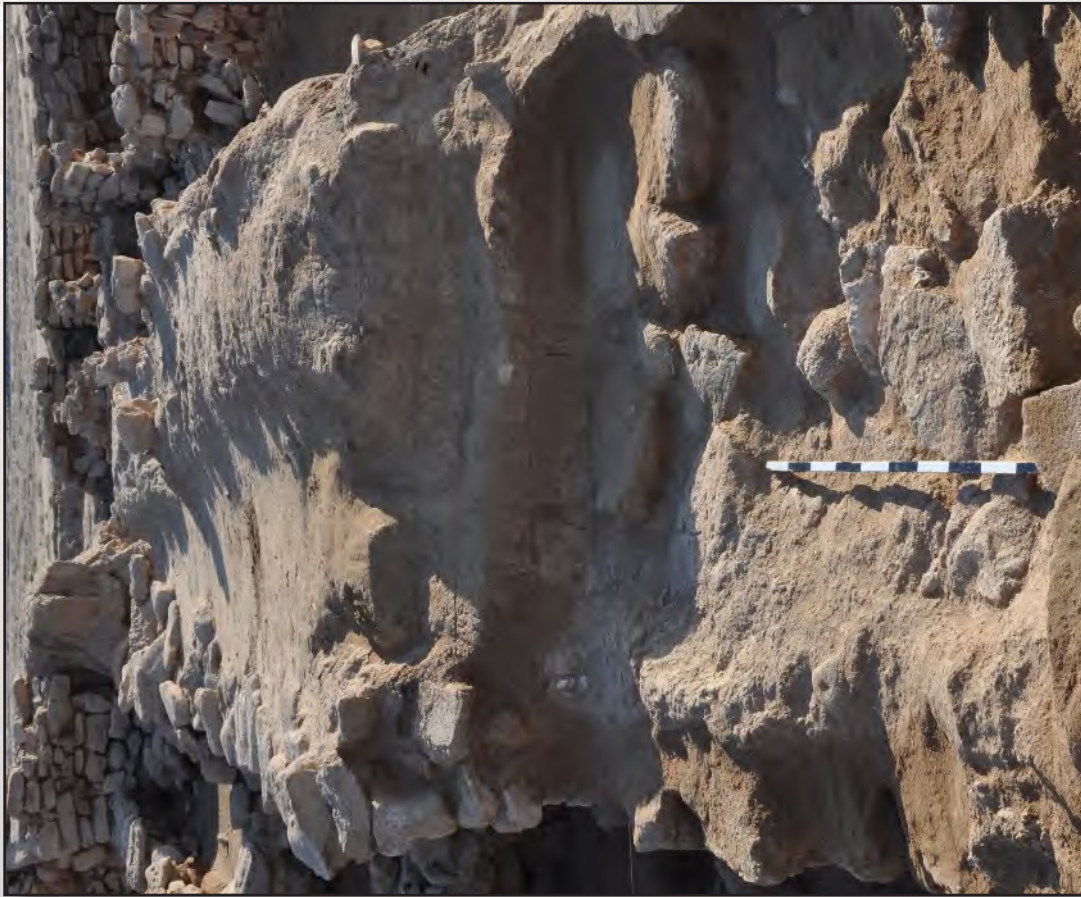
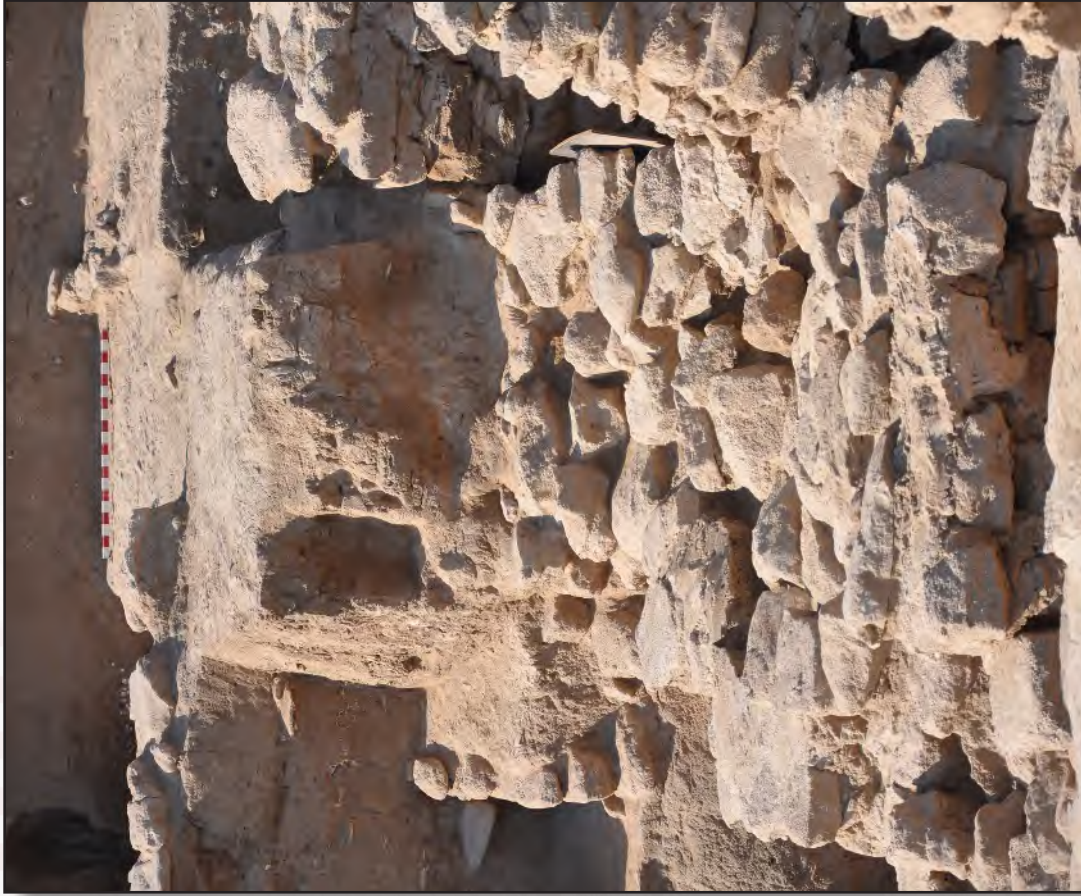
Mud brick elevation of the first rampart. **Left**, in C3, the outer face is protected by a stone face. **Right**, in A2/A1

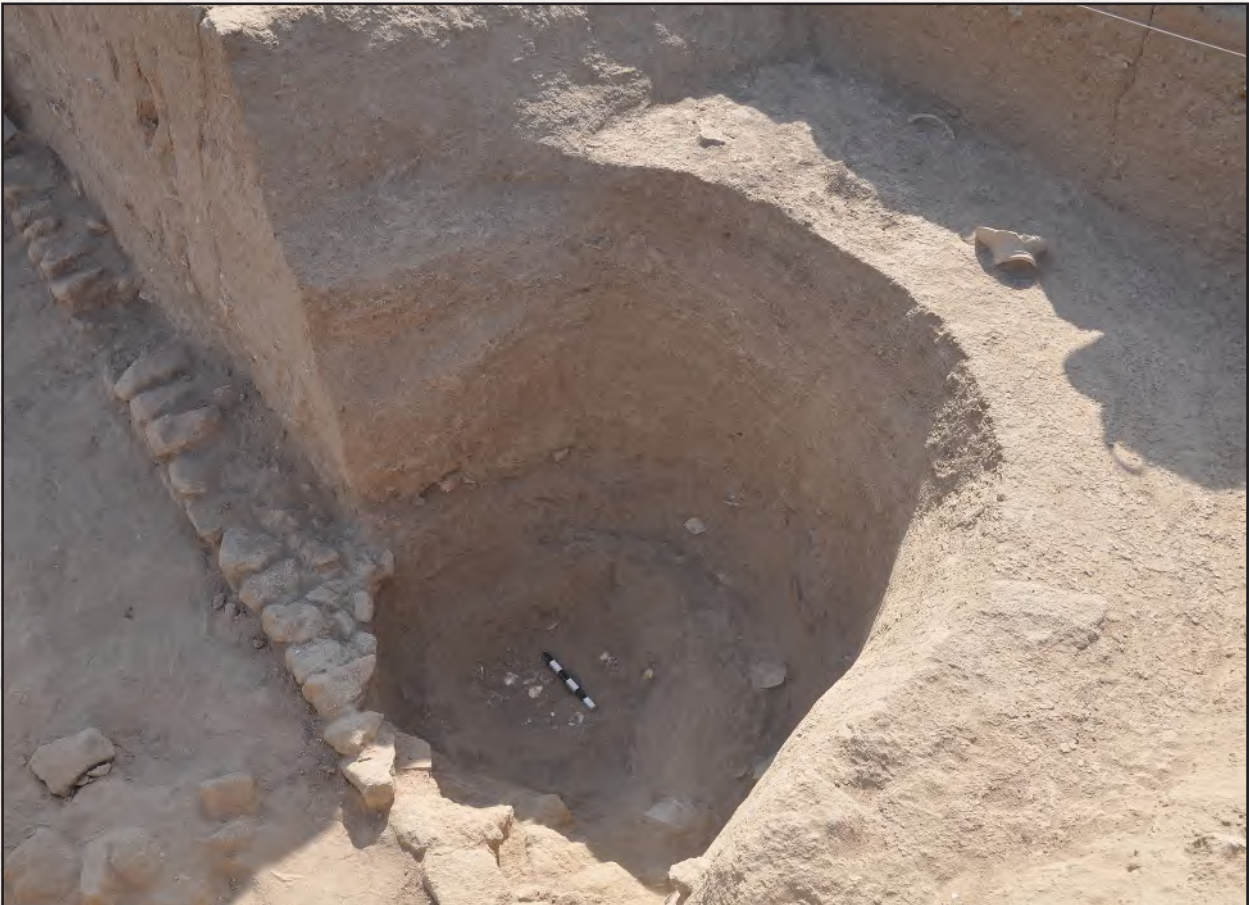
A1, the modern pit A1-F08-3, which was full of shells. It destroyed the wall M342 (below), which is part of the bent-axe defense system. View to the south-west.

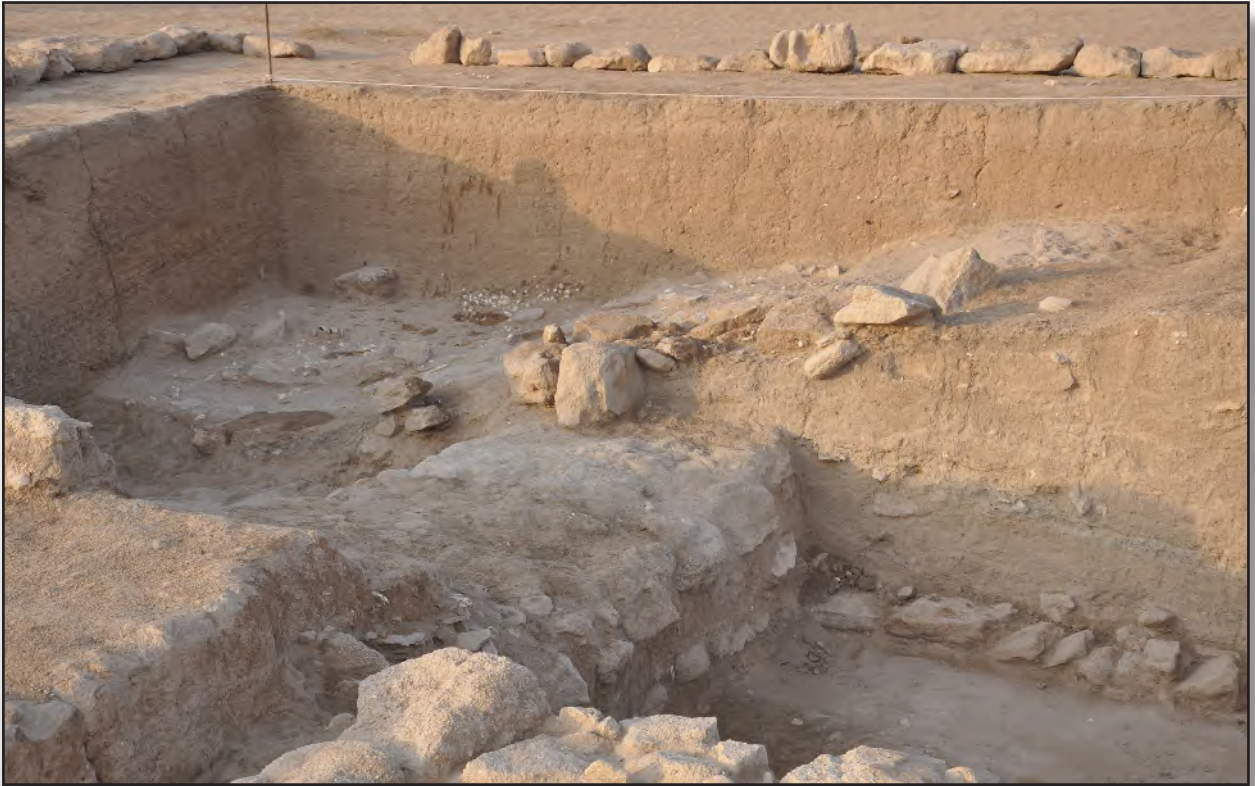
A1, the pit A1-F09-2, located in the south-west angle of the sounding, which destroyed part of the first rampart elevation (the fallen stones are in the pit). On the first plan, the first rampart. View to the south-west.

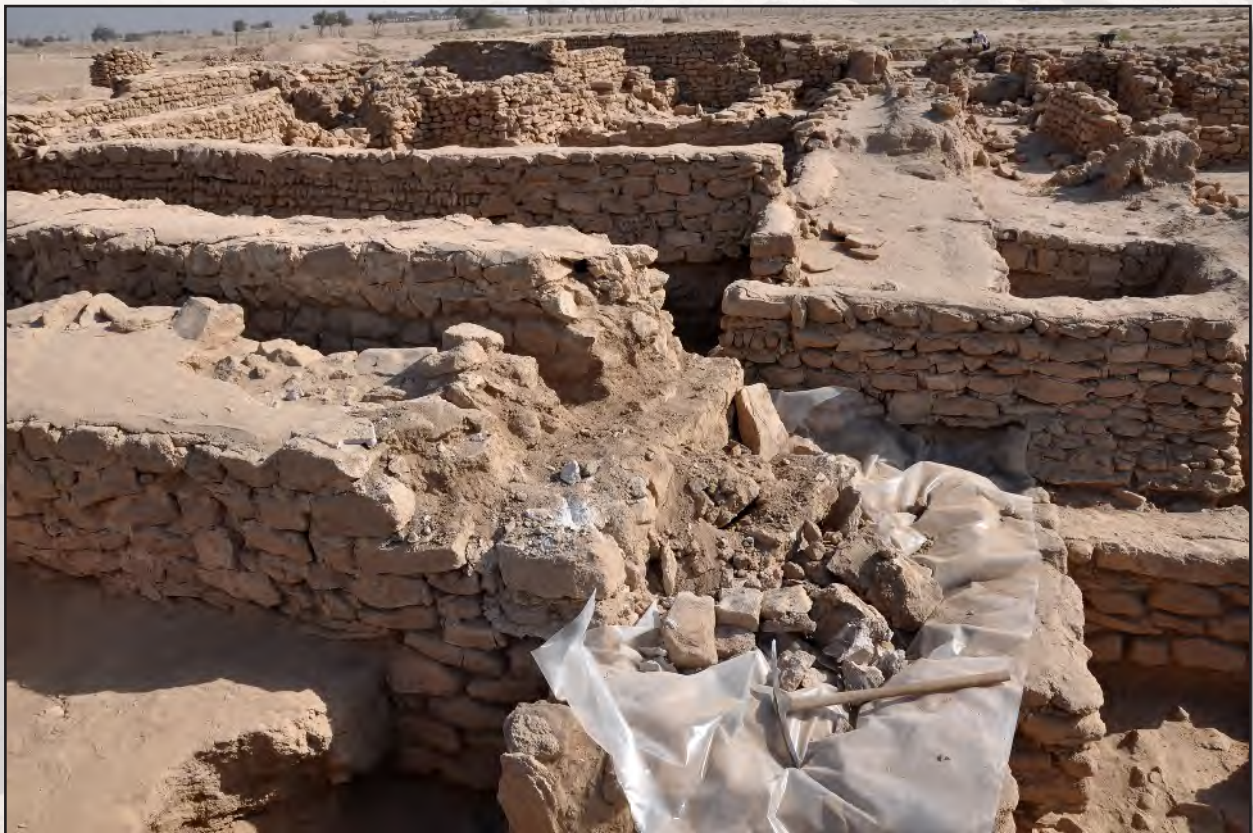
A2. Removal of the cemented wall which was linking the tower 2 (on the left) and the latest corridor wall M301, to reconstitute the state after ancient excavations. The cemented wall M348C, just after the nylon, has been removed too. View to the east.

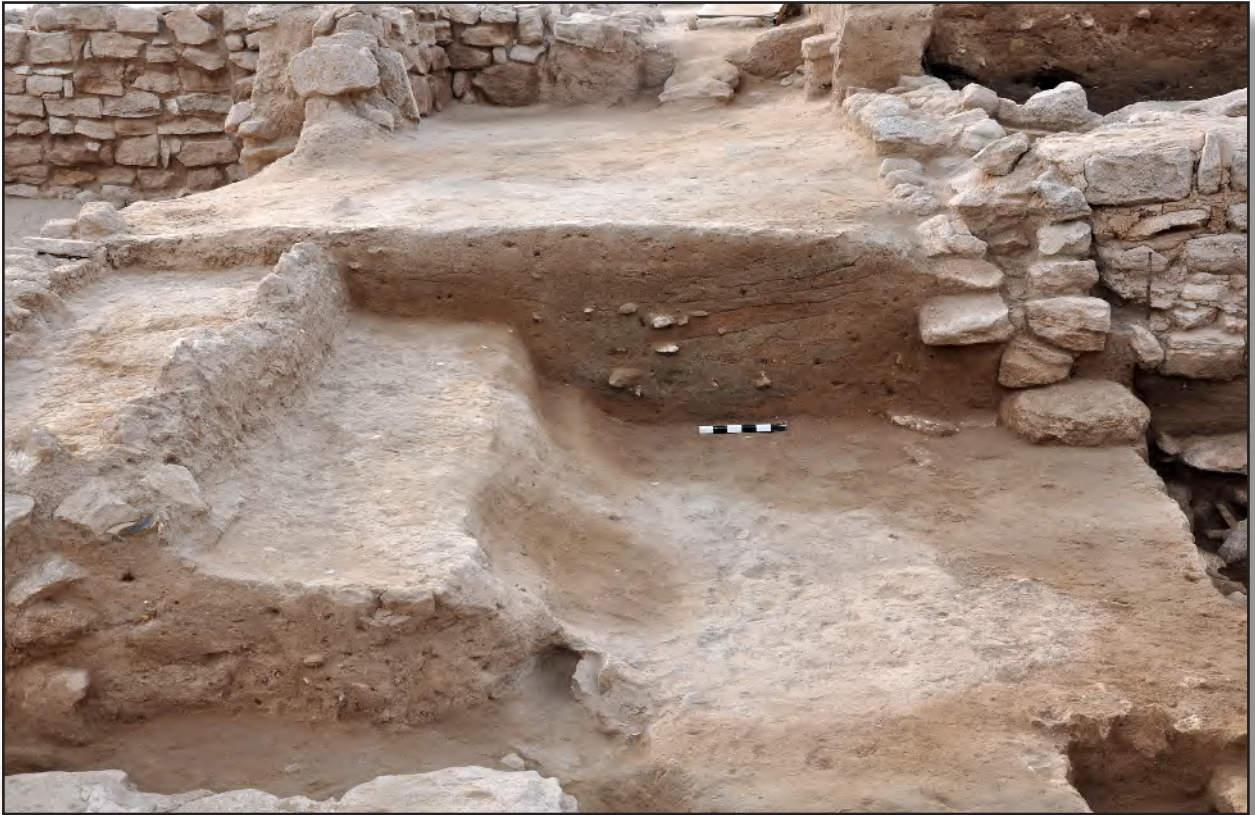
A2, the south baulk above the N-S street. Notice the alternance of green and red layers with a curved profile. On the right, M346, on the left M351 ; on the extreme right, "false wall". View to the south.

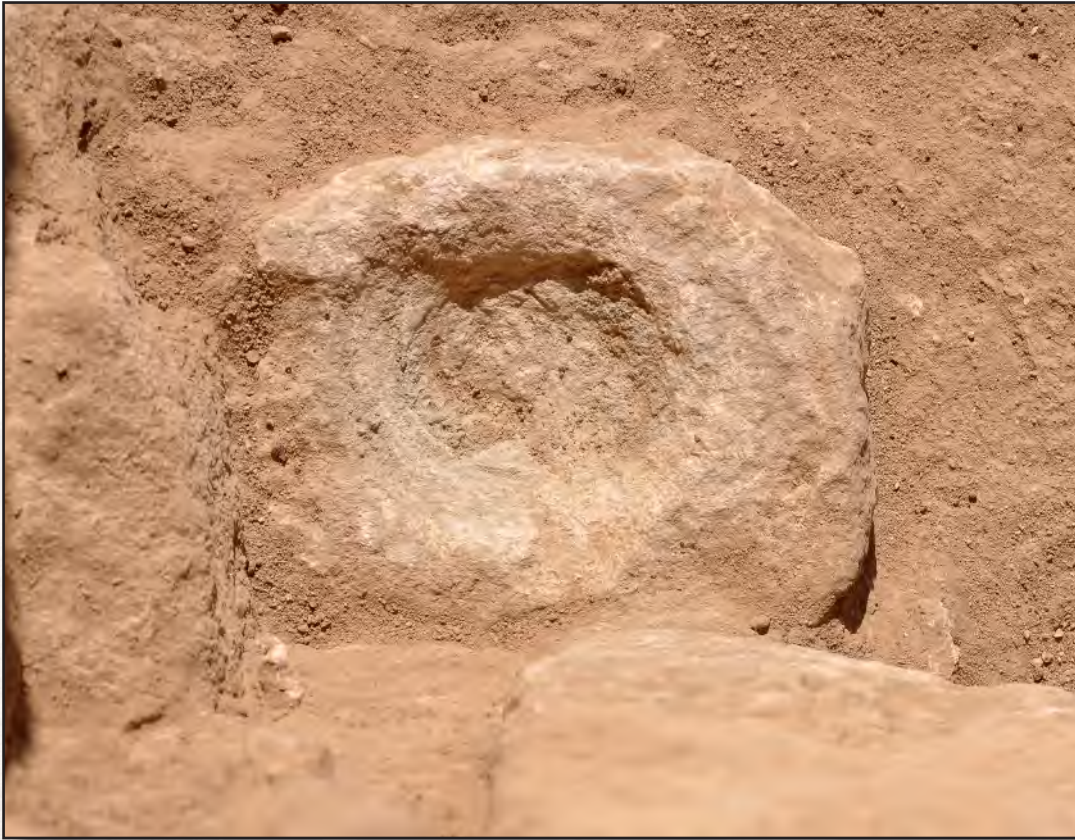
A2, the north gate of the first rampart. Detail of the door socket.

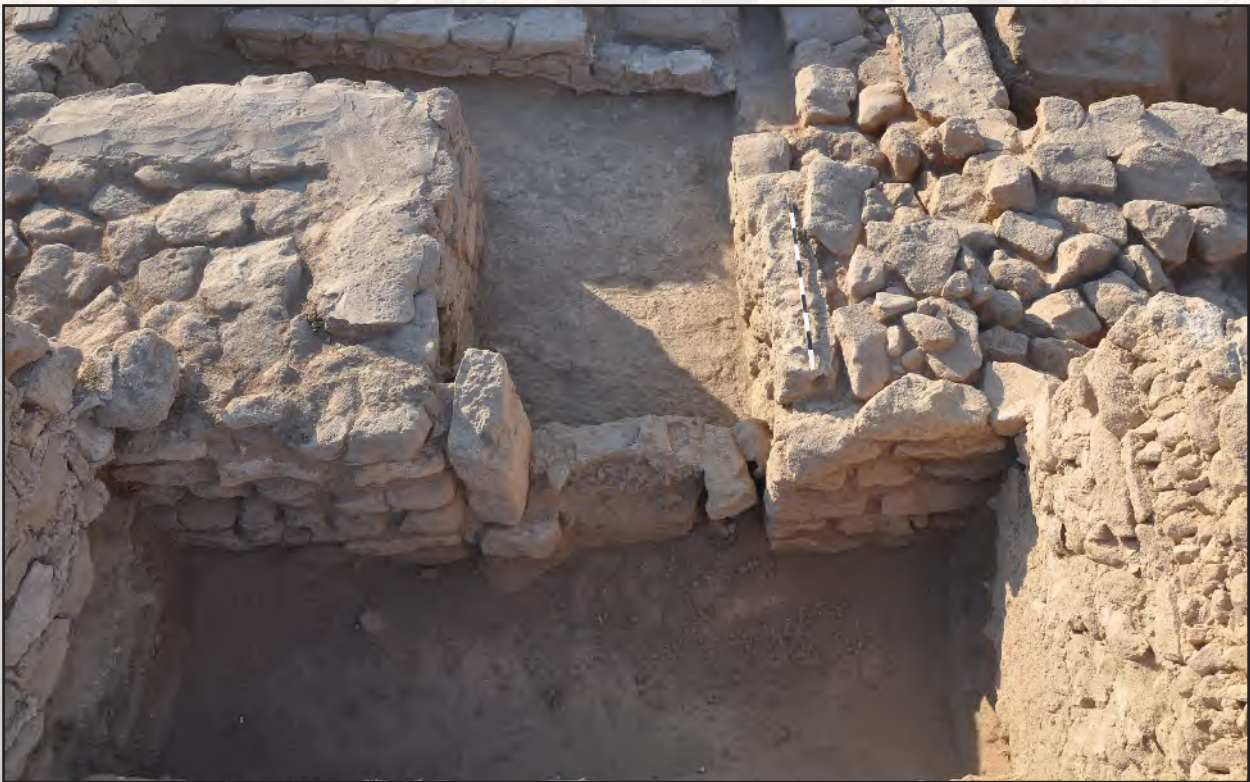
A2, the north gate of the first rampart. The threshold has been cemented in modern period. On the first plan, an ancient deep sounding. View to the south.

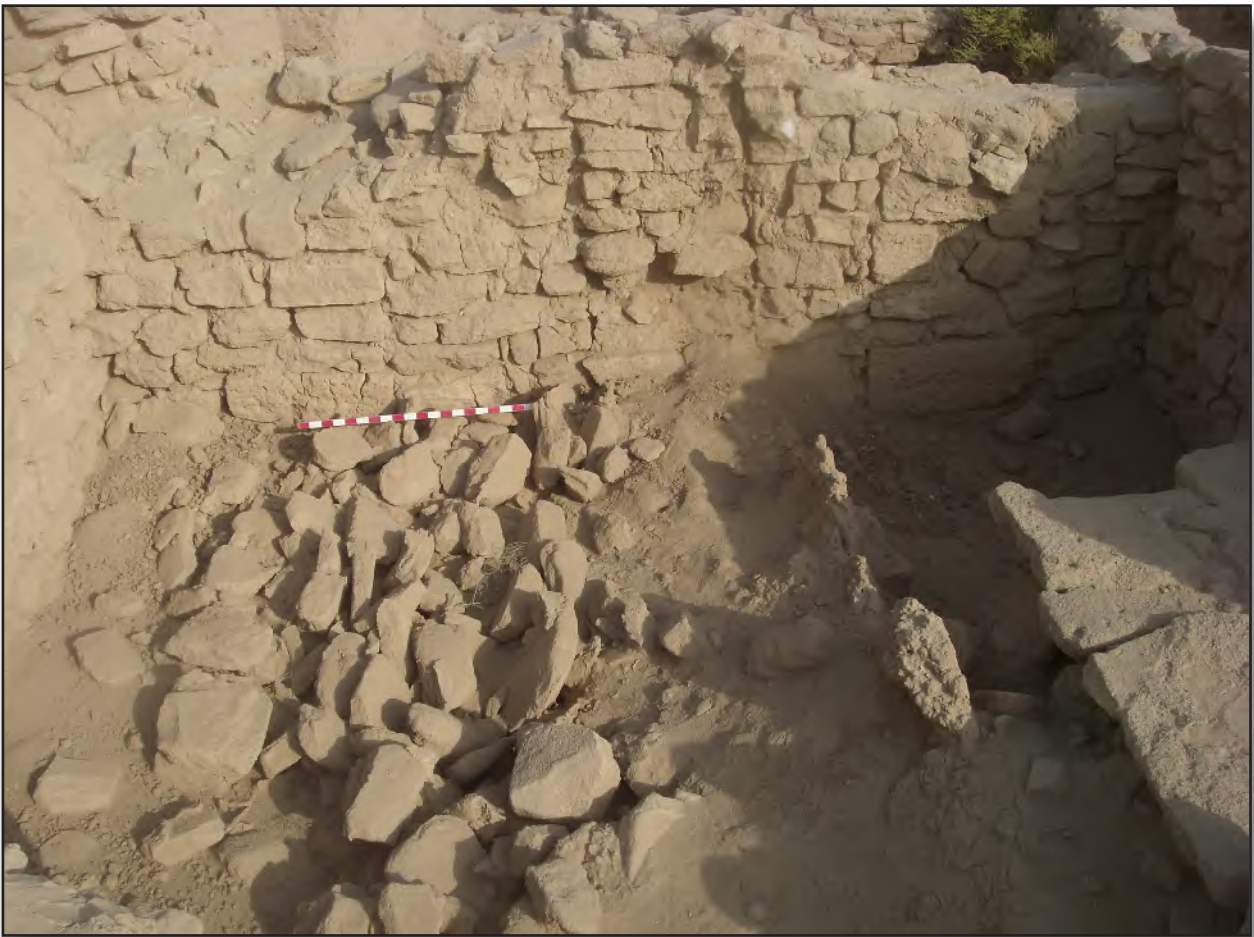
B sector, tower 6 before work. The collapse of the wall M354. View to the north.

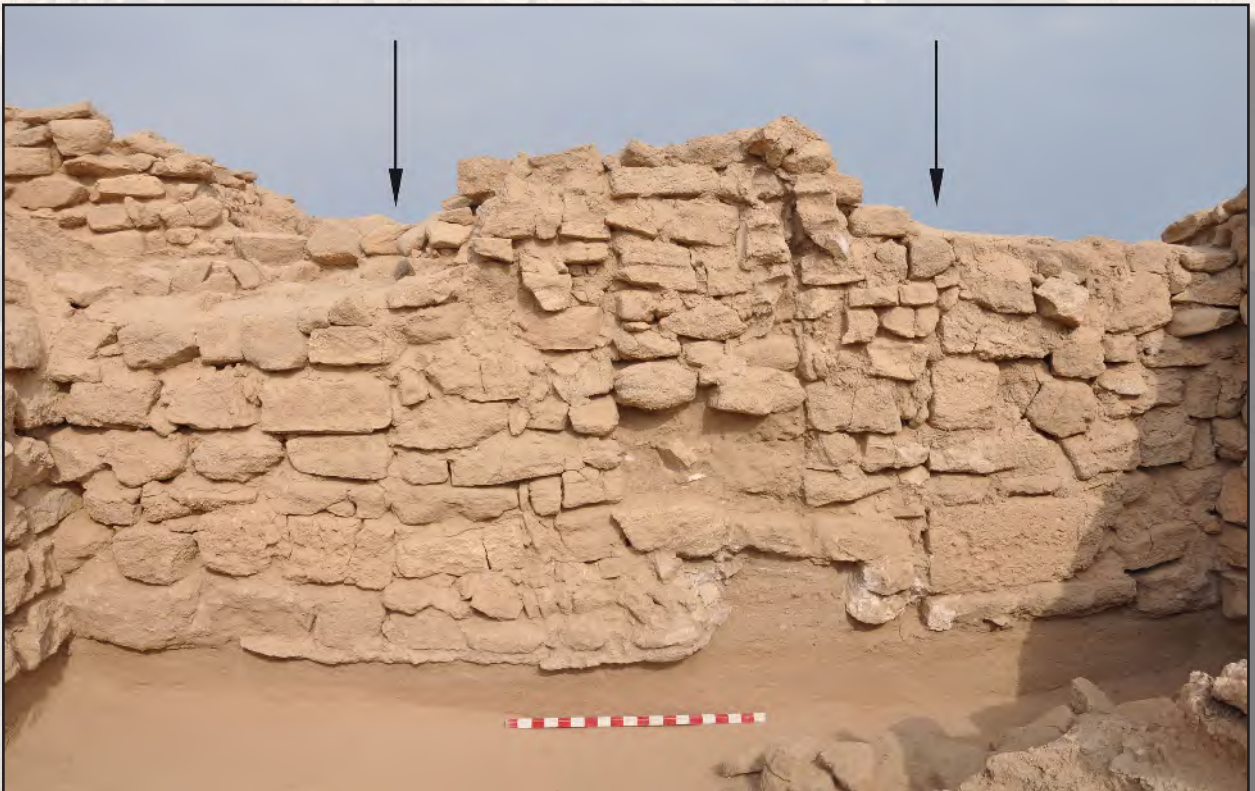
B sector, tower 6. The north door and the two fill-in ; the arrows show the first entrance. View to the north.
