Kuwaiti-French Expedition in Failaka. The Hellenistic Fortress (Tell Saïd). Preliminary Scientific Report 2009

Mathilde Gelin, Shehab A.H. Shehab, Abdallah Alaeddine, Ahmad Deb,
Jean-Michel Gelin, Shaker Al-Shbib

KUWAITI-FRENCH EXPEDITION IN FAILAKA
THE HELLENISTIC FORTRESS (Tell Saïd)
Preliminary Scientific Report 2009

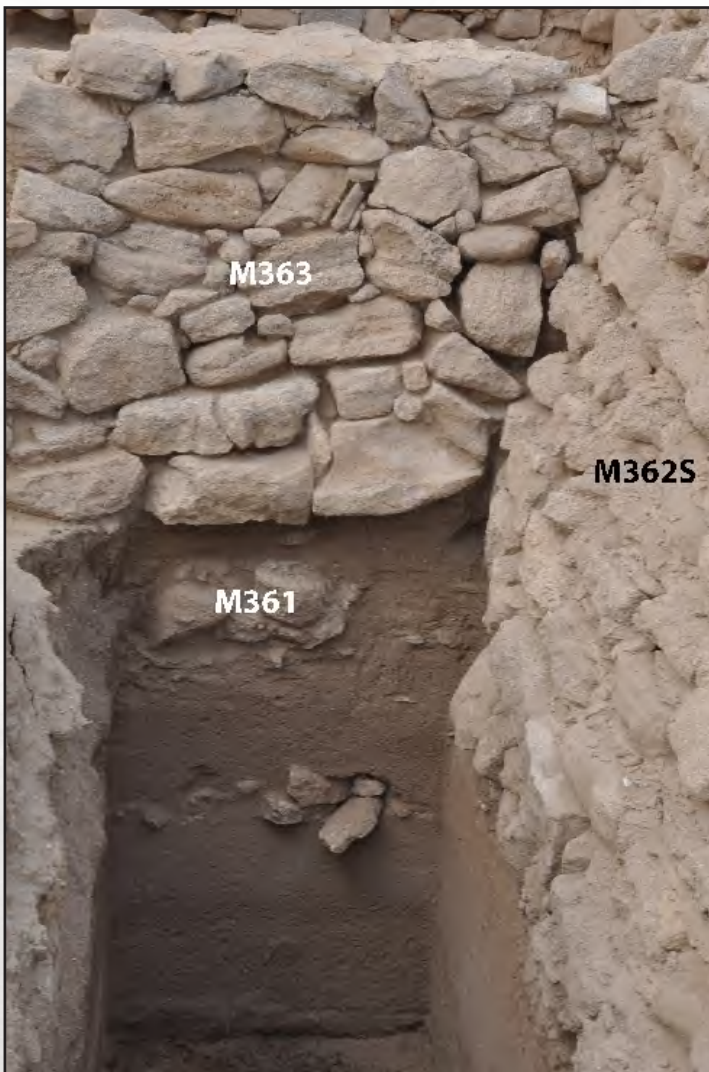
Sounding C21. Below, the stones are part of the rubble foundation layer of the rampart. Above, the reinforcement (M363) of the rampart, running against the one (M362S) of tower 4. Under it, some cemented stones. View to the west.

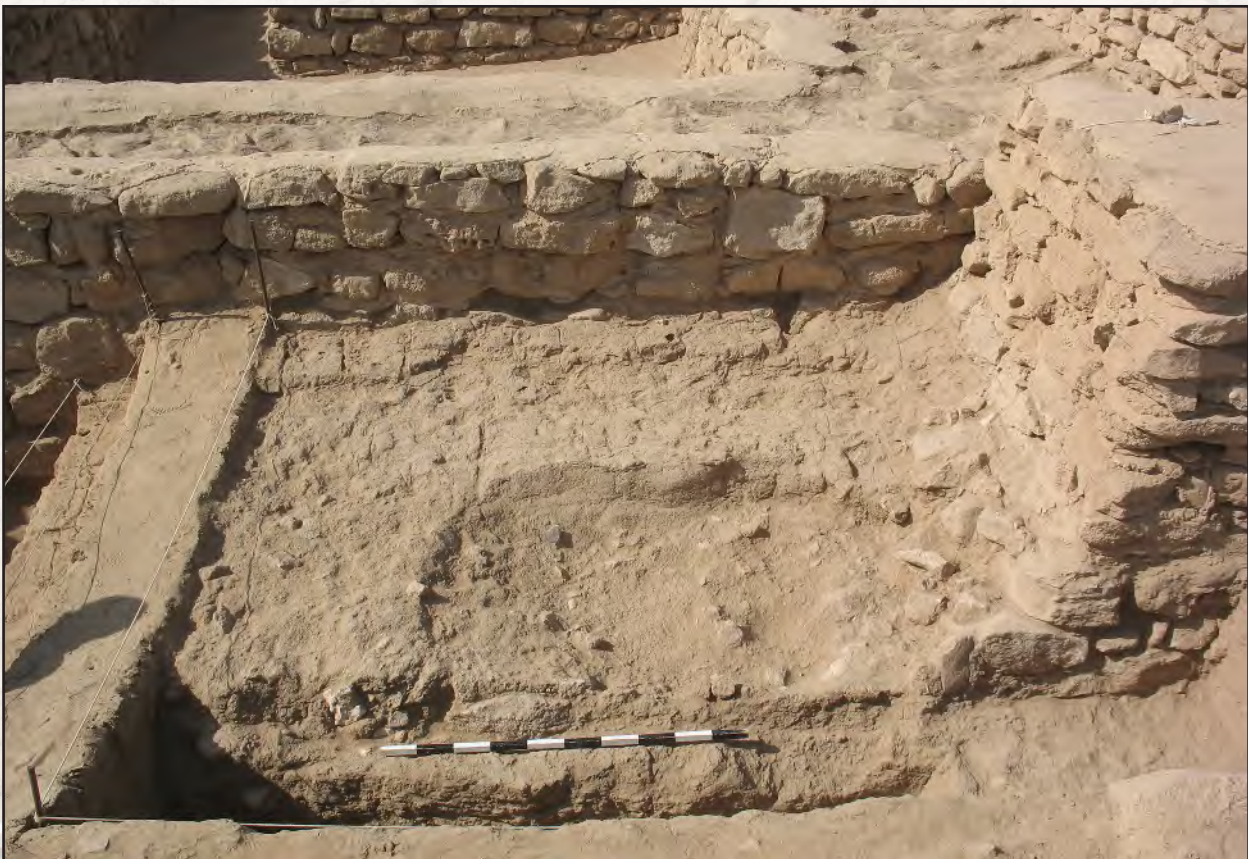
Sounding C11. The mud brick construction M359 (reinforcement ?) against tower 4. A pit has been dug inside, then it has been destroyed to install the stones reinforcement M362N visible on the right. View to the west.

At the eastern part of the fortress, another mud brick wall M359, located outside the ramparts, has been found in the C1 sector, against the east wall of the tower 4 (north-east angle of the first rampart, see below "Archaeological study of C11 and C12 soundings"). This wall comes after the tower, as it rests against it, and as its foundation level is higher. But it comes before the reinforcement M362 built in ashlar masonry (rubble) which surrounds the whole tower, as this one stands on the mud brick wall. Unfortunately, this mud brick wall has been destroyed in its eastern and southern parts, by the reinforcement and by the ancient excavations, so it is impossible to determine precisely its original thickness. It seems to have been a little bit thicker than an habitation wall (which is usually maximum two bricks thick) and could then be associated to a sooner reinforcement of the tower. The later reinforcement has been destroyed exactly at the same place.

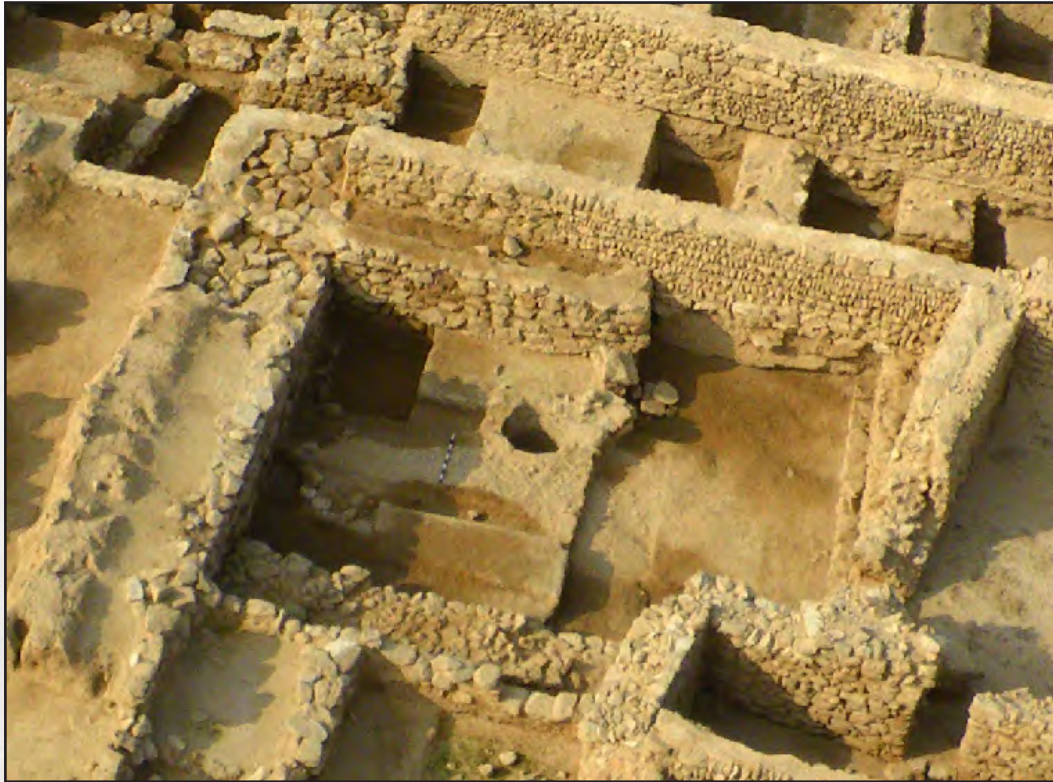
C3 sector.
The possible tower 3 remains mainly with its west wall M306 ; it has probably been destroyed to install the bent-axis walls and the place used as a courtyard. View to the west. Picture Y. Guichard © DAM Kuwait.

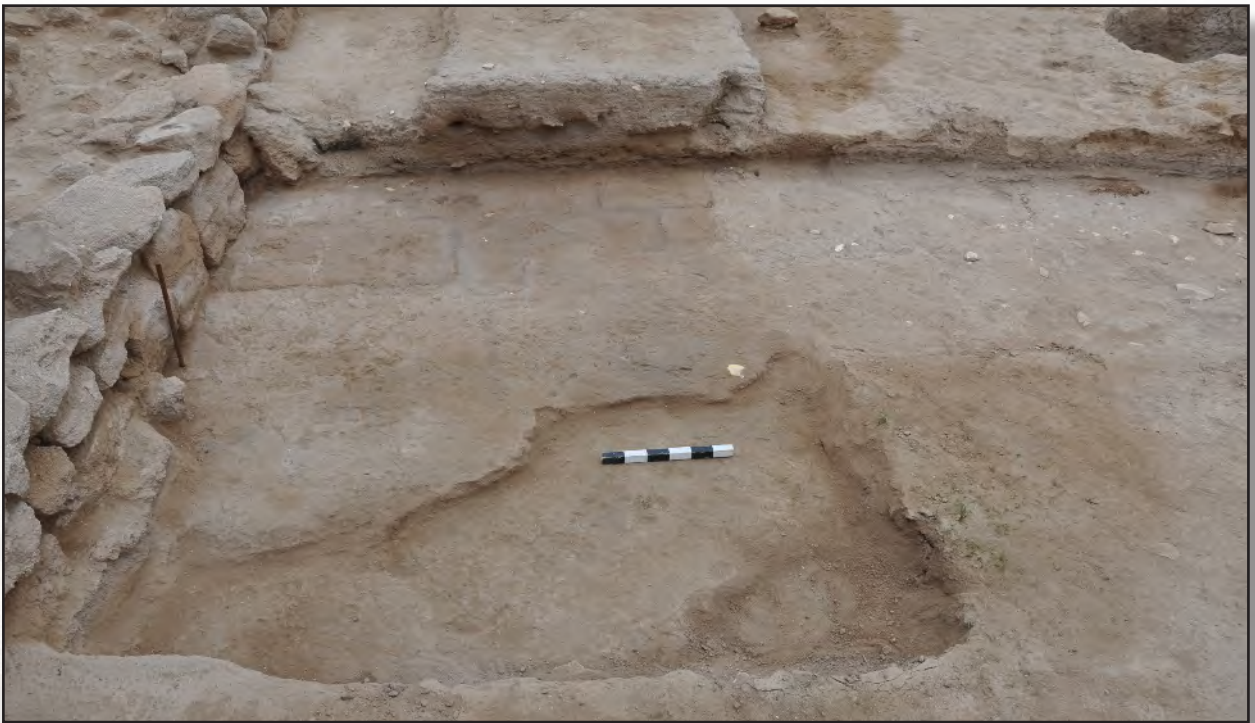
C3 sector. The mud brick wall M365, which pre-existed to the bent-axis wall M273 (on the left). This wall is maybe our unique witness of an installation occurring before the Hellenistic fortress, or of an advanced defense linked with the first rampart. View to the south.

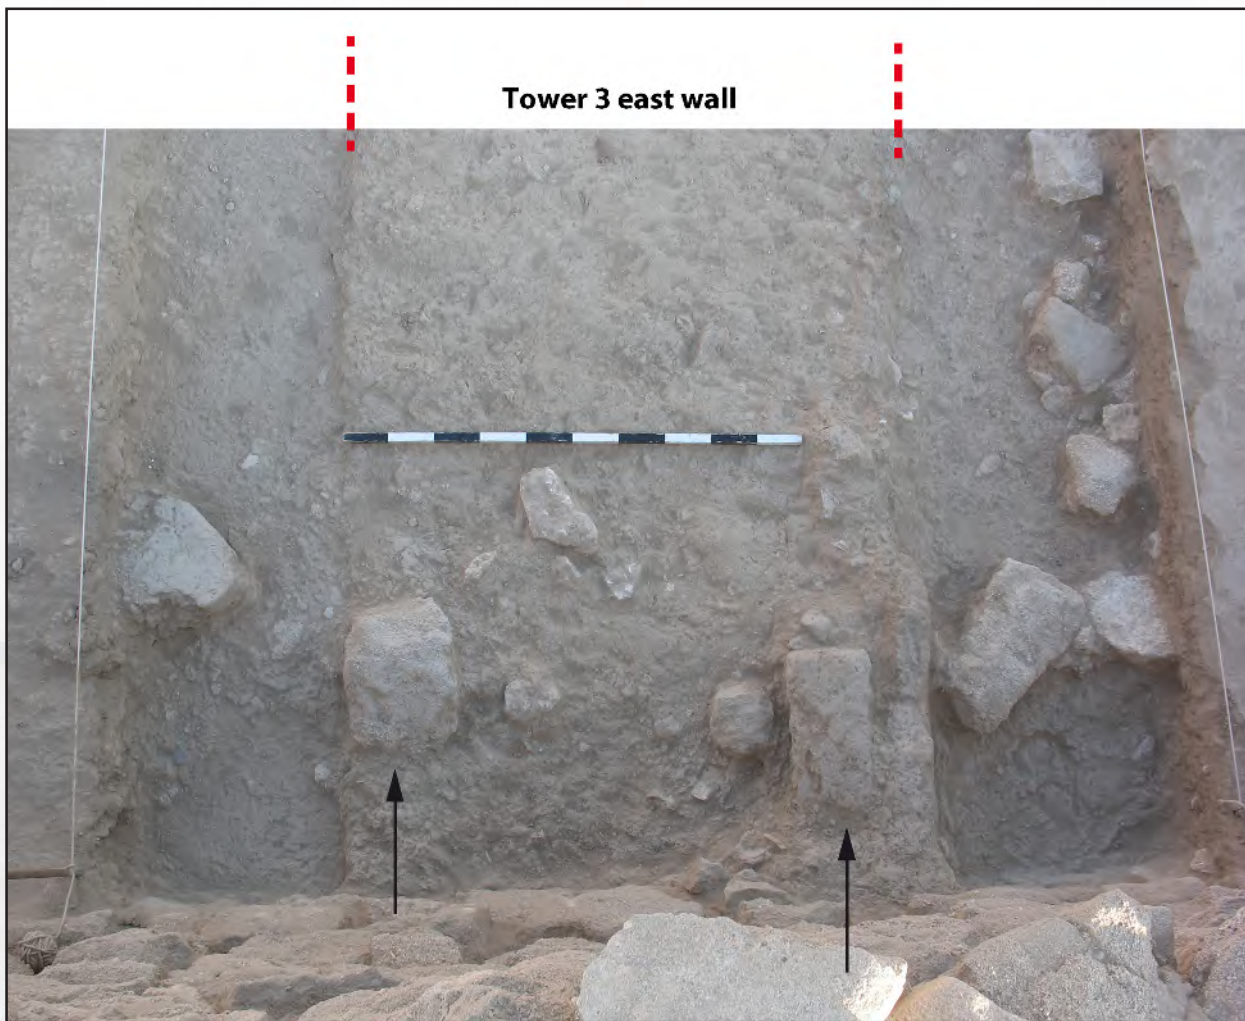
Tower 3 east wall

C3 sector. The stone against the rampart (on the left) is probably the only remain from the inner face of the tower 3 east wall. The red lines represent the limits of the east wall. On the right, mud bricks from a probably later wall.
