## **Kuwaiti-French Expedition in Failaka. The Hellenistic Fortress (Tell Saïd). Preliminary Scientific Report 2009**

**KUWAITI-FRENCH EXPEDITION IN FAILAKA**  
**THE HELLENISTIC FORTRESS (Tell Saïd)**  
**Preliminary Scientific Report 2009**

**2012**

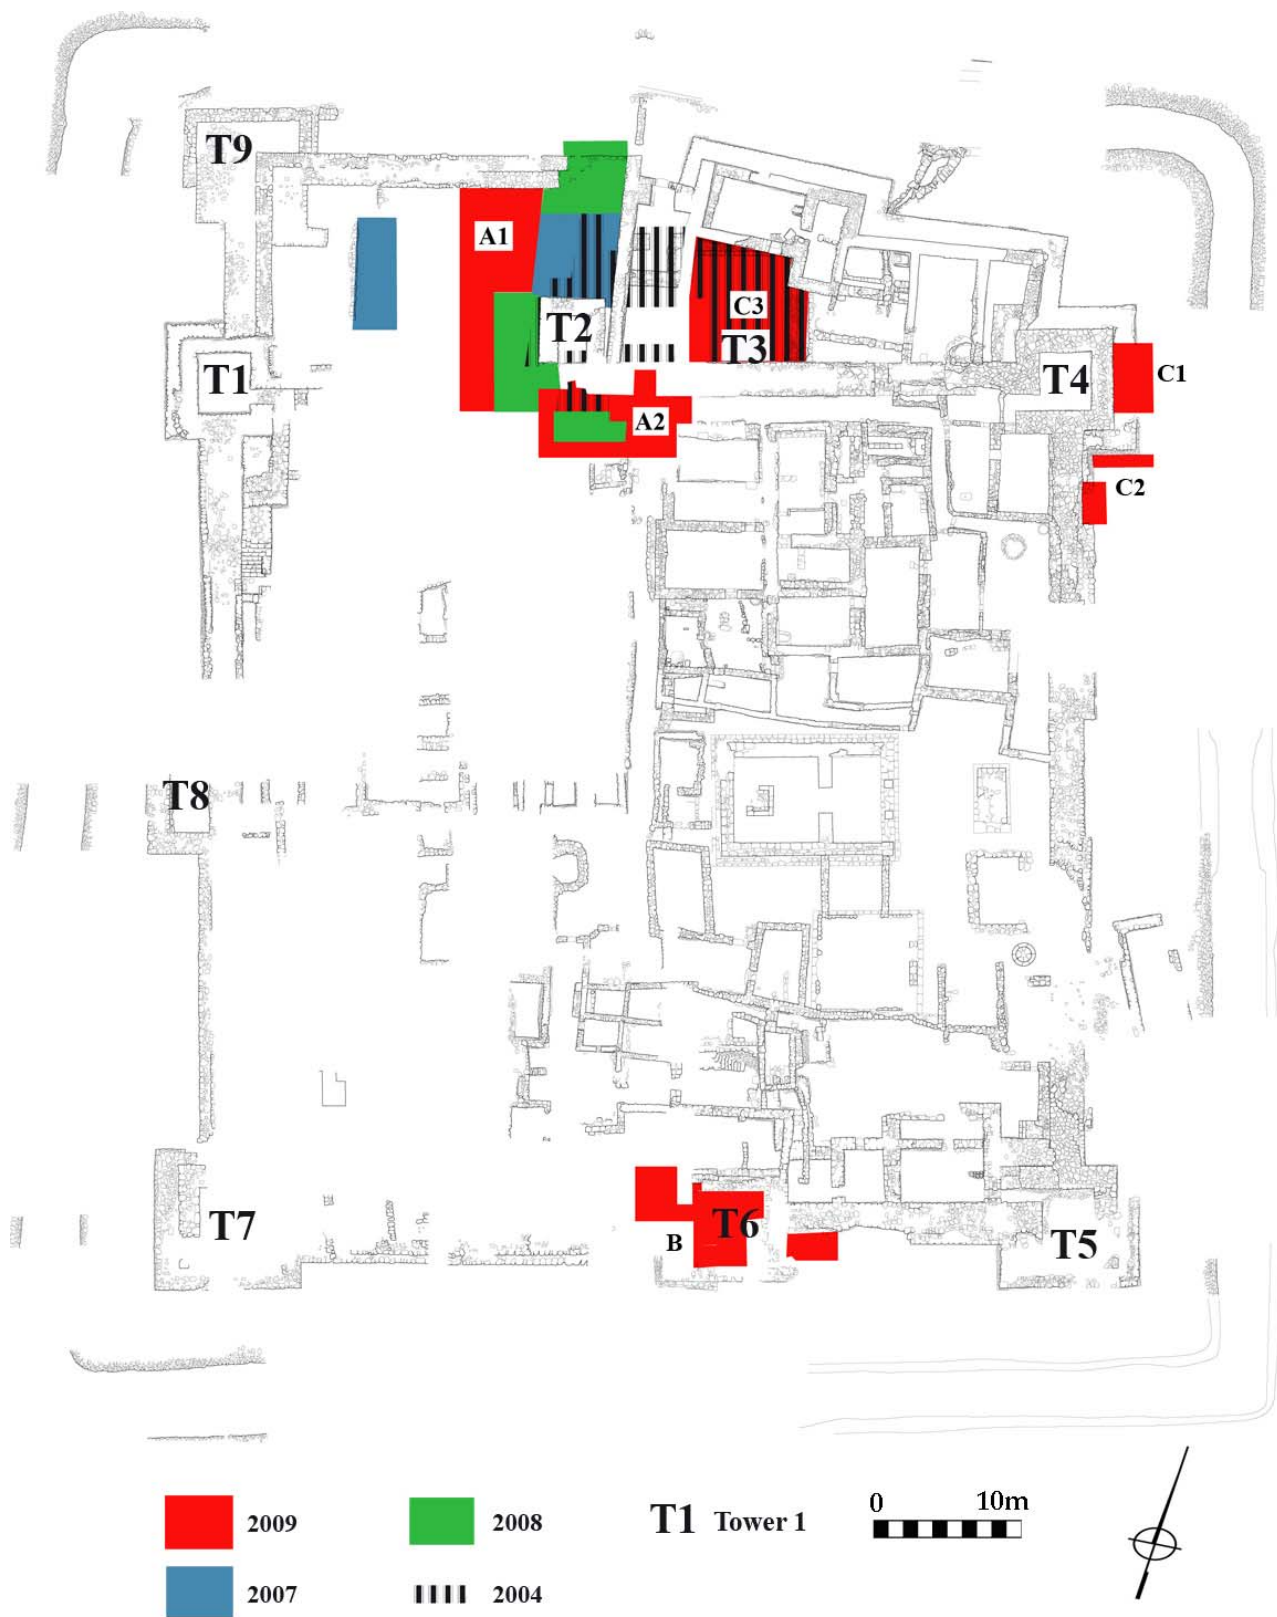
Localization of the fieldworks and towers numbers. After O. Callot.

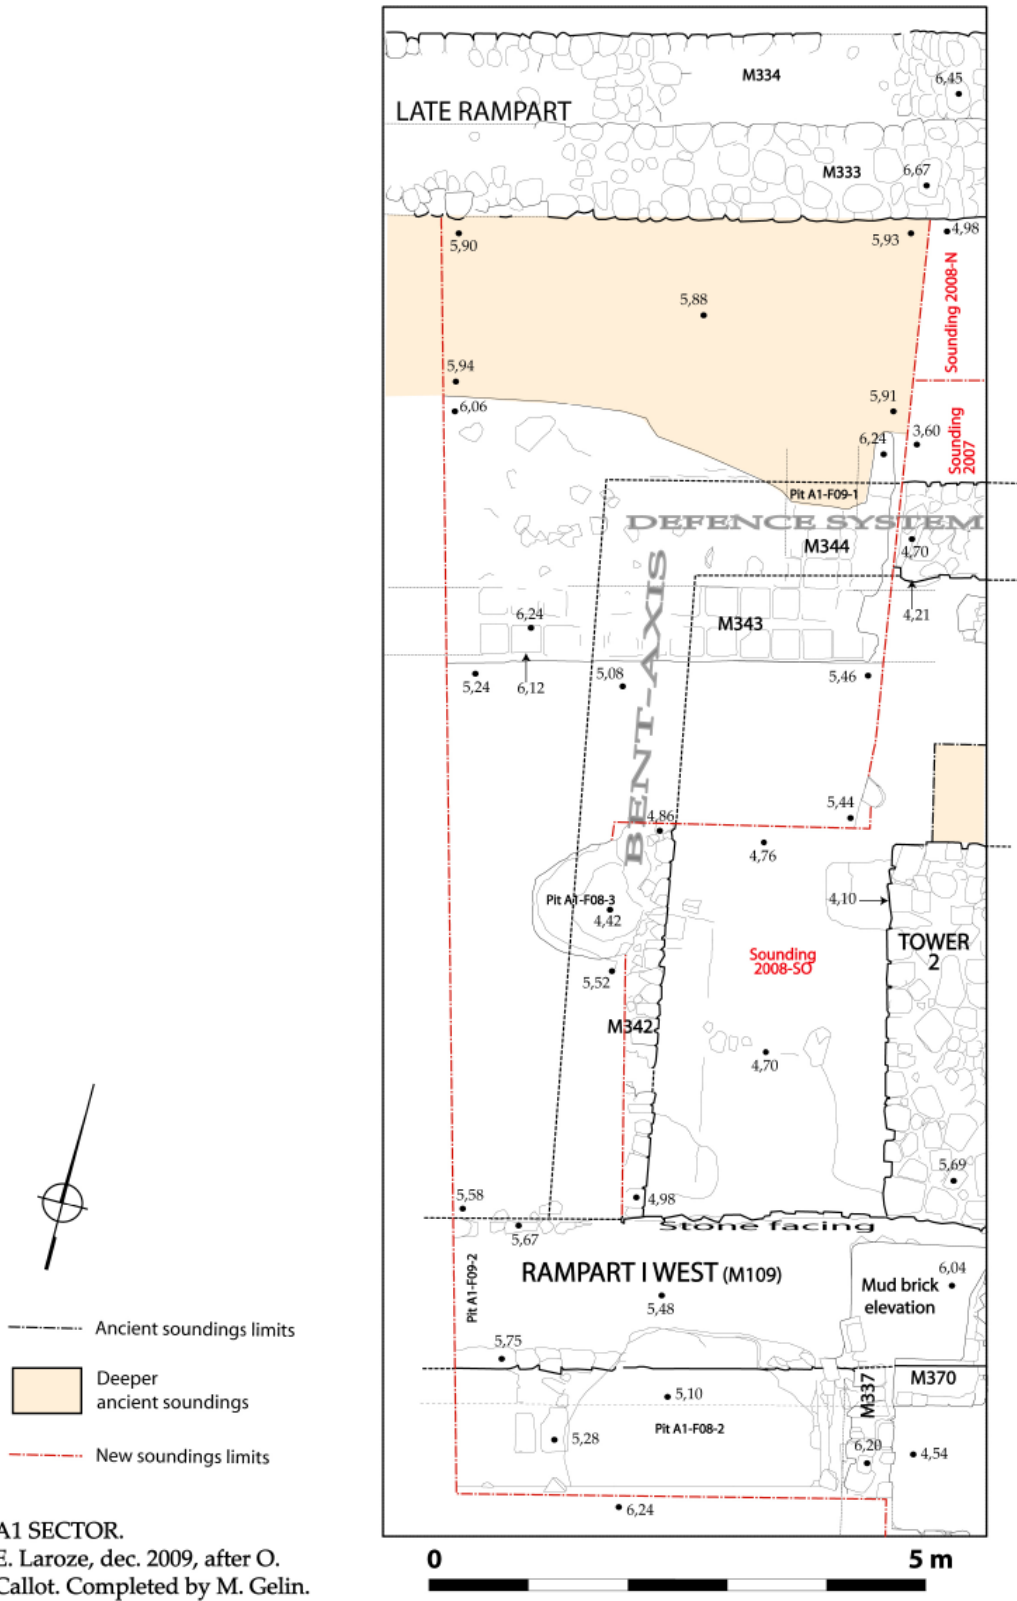
A1 SECTOR.  
 E. Laroze, dec. 2009, after O.  
 Callot. Completed by M. Gelin.

In sector A1 north side, we found a layer interpreted as a modern soil, S09-01, made of mud ; near the pit A1-F08-3, it was covered by shells associated to the pit. Under this layer, two late mud bricks walls were discovered in bad conservation status. Only one course of mud bricks is preserved and no foundation has been put in place, as the walls lay directly on the soil. The direction of the first mud brick structure M343 is E-W and seems to be the extension of the wall M328 which has been discovered in 2007 in the trench 2007-2, and still existing under accumulations located between the trenches. It has been destroyed in its east part, by ancient excavators' trench (cleaned in 2007), and at its west part by the same ancient work (cleaned in 2007). In the west section of the trench 07-1, another line of mud brick appeared and was confirmed by the discovery of a second wall M344, perpendicular to M343 and linked with at its eastern side. The wall M344 has been cut in its northern part, by the ancient expedition trench dug along the last north rampart (see ancient photo).

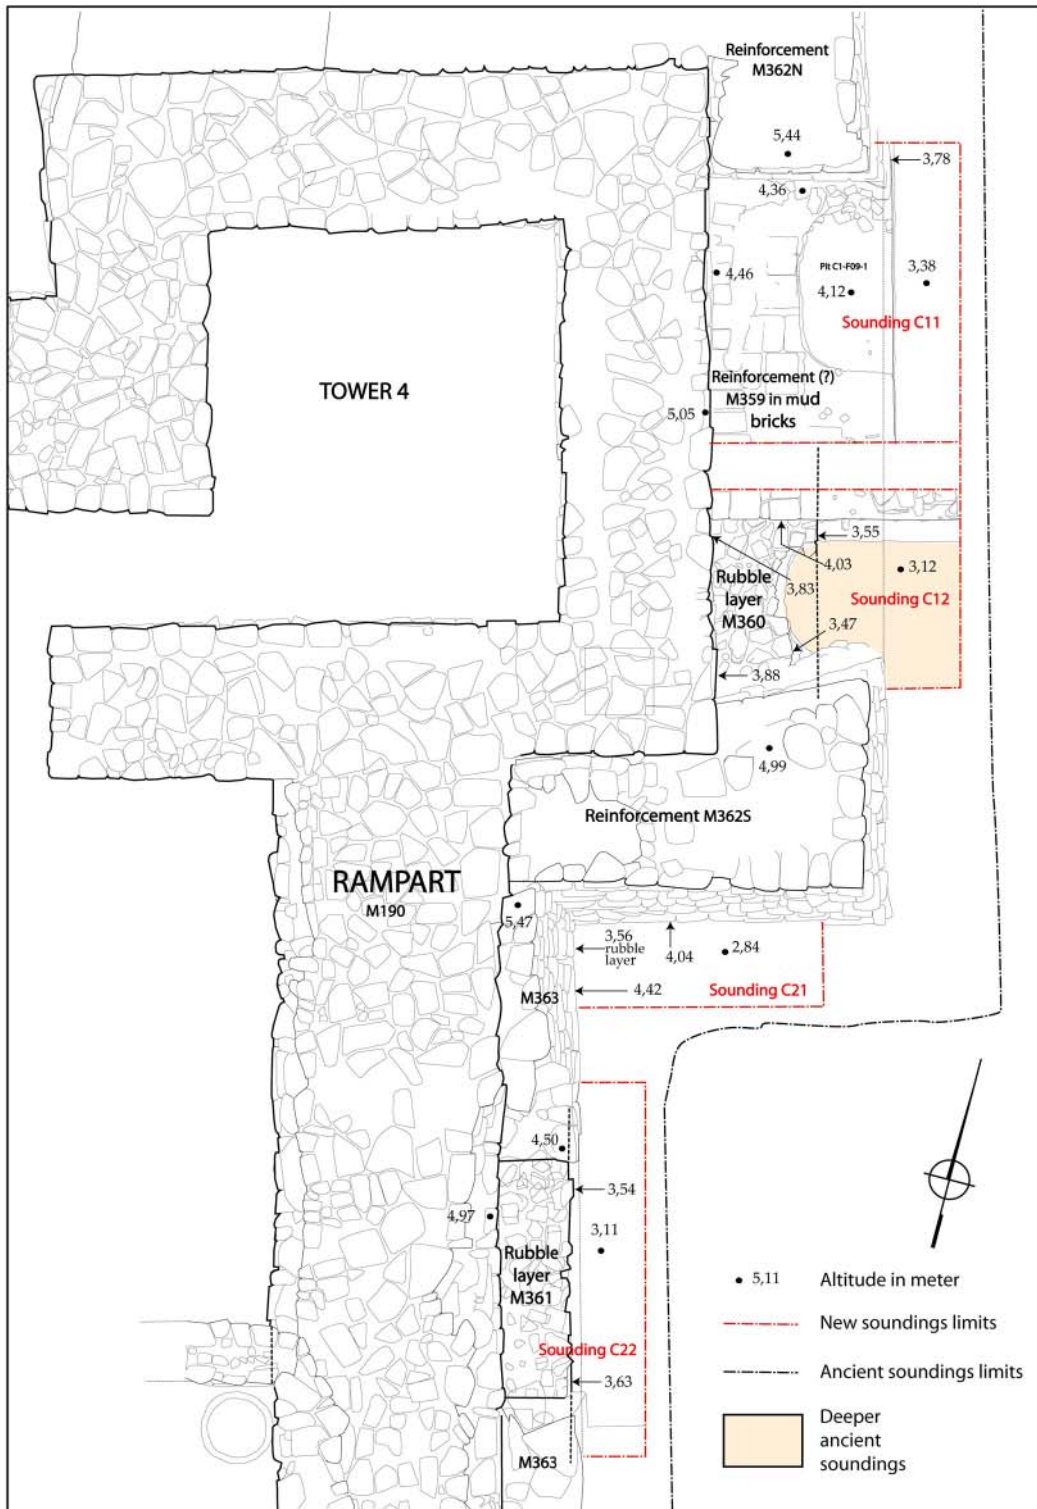
C1 AND C2 SECTORS.  
E. Laroze, dec. 2009, after O. Callot.  
Completed by M. Gelin.

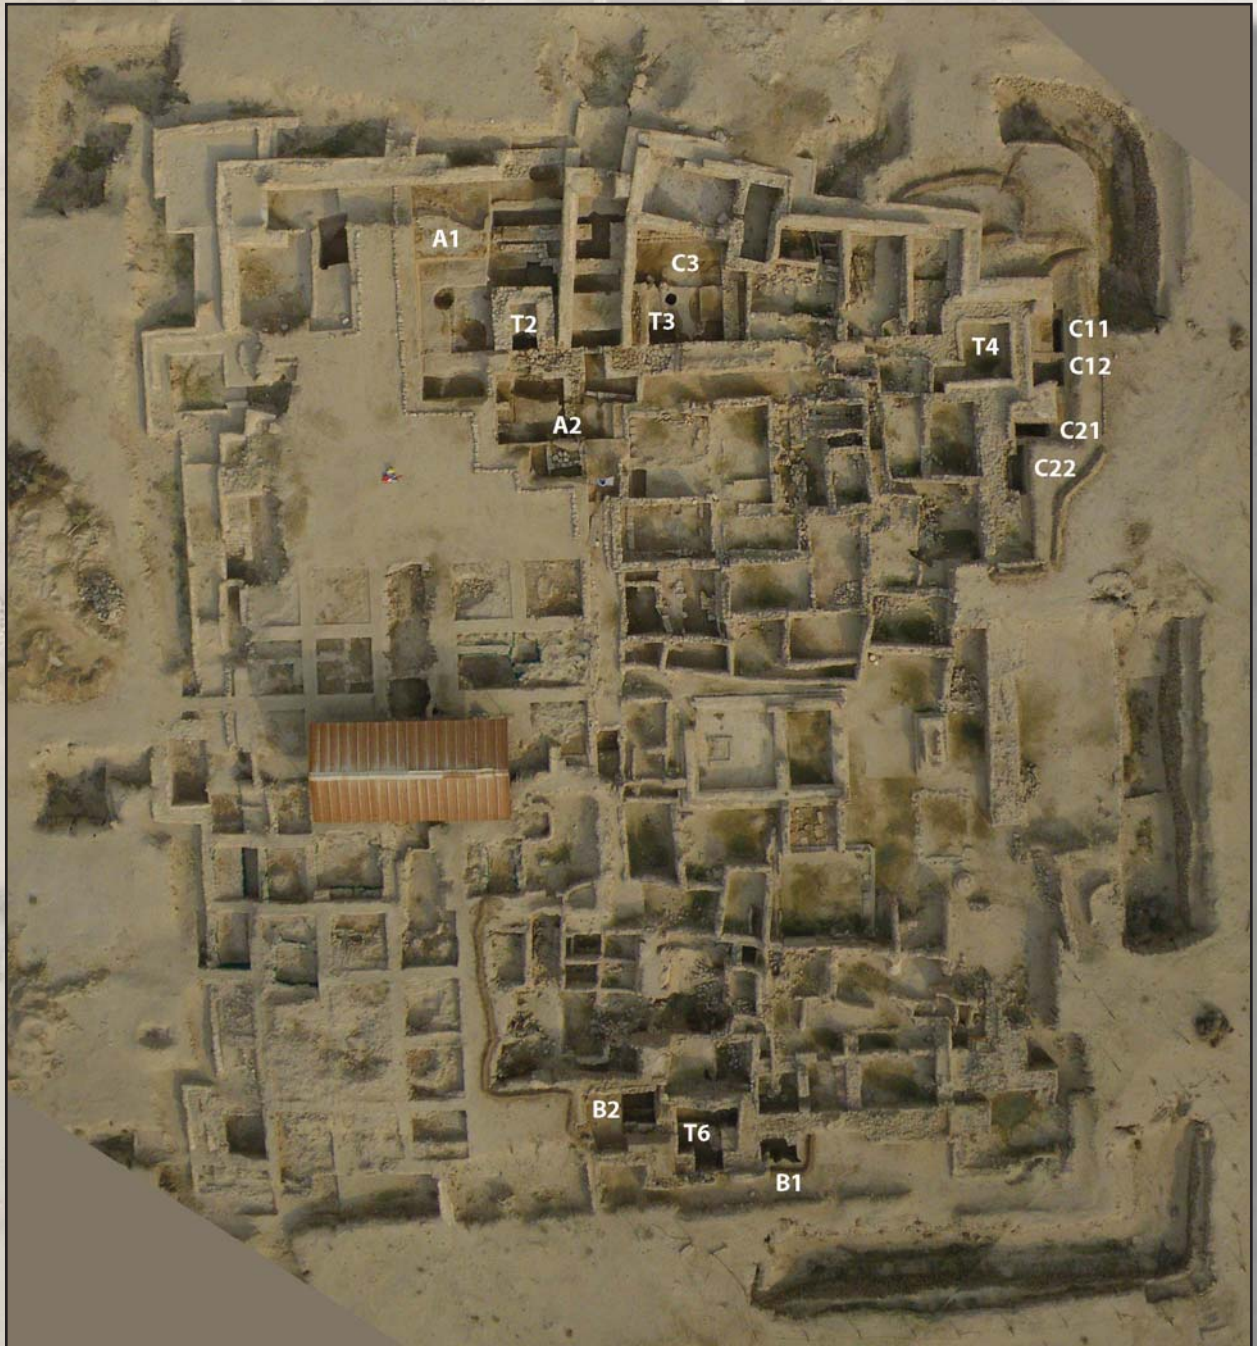
2009 campaign. Localization of soundings and towers concerned by our work.  
 Picture Y. Guichard © DAM Kuwait.

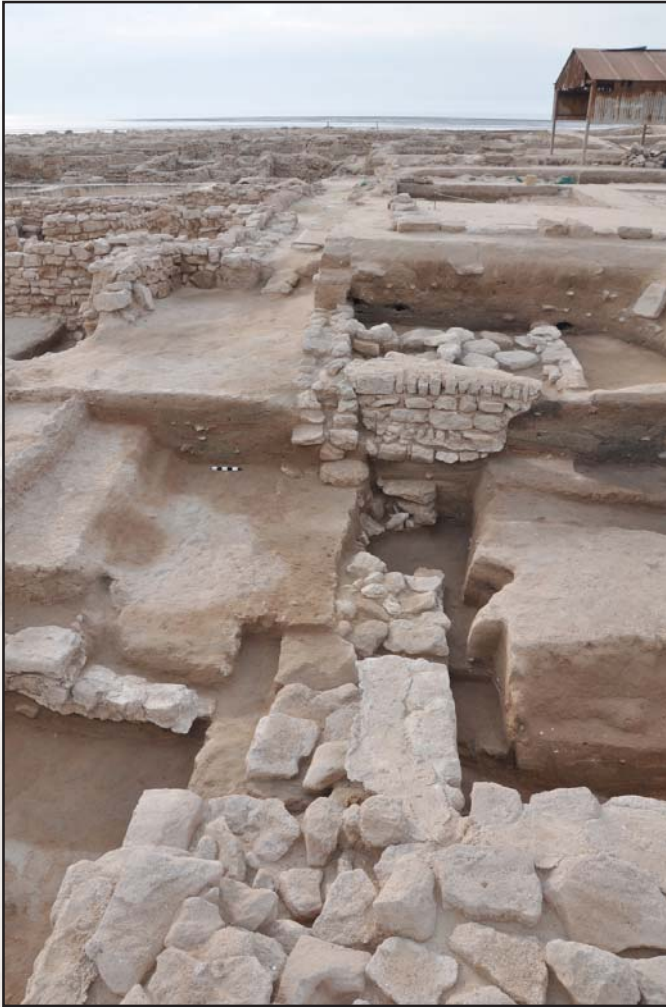
Example of **damages** caused by ancient deep soundings, destroying the links between walls and stratigraphy, view to the south. Here, the wall M320 in A2 sector, surrounded and partly destroyed by ancient soundings. At its south extremity, the baulk has been cemented, creating a modern wall ; at its junction with the rampart (first plan), the top has been cemented.

In other places in the site, the ancient trenches, which have not been filled after work, represent a lot of holes where the water and the humidity stagnate. As they have been dug on the bases of the walls and, sometimes, deeper than the walls themselves, the result is that these walls are now destabilized and may fell down.

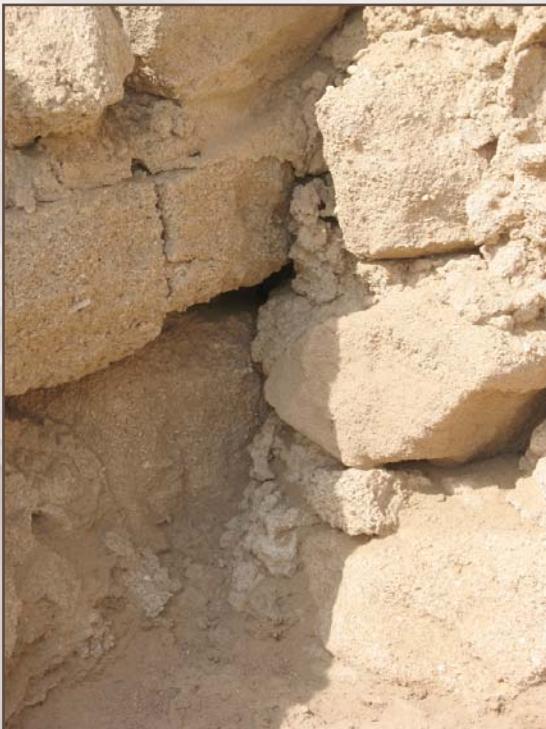
Detail of a junction between two walls. It has been totally **cemented** and the wall on the right has been partly reconstructed. The original link between these walls is now impossible to determine.

<sup>6</sup> This work is also a true danger for the ancient buildings : very often, the top of the walls has been rebuilt with a concave or "V" profile (the level is higher on the faces than on the centre), leading the water inside the masonry. One of the basic rules in restoration is, on the contrary, to evacuate water and humidity from the walls, for example with a convex or "Λ" profile on the top. Finally, the white cement put on the faces creates a barrier for air and humidity circulation, giving a great risk to rot the inside masonry.

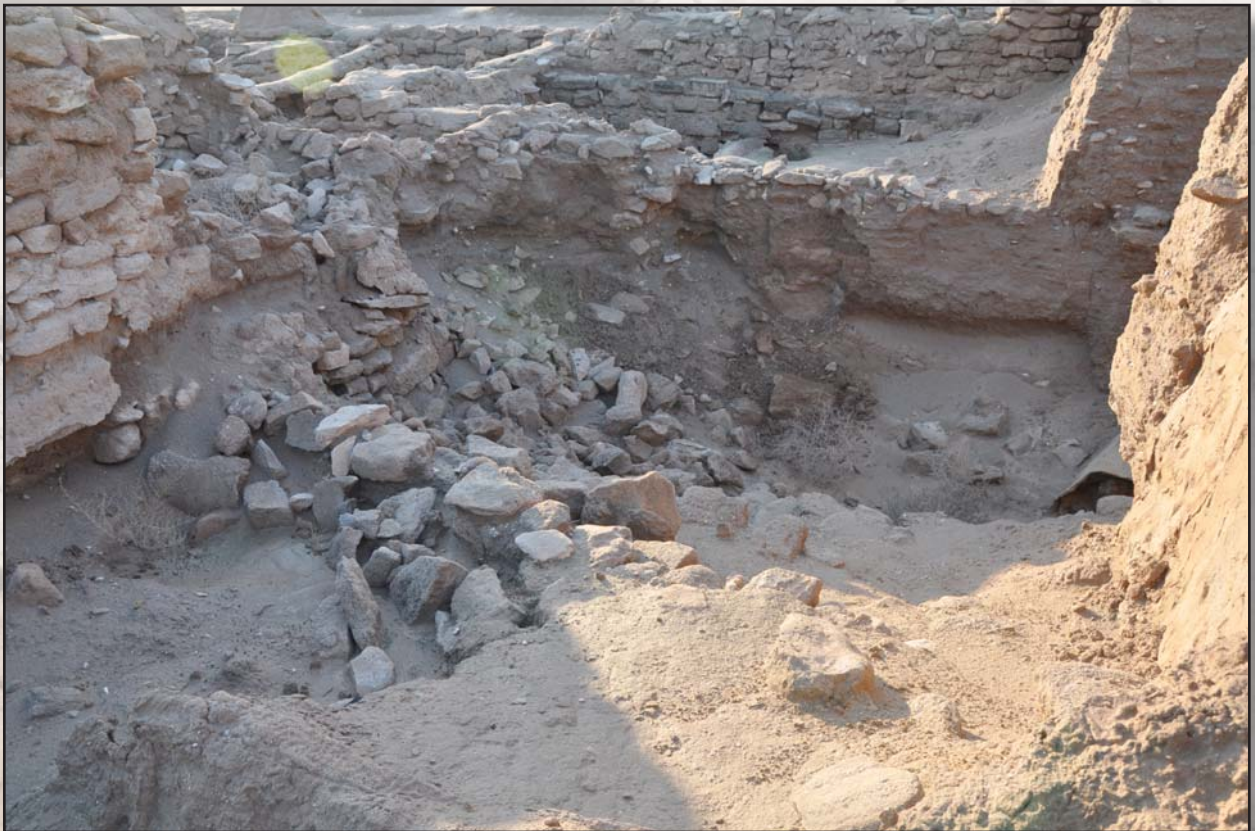
Example of **destructions** due to ancient deep soundings not refilled and humidity. South part of the fortress.

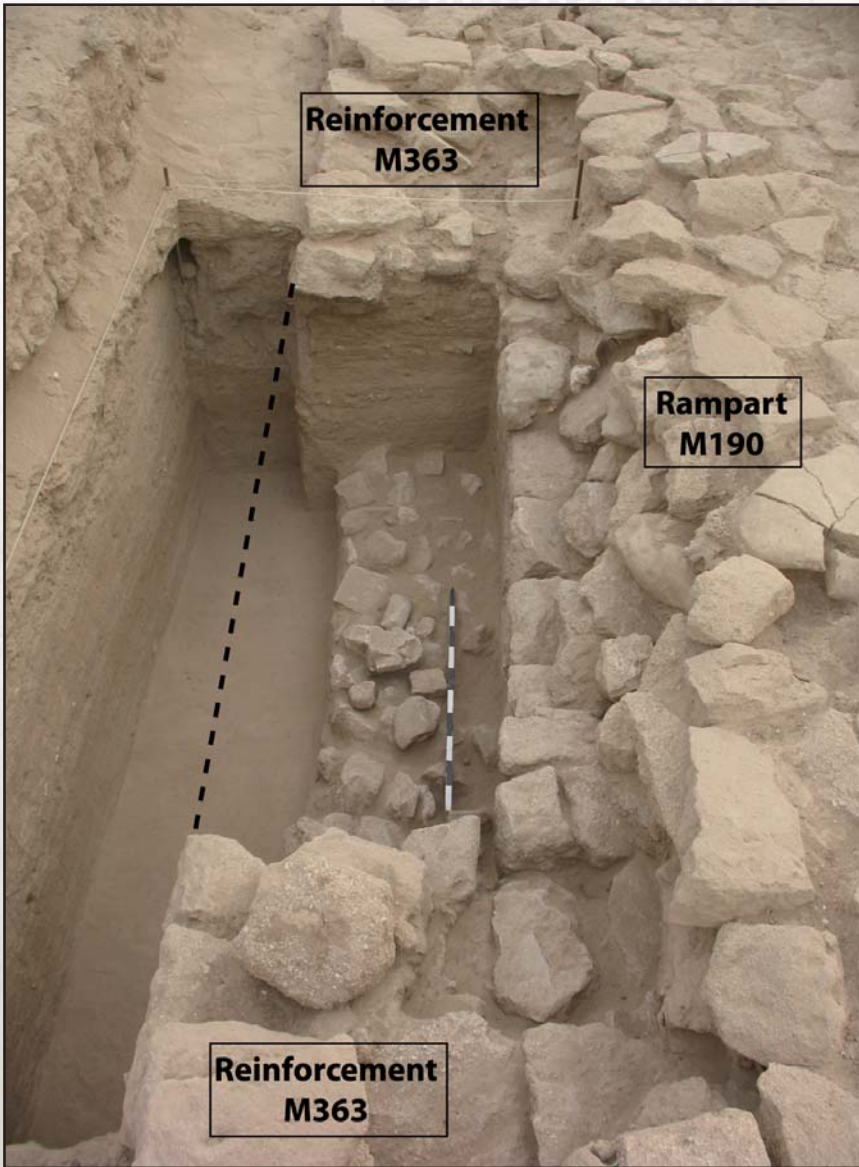
The rubble preparation layer under the rampart. Left, under the east rampart (outer face) in C22, view to the south. The broken wall above is a later embankment (M363). Below, under the north rampart (outer face) in C3, view to the south.

The use of a sand layer in foundations of a building appears to be a usual practice in antic constructions from Arabian Peninsula, as in Shabwa in Yemen, and generally in sandy areas, as in Egypt<sup>16</sup>. It takes the appearance of a unique layer, thick or not, specially put for this purpose. But the combination of the rubble layer with the sand one, in the limits of my knowledge, has not been seen before : either the sand layer exists, alone, or a rubble layer exists directly under the wall, alone. It seems that this could be a particularity in Failaka. And another particularity is that here, this sand layer is naturally present, probably put by the sea, and seems to have been exploited just because it was naturally thick and with a regular horizontal level, as it is seen in the east part of the site<sup>17</sup>.

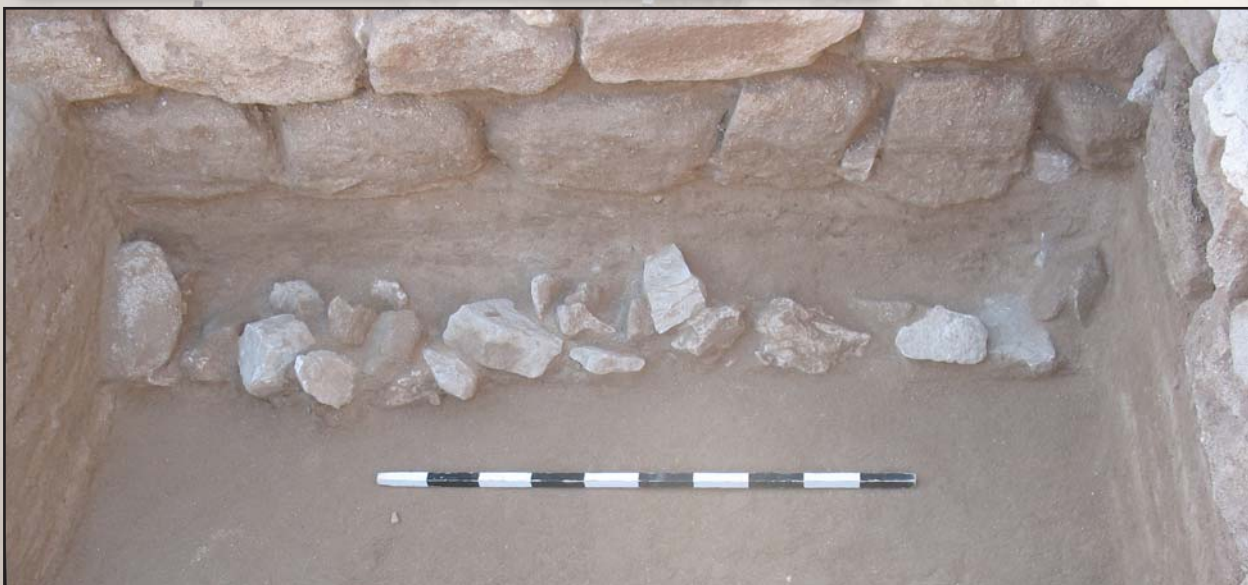
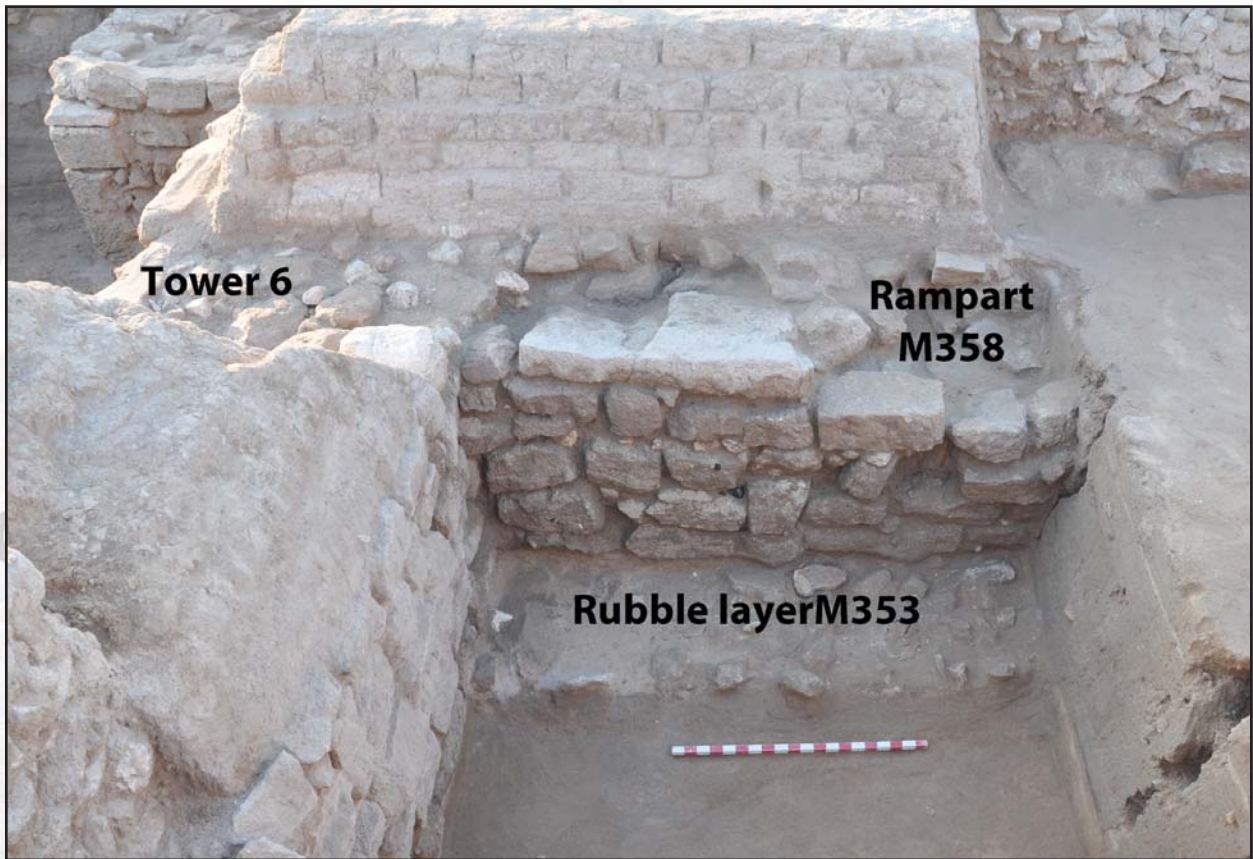
The rubble preparation layer under the rampart. **Above**, under the south wall (inner face) in B2, view to the south. **Below**, under the south rampart (outer face) in B1, view to the north.

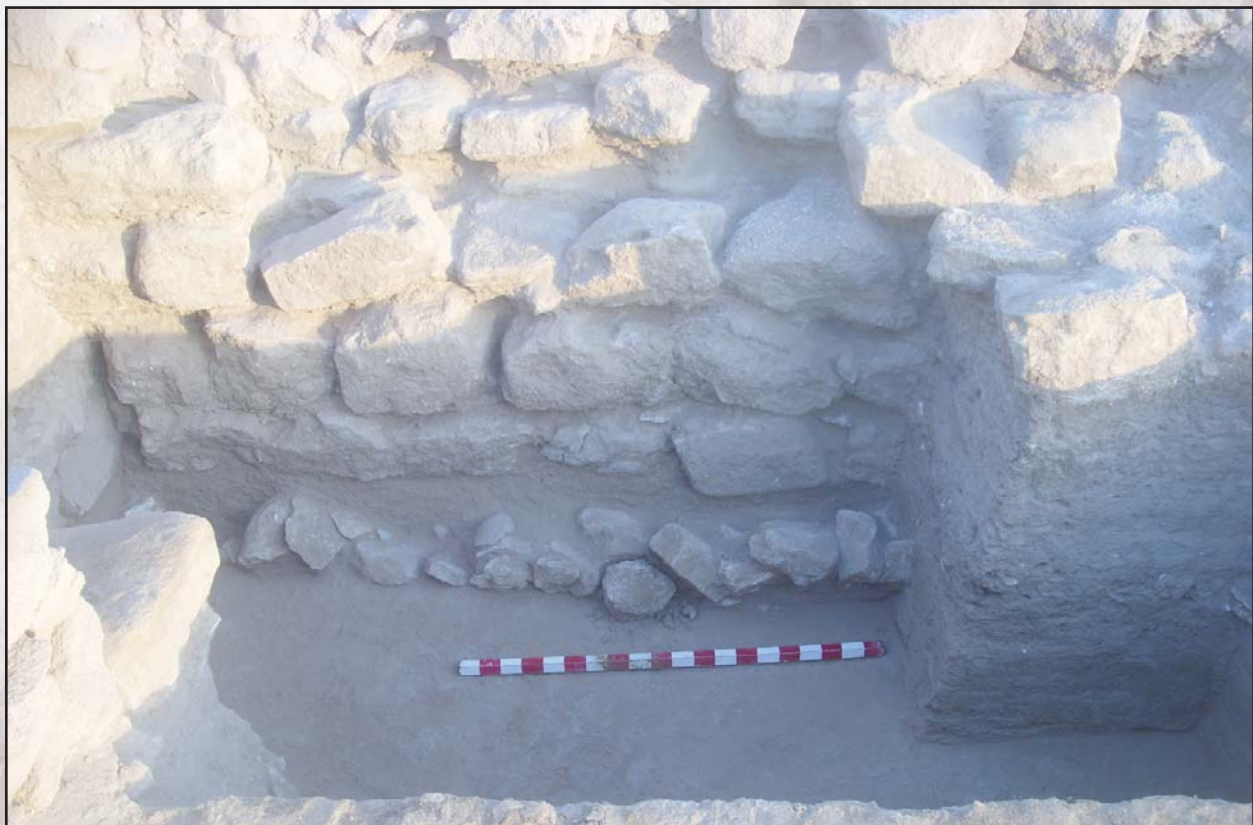
The rubble preparation layer under the towers. Above, under the tower 2 (inner face) in A2, view to the north. Below, under the tower 4 (outer face) in C12, view to the west. Here, the previous excavations destroyed part of it.

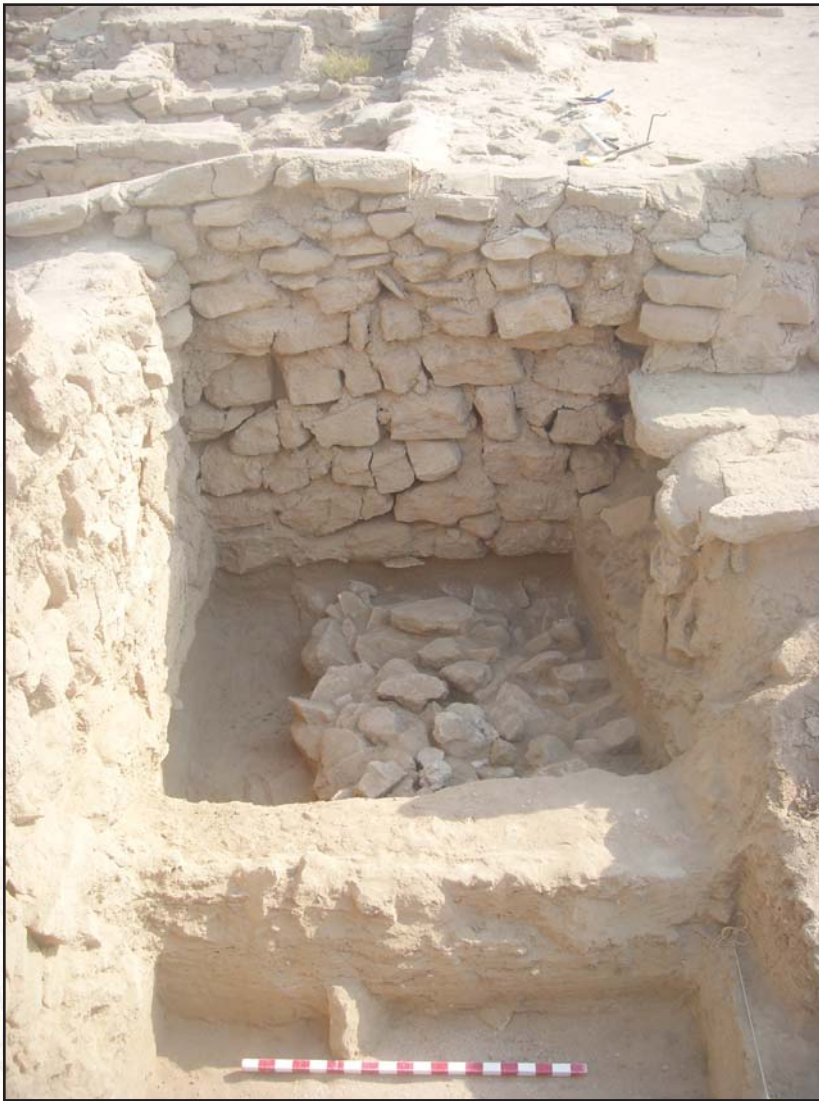
Tower 6, the rubble preparation layer under the south rampart, penetrating inside the tower. In the west half of the tower (below in the picture), it doesn't exist. View to the east.

from the east, it goes directly through the south gate (tower 6), following the line of the rampart without considering the east wall of the tower. Does this mean that the original plan of the fortress included the tower 4, but that the tower 6 was not planned, or planned to be on a western location ? In C3 sector, we also observed that the rubble layer doesn't exist under the west wall of the tower 3 or under east and west walls of tower 2. Does this signify that these towers have been planned after the rampart construction ?

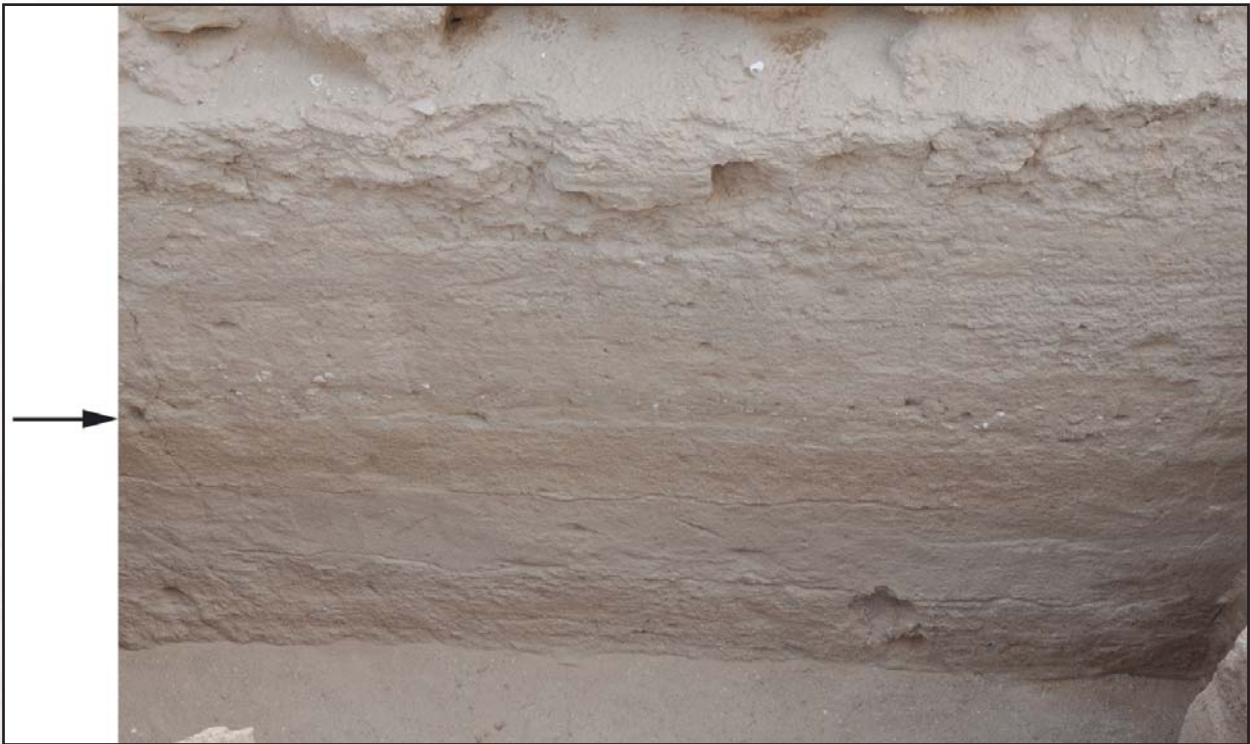
The nearly horizontal sand layer, inside which the rubble layer has been put. C22 east baulk.

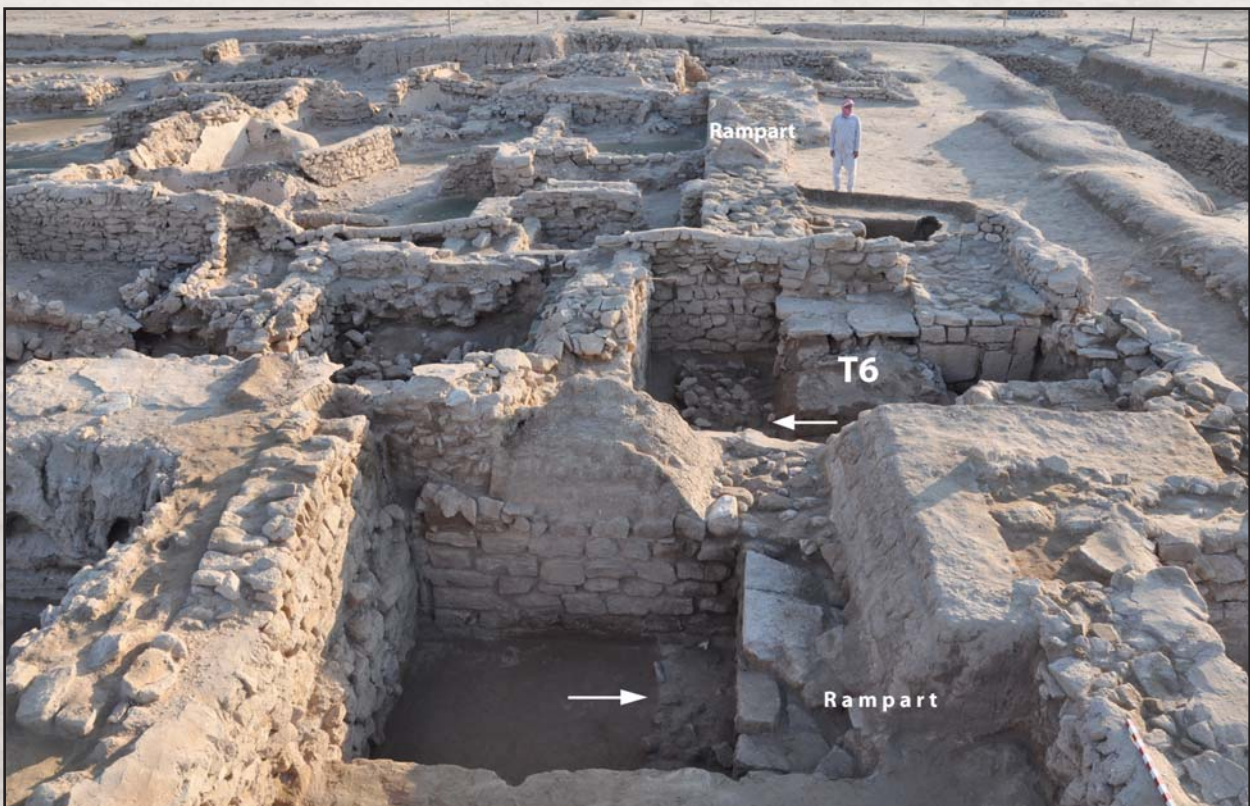
General view of the south rampart, showing the rubble layer under the line of the wall (white arrows). On the first plan, the mud bricks elevation of the rampart has been partly destroyed by ancient excavations. View to the east.

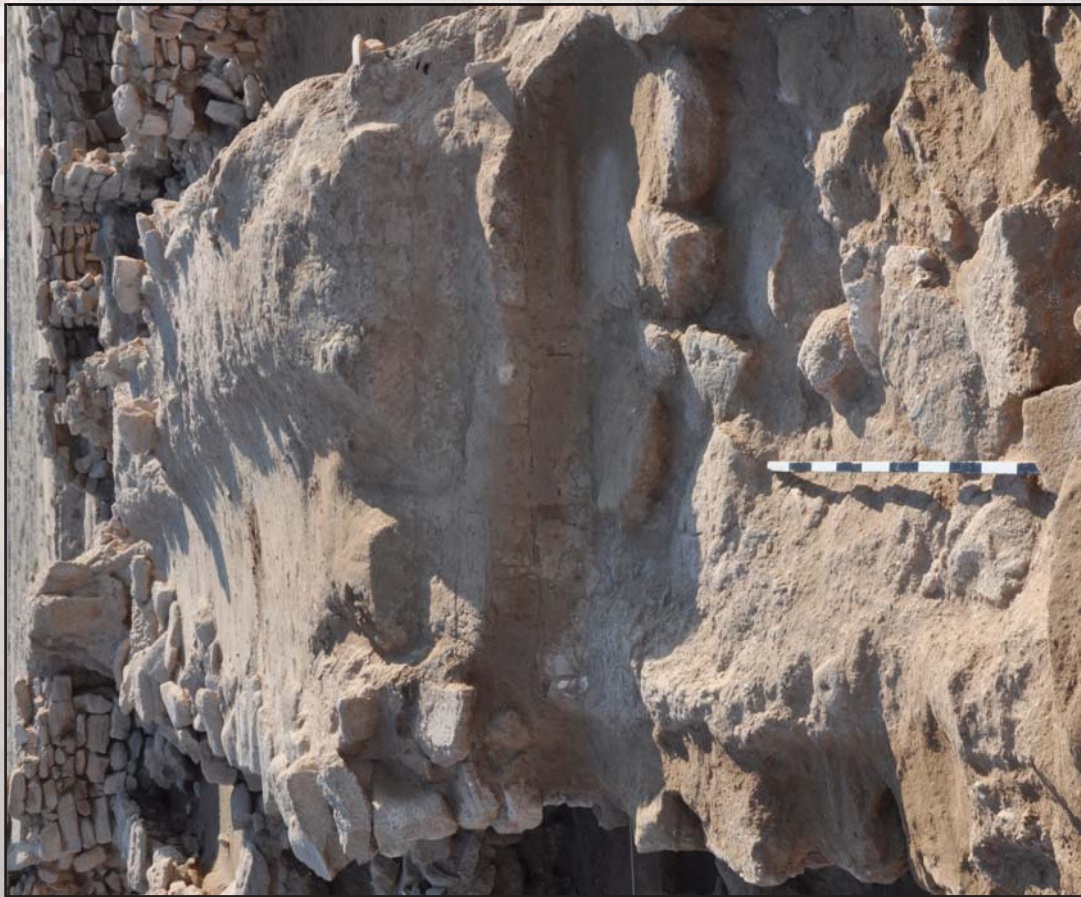
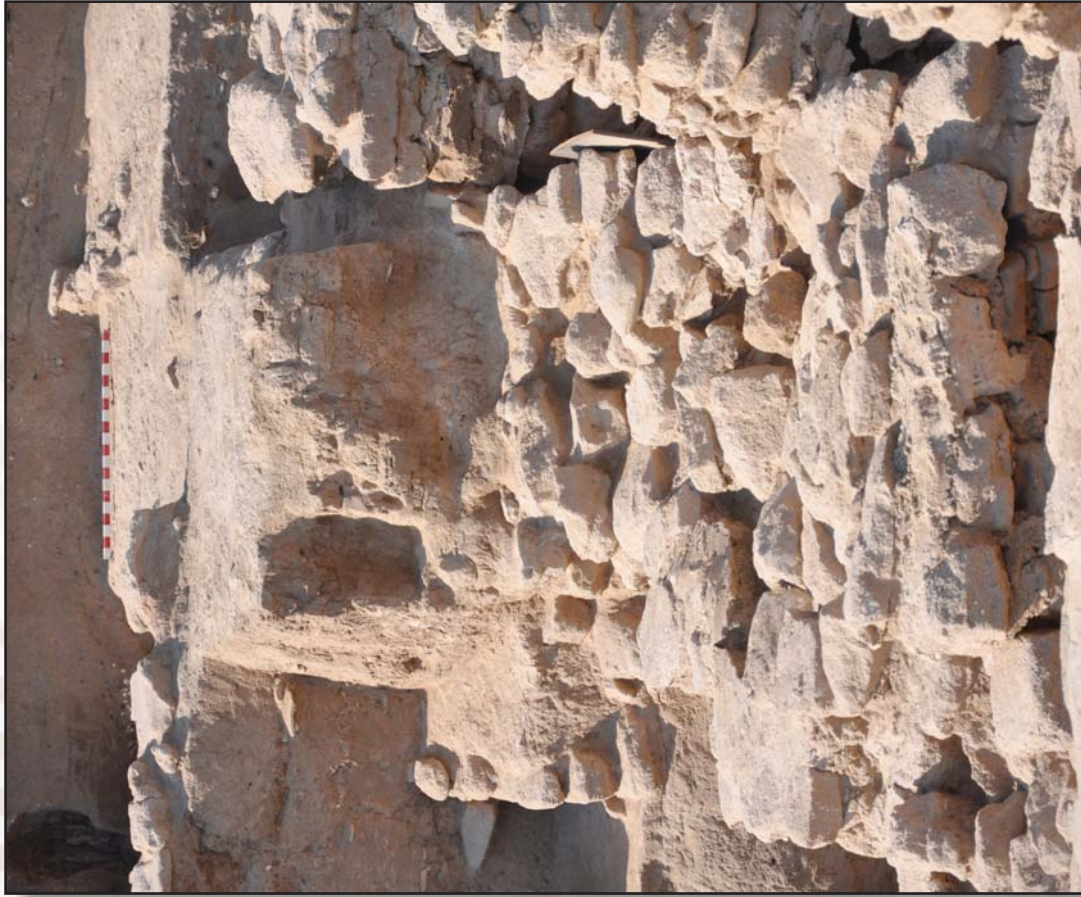
Mud brick elevation of the first rampart. **Left**, in C3, the outer face is protected by a stone face. **Right**, in A2/A1

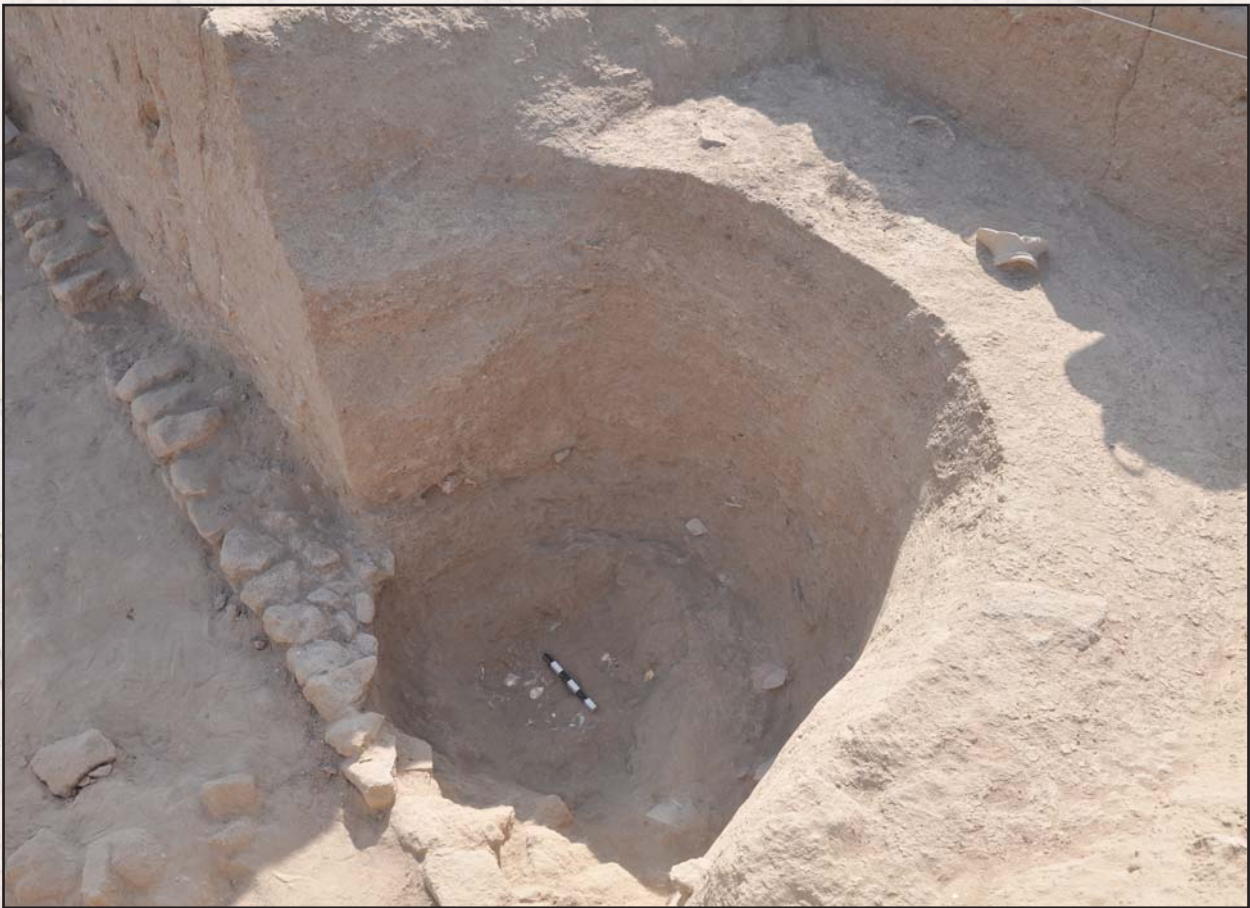
**A1**, the modern pit A1-F08-3, which was full of shells. It destroyed the wall M342 (below), which is part of the bent-axe defense system. View to the south-west.

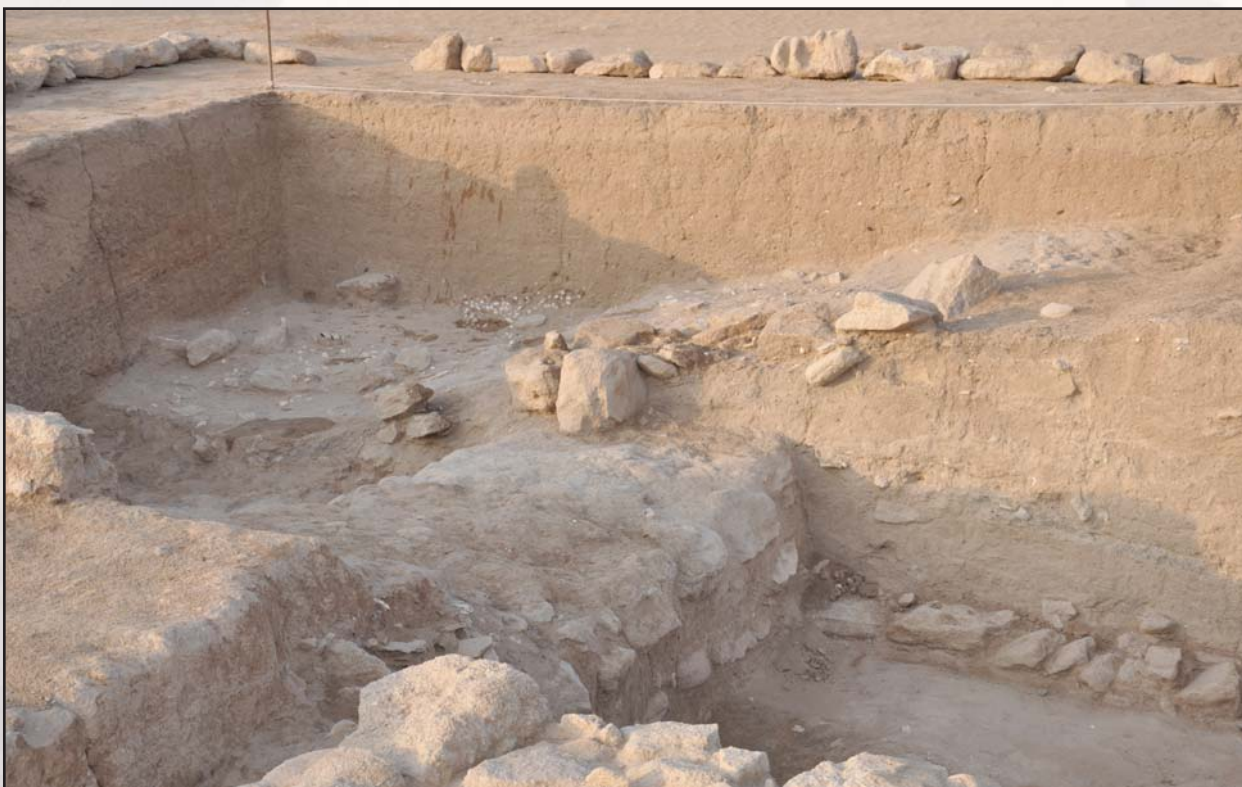
**A1**, the pit A1-F09-2, located in the south-west angle of the sounding, which destroyed part of the first rampart elevation (the fallen stones are in the pit). On the first plan, the first rampart. View to the south-west.

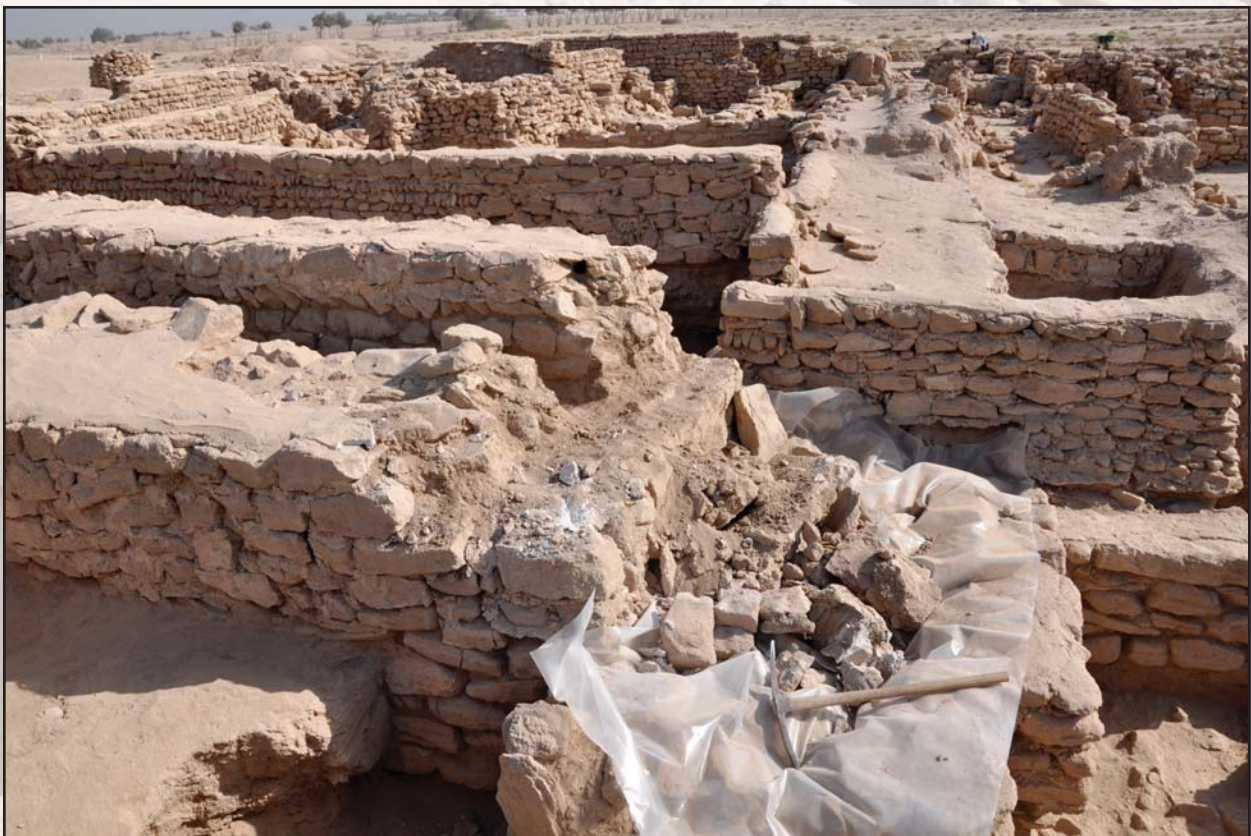
**A2.** Removal of the cemented wall which was linking the tower 2 (on the left) and the latest corridor wall M301, to reconstitute the state after ancient excavations. The cemented wall M348C, just after the nylon, has been removed too. View to the east.
