## **Kuwaiti-French Expedition in Failaka. The Hellenistic Fortress (Tell Saïd). Preliminary Scientific Report 2009**

**KUWAITI-FRENCH EXPEDITION IN FAILAKA**  
**THE HELLENISTIC FORTRESS (Tell Saïd)**  
**Preliminary Scientific Report 2009**

**2012**

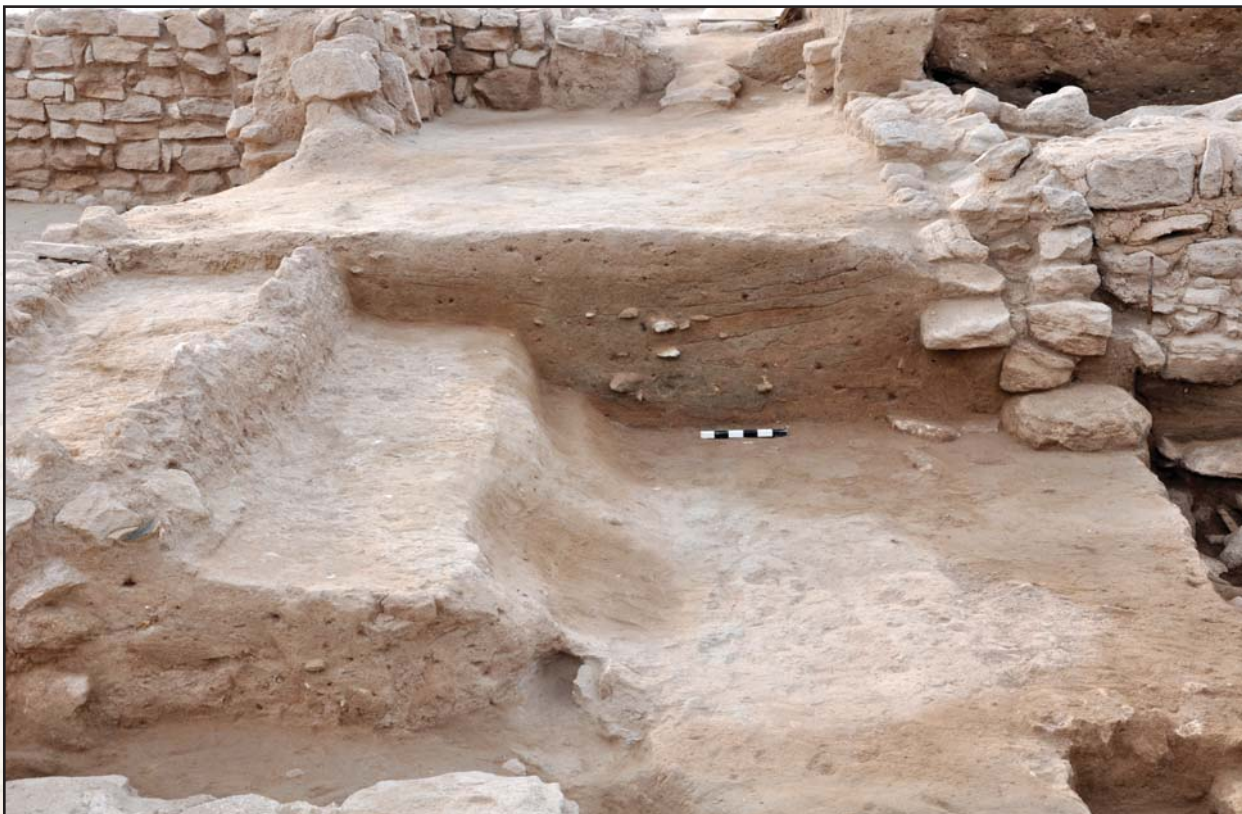
A2, the south baulk above the N-S street. Notice the alternance of green and red layers with a curved profile. On the right, M346, on the left M351 ; on the extreme right, "false wall". View to the south.

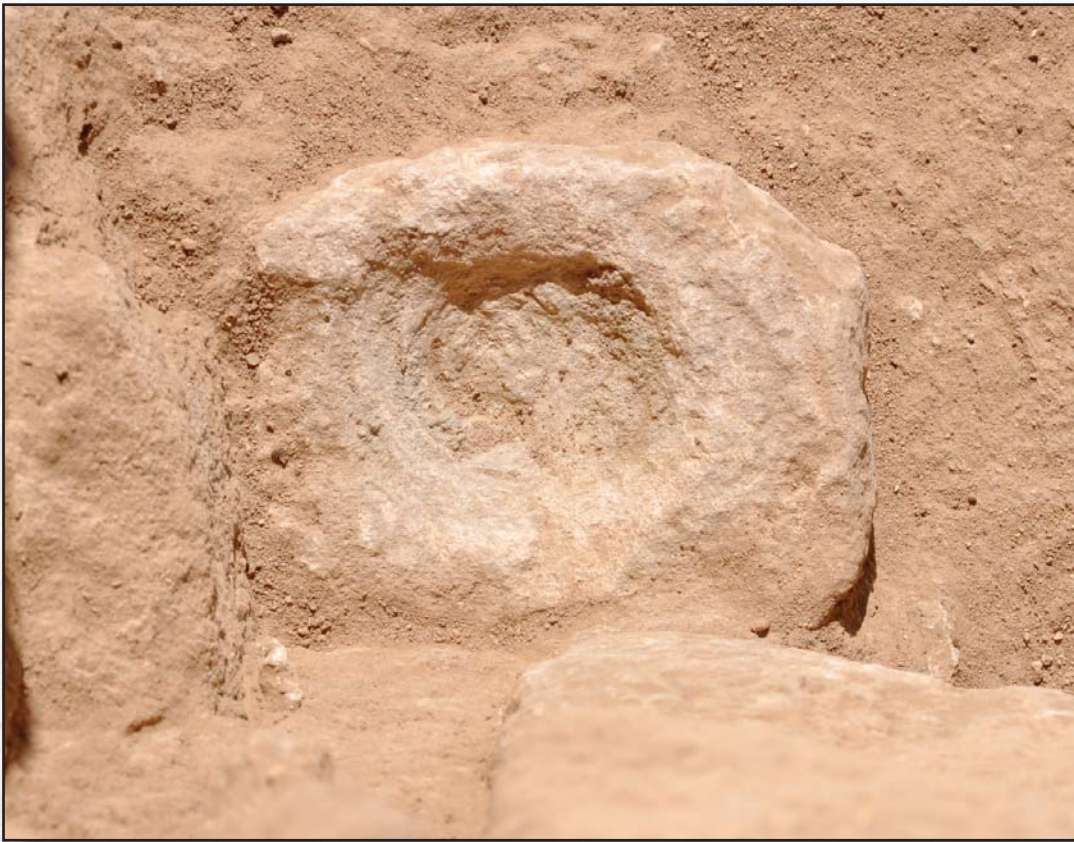
A2, the north gate of the first rampart. Detail of the door socket.

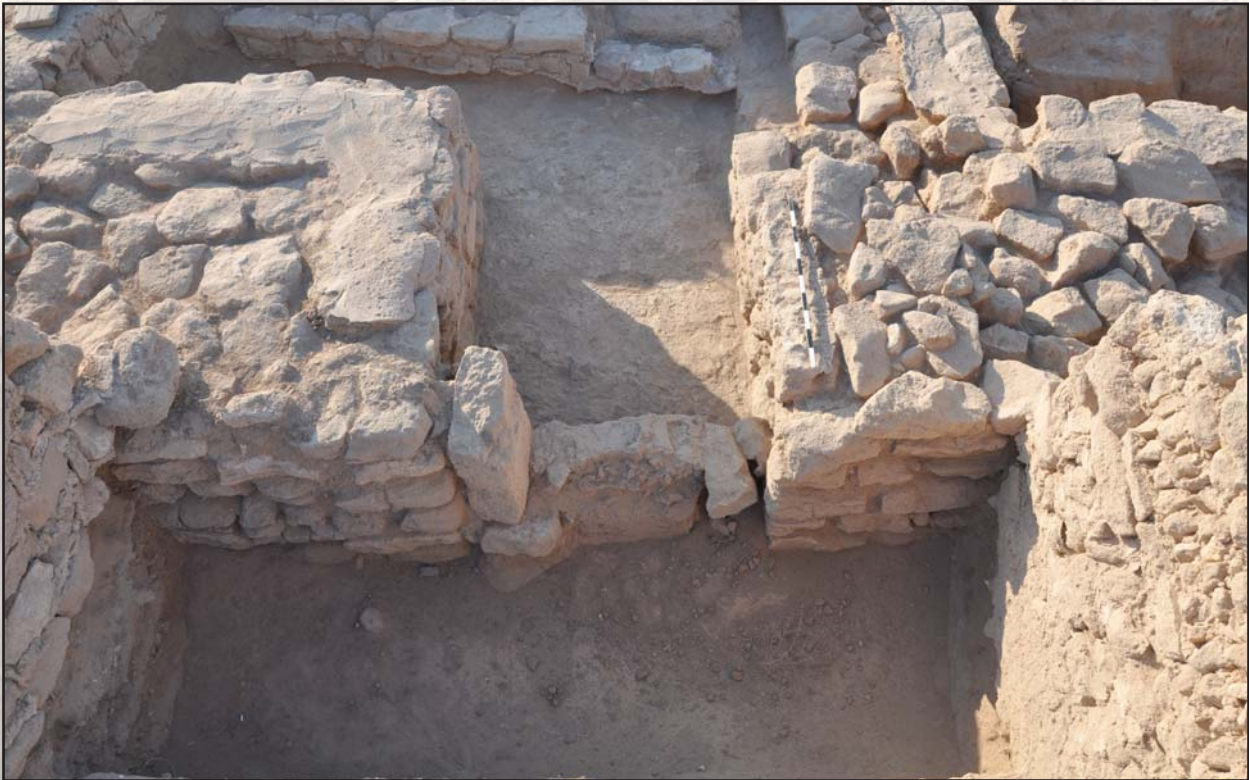
A2, the north gate of the first rampart. The threshold has been cemented in modern period. On the first plan, an ancient deep sounding. View to the south.

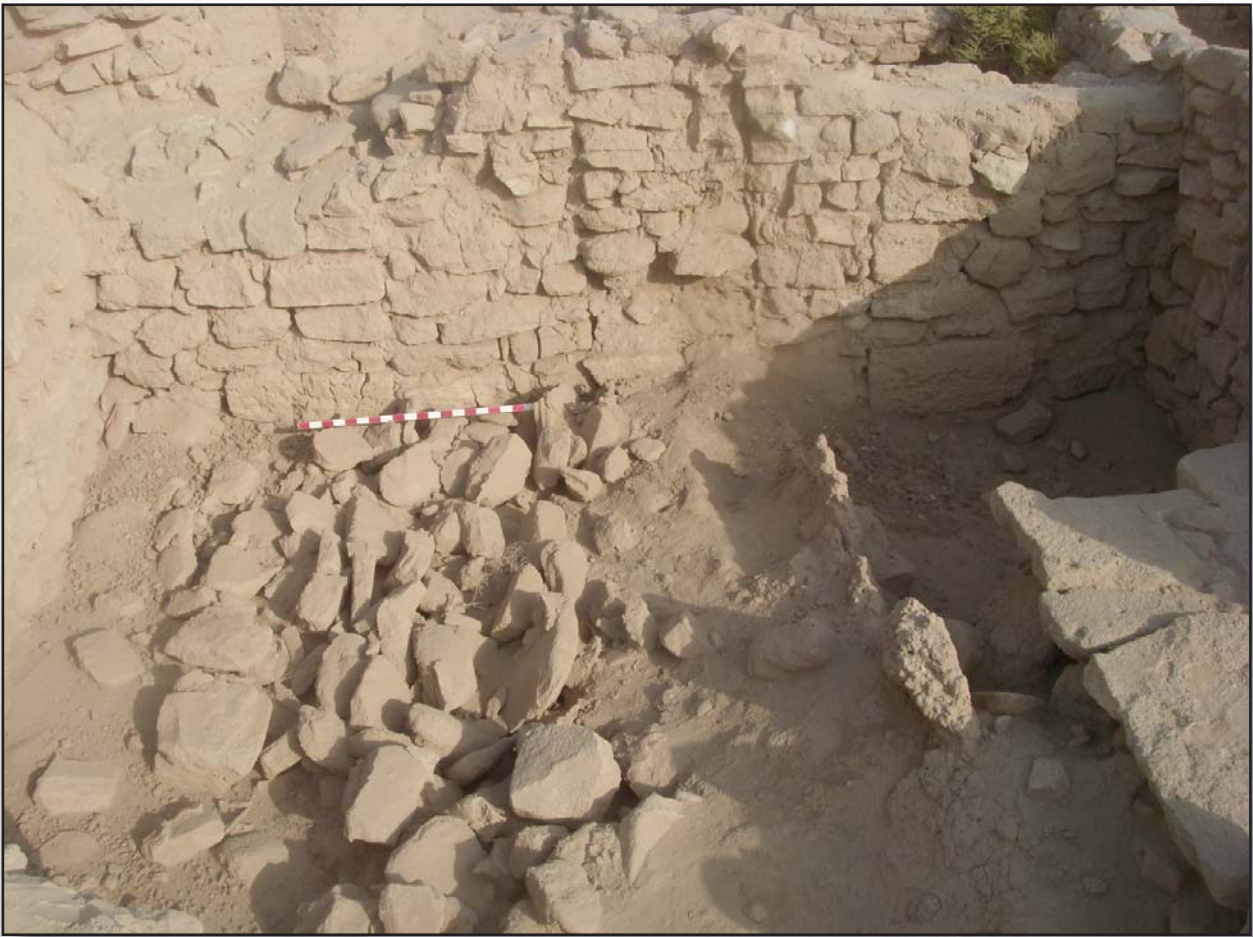
**B sector**, tower 6 before work. The collapse of the wall M354. View to the north.

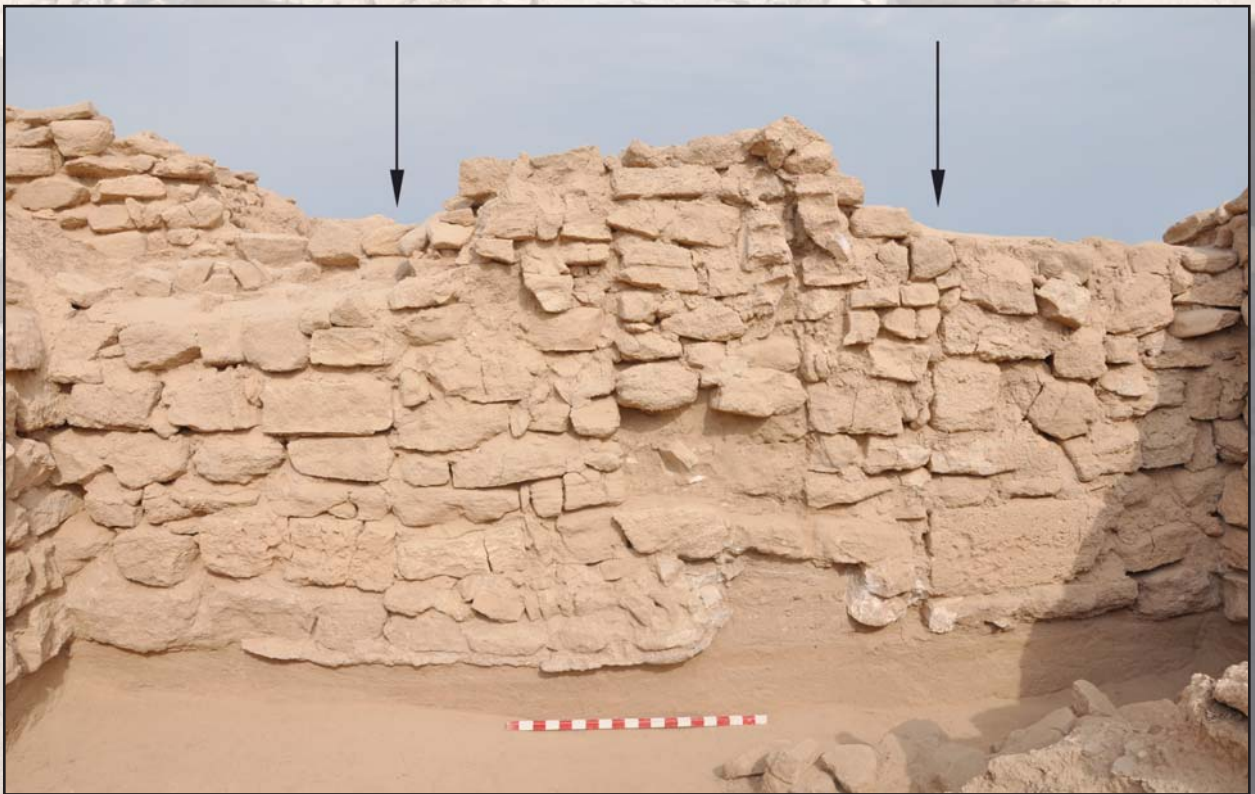
**B sector**, tower 6. The north door and the two fill-in ; the arrows show the first entrance. View to the north.

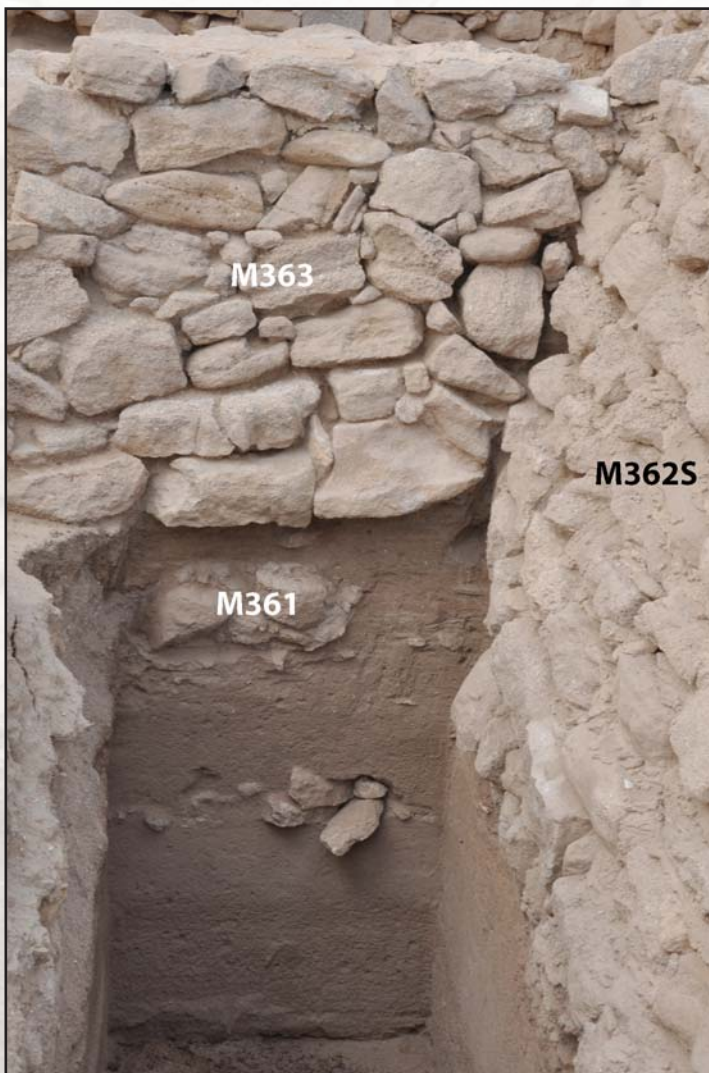
**Sounding C21.** Below, the stones are part of the rubble foundation layer of the rampart. Above, the reinforcement (M363) of the rampart, running against the one (M362S) of tower 4. Under it, some cemented stones. View to the west.

At the eastern part of the fortress, another mud brick wall M359, located outside the ramparts, has been found in the C1 sector, against the east wall of the tower 4 (north-east angle of the first rampart, see below "Archaeological study of C11 and C12 soundings"). This wall comes after the tower, as it rests against it, and as its foundation level is higher. But it comes before the reinforcement M362 built in ashlar masonry (rubble) which surrounds the whole tower, as this one stands on the mud brick wall. Unfortunately, this mud brick wall has been destroyed in its eastern and southern parts, by the reinforcement and by the ancient excavations, so it is impossible to determine precisely its original thickness. It seems to have been a little bit thicker than an habitation wall (which is usually maximum two bricks thick) and could then be associated to a sooner reinforcement of the tower. The later reinforcement has been destroyed exactly at the same place.

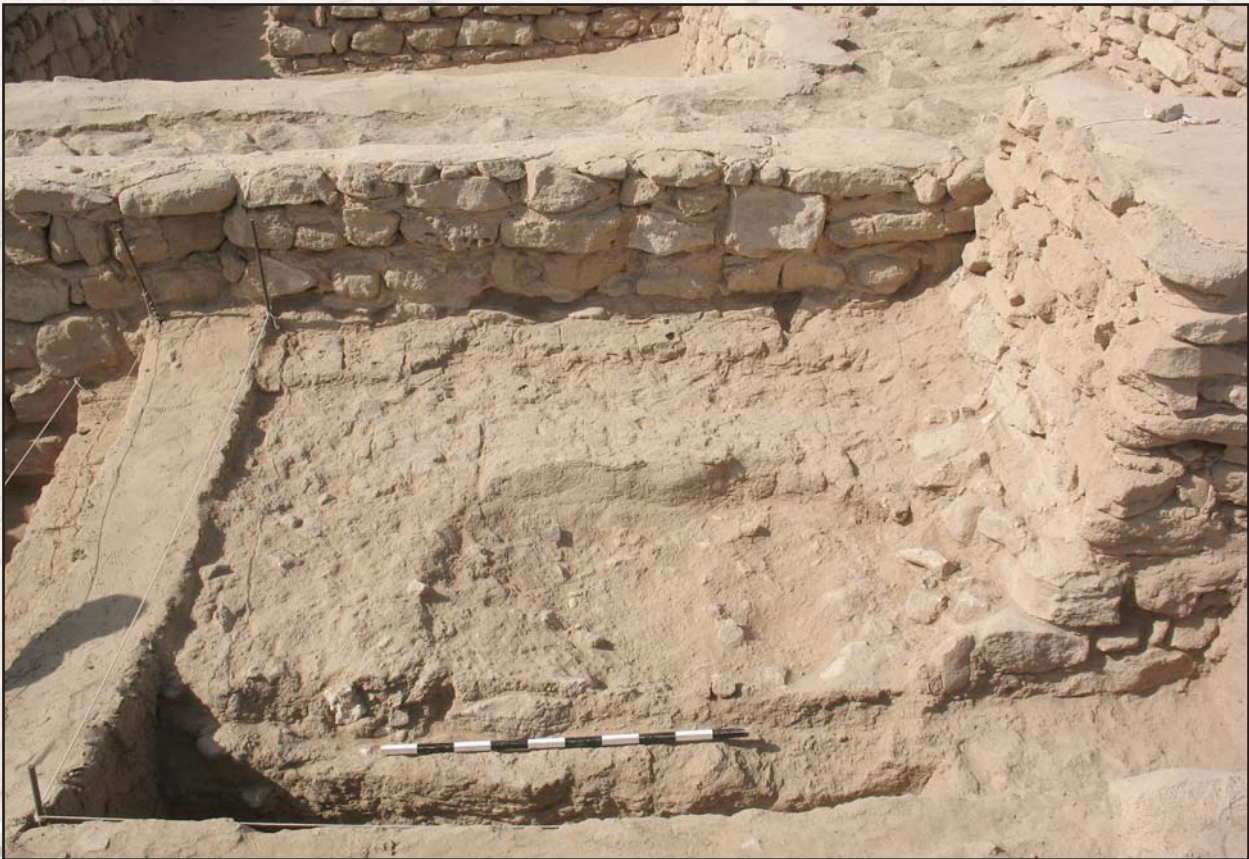
**Sounding C11.** The mud brick construction M359 (reinforcement ?) against tower 4. A pit has been dug inside, then it has been destroyed to install the stones reinforcement M362N visible on the right. View to the west.

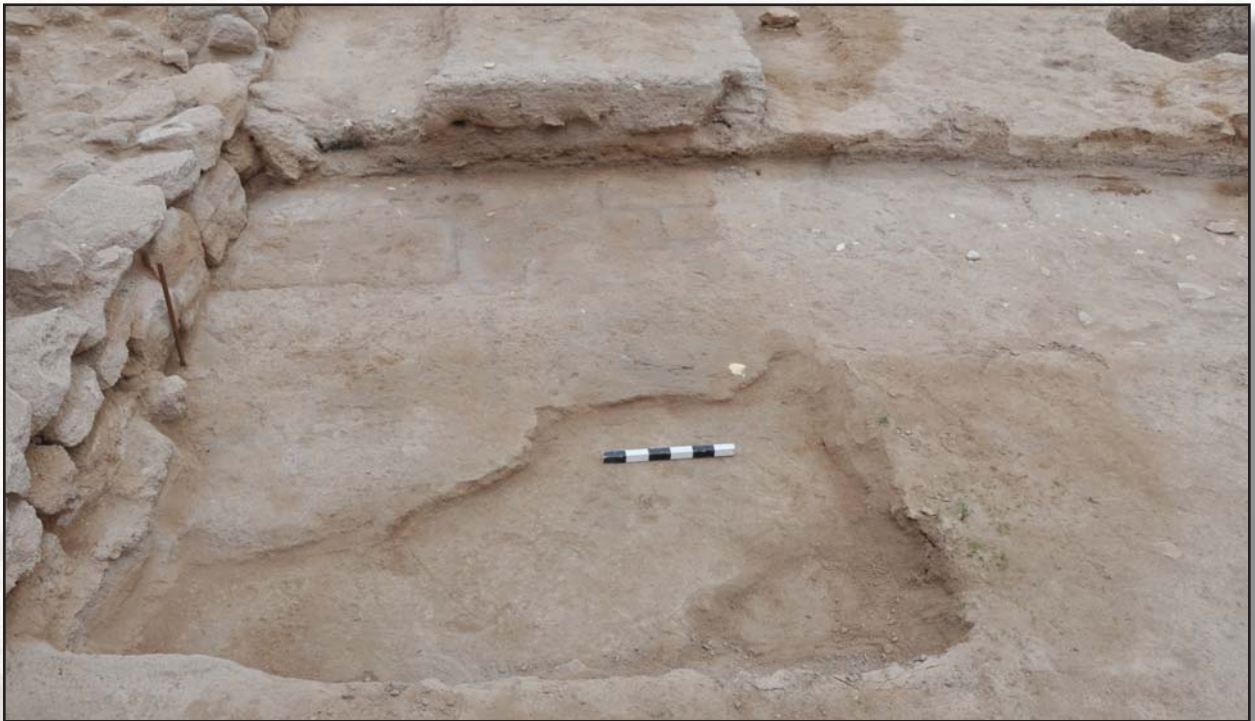
**C3 sector.** The mud brick wall M365, which pre-existed to the bent-axis wall M273 (on the left). This wall is maybe our unique witness of an installation occurring before the Hellenistic fortress, or of an advanced defense linked with the first rampart. View to the south.

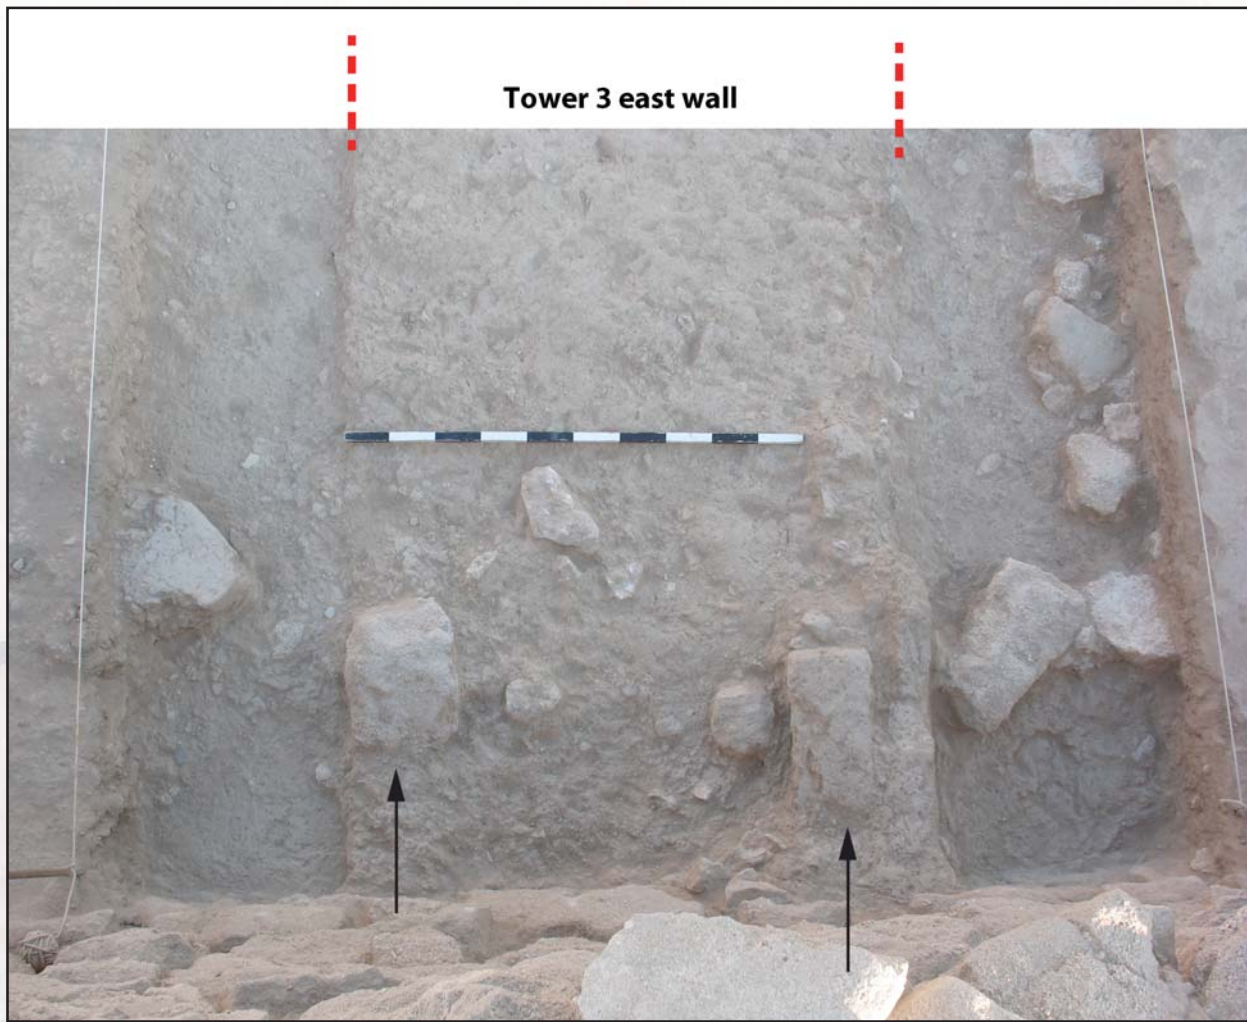
**C3 sector.** The stone against the rampart (on the left) is probably the only remain from the inner face of the tower 3 east wall. The red lines represent the limits of the east wall. On the right, mud bricks from a probably later wall.
