## The PROMETRA Program: Fuel Cladding Mechanical Behavior under High Strain Rate

# The PROMETRA Program: Fuel Cladding Mechanical Behavior under High Strain Rate

An assessment of the mechanical properties of the highly irradiated fuel claddings under high strain rate has been carried out in the framework of the PROMETRA program undertaken by the French Institut de Radioprotection et de Sûreté Nucléaire in collaboration with Electricité de France and Commissariat à l’Energie Atomique (CEA). Three types of tests, including burst tests, hoop and axial tensile tests, have been performed at CEA-Saclay hot laboratories to determine the cladding tensile properties to use in the SCANAIR code. The prototypicality of each test with regard to the reactivity-initiated accident loading conditions can be addressed and analyzed in terms of strain or stress ratio. The high-strain-rate ductile mechanical properties of irradiated ZIRLO and M5 alloys derived from the PROMETRA program and their comparison to the stress-relieved irradiated Zircaloy-4 are reported. Then, the clad brittle behavior, in particular for highly corroded or spalled Zircaloy-4 cladding, is investigated.

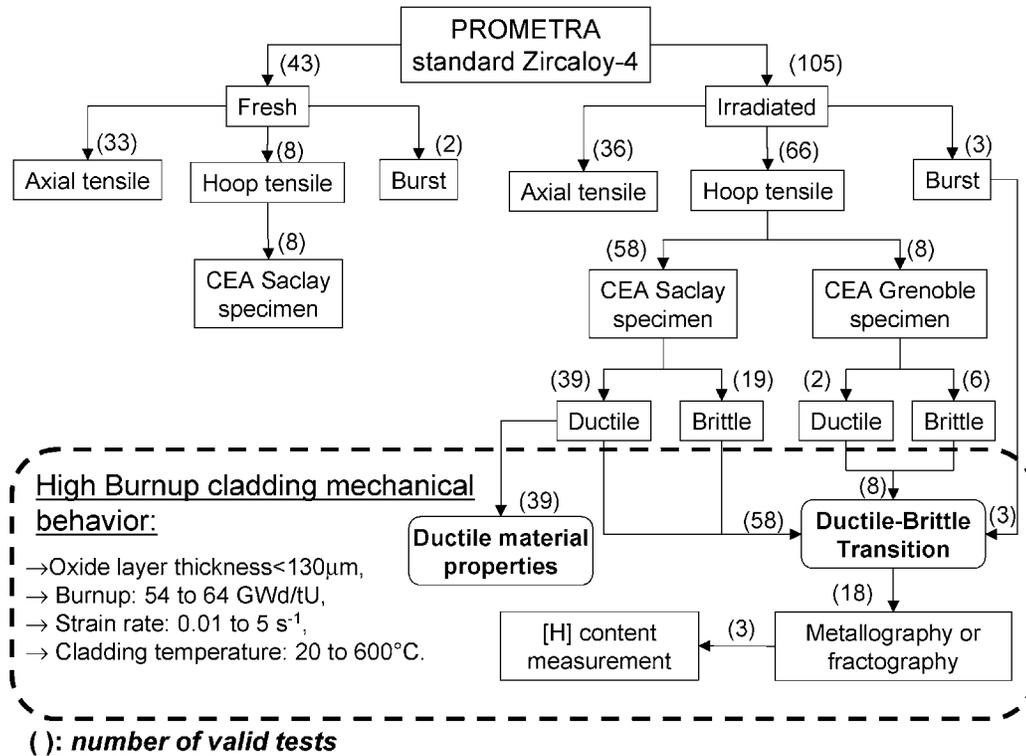
Fig. 1. Tests and analysis on standard Zry-4 performed within the PROMETRA program.

The overview of the PROMETRA testing program performed on standard Zry-4 is described in Fig. 1, including the number of each type of test (valid tests only).

As can be seen, the hoop tensile tests (ring test) represent most of the tests performed on irradiated samples.

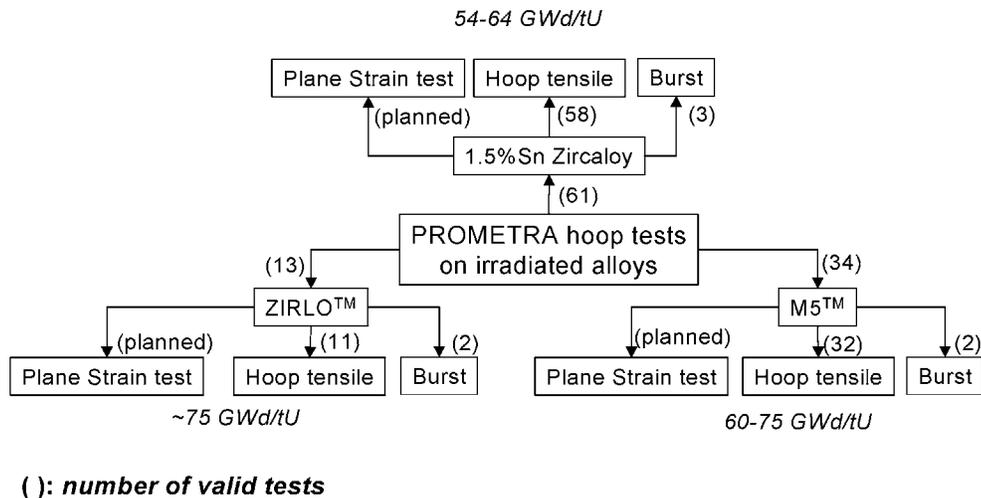
Fig. 2. PROMETRA hoop tests on irradiated cladding alloys.

More specifically, an overview of the hoop tensile tests performed on different types of irradiated cladding alloy (standard Zry-4, M5, ZIRLO) is shown in Fig. 2. All the tests performed so far on ZIRLO and M5 exhibited a ductile behavior.

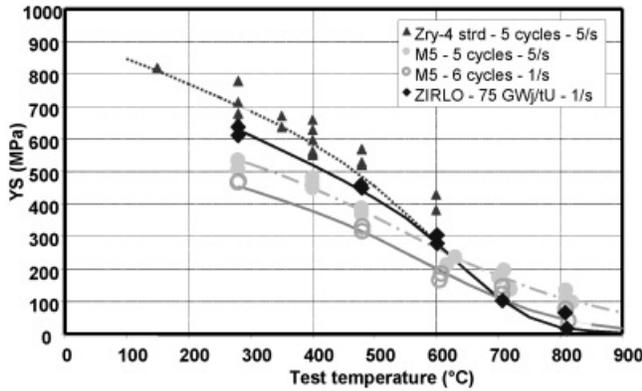
Fig. 4. Yield stress as a function of test temperature.

In the aforementioned validity range, the ductile material strengths have been fitted according to Eq. (2) and plotted in Figs. 4 and 5:

First, it can be noted that the results observed with induction heating follow continuously the trend observed with conventional heating (furnace).

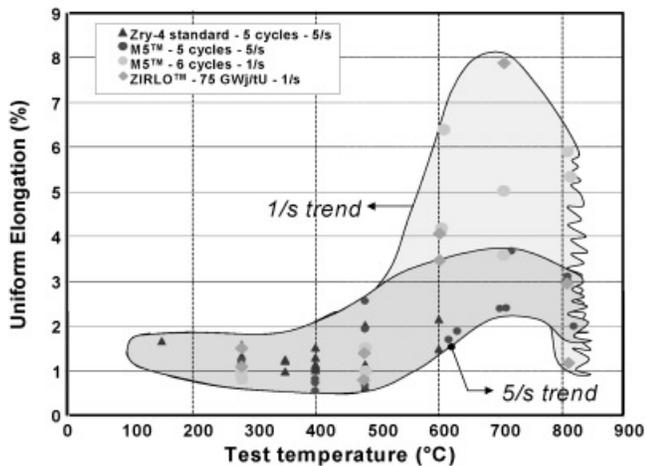
Fig. 6. Uniform elongation as a function of test temperature.

The comparison between M5 alloy irradiated for five and six cycles, ZIRLO irradiated for five cycles, and Zry-4 alloy irradiated for five cycles does not show any important evolution on engineering strain up to 500°C. Uniform elongation value is  $\sim 1.5\% \pm 0.5\%$ . Over 500°C, a strain rate dependency on UE occurs (Fig. 6).

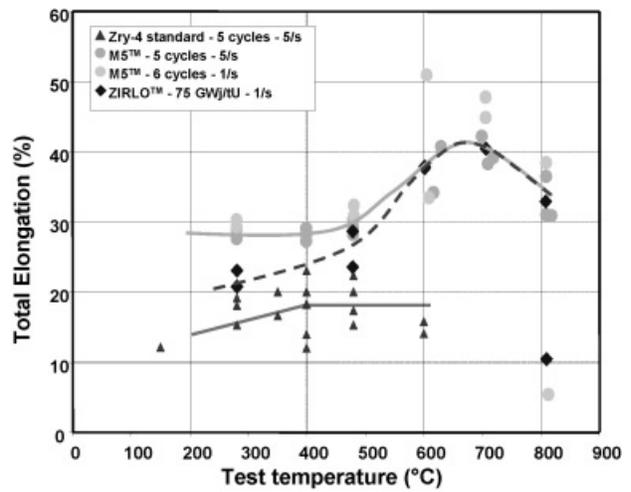
Fig. 7. Total elongation as a function of test temperature.

on the basis of the TE remains slightly higher for M5 and ZIRLO alloys than for Zry-4. A slight effect of strain rate on M5 results can be noticed over 500°C (Fig. 7).

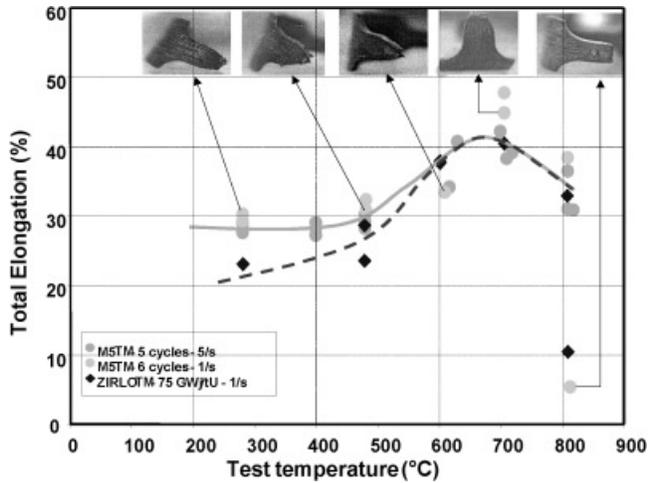
Fig. 8. M5 and ZIRLO TE as a function of test temperature with visual examinations of a six-cycle M5 sample.

Figure 8 exhibits low-magnification visual examinations of the six-cycle M5 ring samples taken at different test temperatures, which show the specific nature of the ring damage near 800°C, with a very weak necking in the broken leg, giving a brittle-like appearance of the failure (Fig. 9). At the same time, the through-thickness visual examination (Fig. 10) showed a very important necking ( $\sim 80$  to 100%). Thus, the reduction of area is obtained in the width of the gauge length for temperature  $< 600^\circ\text{C}$  and through the thickness of the sample for temperatures

>600°C, which suggests that a change in the mode of deformation occurs.

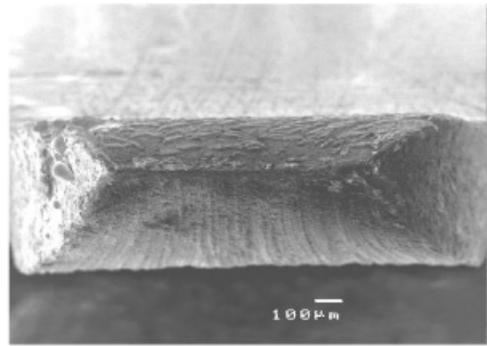
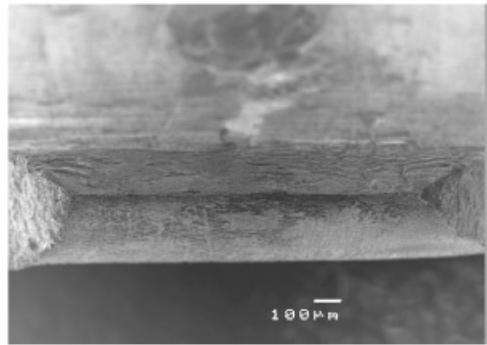
Fig. 11. SEM analysis of the six-cycle M5 broken leg (ABDJ4—809°C).

Fig. 12. SEM analysis of the ZIRLO 75 GWd/t HM broken leg (ABIO16—706°C).

firmed with the SEM analyses, as shown in Figs. 11 and 12 for both the M5 and the ZIRLO samples, respectively. For the M5, equiaxial grains (3 to 8  $\mu\text{m}$ ) with some hydrides located at the grain boundaries as well as inside the grains (Fig. 13) could be observed. In contrast to the as-received alloy, which has circumferentially oriented hydrides, they were found to be uniformly distributed without a preferential orientation after the test. For ZIRLO, a fine microstructure was observed with elongated hydrides, as shown in Fig. 14.

Further posttest scanning electron microscopy (SEM) analyses and metallographic observations have been achieved in order to understand and explain this behavior. A total through-thickness reduction of area was con-

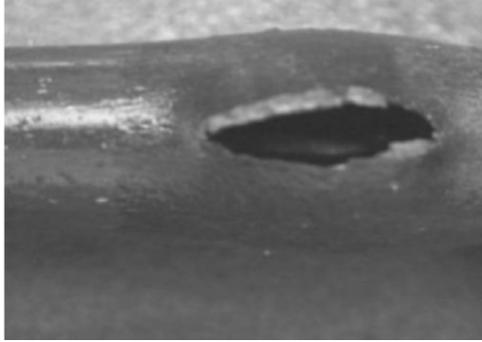
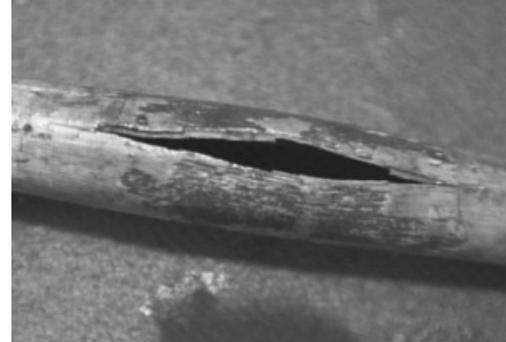
Figures 15 and 16 show the samples after burst tests. These pictures reveal that the clad deformation is more pronounced for the M5 alloy than for the ZIRLO alloy: The M5 alloy shows a large ballooning and short axial crack (the crack length is  $\sim 9$  mm for a maximum

Fig. 15. Burst test on M5 sample (ABEF).

Fig. 16. Burst test on ZIRLO sample (DFIM).

pressure of 87.6 MPa at ultimate hoop strength), indicating a high ductility, with an average total hoop elongation of 14%.

For the ZIRLO samples, the crack is elongated and straight. Zirconia spalling occurs in the vicinity of the cracks. Lower total hoop elongations are measured (1.6% on average, which is close to the hoop UE considering the accuracy of 2%). The crack length reaches 18 mm for a maximum pressure of 82.6 MPa at ultimate hoop strength.

This difference of ductility between both alloys is explained by the well-known influence of the material corrosion, higher for the ZIRLO alloy than for the M5 alloy.

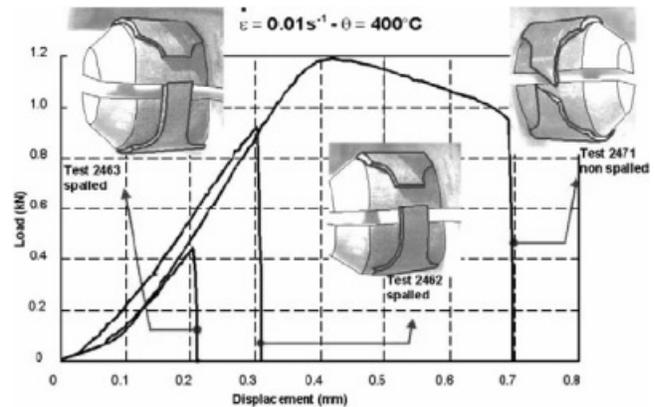
Fig. 17. Cladding embrittlement on CEA-Saclay hoop tensile test at 400°C and 0.01/s .

It has been observed on high-burnup fuel cladding that applying very similar loading conditions to apparently similar claddings led to very different test results. To illustrate this statement, a set of load-displacement curves obtained on three CEA-Saclay hoop tensile tests are plotted in Fig. 17. The three tests have comparable outer oxide layer depth (130  $\mu\text{m}$ ). Oxide layers of tests 2462 and 2463 were subjected to in-pile spallation, and the gauge section was machined in a spalled area and the oxide layer of test 2471 remained unspalled. The behavior of test 2471 is ductile, whereas the behavior of tests 2462 and 2463 is clearly brittle.

The usual signs of cladding embrittlement on axially short hoop tensile ring tests are

1. unusually low fracture strain
2. fracture plane not oriented at 45 deg but in a radial-axial direction.

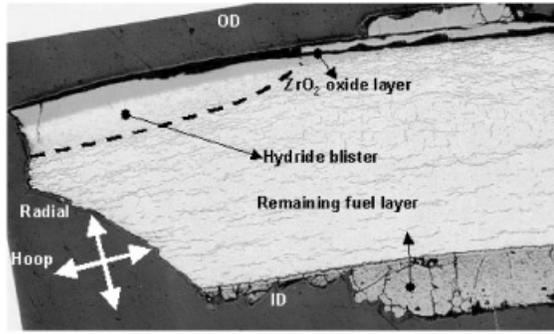
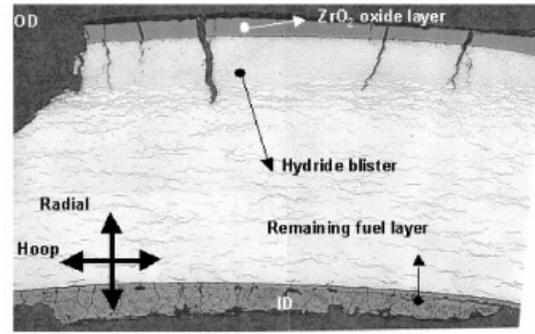
Fig. 18. Hydride blisters on posttest metallography after hydride etching.

Q02-557 CEA -Grenoble hoop tensile test

Q02-566 CEA -Grenoble hoop tensile test

In the framework of the PROMETRA program, for stress-relieved Zry-4, pure zirconium hydrides with lenticular shape, called hydride blisters or hydride lenses, have been frequently observed, but only on spalled claddings. The usually invoked mechanism (see Ref. 14, for example) to generate these hydride lenses is that in the spalled area of a highly corroded cladding, there is a cold spot attracting the hydrogen dissolved in the surrounding hot area by a diffusion mechanism. This mechanism is the one used to create artificial hydride blisters in Zircaloy.<sup>15</sup>

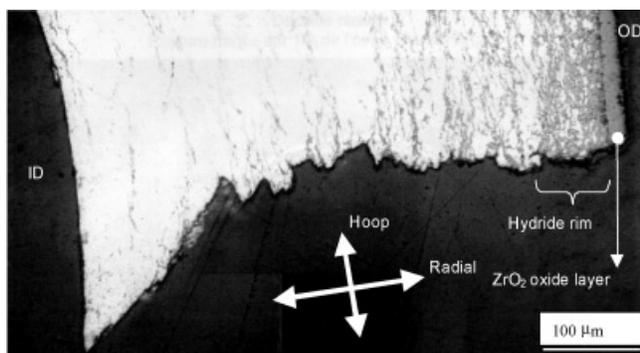
Hydride-rich rims sometimes appear at the outer diameter of the cladding at a pellet/pellet interface. The colder region surrounding this interface also attracts hydrogen, enhancing cladding corrosion.<sup>16</sup> Thus, there is also usually a thicker corrosion layer at pellet/pellet interfaces.<sup>14</sup> This mechanism corresponds to axially short hydride rims. Axially extensive hydride rims are also sometimes observed on fractographic examinations after

Fig. 19. Hydride rim on posttest metallography of CEA-Saclay hoop tensile test 2470 after hydride etching (70- $\mu\text{m}$ -deep hydride rim).

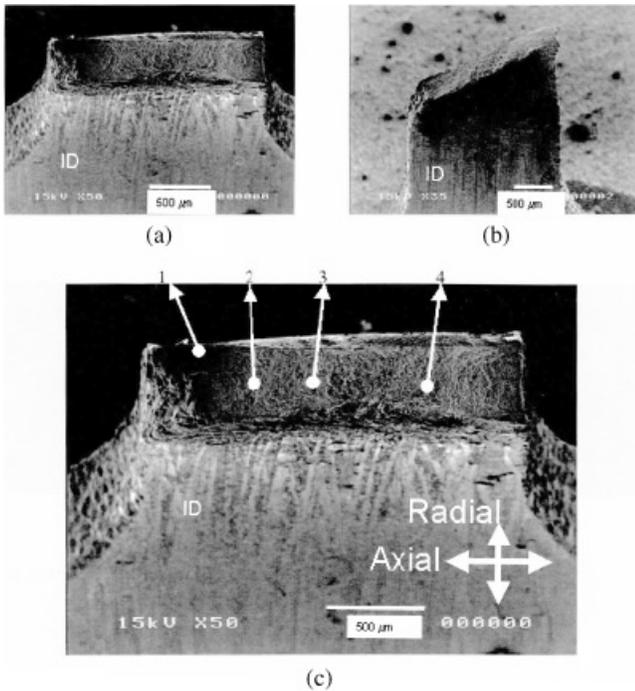
Fig. 20. Low-magnification aspect of ductile failure in PROMETRA test 2403.

Figures 20 and 21 present the usual posttest fractographic aspect of a ductile specimen (PROMETRA 2403, on the M05 rod span 5). A low-magnification SEM image is shown in Fig. 20. In this figure, the failure plane is orientated at 45 deg to the loading direction; this is one of the macroscopic indications of a ductile failure. Some necking can be observed in Fig. 20c; here, four locations are indicated and high-magnification SEM examinations of each of these locations appear in Fig. 21.

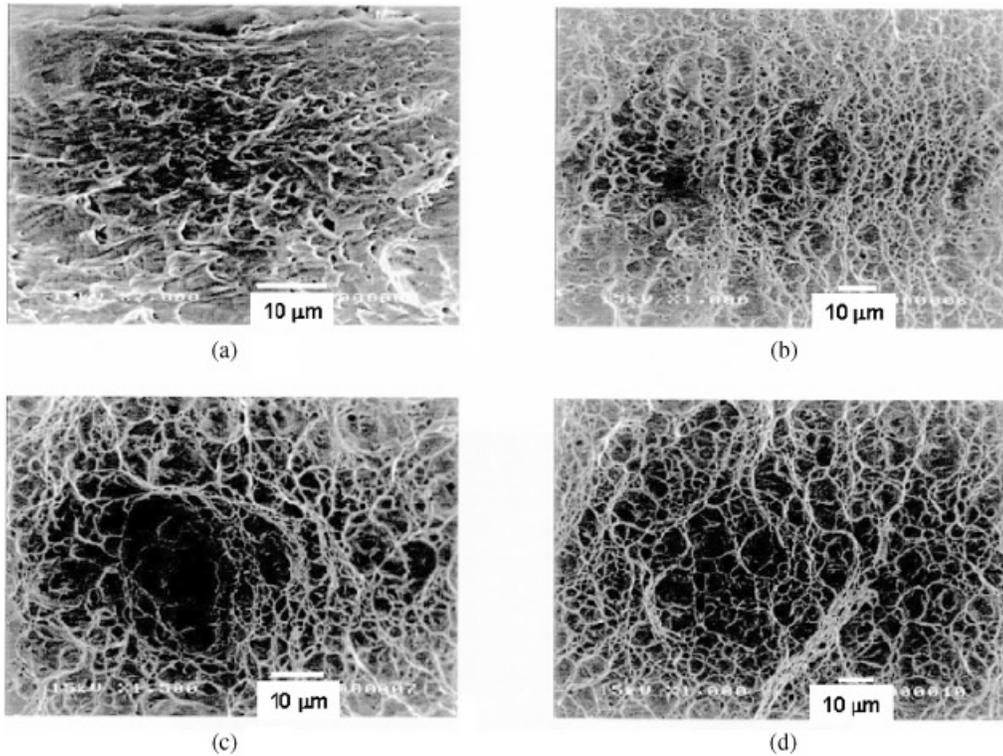
Fig. 21. High-magnification aspect of ductile failure in PROMETRA test 2403.

In Fig. 21, the fracture aspect is fully transgranular with ductile dimples at all locations. Figure 21c shows the onset of ductile failure; microvoid coalescence nucleated a penny-shaped crack in the middle of the specimen. This crack failed in a ductile manner in a highly porous (many microvoids nucleated) material.

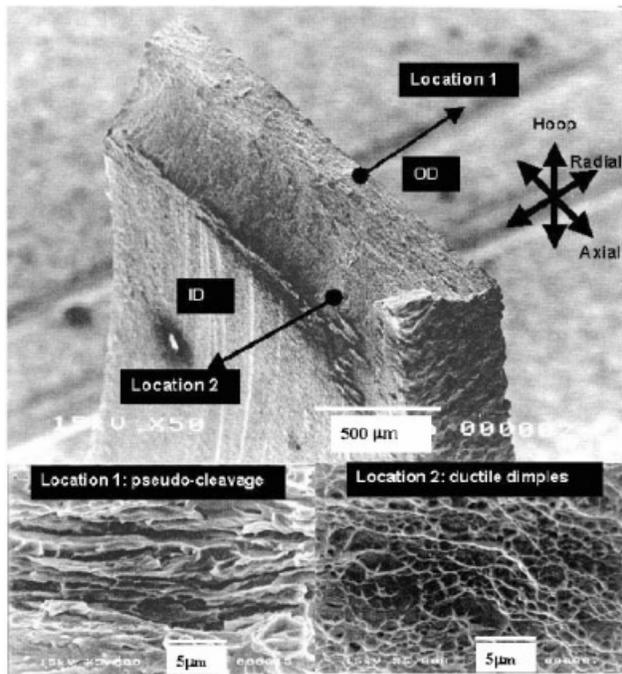
Fig. 22. Brittle failure initiated by a hydride rim on PROMETRA test specimen 2400.

The SEM observations performed on CEA-Saclay hoop tensile test 2400 (Table VII) are shown in Fig. 22. The fracture aspect is typical of a specimen with a

hydride rim located at the outer diameter. The outer region with a pseudocleavage fracture aspect is included in a radial-axial plane; the inner region with ductile dimples has a 45-deg orientation. The main fracture steps identified in Refs. 17 and 18 can also be derived from this fractography. An incipient crack is initiated in the hydride rim, the crack being in a radial axial plane. There is a potential for radial crack growth and for a sufficiently high tensile stress or strain so that the remaining ligament cannot carry the load anymore and the specimen fails with a 45-deg rotated fracture angle.

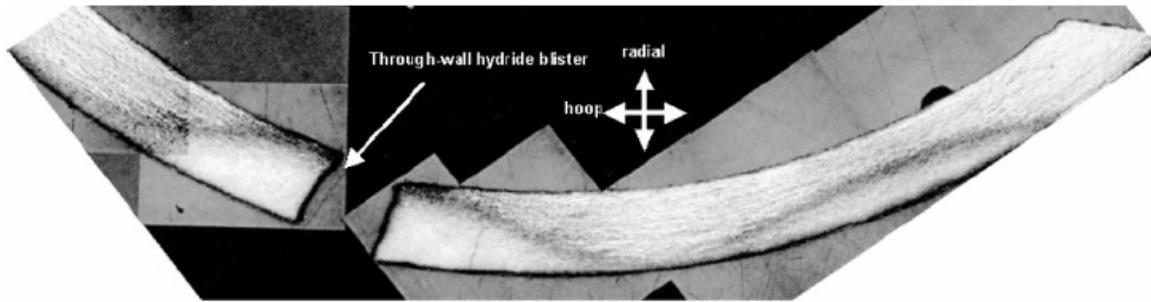
Fig. 23. Metallography with hydride etching of the brittle PROMETRA test 2468.

The observed depth of hydride lenses ranged from nearly zero up to the entire cladding thickness. In the case of PROMETRA test 2468, performed on the highly corroded P07 rod with 130- $\mu\text{m}$  oxide layer thickness and oxide spallation, a through-wall hydride lens has been evidenced and is illustrated in Fig. 23. This specimen failed out of the gauge section, and a rough estimate of the failure stress,  $\sim 145$  MPa, could be determined. It is the lowest failure stress measured within the entire PROMETRA database on high-burnup stress-relieved Zry-4. Very low failure stress values were also obtained on some other ring tests or burst tests that failed at higher but similar stress levels.

It is assumed that 145 MPa is approximately the fracture hoop stress of a hydride blister. This value has the same order of magnitude as the one determined in Ref. 17 on fresh cladding with laboratory-created blisters.

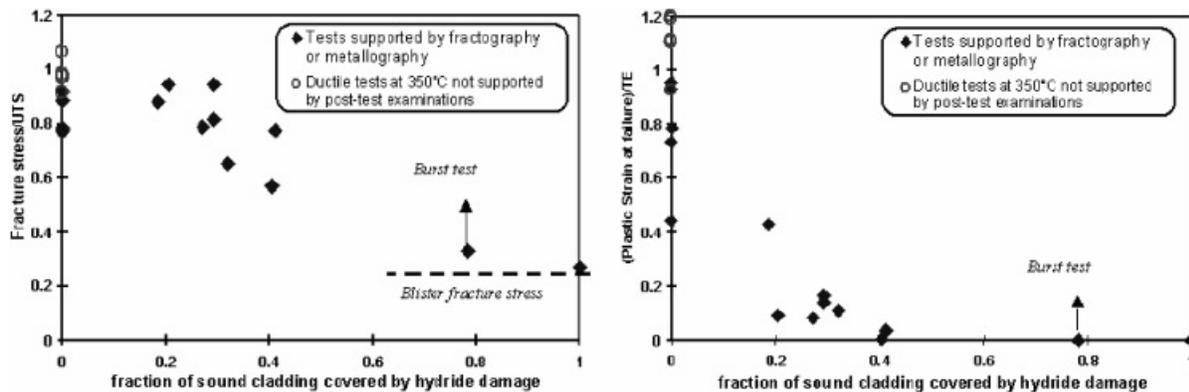
Fig. 24. Influence of hydride damage depth on fracture stress and fracture strain.

Figure 24 illustrates the deleterious influence of hydride damage on cladding mechanical properties. For a hydride damage deeper than 30 to 40% of the sound cladding thickness, no residual strain is expected. Similar curves were obtained on fresh Zircaloy with hydride rims or hydride blisters reported in Refs. 18 and 19 and more recently in Ref. 17. The fracture strain, determined mainly on ring specimens with near-uniaxial tension loading, most probably overpredicts the integrity of an actual irradiated fuel rod submitted to RIA loading under close-to-plane strain loading conditions.<sup>20</sup>

The hydride damage depth, defined as the hydride blister depth or hydride rim depth, has been roughly estimated either from metallography (based on hydride etching) or from fractography (pseudocleavage-affected depth) of specimens tested between 280 and 480°C. The obtained hydride damage depth values normalized by the sound cladding thickness are presented in Fig. 24. In this figure, two curves are plotted: the normalized fracture stresses and the normalized plastic strains at failure (actually residual strains divided by ductile TE value at the corresponding temperature), as derived from these post-test examinations.
