Coupling of X-ray computed tomography and surface in situ analysis combined with digital image correlation method to study low cycle fatigue damage micromechanisms in lost foam casting A319 alloy

Long Wang, Nathalie Limodin, Ahmed El Bartali, Eric Charkaluk

Abstract

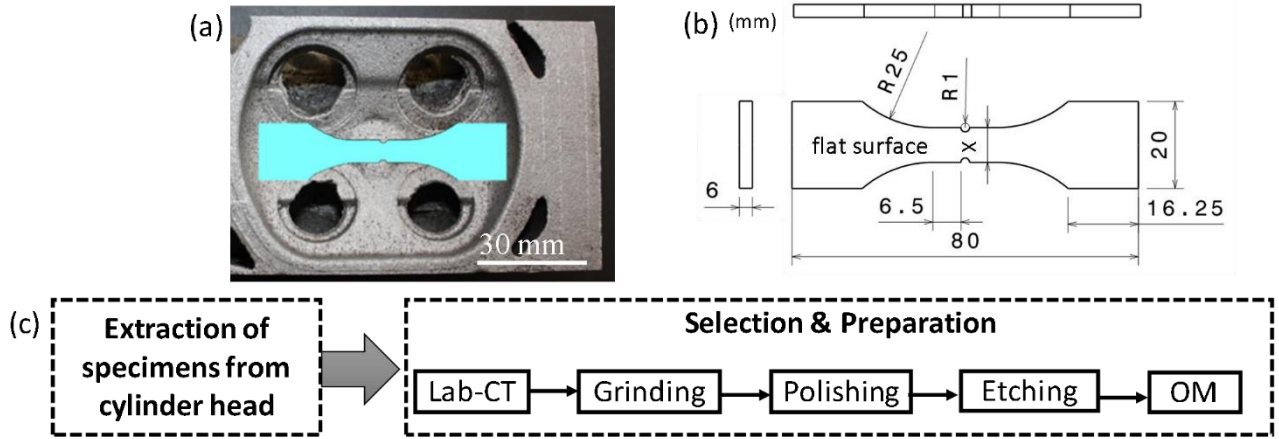
Figure 1: (a) Extractions of specimens from cylinder head; (b) size in mm of extracted specimen ($X=10$ (resp. $= 8$), (Stress concentration factor) = 2.45 (resp. = 2.3) for Specimen 1 (resp. Specimen 2)); (c) the procedure of extraction, preparation of specimens and selection of ROI.

The material used in this study was extracted from an A319 (7.85 wt.% Si, 0.30 wt.% Fe, 3.05 wt.% Cu, 0.19 wt.% Mn, 0.28 wt.% Mg) prototype cylinder head, which was manufactured using LFC process, from the most critical area, i.e. the fire deck²² (Fig. 1a).

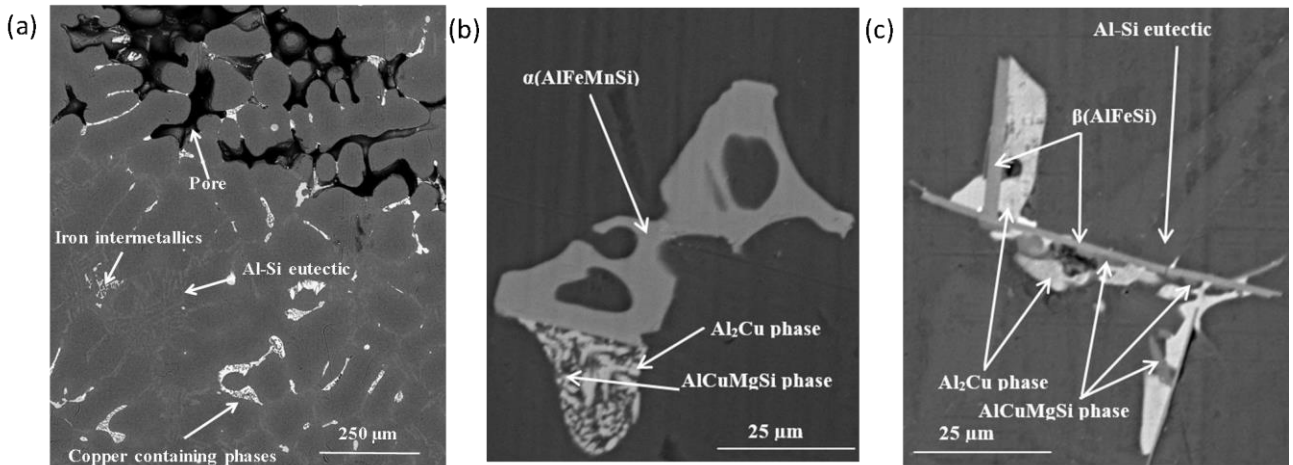
Figure 2: 2D characterizations of LFC A319 alloy using SEM (BSE images): (a) an overview of the microstructural constituents; (b) and (c): higher resolution images reveal the details of iron intermetallics and copper containing phases.

2D characterizations were first performed using SEM together with EDS in order to identify the different phases. The microstructural constituents in the LFC A319 alloy are pores and hard inclusions including eutectic Si, iron intermetallics and copper containing phases (Fig. 2a). Iron intermetallics involve α and β phases: α (AlFeMnSi) phase usually presents a "Chinese script" morphology (in Fig. 2a-b, the iron intermetallics marked by an arrow is an α phase), while β (AlFeSi) phase almost always presents a needle-like morphology (Fig. 2c). The copper containing phases involve Al_2Cu and AlCuMgSi phases the latter being always connected with the former (Fig. 2b-c). Both copper containing phases have a very complex microstructure while the size of AlCuMgSi phases is usually much smaller (less than 1 μm) than that of other hard inclusions. The copper containing phases may connect with the Al-Si eutectic phase (Fig. 2a) or with iron intermetallics (α and β) (Fig. 2b-c).

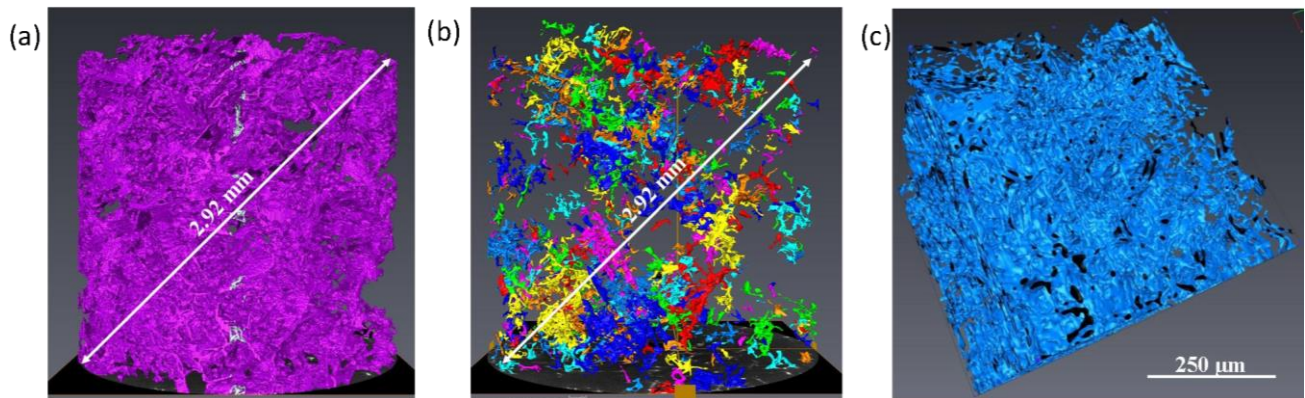
Figure 3: 3D rendering of (a) iron intermetallics, (b) copper containing phases and (c) Si in LFC A319 alloy.

Fig. 3a (respectively b) gives the 3D rendering of iron intermetallics (respectively copper containing phases) in the whole studied volume while Fig. 3c gives the 3D rendering of Si in a subvolume of $500 \times 500 \times 500 \mu\text{m}^3$ to allow a better understanding of its morphology. Both Si and

iron intermetallics (including α and β phases that are connected in volume) form complex and highly interconnected networks and extend in the whole characterized volume, i.e. the maximum Feret diameter²¹ of individual segmented objects reaches the maximum size of the characterized volume; the example of iron intermetallics is shown in Fig. 3a. The copper containing phases, shown in Fig. 3b, are considered as a whole as AlCuMgSi phase cannot be distinguished from the connected Al₂Cu phase due to its small size compared to the current resolution. They also form a complex microstructure but are less extended than Si and iron intermetallics with a maximum Feret diameter of 0.98 mm that is smaller than the maximum size of the characterized volume, i.e. 2.92 mm. The volume fractions of the different microstructural constituents estimated under the current used resolution are: pores \approx 1.0%²¹, Si \approx 9.7%, iron intermetallics \approx 7.4%, copper containing phases \approx 1.3%³.

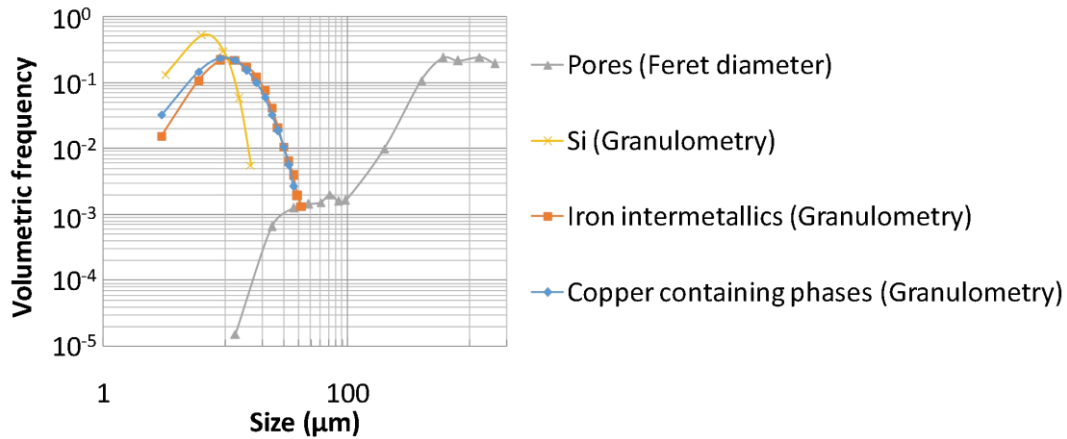
Figure 4: Distributions of pores, and hard inclusions, i.e. Si, iron intermetallics and copper containing phases, as a function of size (Ferret diameter for pores, granulometry for hard inclusions).

The Feret diameter, which is used to characterize the size of pores, is no longer suitable to characterize the size of hard inclusions due to their interconnected and extended morphologies. Thus a granulometric analysis²³, which measures the thickness distribution of a given phase, was introduced to characterize the size of hard inclusions. Fig. 4 compares the size distribution, i.e. Feret diameter for pores²¹ and local thickness for hard inclusions, of the microstructure constituents; the volumetric frequency is defined as the volume of phase having the considered size divided by the total volume of phase. Pores are much larger than hard inclusions. The pores having Feret diameter between 400 μ m and 1200 μ m represent 98% of the total volume of pores. In the same time, the iron intermetallics (respectively copper containing phases) having a local thickness between 6 μ m and 18 μ m represent more than 82% of the total volume of iron intermetallics (respectively copper containing phases) and the Si having a local thickness between 3 μ m and 12 μ m represent more than 99% of the total volume of Si. From a size point of view, the pores can be considered as the most critical defects in the volume.

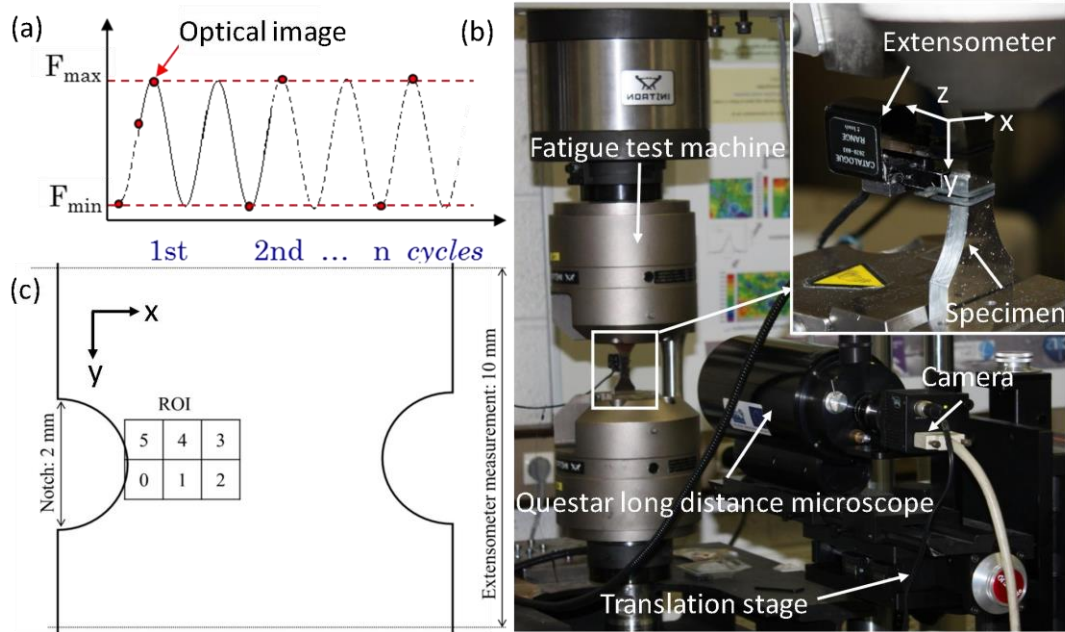
Figure 5: (a) Scheme of images acquisition during fatigue tests; (b) fatigue tests with surface in-situ observations; (c) Schema of DIC measurement and extensometer measurement.

The tests were periodically interrupted with the specimen held under load when obvious damage evolutions were observed on surface, otherwise the tests were also interrupted after a few cycles (less than $10^{n+1}/3$ cycles, i.e. at least 3 interruptions, for the tests performed between the 10^n th cycle and the 10^{n+1} th cycle, $n=0, 1, 2, \dots$) even without evidence of damage evolutions (Fig. 5a). Once the tests were interrupted, six images (3×2 , named as ‘Zone 0’, ‘Zone 1’ ... ‘Zone 5’ in Fig. 5c) were taken in order

to cover the selected ROI (about $2.7 \times 1.5 \text{ mm}^2$). An appropriate overlap between adjacent images is necessary for the further stitching of the images to a larger one, which was performed using automatic Image Stitching plugins²⁶ in ImageJ. The basic loading conditions of each specimen are listed in Table 2. Post mortem analyses were performed on the fracture surface by using OM and SEM in order to identify the possible crack initiation sites in fatigue and to study the fracture morphologies.

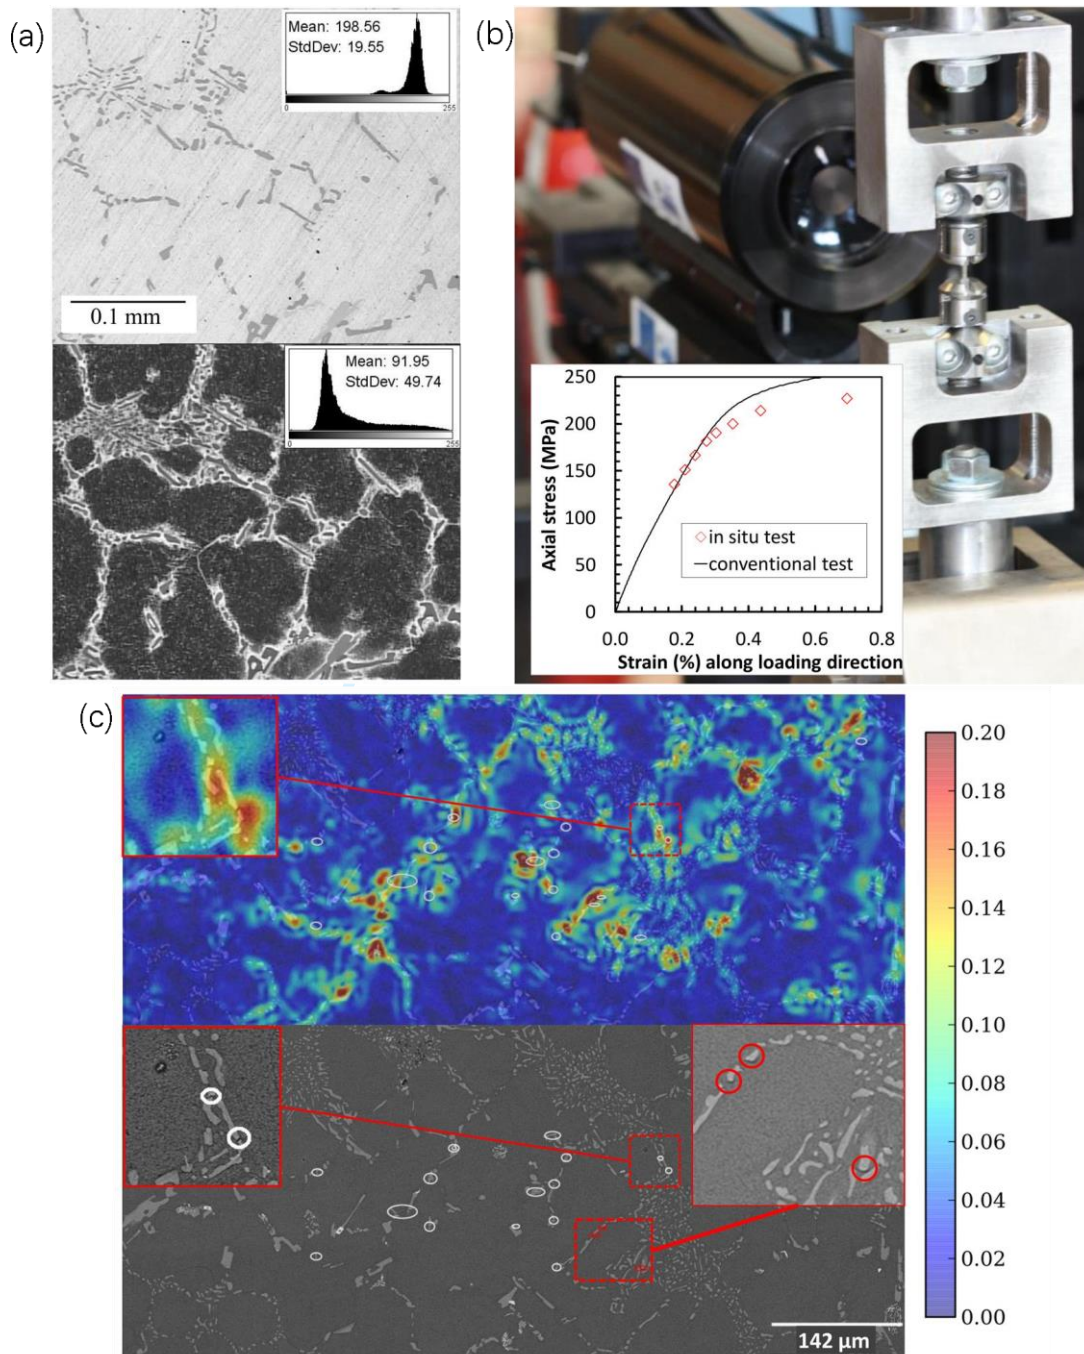
Figure 6: (a) Optical microscopy images of the specimen surface before (top) and after (down) etching; histograms show the dynamic of the corresponding image in 8bit format; (b) Experimental set-up with Questar microscope; the stress-strain curve of the test is compared to that of a conventional test; (c) Cumulated strain field computed from DIC at the last load step before failure (237 MPa) and the corresponding SEM image showing fracture and debonding of Si particles; loading was along the vertical direction.

measurement (represented with a plain line in Fig. 6b). Thus, the experimental protocol developed in this study to perform DIC at the scale of the microstructure can be used to understand damage mechanisms at a fine spatial scale in Al-Si cast alloys.

In Fig. 6c, strain heterogeneity is observed in the ROI of the specimen and was compared with SEM observations at a magnification large enough (500) to detect microcracks (circled in white in the lower image in Fig. 6c) that were not visible in the optical image. In fact, strain localization appeared in the eutectic Al-Si constituent at a stress level of 220 MPa (average strain of about 0.44 %) and increased at a stress level of 237 MPa (average strain of about 0.71 %). The comparison of the microcracks (white circles in Fig. 6c) and the debonding (red circles) of eutectic Si particles observed after the test with the strain field at the last loading step before failure shows (1) that most of the strain localization can be ascribed to Si particles and (2) that Si damage has occurred at areas where a strain localization was indeed visible at the last loading step of the tensile test. To the authors' knowledge, this type of comparison between DIC and fracture in such materials at such a scale is a new result.

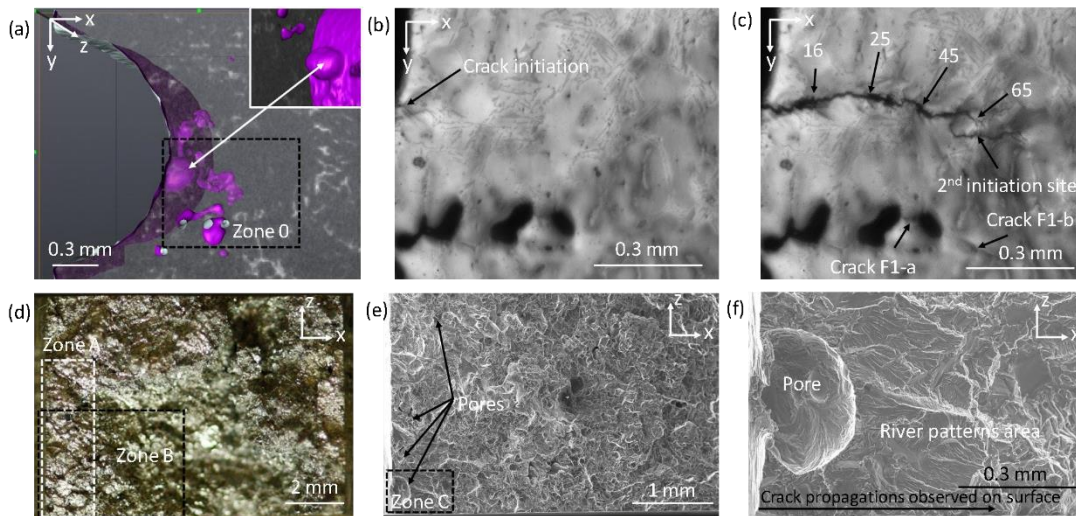
Figure 7: Specimen 1: (a) 3D rendering of pores near the selected ROI on flat surface while the surface is set transparent; in-situ observation images captured after (b) 7000 cycles and (c) 90000 cycles in Zone 0 of (a), the arrows with number indicate the position of the arrested crack tip after the number of loading cycles shown in units of 1000; (d) whole fracture surface; (e) SEM image of Zone B in (d); (f) SE image of Zone C in (e).

In Specimen 1 (Fig. 7), no obvious cluster of pores was observed near the flat surface in the notched cross-section using Lab-CT. However, a surface pore located in the notch root (marked by arrows in Fig. 7a) is less than 0.1 mm from the flat surface. The pore's volume is about 0.012 mm^3 , and its max. Feret diameter is about 0.38 mm. Fig. 7a and f show that the pore is rather spherical suggesting that it is a gas pore not a microshrinkage cavity. Although it is not very large compared with standard large pores in this material²¹, this pore is supposed to be the most probable crack initiation site on the observed surface through the comprehensive evaluation based on the influence of pores' size and location^{12,21,25}: (a) it is quite near the flat surface and the notch root contrary to other larger pores in bulk, (b) it is larger than other pores located on the observed surface. Thus, the flat surface area in front of this pore was selected as the ROI. In fact, Specimen 1 failed from a single crack (Fig. 7b) that nucleated at Si phase on the flat surface right in front of this pore. In order to check the influence of this pore on crack initiation, fracture analysis was performed.

One half of the broken specimen was observed using a single-lens reflex camera (Fig. 7d). Zone A is more likely to be crack initiation and propagation areas instead of final fracture area as it is more

flat than other areas in fracture surface. River patterns³⁸, of which the direction represents the direction of the crack propagation, were indeed observed around the above mentioned pore in Fig. 7f with a higher resolution. Thus, the crack initiation, which was observed on the flat surface, could be ascribed to this pore that is surface-breaking in the notch area but is some distance below the flat surface where in-situ observations were done.

SEM observations were also performed on the whole fracture surface. The area, i.e. Zone A in Fig. 7d, where the river patterns were observed corresponds to the area where crack initiated and propagated. The other areas without river patterns are the fast fracture area in the final stage of fatigue test. This is consistent with the in-situ surface observation as cracks were only observed to grow on surface above this area.

Several pores, marked by arrows in Fig. 7e, were found in the crack propagation area, i.e. Zone A. They present evidence of river patterns so that it is difficult to identify the first initiation site inside the specimen. There are several possible scenarios: (1) One crack initiated from one of these pores, and then grew through other pores towards the free surface. (2) Cracks initiated from several pores at the same time or at different cycles, and then coalesced during the propagation. (3) Cracks initiated from hard inclusions in bulk that are not connected with pores under the influence of the stress concentration induced by pores and then propagated through the pores.

In Specimen 1, crack initiating at Si particle after 7 000 cycles (Fig. 7b) propagated along hard inclusions, including Si phase, iron intermetallics (both α and β phases), Al_2Cu and AlCuMgSi phases, until 65 000 cycles where the crack tip was arrested by hard inclusions (Fig. 7c). Meanwhile, another crack initiated at hard inclusions at a 2nd initiation site below the arrested crack tip (Fig. 7c) after 85 000 cycles. Inside the specimen, this secondary crack may be a branch of the main crack as it is close to the arrested principal crack tip (Fig. 7c) or it may also be an independent nucleation site. However, one cannot confirm it using fracture analysis as the 2nd initiation site is covered in the final fracture surface. The principal crack was arrested until final failure. When the crack from the 2nd initiation site (Fig. 7c) connected with this principal crack after 90 000 cycles, failure occurred quickly.

For Specimen 1, the cracks initiated in Zone 0 after 7 000 cycles and the propagation remained in Zone 0 (Fig. 7c) even in the last in-situ observation step (about 10^5 cycles) before final failure; no cracks could be observed in the other five zones. On the contrary for Specimen 2, the cracks initiated in Zones 0 and 5 during the tensile stage of 1st cycle and they were in-situ observed to grow in all the six zones before final failure.

The location of pore is also demonstrated to be an important factor on crack initiation: Cracks initiated around a surface pore at the notch root in Specimen 1 (Fig. 7) instead of other larger pores far from surface; In Specimen 2 (Fig. 8), more cracks initiated from the near surface Pore A and the surface Pore C than from the larger subsurface Pore B (Table 3).

- For Specimen 1: (a) When crack tip was arrested at 45 K cycles in Fig. 7c, Crack F1-a, which is just below the arrested crack tip, initiated at Si particle between two surface pores, which are actually one pore that is connected in subsurface as shown in the Lab-CT observation (Fig. 7a). (b) When crack tip was arrested at 65 K cycles, Crack F1-b, which is just below the arrested crack tip, initiated at copper containing phases. In the same time, crack initiated at hard inclusions (iron intermetallics, Al₂Cu phase and AlCuMgSi phase) at 2nd initiation site, which is also below the arrested crack tip.

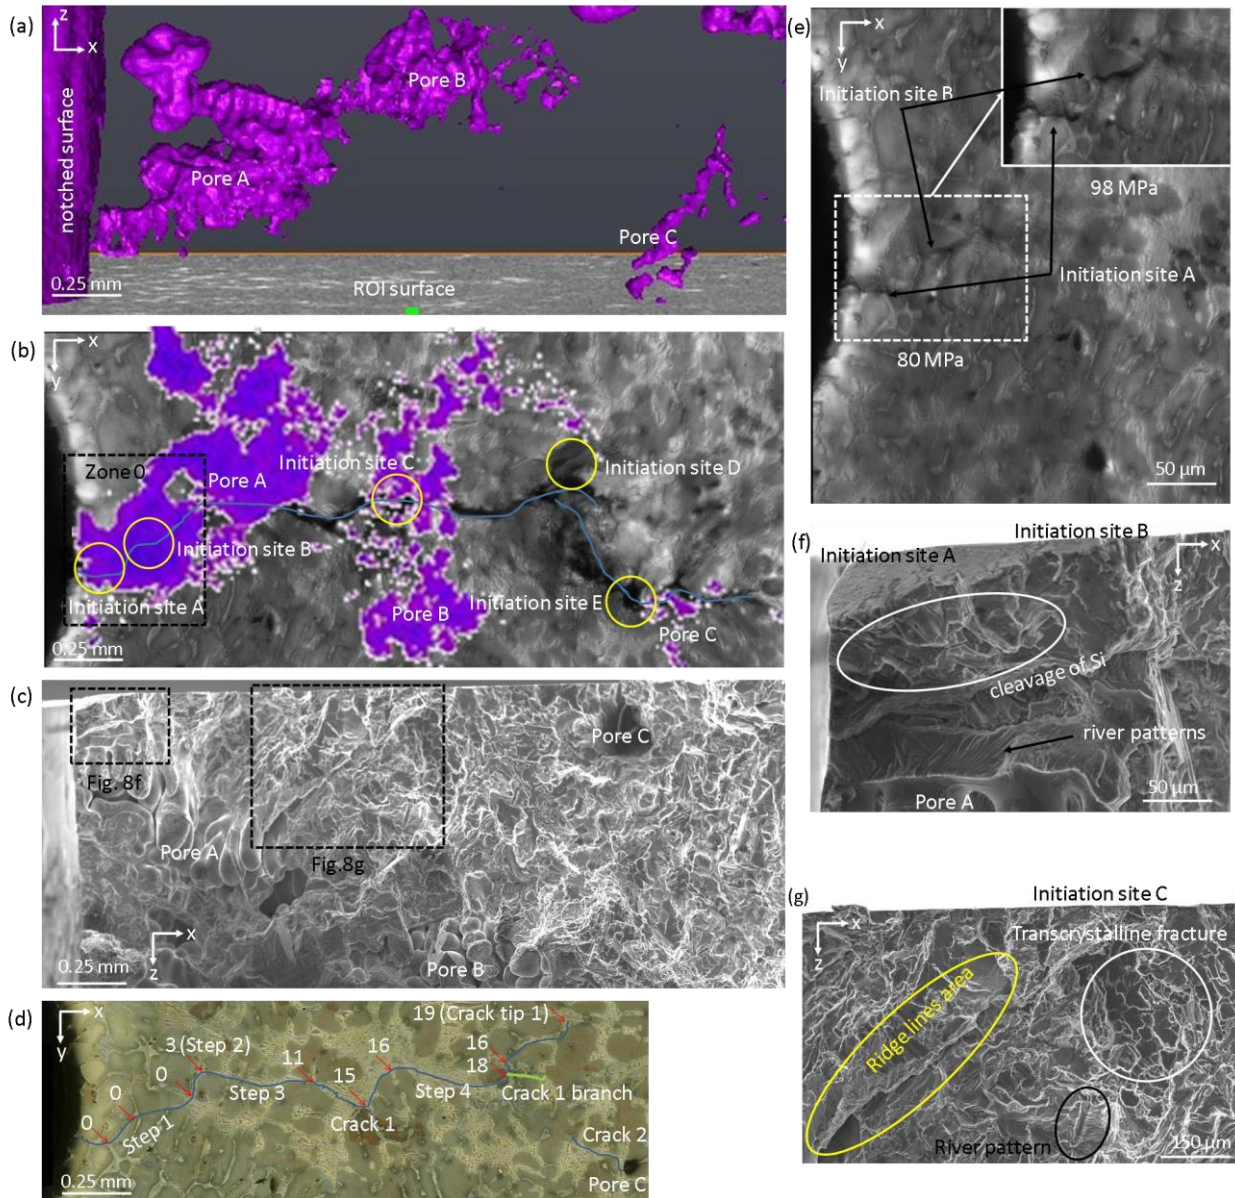
Figure 8: Specimen 2: (a) 3D rendering of a cluster of pores below the selected ROI on surface; (b) in-situ observation image (stitched using six images) captured after 20300 cycles with the 2D projection of 3D pores from (a) shown in purple and final fracture marked with blue line; (c) the fracture surface observed by SEM in the corresponding area shown in (b); (d) OM image in ROI with the observed crack marked with lines and the arrows indicate the position of the crack tip after the number of loading cycles shown in units of 1000; (e) in-situ observation images captured during tensile stage of 1st cycle (Zone 0 in (b)); (f) (g) SEM image in the corresponding zones in (c).

Fig. 8 presents a comprehensive analysis of Specimen 2 including 3D rendering of pores in the bulk of specimen (Fig. 8a), in-situ surface observations (Fig.8b, e), OM surface observation (Fig. 8d) and fracture analysis (Fig. 8c, f and g). In Specimen 2, cracks initiated on surface from five different sites identified as A, B, C, D, and E in Fig. 8b. Cracks initiated from sites A and B (Fig. 8e) before the maximum load of the 1st cycle was reached, i.e. below an applied stress of 80MPa. The opening of these two cracks became larger with a further increase of the stress up to the maximum value of the 1st cycle (in the top right of Fig. 8e). Thus, the maximum loading in the 1st cycle was stopped at about 98 MPa, which is lower than for Specimen 1.

SEM post-mortem analysis showed that these two crack initiation sites on surface were not only at hard inclusions but also in Al matrix and that they are located just above Pore A (Figs. 8a-c). Thus, the cracks were likely to have initiated from Pore A and then propagated to the flat surface. Fracture analysis in Fig. 8f shows that the distance between initiation sites A/B and Pore A is less than 0.1 mm.

The cracks initiated on surface at sites A/B during the tensile stage of the 1st cycle, thus the damage mechanisms could not be ascribed to fatigue but to the large stress concentration caused by the large Pore A in subsurface. This crack corresponds to brittle fracture zones with cleavage of Si (Fig. 8f).

Cracks were observed to initiate at sites C and D (Fig. 8b) suddenly between the 15 860th cycle and the 15 890th cycle. These two initiation sites were across hard inclusions and Al matrix and cracks opened very quickly. Pore B is below the initiation site C (Figs. 8a-c) at a depth of about 0.8 mm as shown in Table 3. Although the river patterns marked in Fig. 8g revealed the direction of cracks originated from the cleavage of a Si particle in a local area, one cannot obtain more information about crack propagation in a larger area. However, the ‘ridge’ line (Fig. 8g), which formed during the coalescence of cracks from two different planes³⁹, was observed between initiation site C and Pore A (Fig. 8c). This implies that crack initiation C may be due to coalescence of two cracks.

Crack 2, which is marked in Fig. 8d, was observed to initiate from site E (Fig 8b) near Pore C after 19 350 cycles. The influence of surface Pore C on crack initiation at site E is obvious.

After nucleation at sites A and B in Specimen 2 at 1st cycle, cracks were arrested for more than 2 000 cycles (step 1 in Figs. 8d and 9a) by hard inclusions perpendicular to each crack tips. Once the hard inclusions had failed, the two cracks grew again and connected on surface. Both cracks (Fig. 8e) coalesced due to crack propagation below the surface under cyclic loadings as river patterns were observed between Pore A and these two initiation sites (Fig. 8f). Then, this coalesced crack was observed to propagate along hard inclusions (step 2 and 3 in Figs. 8d and 9a). After 15 860 cycles, one crack, which has nucleated from Pore A, propagated towards site C on surface, and another crack initiated at site D on surface. They joined with each other (step 4 in Figs. 8d and 9a) and also joined with the cracks that nucleated from site A/B through cracks growth along hard inclusions after 18 000 cycles. Transcrystalline fracture⁴⁰ was observed in the fracture surface below site D (Fig. 8g). It may

be caused by monotonic loading when cracks coalesced between sites C and D. However, one cannot confirm it just from fracture analysis. This large coalesced crack, i.e. Crack 1 in Fig. 8d, propagated until Crack tip 1 where the crack was arrested by hard inclusions. Then, Crack 2 propagated along hard inclusions towards the arrested Crack 1 (Fig. 8d). In the same time, a branch crack propagated in the direction perpendicular to the loading direction and along hard inclusions. When Crack 2 coalesced with the branch of crack 1 after 20 400 cycles, fracture occurred in the following 30 cycles.

- For Specimen 2: When the main crack was arrested by hard inclusions at crack tip 1 (Fig. 8d), Crack 2 initiated on surface around Pore C after 19 350 cycles. Although strain localizations are easily generated around such large pores, no crack was observed before the crack was arrested at crack tip 1.

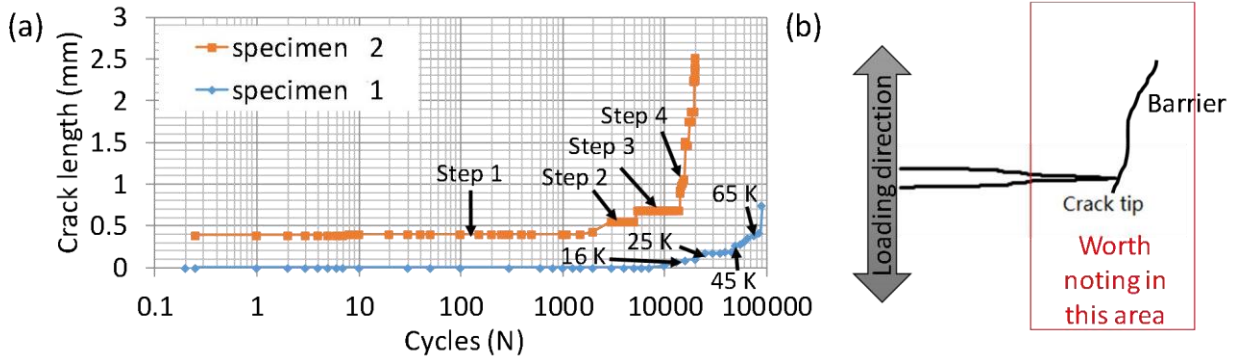
Figure 9: (a) Crack length evolution with number of cycles; (b) schematic drawing of the area where crack tip is arrested by barrier.

The cumulative crack lengths of Specimens 1 and 2 were measured using ImageJ software on in-situ captured images for the quantitative analysis of crack propagation (Fig. 9a). The measured crack

length corresponds to the distance between the initiation site at the notch root and the farthest crack tip. Crack observed on surface of Specimen 2 is much longer than that of Specimen 1 due to numerous large near surface pores in Specimen 2 (Figs. 7-8).

(Fig. 9b) around the crack tip and along the loading direction:

The failure of hard inclusions needs enough applied stress⁴³. Thus, the above observations imply that stress concentrations may occur in the same vertical direction as the crack tip, i.e. the area marked in Fig. 9b, when the crack was arrested. Actually, such strain localizations are confirmed by DIC measurements, for example, 2nd Crack initiation site for Specimen 1 in Fig. 11b and Crack 2 for Specimen 2 (Initiation site E) in Fig. 12. As discussed in 4.1, it should be noted that initiation site E is a little away from the vertical direction of the arrested crack tip due to the combined effect of the stress concentrations caused by arrested crack tip and Pore C.

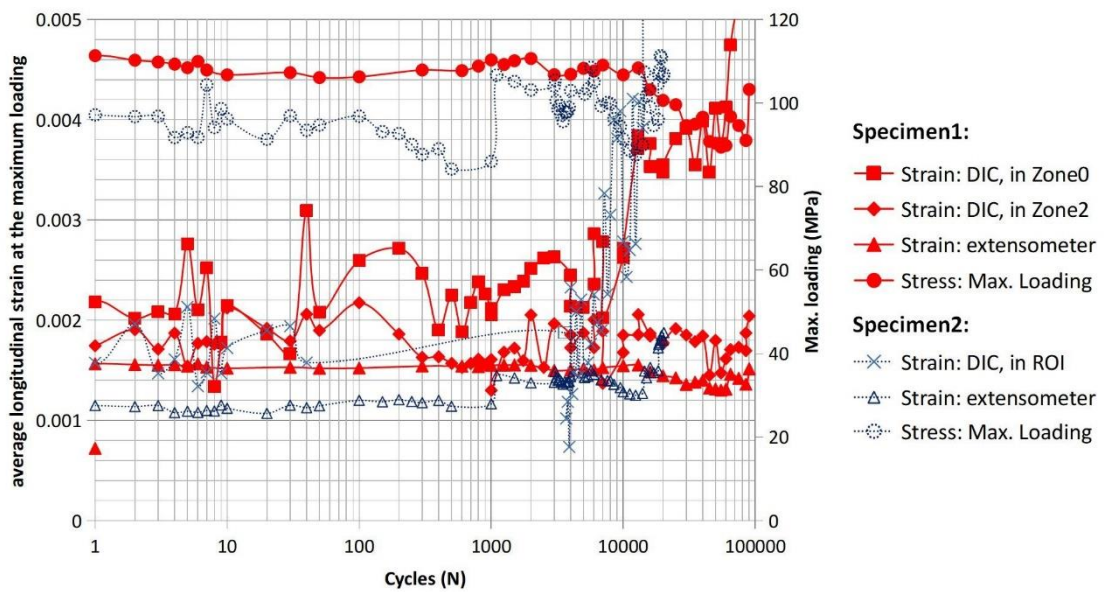
Figure 10: Evolution of average longitudinal strain in Specimens 1 and 2, as measured by extensometer and DIC at the maximum load, with the number of cycles.

Cracks were observed to initiate in Zone 0 due to the pores below the surface in an area where a larger deformation was indeed measured. During the fatigue test, the gap (Fig. 10) between the measured strain in Zone 0 and that in Zone 2 grew larger after crack initiation in Zone 0 after 7000 cycles: the measured strain in Zone 2 is basically below 0.2% while that in Zone 0 increases from less than 0.3% to more than 0.5%. Thus, as mentioned above, the large deformations measured by DIC for Zone 0 of Specimen 1 from 7000 cycles in Fig. 10 were mainly induced by the discontinuities appeared at the crack. The similar situation was also observed for Specimen 2. On the contrary, the average strain in Zone 2 of Specimen 1, where there is no crack, keeps relatively constant during the test.

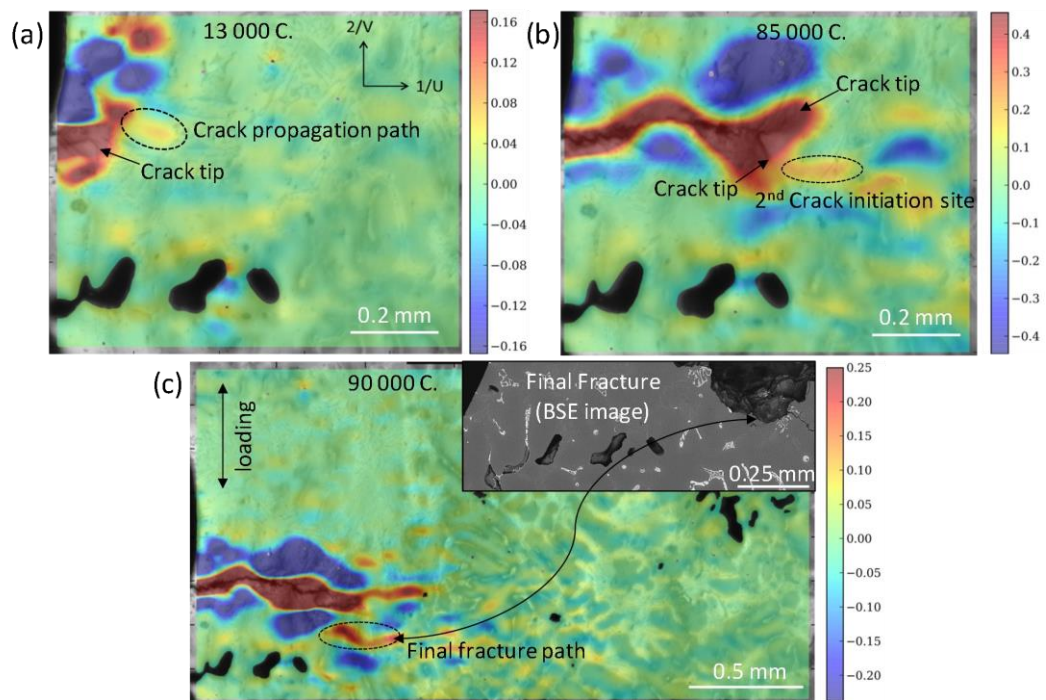
Figure 11: DIC strain (ϵ_{22}) measurement of Specimen 1: (a) 13 000 cycles and (b) 85 000 cycles in zone 0; (c) 90 000 cycles (last step before final failure) in the ROI shown with BSE image of final fracture in the top right.

Several examples of strain fields measured by DIC for both Specimens 1 and 2 are shown in Figs. 11 and 12. The deformed image, i.e. the image taken at the corresponding cycle, was put behind the measured field to allow its comparison with surface microstructure. In fact, as the measured fields are related to the reference image instead of the deformed images, a little difference may exist between the translucent field and the microstructure behind.

In Fig. 11, the large deformations at the cracks (see red areas in Fig. 11) are caused by opening of cracks. In the areas marked with circles in (a) and (b), strain localizations (>3% for (a), while >6% for (b)) occurred while there was still no crack. Surface crack passed through the area marked in (a) in the following cycles, and a 2nd crack initiated in the area marked in (b). Thus, strain localizations were measured in these areas prior to the observations of cracks on surface. Besides, the strain measured by

DIC in the areas marked with circles in (a) and (b) may also be overestimated as out-of-plane deformation may have occurred in these areas where cracks appeared in the following cycles.

One example of strain fields in the whole ROI of Specimen 1 is shown in Fig. 11c. Besides the Zone 0 (the lower left corner area in the stitched image), no obvious strain localization was observed until the last step before failure (after 90 000 cycles). The DIC performed in the other five zones highlights the role of strain localizations in crack nucleation from another perspective: no strain localizations no crack nucleation. Besides, the strain localization (marked by a circle in Fig. 11c) prior to the appearance of crack occurred where the final fracture took place.

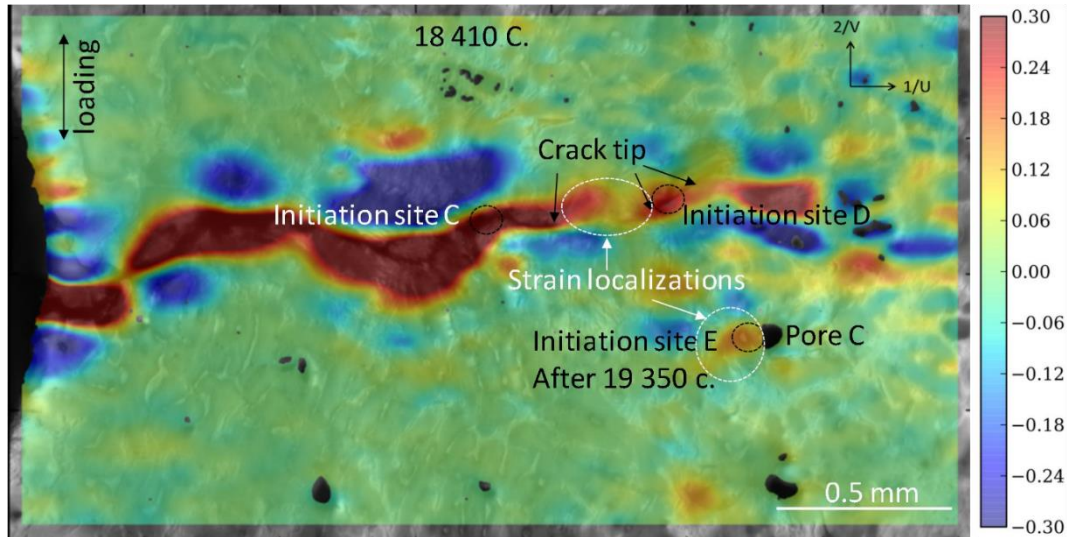
Figure 12: DIC strain (ϵ_{22}) measurement Specimen 2: 18 410 cycles in the ROI.

The relations between strain localization and crack were also observed for Specimen 2 in Fig. 12. The crack tips after 18 410 cycles are marked by arrows, and the cracks initiated from sites C and D have not connected yet. The strain localizations measured in the area (marked with a white circle around Initiation site E) where a secondary crack initiated around the surface pore after 19 350 cycles when the main crack was arrested by hard inclusions around crack tip, indicates the influence of strain localizations on crack initiation. Meanwhile, the strain localizations measured in the area (marked with a white circle between crack tips) where two separate cracks connected on surface in the following cycles are mainly ascribed to the coupling influence of the two separate crack tips.
