The development of Kangiqsualujjuaq and the threat of snow avalanches in a permafrost degradation context, Nunavik, Canada

Armelle Decaulne, Najat Bhiry, Janie Faucher-Roy, Clara Pelletier Boily

Espace populations sociétés

Espaces et sociétés arctiques

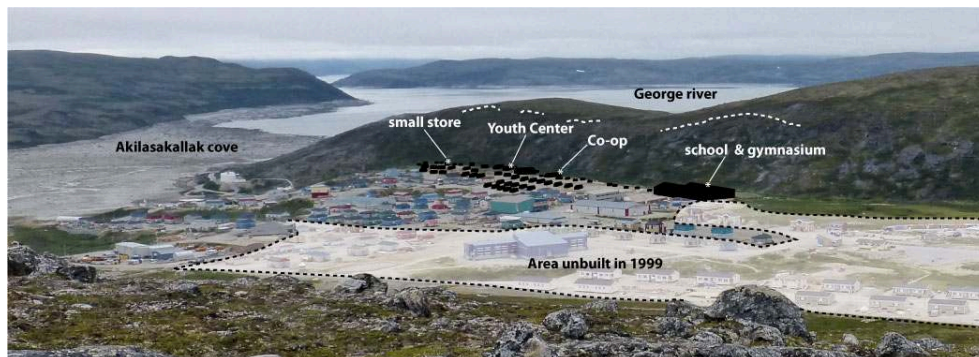
Figure 6 – Kangiqsualujjuaq in 2019.

In black, a schematic reconstruction of the location of former buildings, which today corresponds to the exclusion zone, and known damaged buildings by snow-avalanche events prior to 1999; the white dashed lines represent the departure zones of those snow avalanches.

- 13 Previously, other snow-avalanche events had been observed (Figure 6A), but these did not cause such extensive damage and harm to people. The dates for these events are not precise [Stethem *et al.*, 1999; Hétu, 2001]:

- the “small store” was hit in March or April 1981 or 1982, catching one person who was not injured; the runout of the snow-avalanche from the foot of the slope was approximately 20 m;

- the back wall of the Co-op store was hit twice, in March or April 1982, 1984 or 1986: canoes were damaged in one of the two snow avalanches, and one person was caught in the other one, without sustaining an injury; the runout distance to the Co-op was about 20 m;

- the back wall of the Youth Centre was hit in March or April 1984 or 1986; no one was injured, although the runout distance to the building is the shortest, at only 14 m;

- the back wall of the school gymnasium was hit in March 1993, and the steps leading to the door were buried under 1.5 m of snow; two people were buried but extracted alive, although one was injured; the runout distance was 40 m.

- 19 Globally, the territory of the municipality of Kangiqsualujjuaq can be divided into three sectors according to its superficial sediment/substrate and topography (Figure 6) and associated reaction to permafrost thaw:

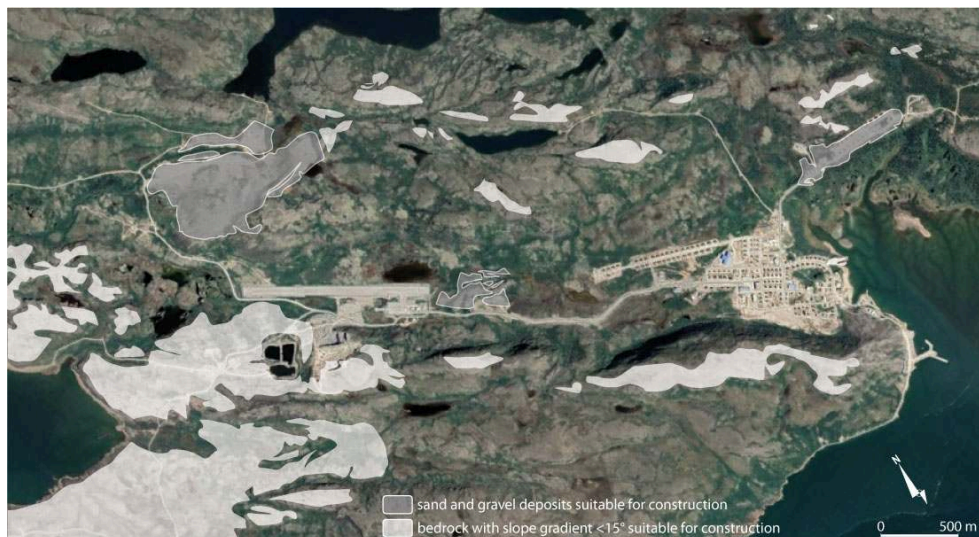
Figure 8 – Location of the suitable construction areas on surfaces where permafrost thawing and active layer fluctuations have little effect on the stability of the surface, away from active slope processes areas (modified from Aubé-Michaud et al., 2017).
