The development of Kangiqsualujjuaq and the threat of snow avalanches in a permafrost degradation context, Nunavik, Canada

Armelle Decaulne, Najat Bhiry, Janie Faucher-Roy, Clara Pelletier Boily

Armelle Decaulne, Najat Bhiry, Janie Faucher-Roy, Clara Pelletier Boily. The development of Kangiqsualujjuaq and the threat of snow avalanches in a permafrost degradation context, Nunavik, Canada. *Espace Populations Sociétés*, 2021, 2020/3-2021/1, 10.4000/eps.10497 . hal-03164690

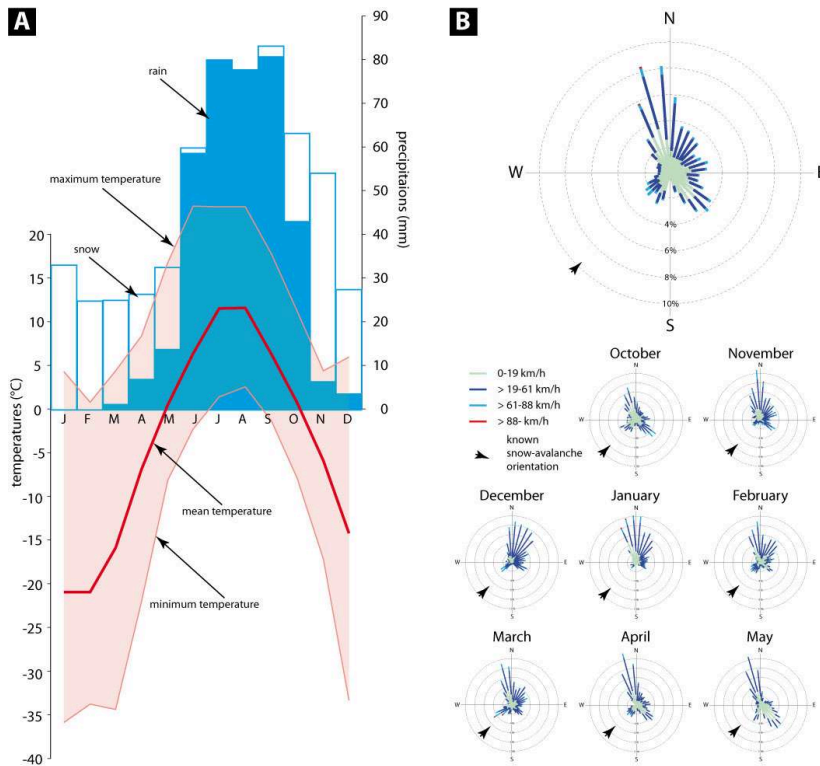
Figure 2 – Climate data. A: temperature and precipitation in Kuujjuaq, from 2006-2015; B: origin and mean speed of daily winds in Kangiqsualujjuaq CEN station from 2005-2008 and winter months details (modified from Aubé Michaud et al., 2017).

- 4 In the analysis of snow-avalanche hazards and associated risks, the knowledge of past events is highly depending on the occupation period and clear account of events (dates, location of the path, type of snow, runout distance, etc) [McClung and Schaerer, 1993 ; Stethem *et al.*, 2003], enabling differentiating the situation of risk from punctual catastrophic events [Dauphiné and Provitolo, 2003] ; in Kangiqsualujjuaq valley, human occupation has been only temporary before the settlement, the precise camp sites being not precisely known ; the village further recorded a constant demographic growth since its establishment. Wind has a strong role in the gathering of the snow that will be forming the snow avalanche : in Kangiqsualujjuaq, none of the known snow-avalanche events originate from the usual NNW direction, but from the WSW to SW unusual blizzards (Figure 2B).

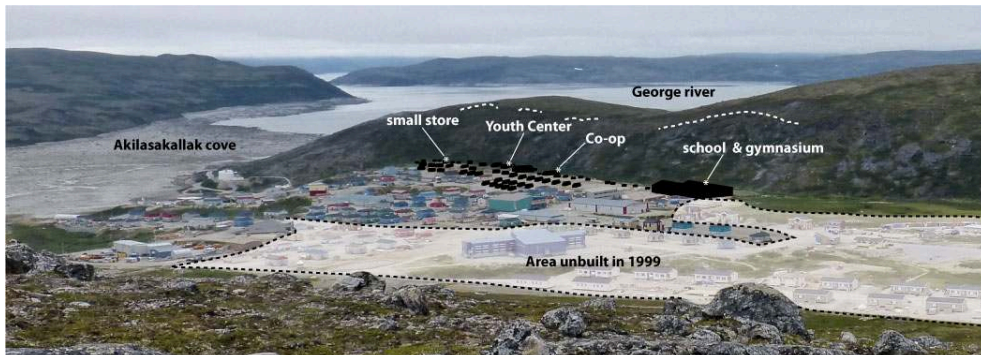
Figure 6 – Kangiqsualujuaq in 2019.

In black, a schematic reconstruction of the location of former buildings, which today corresponds to the exclusion zone, and known damaged buildings by snow-avalanche events prior to 1999; the white dashed lines represent the departure zones of those snow avalanches.

- 13 Previously, other snow-avalanche events had been observed (Figure 6A), but these did not cause such extensive damage and harm to people. The dates for these events are not precise [Stethem *et al.*, 1999; Hétu, 2001]:

- the “small store” was hit in March or April 1981 or 1982, catching one person who was not injured; the runout of the snow-avalanche from the foot of the slope was approximately 20 m;

- the back wall of the Co-op store was hit twice, in March or April 1982, 1984 or 1986: canoes were damaged in one of the two snow avalanches, and one person was caught in the other one, without sustaining an injury; the runout distance to the Co-op was about 20 m;

- the back wall of the Youth Centre was hit in March or April 1984 or 1986; no one was injured, although the runout distance to the building is the shortest, at only 14 m;

- the back wall of the school gymnasium was hit in March 1993, and the steps leading to the door were buried under 1.5 m of snow; two people were buried but extracted alive, although one was injured; the runout distance was 40 m.

designation of new building locations along Akilasakallak cove and the northern part of the valley (Figures 5 E-G and 6).

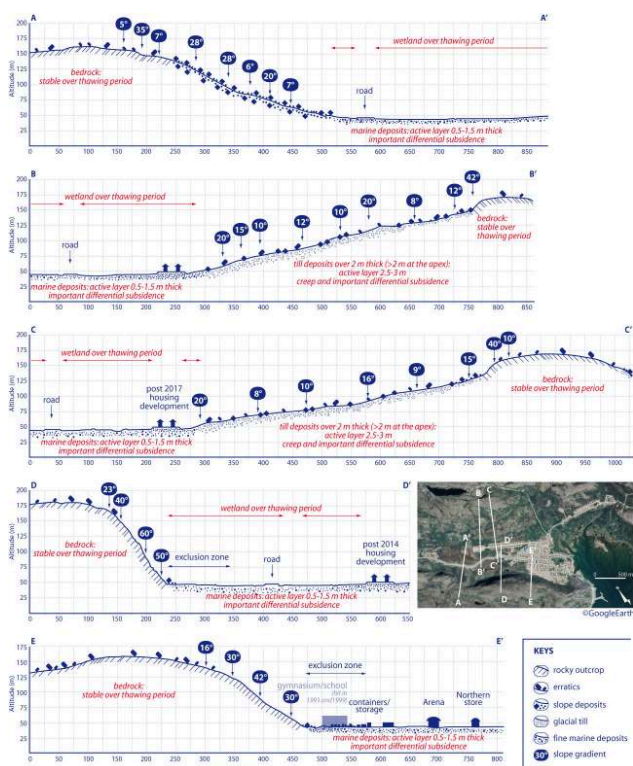
Figure 7 – Cross profiles of Kangiqsualujuaq valley.

From these profiles, one can observe the distribution of the three main surfaces within the valley, i.e., bedrock, glacial till and fine marine deposits. The indications regarding slope gradients also provide information on the potential slope processes, such as snow avalanches, rockfall and creep.

Elevation data extracted from LiDAR 2010, ministère de l'Énergie et des Ressources naturelles.

- 18 The village is also located within a zone of abundant discontinuous permafrost, at the edge of the continuous permafrost zone [Allard *et al.*, 2012]. The permafrost distribution and thickness, as well as the thickness of the active layer, vary considerably depending on the grain size and type of superficial sediments, snow-cover thickness, hydrological conditions and vegetation. In addition some zones of the valley are poorly drained (Figure 7).

20 In such topographic and permafrost conditions, very little terrain is suitable for construction (Figure 7). The bedrock is made of granitic gneiss and would support buildings where the topography is not too uneven; there, the active layer has little effect on the surface stability. Sand and gravel deposits about 2 m thick over the bedrock could also be suitable, as the ice volume within such material remains below 10 m. Gravel and sand deposits over 2 m thick are also well drained, inhibiting important ice content, even with an active layer 2.5-3 m thick. Therefore, the most extensive areas suitable for further construction that could possibly support housing developments are (i) the site beside Akilasakallak cove where houses were transferred from the snow-avalanche exclusion zone after the 1999 avalanche, and (ii) the site beyond the airport. The first area mentioned still has some space left for new construction; the second one is located far from the village core, but already benefits from transportation infrastructures since part of it is used as a sand and gravel quarry. Other surfaces are not suitable for sustained development, requiring post-construction building adjustments and infrastructure maintenance. With reference to Figure 8, we observe that the whole valley bottom is excluded from the prone building surface, as marine deposits are unstable during the thawing period.

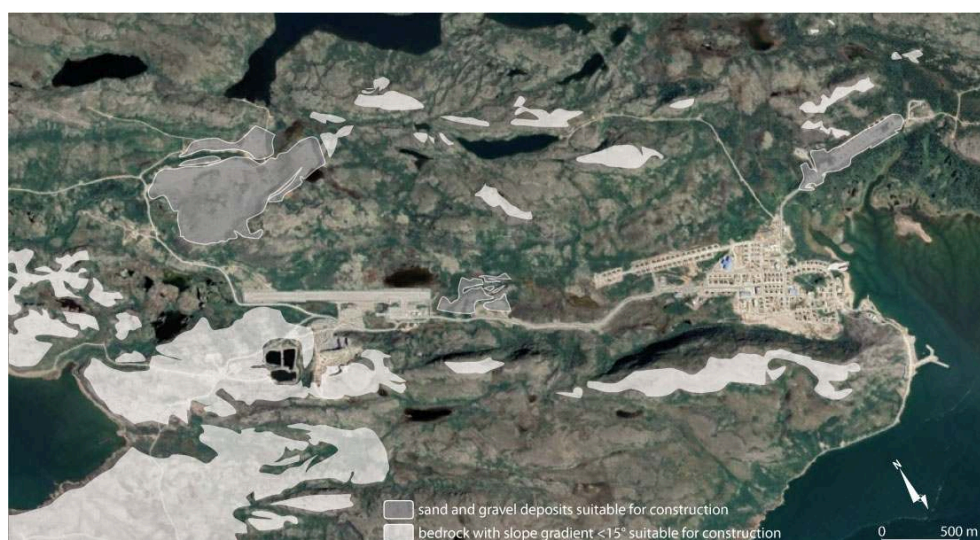
Figure 8 – Location of the suitable construction areas on surfaces where permafrost thawing and active layer fluctuations have little effect on the stability of the surface, away from active slope processes areas (modified from Aubé-Michaud et al., 2017).
