Natural Risks and Water Management in Delphi

Amélie Perrier,¹ Isabelle Moretti² and Luigi Piccardi³

Abstract: The archaeological site of Delphi is subject to several natural hazards including earthquakes, gravity gliding, and slope instabilities. The architectural remains at the site bear the marks of the disasters that occurred in antiquity but also show how ingeniously the ancient Greeks dealt with risks and major events. The greatest danger seems to be landslides and rock falls, which are caused by surface and underground water runoff. The period of reconstruction that followed the collapse of the Temple of Apollo in the 4th century BC seems to mark an important turning point in how ancient designers considered and responded to water-related risks. Water is appropriately channelled and later exploited for thermal baths.

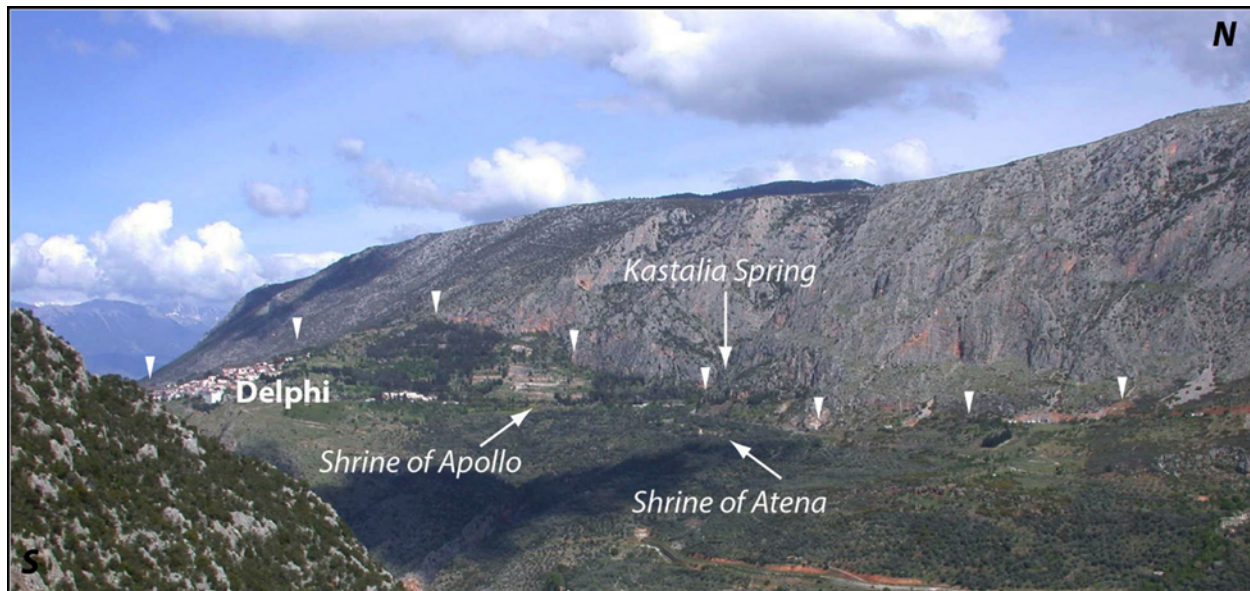
Figure 3: View towards the north of Delphi and the southern slope of Mt Parnassus. White triangles indicate the trace of the active fault.

Delphi is located of the northernmost south dipping fault that borders the Corinth Rift (Figures 2, 3). The site of Delphi lies mainly in slope breccias and flysch but Mesozoic carbonate rocks also outcrop and the blocks of this basement cut by the major faults shape the landscape (Figure 3). Three main tectonic units are present in the area of Delphi: 1) the Parnassus Nappe which overlaps (2) the Pindos Nappe to the west and

south, extending for a distance of c. 28 km from east to west (Figures 2, 3). It is an east/west-trending fault, downthrowing the southern block and with minor right-lateral component of movement, as indicated by the geometry of the fault and slip-parallel lineation on the main fault plane (east of Delphi, the fault plane has an average strike of 260°N, dips 60–65° and is linedated by corrugations and striations with a pitch of about 70°W). For the most part, the main fault plane affects the Mesozoic limestone and Paleogene flysch of the bedrock. Würmian (< c. 18 ka) slope debris and Holocene (< 10 ka) debris cones are faulted as well. Delphi is positioned at a bend of the fault.

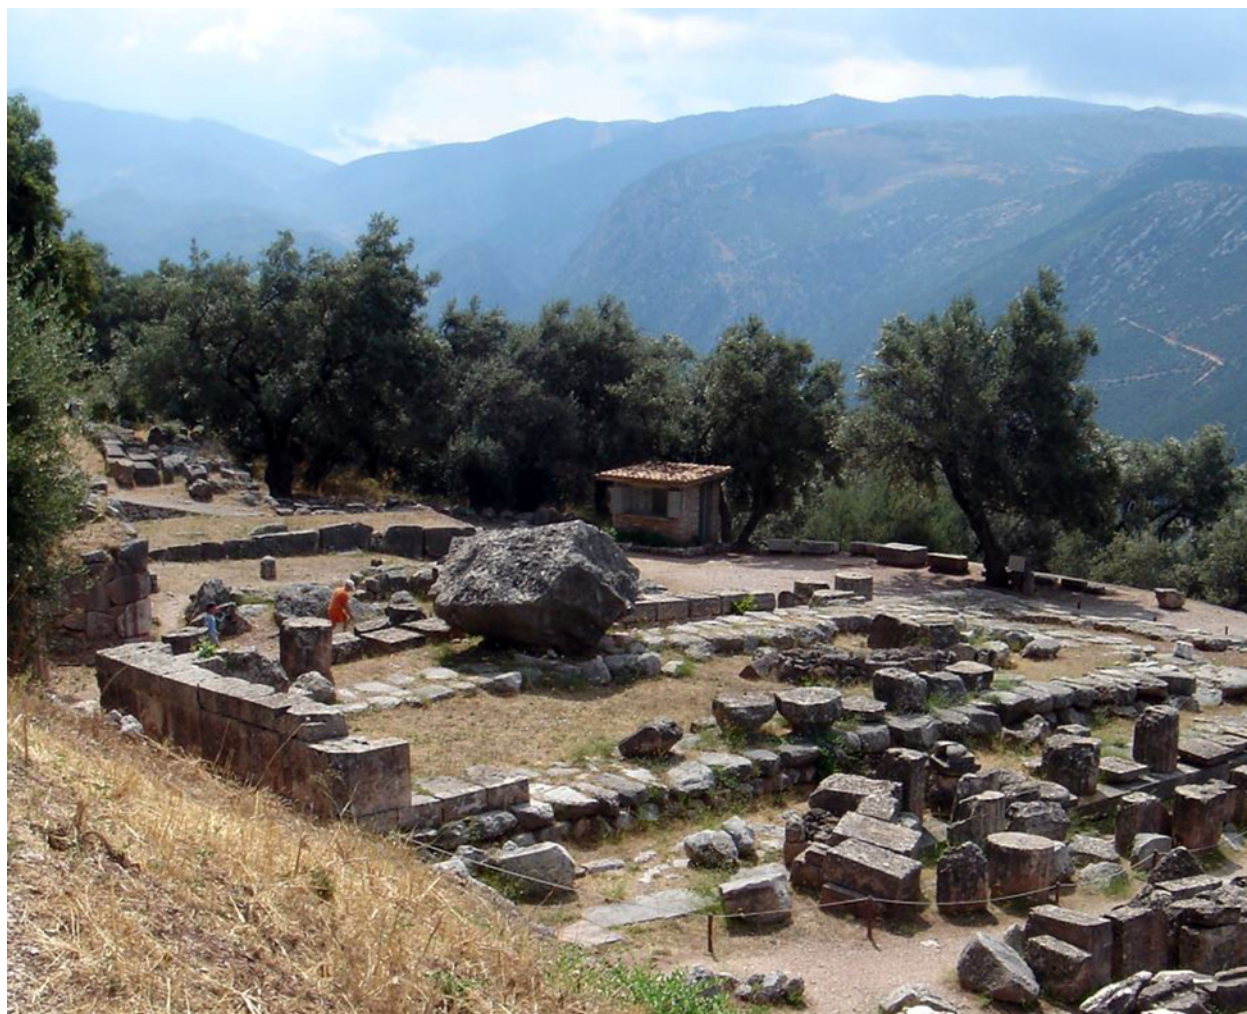
Figure 4: View towards the south of the main Temple of Athena Pronaia (end of 6th c. BC), with one of the blocks that fell on it in 1905 (photo 2005, since the block has been removed). The figure to the left of the block provides the scale.

archaeological site (e.g. the Stadium, Kastalia Spring, and the Gymnasium). At the western part of the site, major rockfalls occurred repeatedly at the stadium also in recent times, and barrier have been set up for protection. Everywhere in the archaeological site, foundations of several ancient structures have been constructed on large fallen blocks of rock, given the abundance of such blocks in the scree material. Many large boulders have fallen after the excavations of the site, and in 1905 a rockfall destroyed a temple in the Sanctuary of Athena, which had remained relatively well preserved until then (fifteen columns were still standing before the rockfall). One of the blocks remained on the temple basement until removed a few years ago (Figure 4).

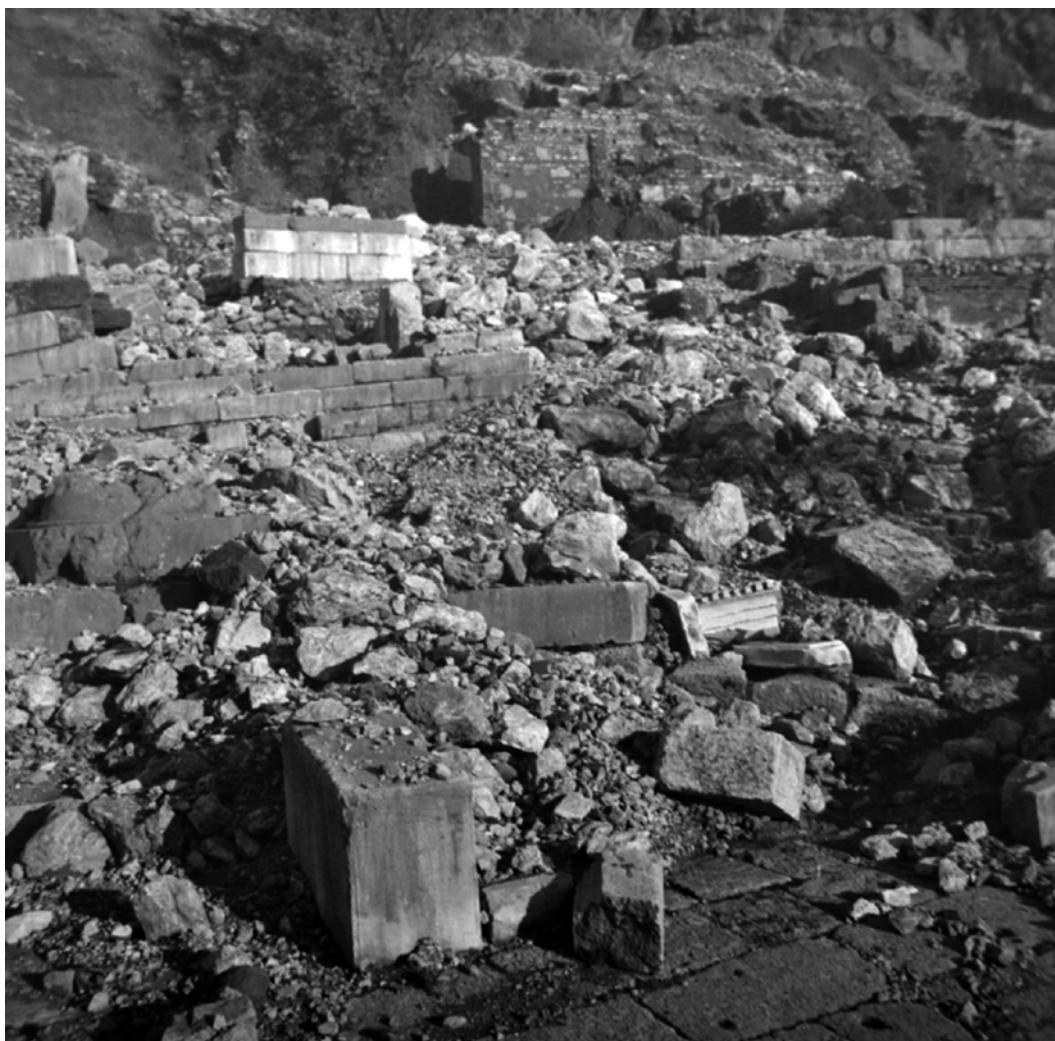
Figure 6: December, 1935. Deposits left by the catastrophic flood event over the Sanctuary of Apollo (French School at Athens).

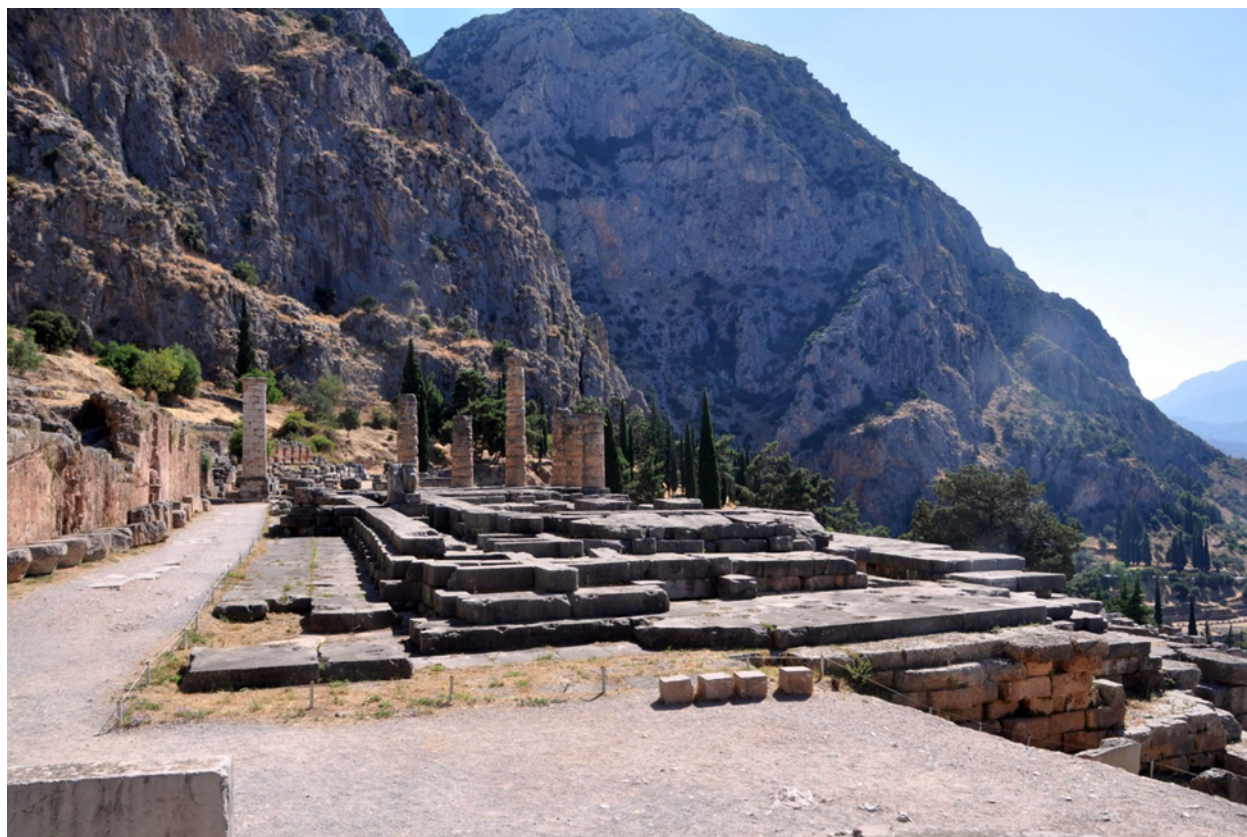
Figure 8: Temple of Apollo. Distortion of the *euthynteria*.

seems to mark a turning point, from which we see architectural responses to the specific risks at the site. Analysis of the deformation of the present remains has revealed that the 4th-century temple was destroyed, as was probably its predecessor, by a violent landslide due to the underground circulation of water, probably combined with a seismic event. Danish architect Erik Hansen measured a difference in level of more than 53 cm between the northwest and southeast corners of the temple's outer *euthynteria* and a southward shift of 85 cm on the east side to the south.⁵⁵ The *euthynteria* on the north side (Figure 8) shows a very pronounced curvature, due to the soil pressure that was partially compensated for, from Antiquity, by the abundant use of cramps of which only the lead gangue gave way. According to this analysis, the deformation of the present ruin is essentially due to a violent episode that took place in Late Antiquity, and not to progressive pressure.⁵⁶

Two elements suggest that the Late Antique event, causing the eastern part to subside and the western part to twist, was the same type of landslide that destroyed the 6th-century temple in 373 BC. On the one hand, the foundations of that temple show at the southwest

corner that they suffered a similar collapse and that the courses had to be straightened to accommodate the foundations of the new temple. On the other hand, the measures taken to ensure architectural security and cohesion in the construction of the 4th-century temple let us understand what happened during the destruction of the previous temple. Indeed, the very important reinforcement of the foundations at the external and internal south-western corners suggests that the south-western corner had become dissociated from the north-western one, causing cracks and opening joints. The plan of the current remains shows the effectiveness of the measures implemented during the reconstruction. During the destruction of the 4th-century temple in Late Antiquity, the southwest corner did not move: the rupture occurred a little further east.

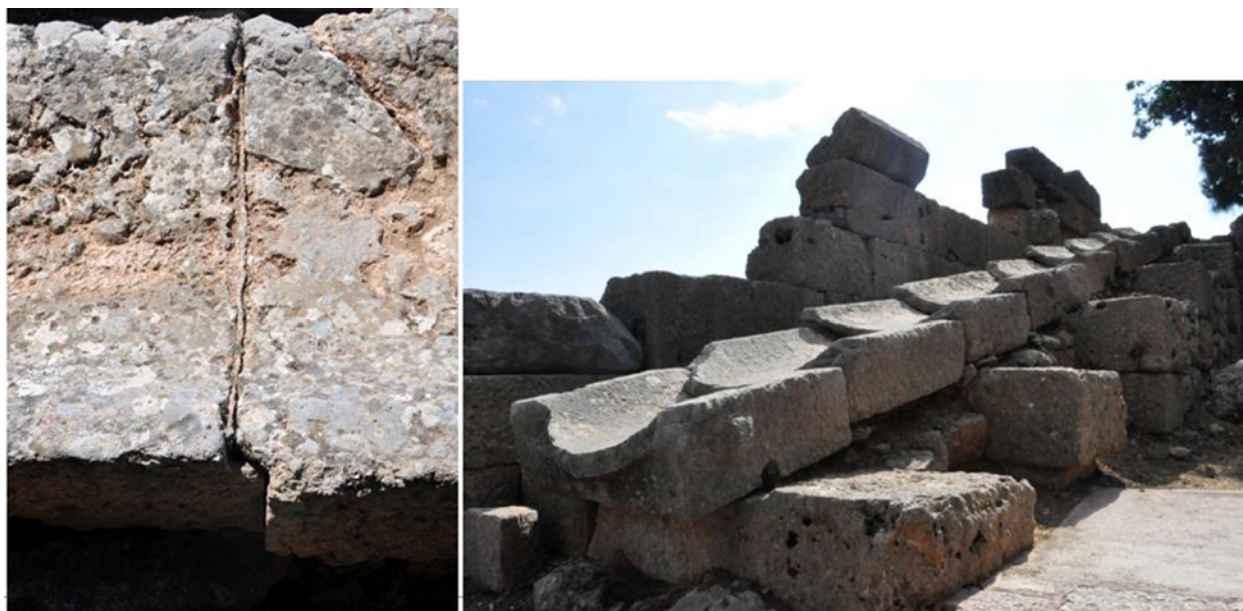
Figure 10: West Stoa: detail of the north gutter sealed with lead; east part of the north gutter.

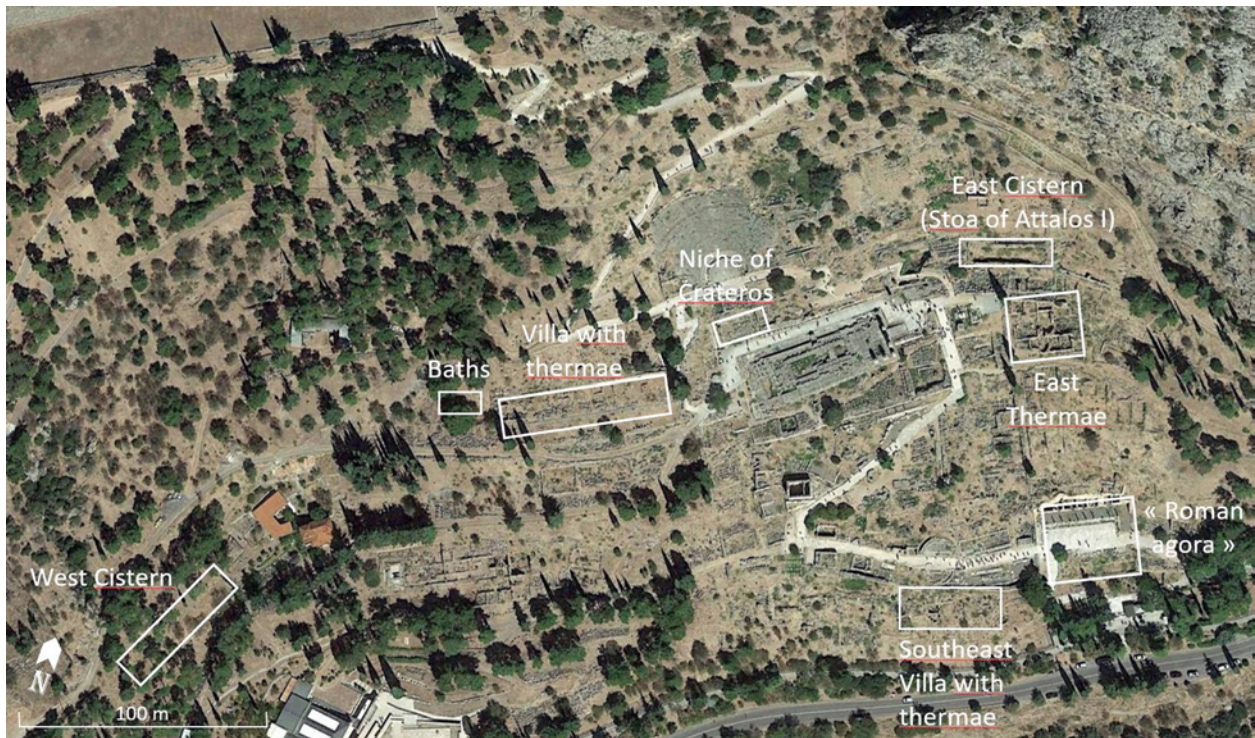
Figure 11: Main hydraulic structures during Late Antiquity in the area of the Sanctuary of Apollo (from Google Earth 2021).

located exactly between the theatre and the temple, just above the *opisthodomos* square, or the cistern in the Stoa of Attalos I, northeast to the temple (Figure 11).

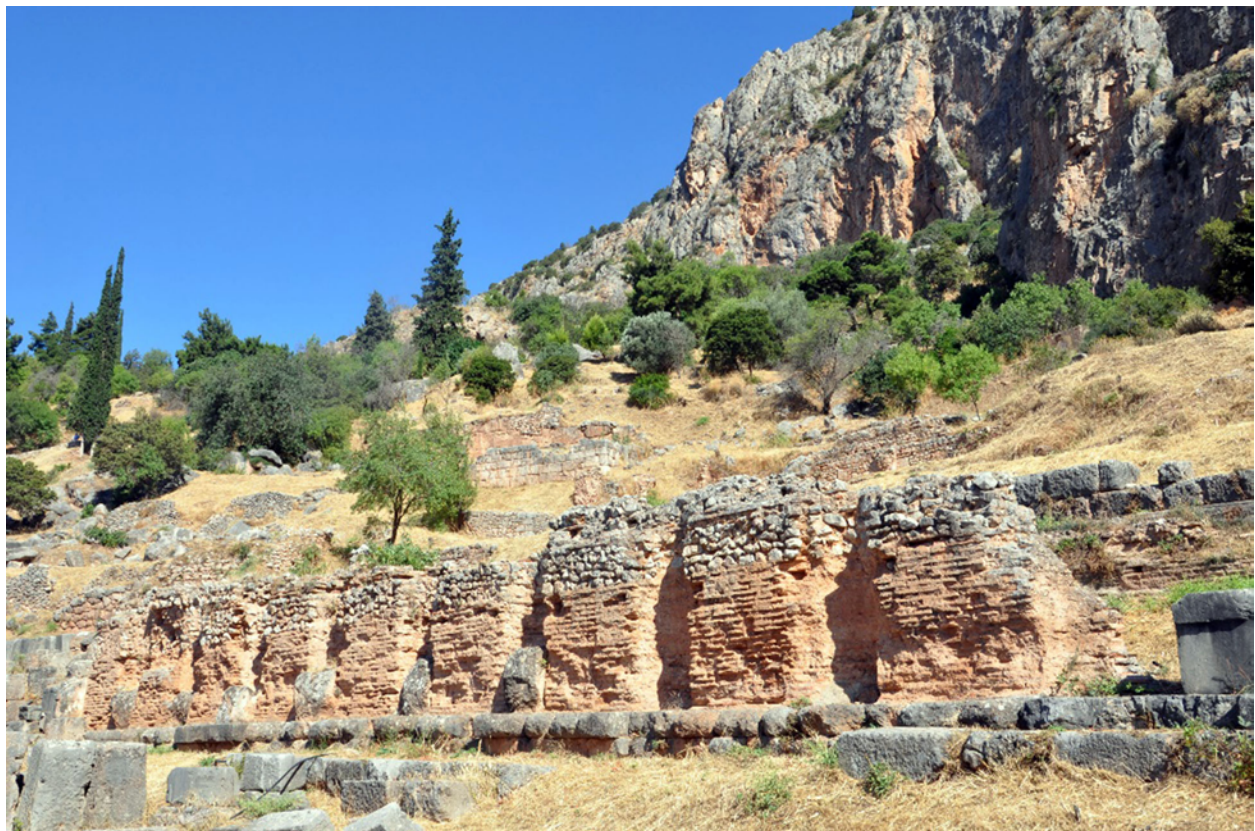
Figure 12: Eastern cistern in the Stoa of Attalos I.

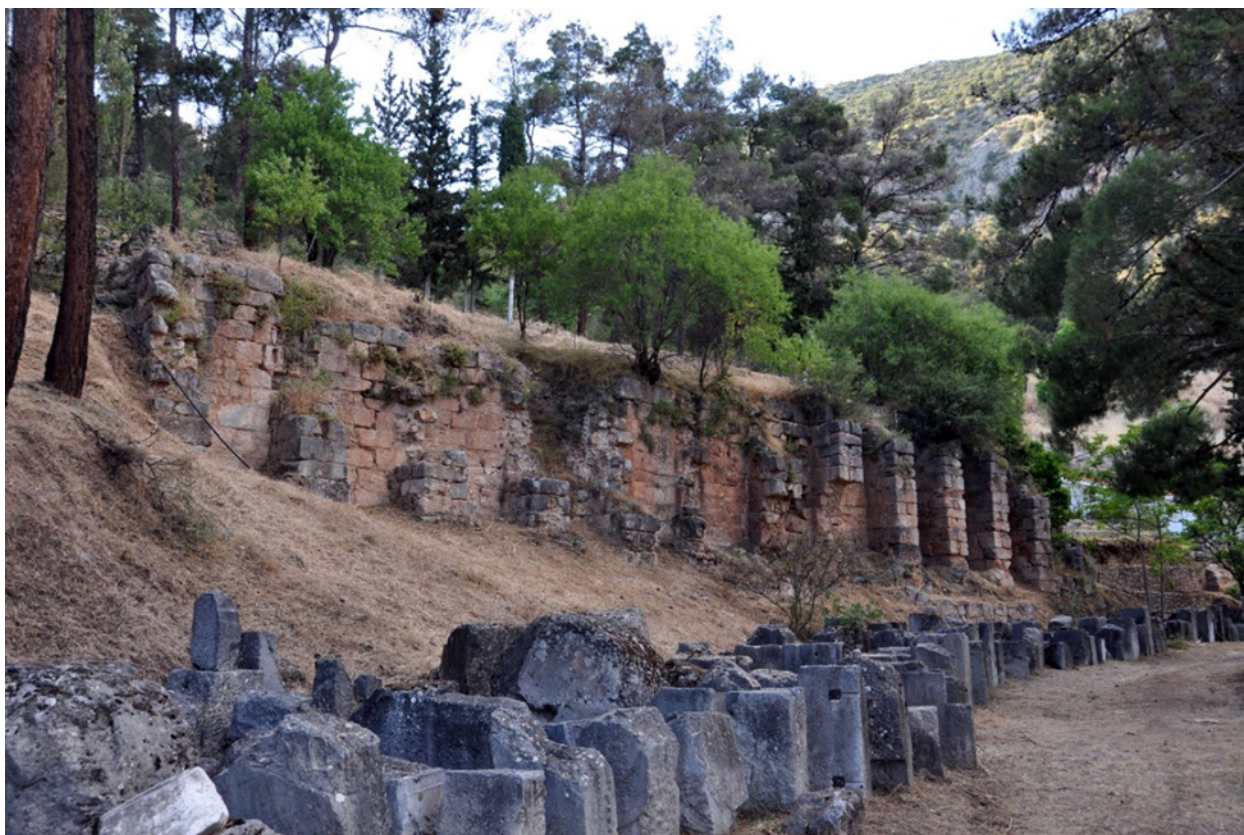
Figure 13: West cistern.
