Internal sulfate attack in mortars containing contaminated fine recycled concrete aggregates

Colman, C.^{a,c,*}, Bulteel, D.^a, Thiery, V.^a, Rémond, S.^b, Michel, F.^c, Courard, L.^c

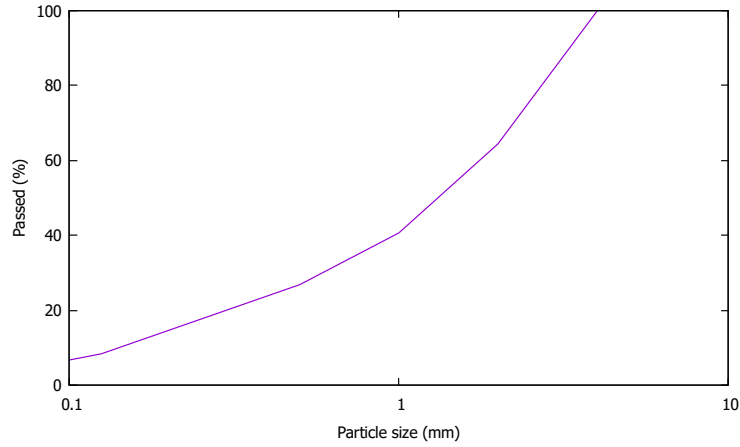
Figure 1: Size distribution 0-4 mm of the used FRA

Figure 1 and Table 2 summarize the properties of the resulting FRA. Water absorption and particle density of the FRA were determined via the method described by Zhao et al. [25]. Characterization techniques for natural aggregates, described in EN 1097-6 [26], consistently underestimate the water absorption of FRA because of the fineness and agglomeration issues between the particles. The method - designed in response to this difficulty - by IFSTTAR [27] seems to overestimate the water absorption of FRA but works well for particles in the 0.5/4 mm range. Thanks to an very good correlation between the hardened cement paste content or mass loss at 475 °C and the water absorption, the water absorption of the fines can then be extrapolated. Using the water absorption of each size fraction (either measured for the coarser particles or calculated for the fines) is more accurate than using either of the two mentioned experimental methods for the whole 0/4 mm bulk [28]. Even though no gypsum was

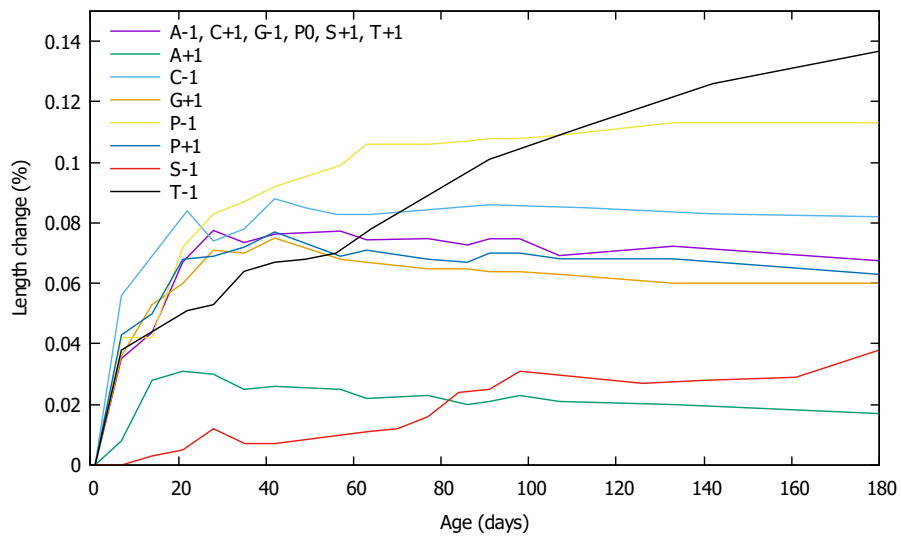
Figure 2: 6 month swelling behavior of the mortar samples in function of the tested parameters

In Figure 2, the length change of the mortars is shown. Standard deviations are not shown on these figures to improve their readability, but are taken into account when performing an unpaired t-test to check whether the swelling results differ from each other statistically.

The four curves on Figure 2 that stay together between the 0.06% and 0.08% marks, show that increasing the porosity, using larger gypsum grains, or limiting the available C_3A did not influence the amount of swelling. SEM results confirmed that the morphology of these samples was very similar. Figure 4 is a typical image found with recycled materials: the recycled aggregate is a cluster of natural aggregates in the original cement paste. The new cement paste, surrounding the recycled aggregates, had a notably higher air content, which has been observed before by Bouarroudj et al. [32] for the same material. This air content can be explained by the surface roughness of the recycled aggregates [33], which captures more air into the mixture than a round (natural) aggregate. Next to that, the difference in surface free energy between the new cement paste and the recycled aggregates could also have played a role in this elevated air content [34]. Figure 5 illustrates how ettringite deposits in these samples were mainly found in pores or air bubbles, which sometimes also resulted in cracks in the surrounding paste.

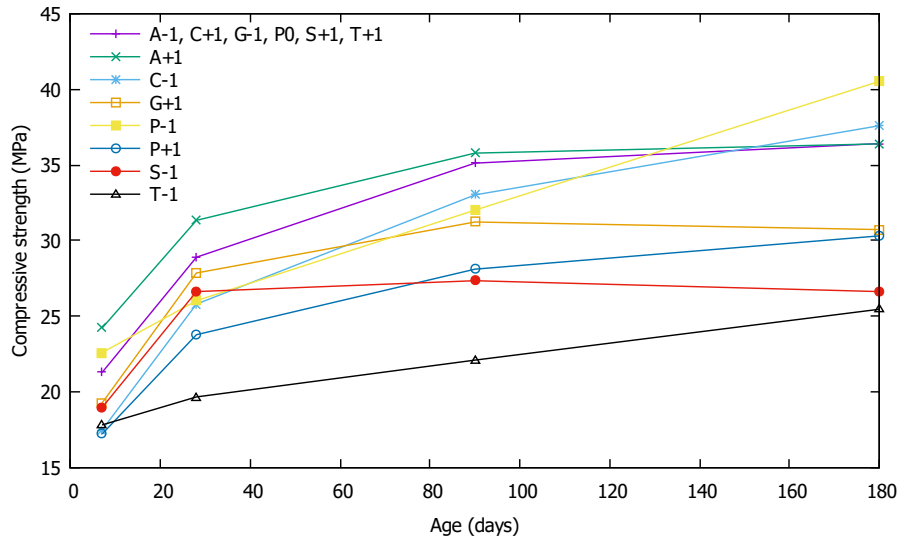
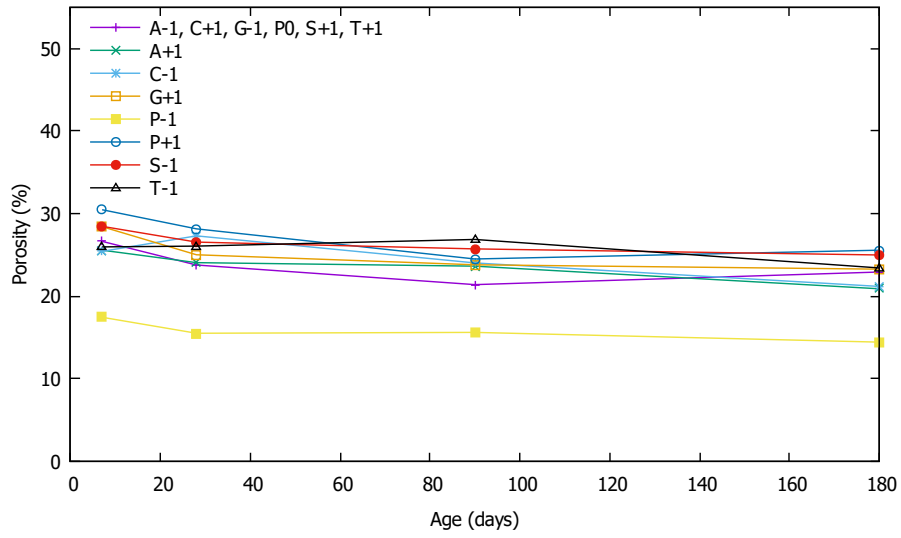
Figure 3: Compressive strength and porosity of the samples at 7, 28, 90 and 180 days

While increasing the W/C ratio did not have an effect on the reaction, lowering it raised the swelling amount. Figure 3 shows a distinctly lower porosity for sample P-1, but not an equally large difference between P0 and P+1. In Figure 7, these findings are confirmed by showing a similar morphology for P0 and
240 P+1, but a significantly denser matrix for P-1. No superplasticizer was added to counteract a loss in workability due to the lower W/C. The microstructure of P-1 also showed the presence of more unreacted cement particles. The P-1 samples displayed many cracks throughout which were filled with ettringite crystals, as illustrated in Figure 8. A high swelling level would seemingly be a
245 good indicator for internal damage.

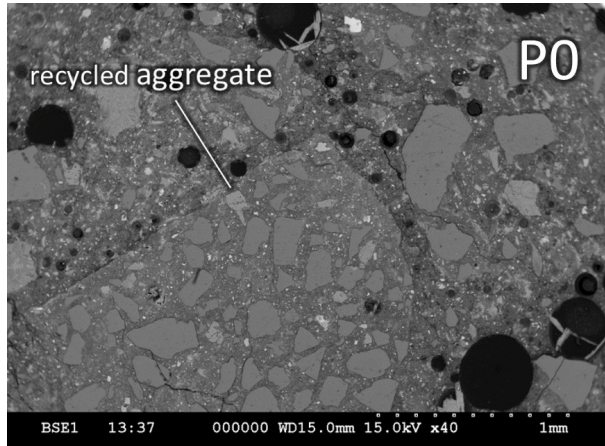
Figure 4: Contrast between a recycled aggregate and the new cement paste with a high air content

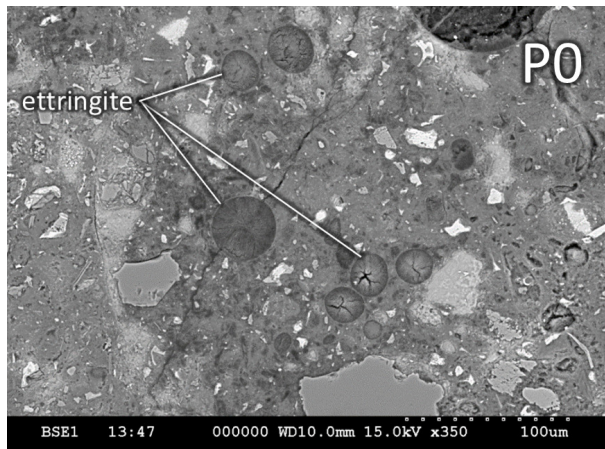
Figure 5: Ettringite was found in pores and air bubbles, which exerted a pressure and cracked the surrounding cement paste

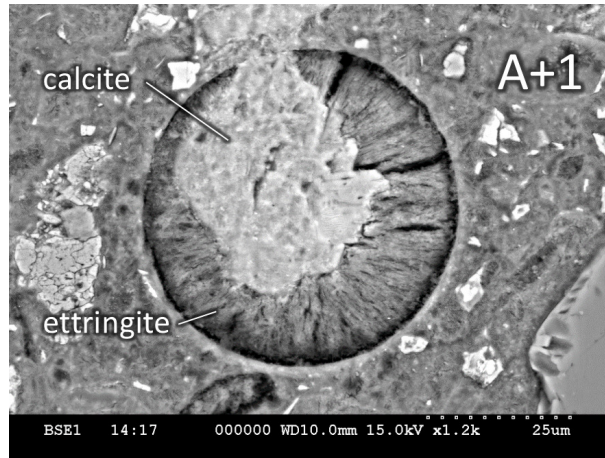
Figure 6: A piece of calcite promoted the formation of ettringite at high alkalinity at an early age

Sample A+1 with an increased alkalinity did not show any evidence of cracks. Air bubbles were often filled with ettringite, but not in a way that caused damage. Instead, a high percentage of them showed the presence of a piece of calcite or portlandite in their center, with ettringite crystals growing outwards
220 of this center and not inwards from the cement paste. This is demonstrated in Figure 6. Calcite has been described as a nucleation center for very fast ettringite growth at high alkalinity [35, 36]. The kinetics of this reaction explain the lack of available sulfates to cause damage in a cured cement matrix. A higher
225 alkalinity has also been observed by Juenger et al. [14] to increase the initial rate of hydration and cause a higher early compressive strength, which has been confirmed in Figure 3. However, the swelling and compressive strength results obtained in these experiments contradicted the findings of numerous authors described in section 1.2. This could be due to the chosen experimental setup:

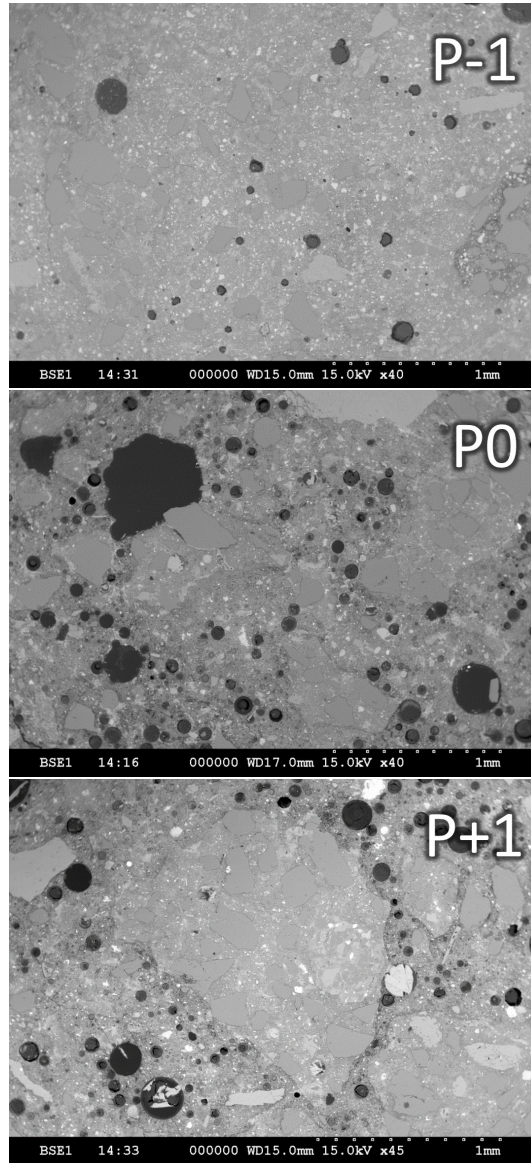
Figure 7: Comparison of the cement paste density between P-1, P0, and P+1

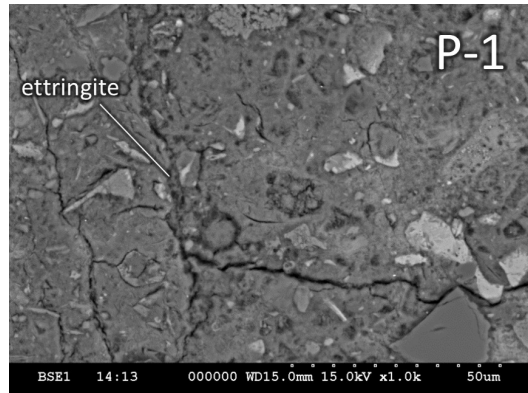
Figure 8: Cracks filled with ettringite in a sample with lower porosity

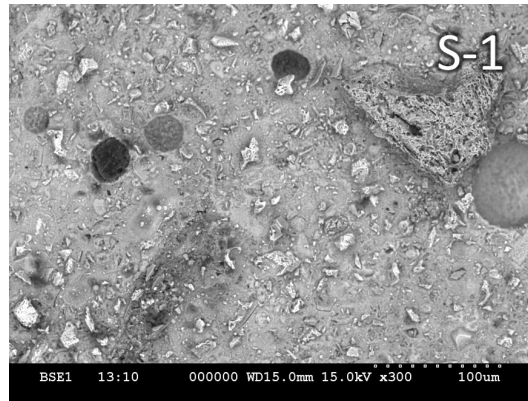
Figure 9: Lowering the sulfate content resulted in an undamaged sample

The S-1 samples contained only 0.28% of water soluble sulfates, which is still well above the maximum allowable limit in recycled aggregates [20]. Still, no significant damage occurred, as shown by its swelling behavior in Figure 2 and microstructure in Figure 9. The long term compressive strength of these samples, shown in Figure 3, was lower than those with higher sulfate contaminations, but only because it did not increase after the first month of aging.

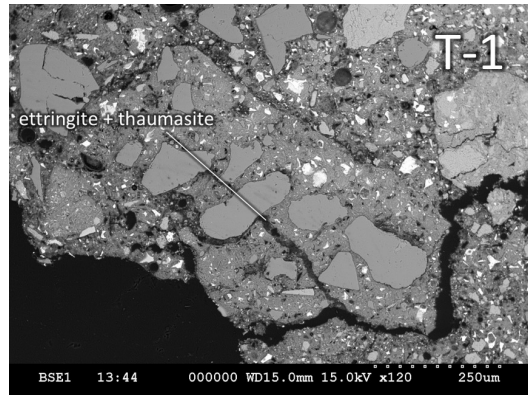
Figure 10: The T-1 samples were damaged by a mixture of ettringite and thaumasite

The samples kept at lower temperatures showed an important amount of swelling compared to the other mixes, but the reaction seems slower and did not reach a stabilization point yet after 6 months. Compressive strength, shown in Figure 3, was much lower compared to the other samples, which is due to the limited amount of cement in this mix. Figure 10 shows the internal damage in these samples, while EDS confirmed that pores, air bubbles or cracks are filled with an ettringite/thaumasite mixture.
