## Fretting-corrosion behavior on dental implant connection in human saliva

Pascale Corne, Pascal de March, Franck Cleymand, Jean Geringer

Pascale Corne, Pascal de March, Franck Cleymand, Jean Geringer. Fretting-corrosion behavior on dental implant connection in human saliva. *Journal of the mechanical behavior of biomedical materials*, 2019, 94, pp.86-92. 10.1016/j.jmbbm.2019.02.025 . hal-03194105

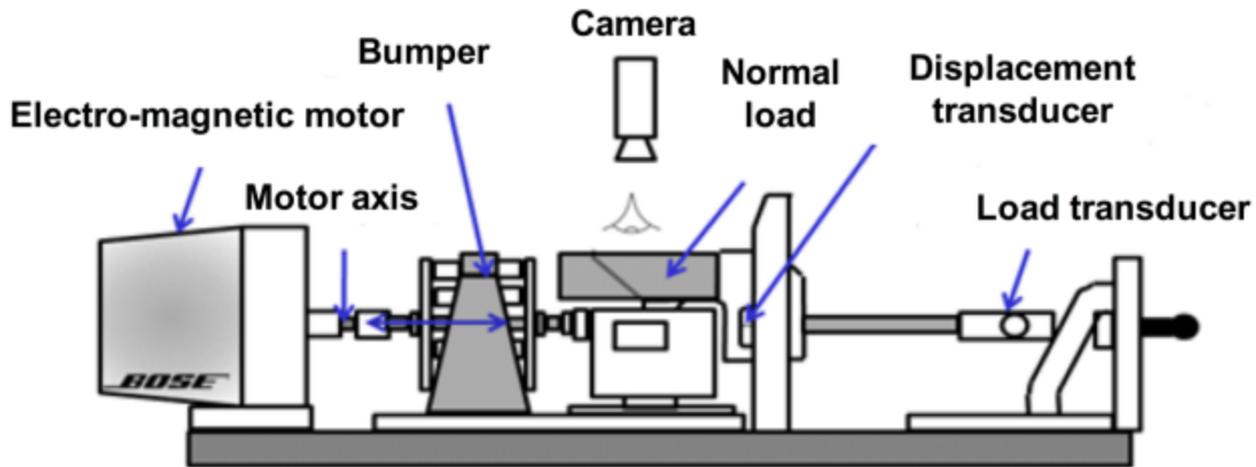
Figure 1: Fretting-corrosion device

The friction was cylinder against plan in order to control the contact mechanics. The experiments have been carried out thanks to a tribocorrosimeter, fretting-corrosion machine, developed by Mines Saint-Etienne and TA instruments™, Company (New Castle, USA) using an electromagnetic motor. A typical fretting-corrosion test was 16 hours of duration, i.e. 57,600 cycles (1s is 1 cycle). The applied normal load, P, was of 127.5 N or 85 N, it is corresponding to the contact pressure (approx. 80 MPa) estimated on the abutment/implant interface by finite element modelling (Ramos Verri, 2015). The sinusoidal amplitude of micro-displacement was  $\pm 40$   $\mu\text{m}$ . As mentioned above, the frequency was of 1 Hz.

*Figure 1: Fretting-corrosion device*

One paid attention on the compliance of the fretting corrosion device that was maintained constant for all tests (Pellier et al., 2011; Kim et al., 2012; Geringer et al., 2013, 2014).

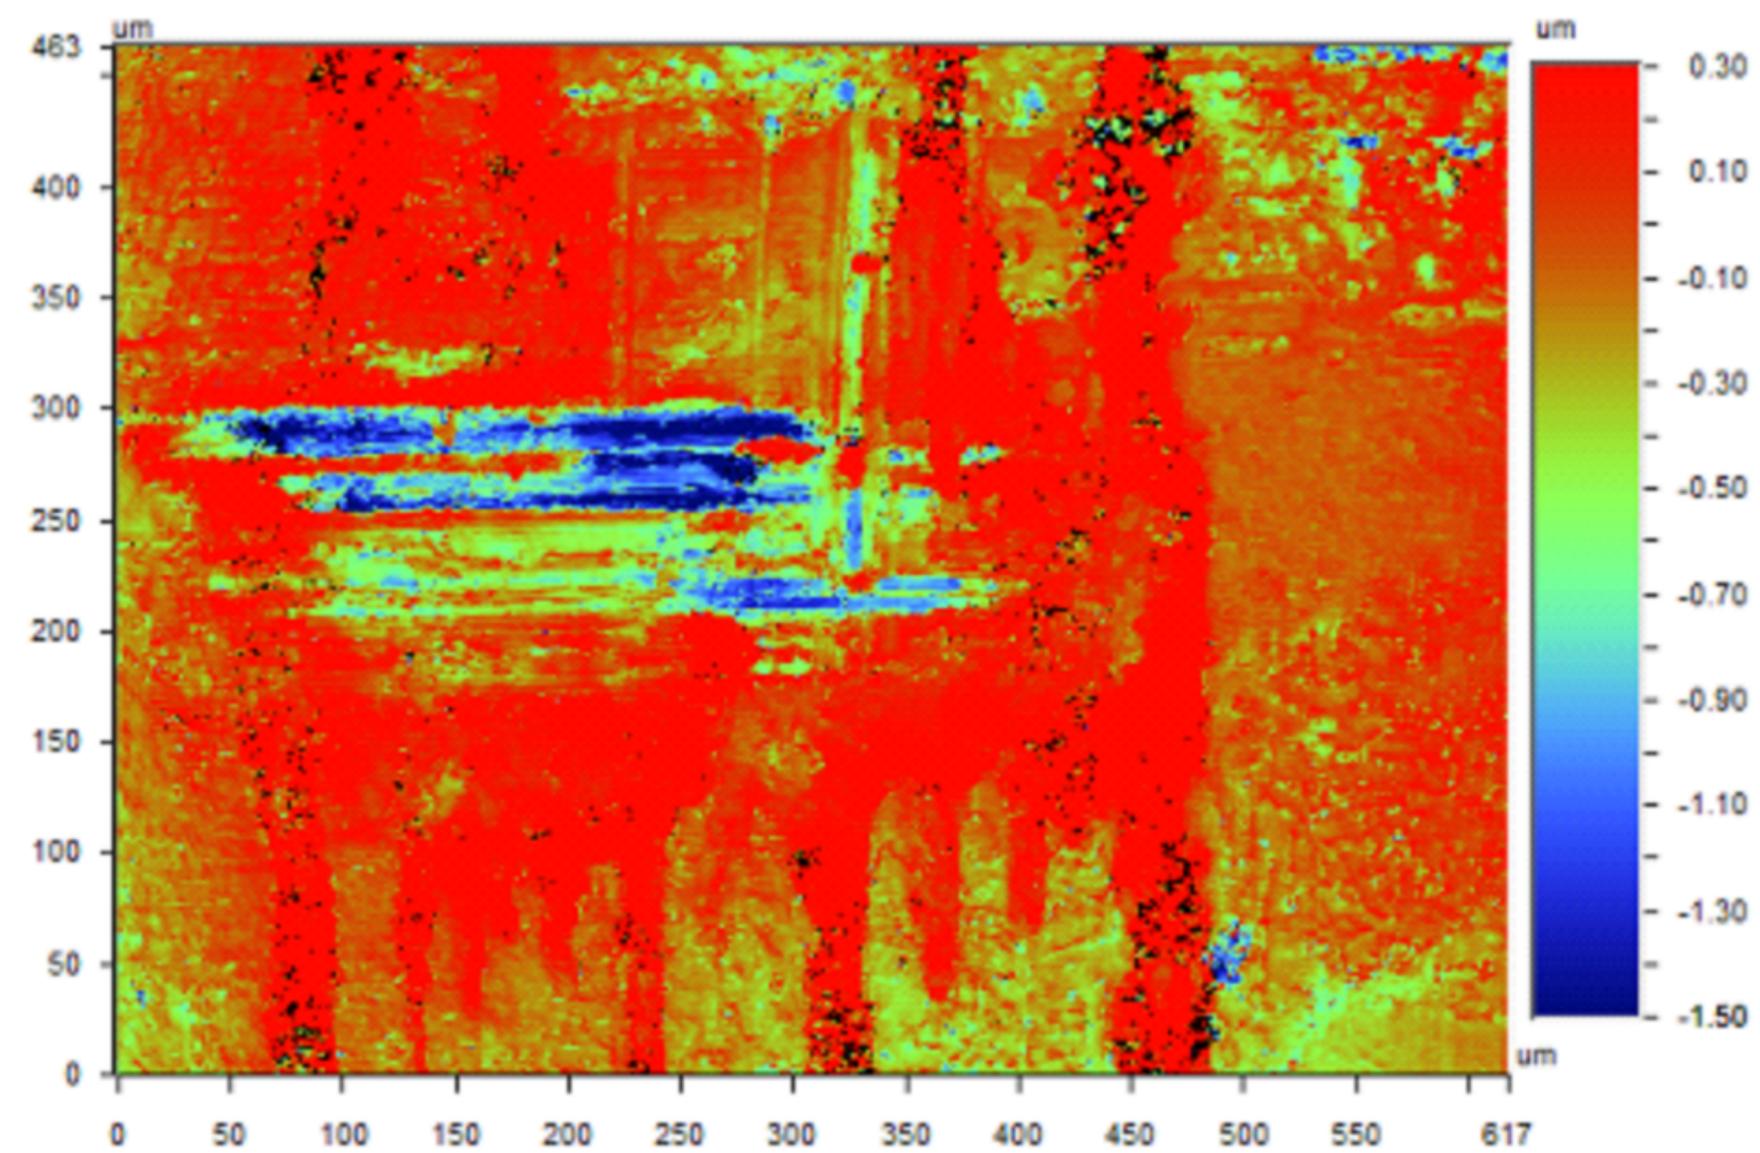
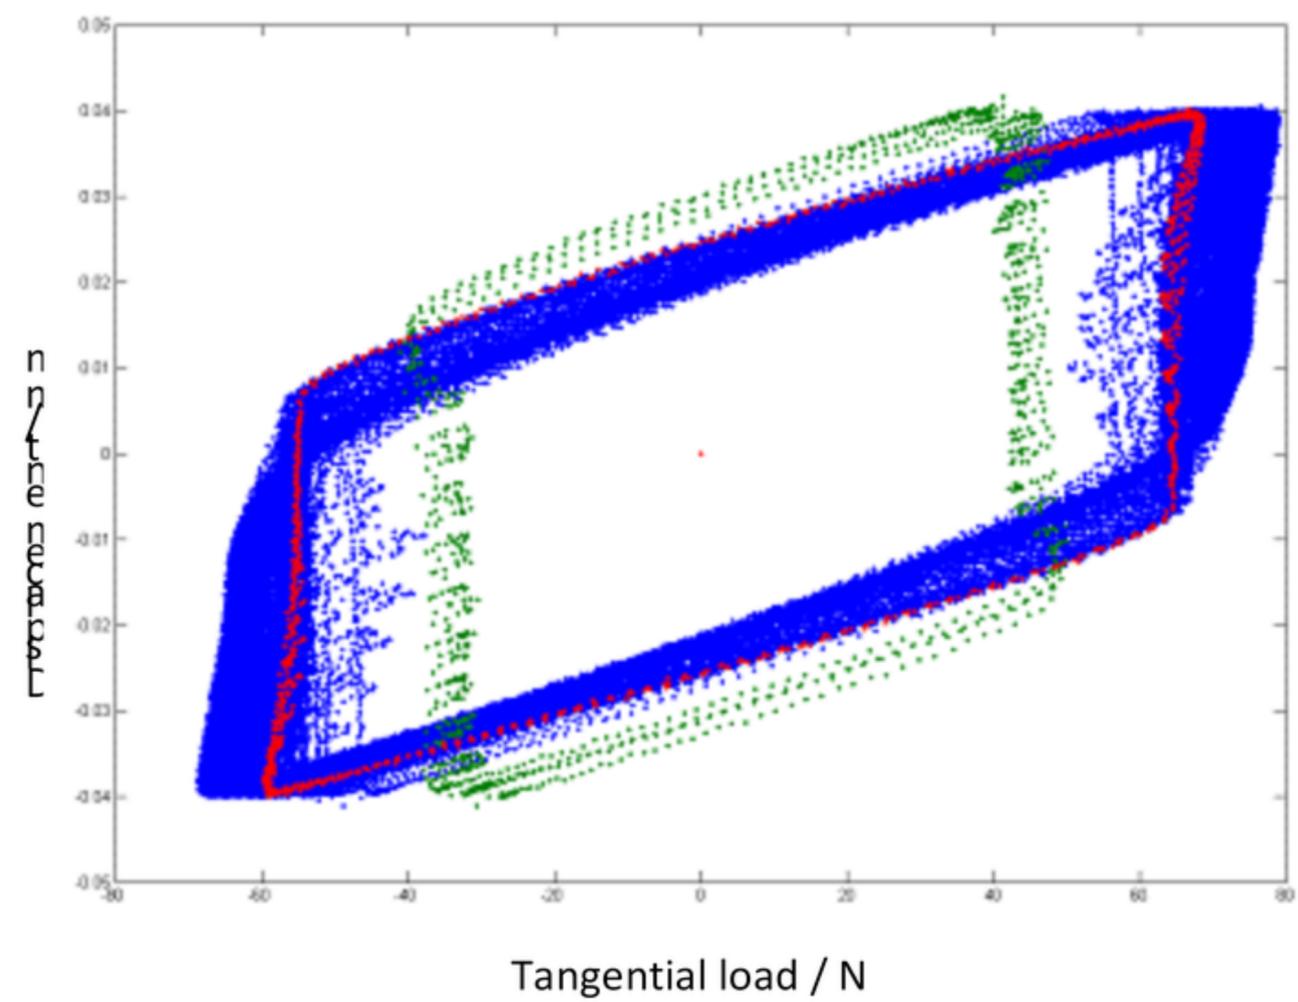
applied normal load. The Figure 3 shows a typical wear track area of Ti-6Al-4V material, 3b) and a fretting log (projection) of the displacement according to tangential load.

*Figure 3: a) Typical wear track area of a Ti-6Al-4V sample; b) Displacement vs. Tangential load, Ti-6Al-4V/Y-TZP contact, green: beginning of the test, blue: middle of the test, red: end of the fretting corrosion test.*

Figure 3: a) Typical wear track area of a Ti-6Al-4V sample; b) Displacement vs. Tangential load, Ti-6Al-4V/Y-TZP contact, green: beginning of the test, blue: middle of the test, red: end of the fretting corrosion test.

First of all, the dissipated energy is the area of the tangential load vs. imposed displacement. The cumulated dissipated energy is the sum of each monitored dissipated energy, every second. The wear rate is calculated from the wear volume, the missing material after friction according to a reference plane. It is normalized according to the sliding distance and the

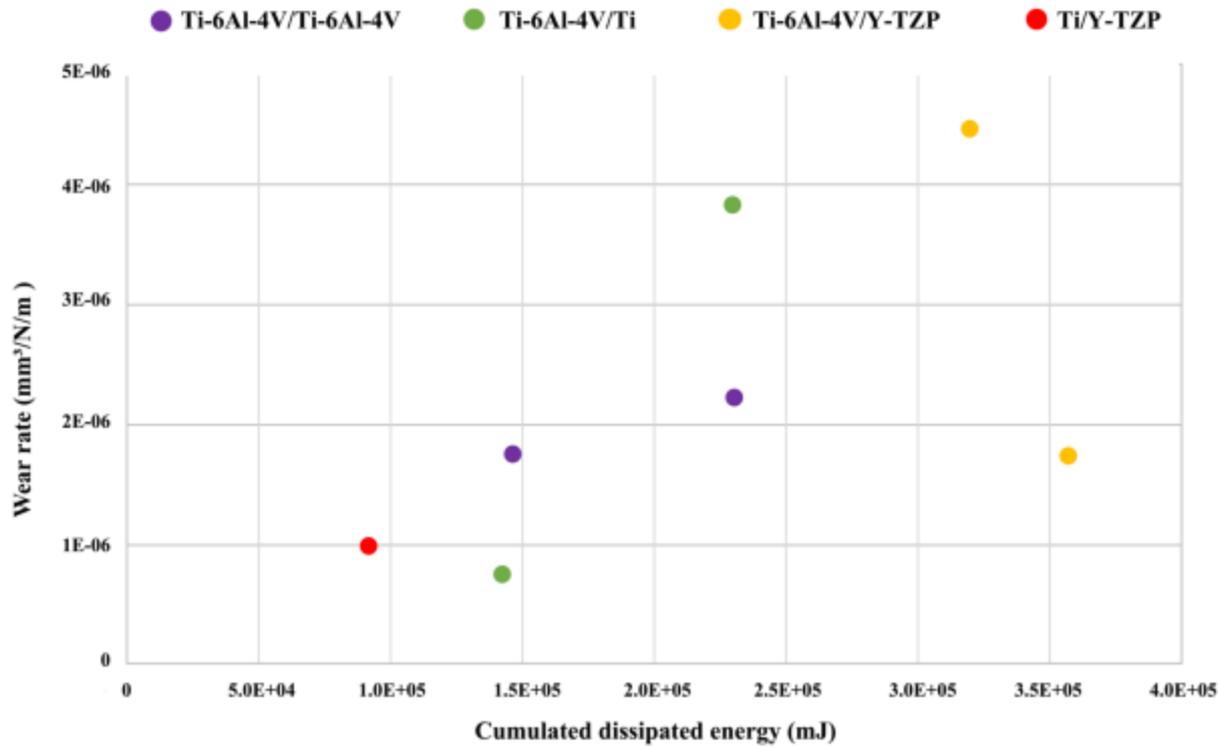
The Figure 4 shows the evolution of the wear rate according to the cumulated dissipated energy.

*Figure 4: Wear rate ( $\text{mm}^3/\text{N.m}$ ) vs. Cumulated dissipated energy (mJ), 4 couples of materials.*

Figure 4: Wear rate ( $\text{mm}^3/\text{N.m}$ ) vs. Cumulated dissipated energy (mJ), 4 couples of materials.

The combination of Ti/Y-TZP materials does highlight the best promising outlook according to the tribological performances, lowest wear rate and lowest dissipated energy.

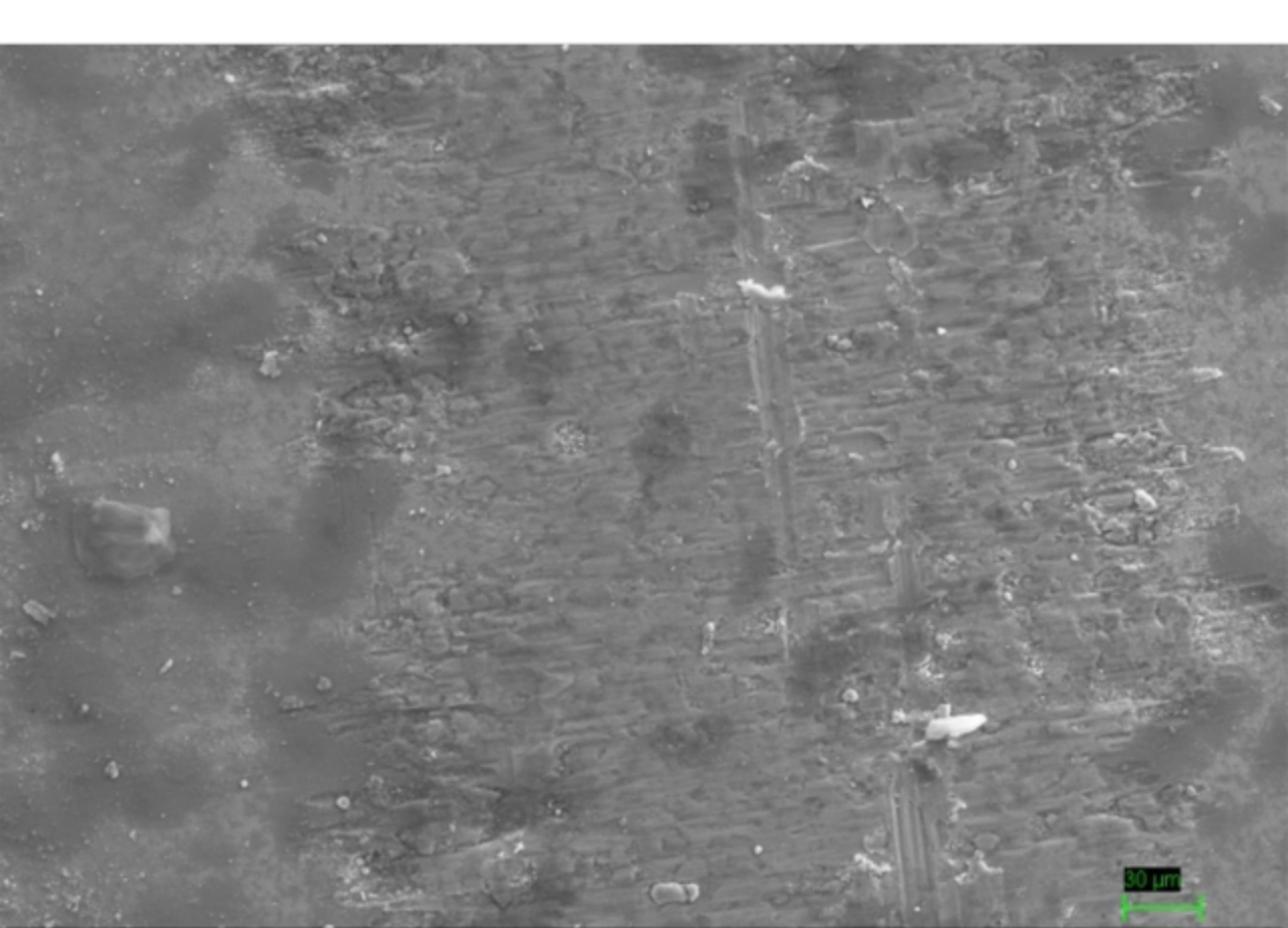
The titanium alloy/titanium alloy combination exhibits a typical behavior. The Figure 5) is showing: a) the total wear track area and b) a crack beneath the top surface provided by observing a cross section inside the wear track area.

*Figure 5: a) the wear track area corresponding to Ti-6Al-4V/Ti-6Al-4V; b) a cross section observation practiced inside the wear track area.*

Figure 5: a) the wear track area corresponding to Ti-6Al-4V/Ti-6Al-4V; b) a cross section observation practiced inside the wear track area.

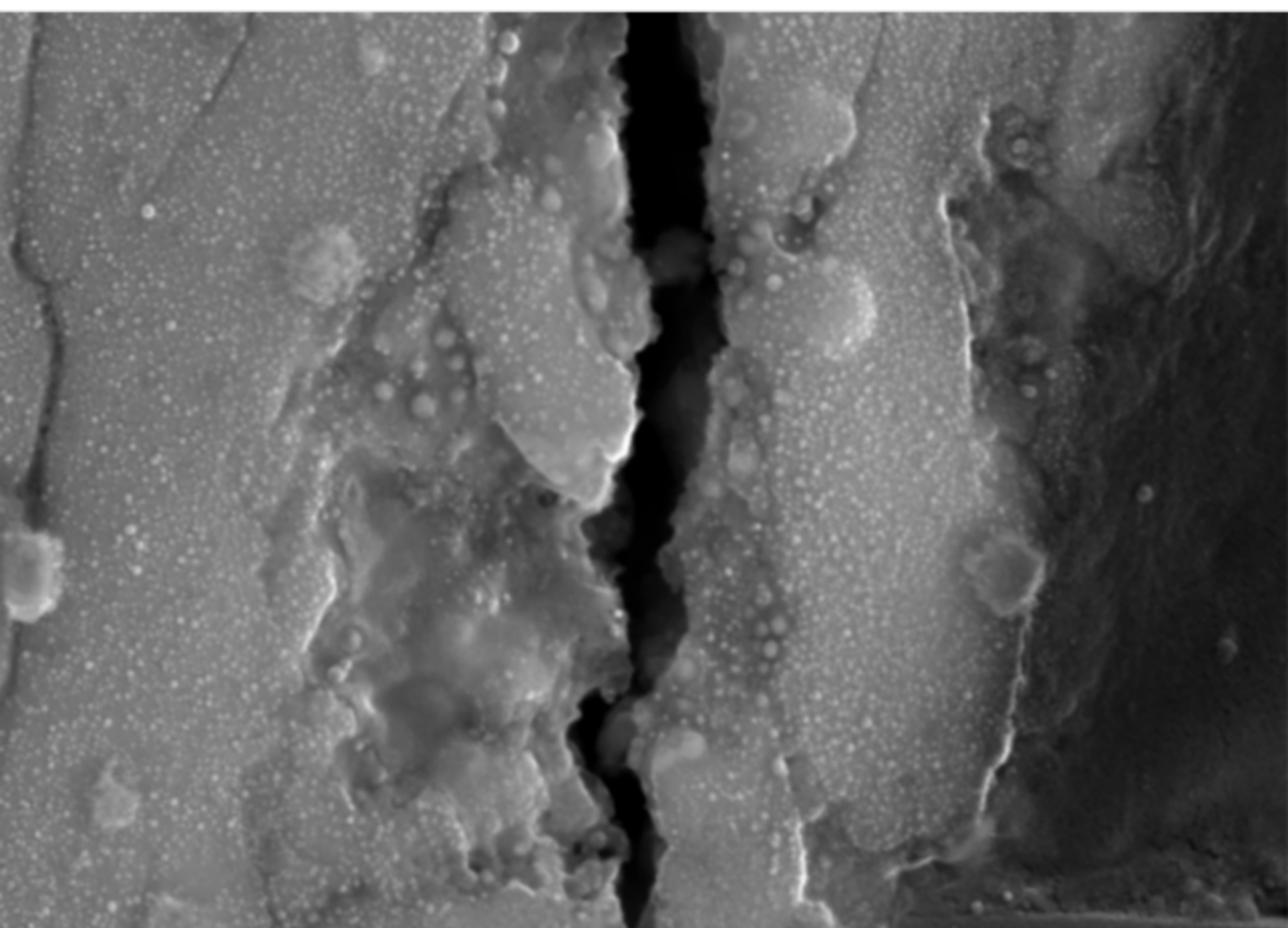
Another interesting point is related to the presence of a third body layer compacted on some parts of the wear track area, Figure 6. The thickness of the third body layer on Figure 6a) is about 1 $\mu$ m. It is worth noting that some metallic debris get an average diameter lower than 1 $\mu$ m.

*Figure 6: a) the wear track area corresponding to Ti-6Al-4V/Ti-6Al-4V; b) a cross section observation practiced inside the wear track area.*

Figure 6: a) the wear track area corresponding to Ti-6Al-4V/Ti-6Al-4V; b) a cross section observation practiced inside the wear track area.

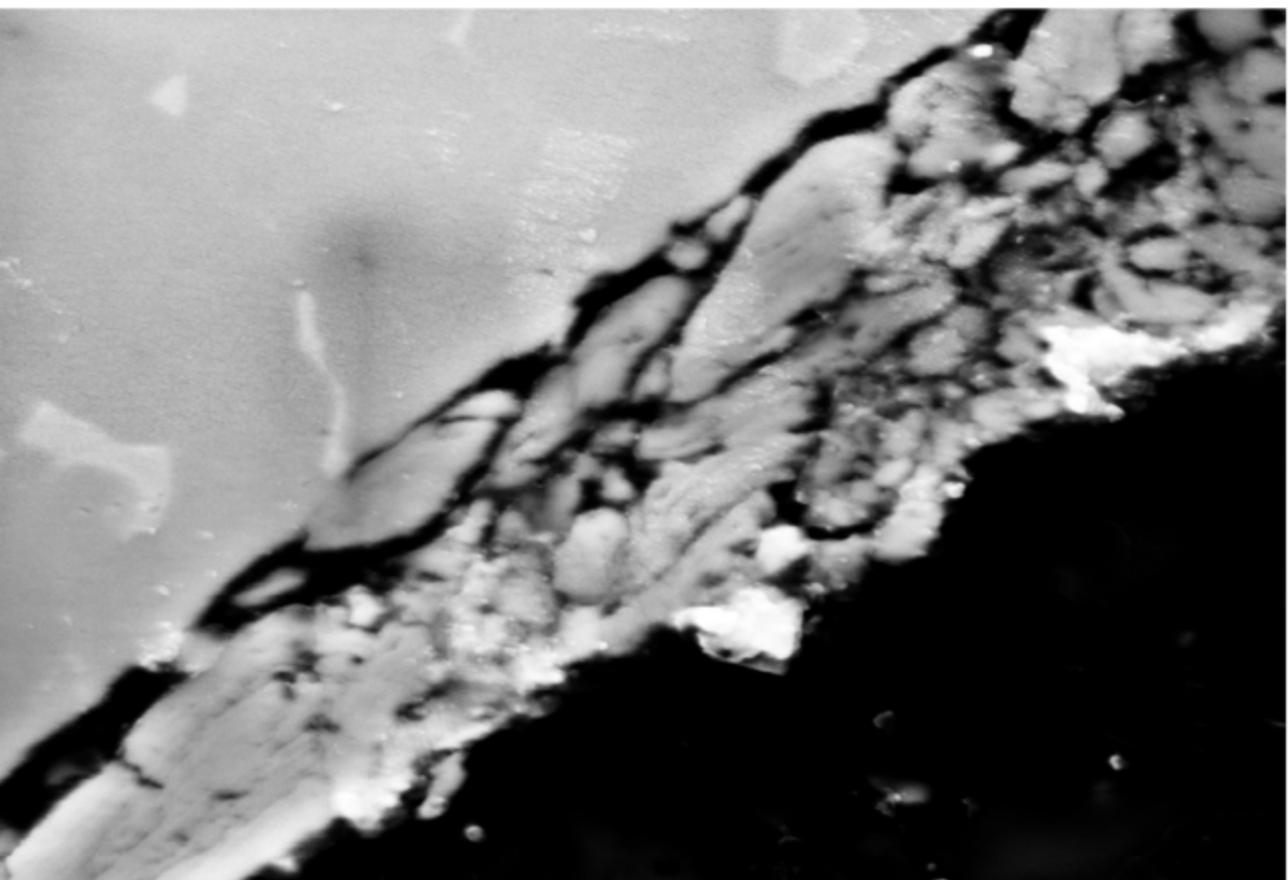
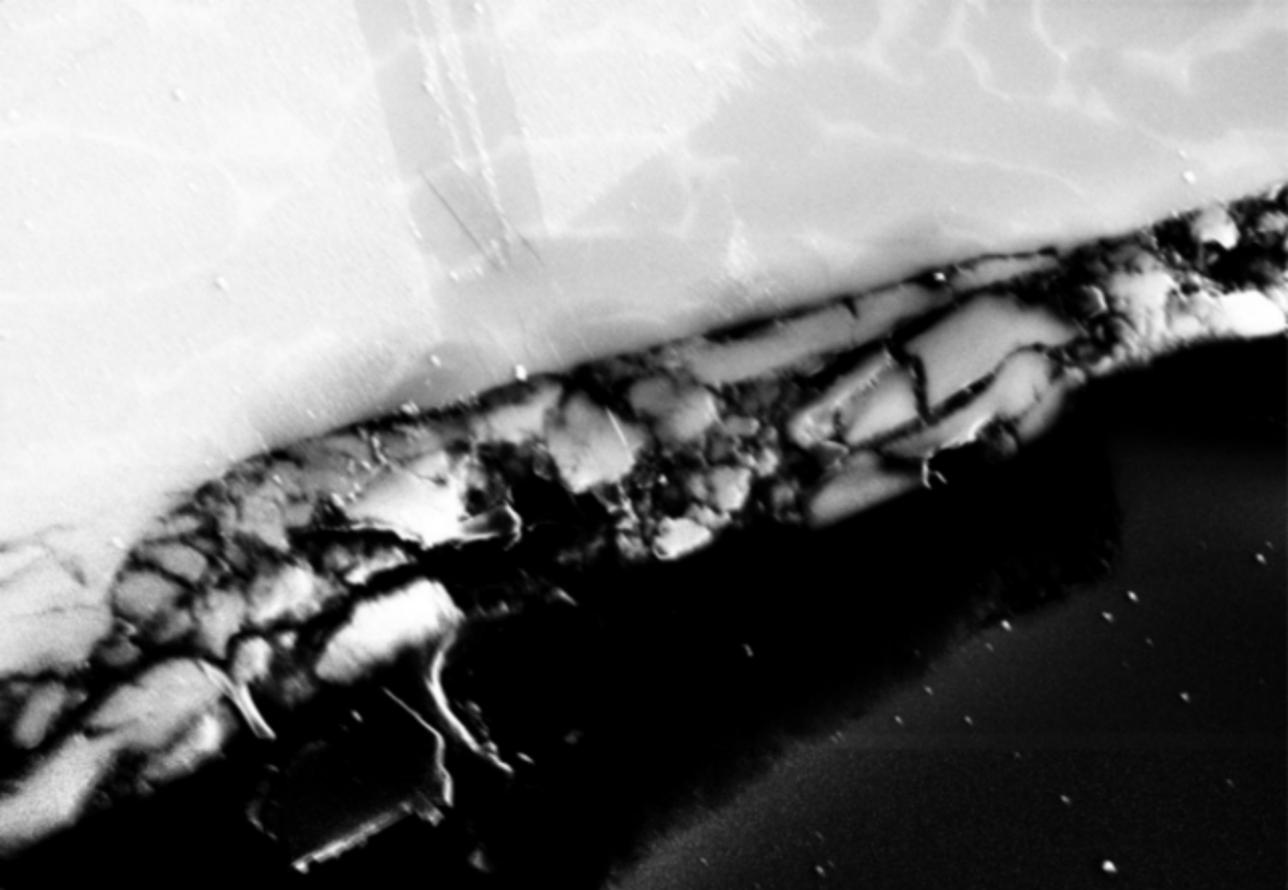
The counter material is quite ceramic material, Y-TZP in this section. The Figure 8 is showing some small particles, debris, in the wear track area of the Ti-6Al-4V. The small particles are slightly, it might be some zirconia particles. The most relevant point is the size, i.e. lower than 1µm, roughly few 100nm. No zirconia material has been found inside the Ti-6Al-4V: it means that there is no mixing process between both materials on the contrary of

*Figure 8: a) SEM image on the wear track area; b) TEM analysis under the wear track area of Ti-6Al-4V sample in the contact with Y-TZP*

Figure 8: Figure 8: a) SEM image on the wear track area; b) TEM analysis under the wear track area of Ti-6Al-4V sample in the contact with Y-TZP

Some debris are from different shapes and sizes due to fretting degradations. From SEM image, Figure 8a), their size is from micrometrical scale till dozens of nanometers. By keeping in mind that gingiva fibroblast diameter is of 30  $\mu\text{m}$ , the nanometric scale of debris may encounter some issues about the bone and gingival remodeling. These debris may enhance the phagocytosis by fibroblast and disrupted the usual cells functioning, leading enjoy to apoptosis. This debris misfit was well described in the literature (Mathew et al., 2014; Revathi et al., 2017; Sridhar et al., 2016). Some inflammation, some weird deceleration around implants, was identified around some implants, i.e. allergy (Chaturvedi, 2009). Moreover, due to debris, the osteoclasts differentiation is promoted; thus, the implant failure is ongoing. It is worth noting most of the time, some implants failures are attributed to the dental plaques (Persson and Renvert, 2014). Due to debris when considering some dental

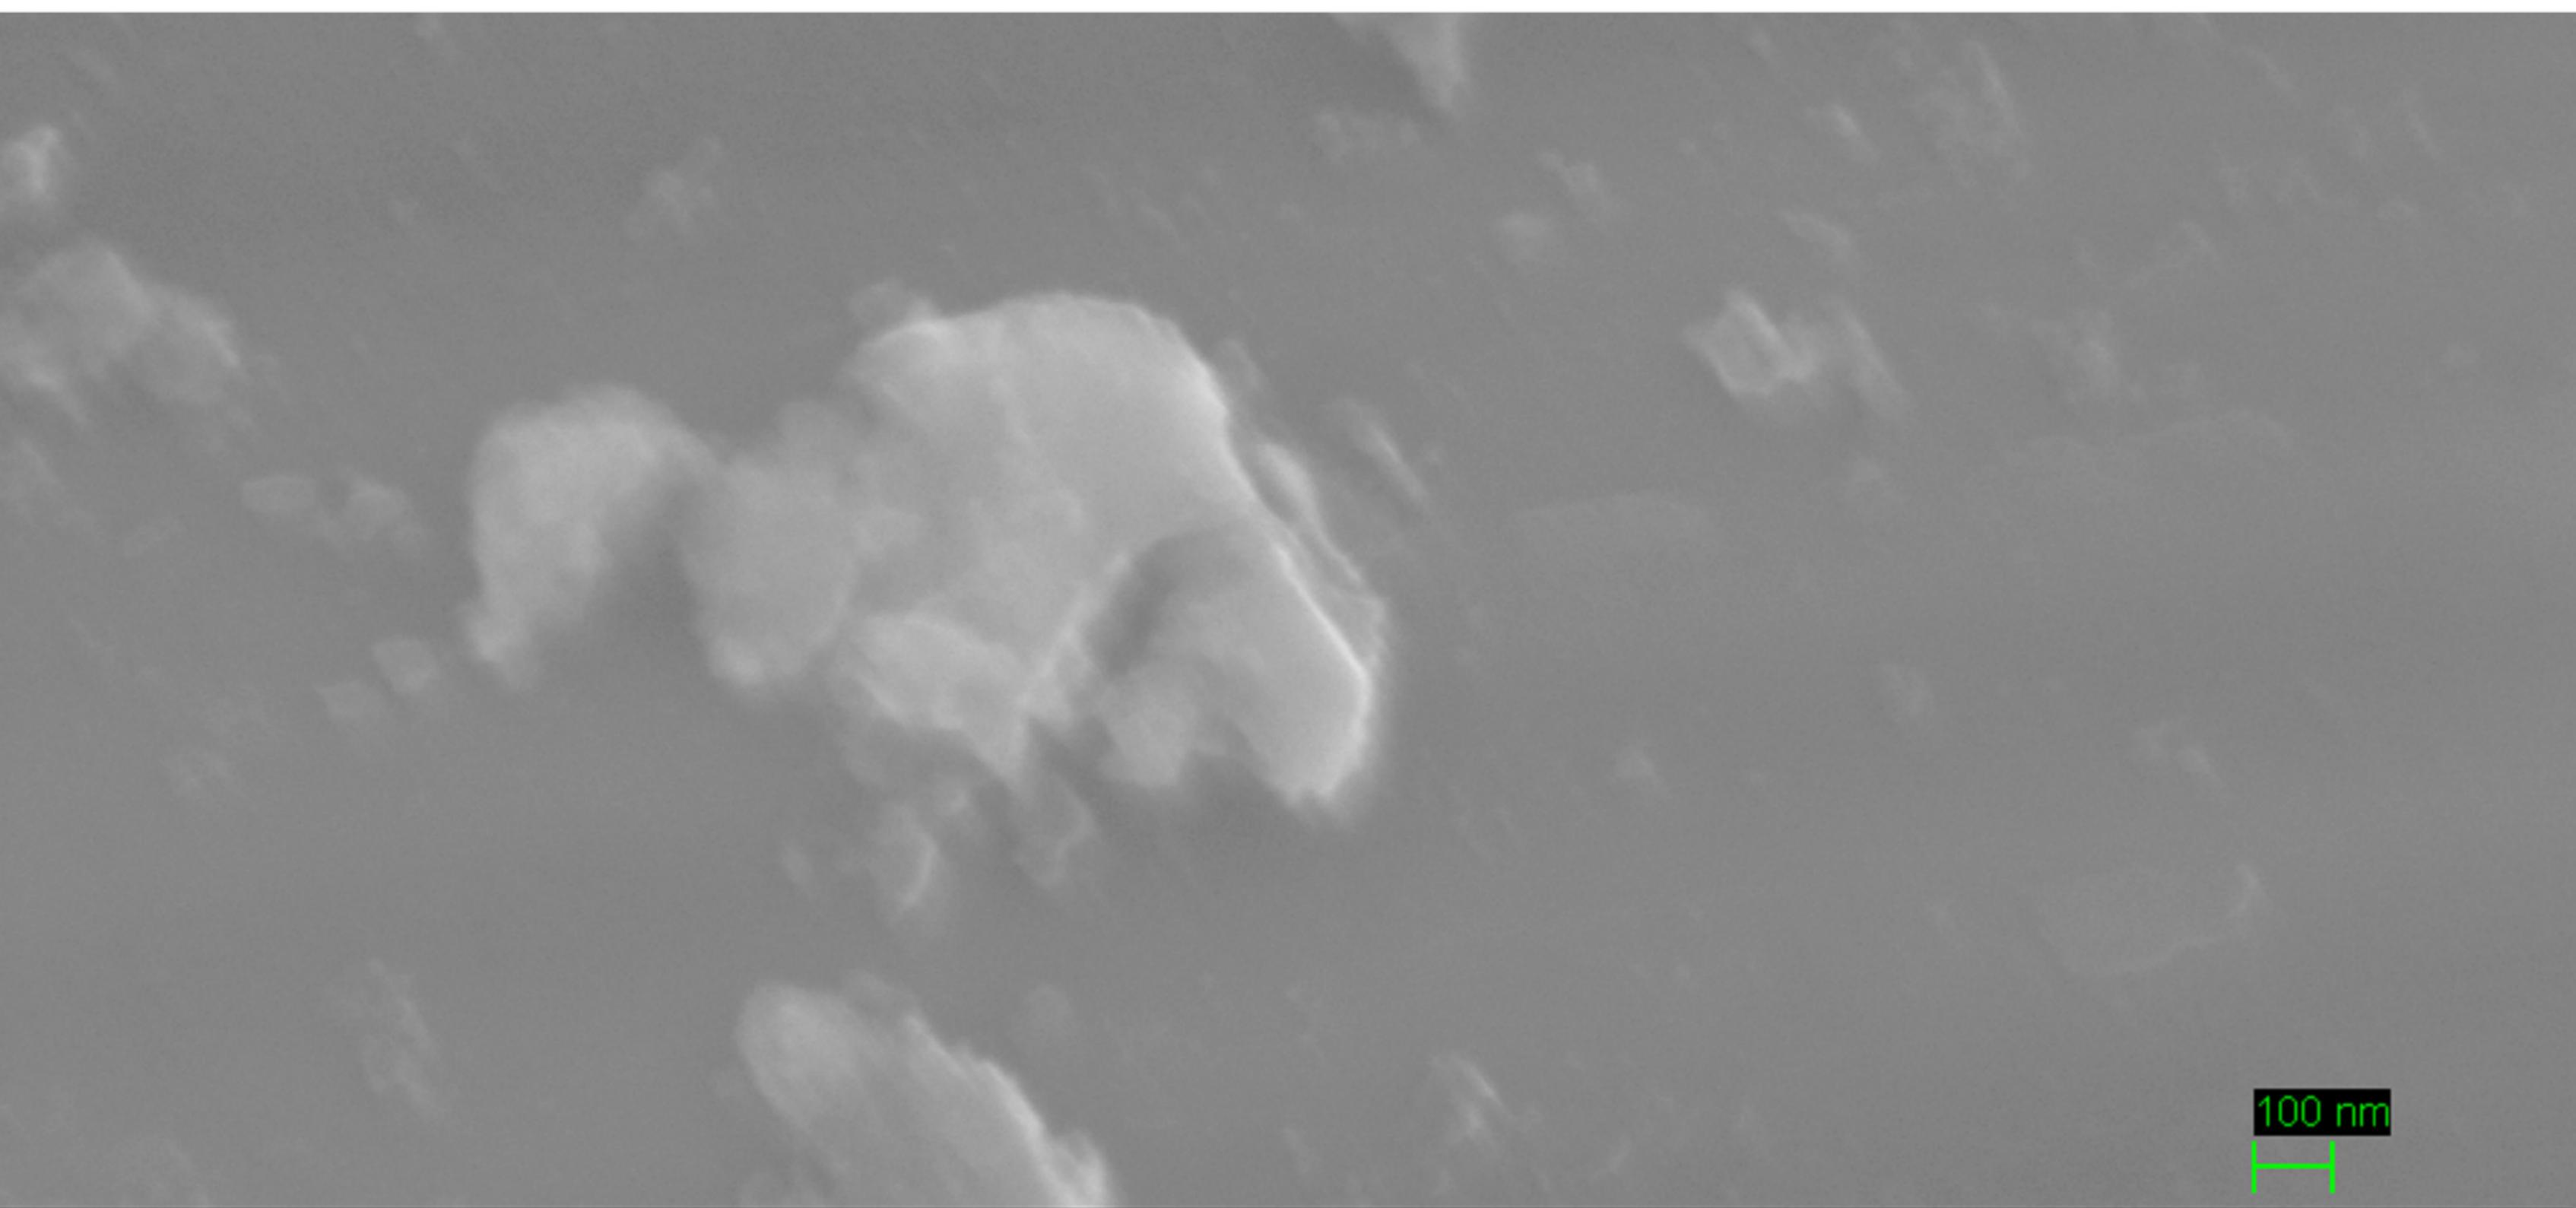
*Figure 7: a) TEM analysis in the wear track area Ti-6Al-4V/Ti-6Al-4V, STEM HAADF; b) TEM analysis in the wear track area Ti-6Al-4V/Y-TZP, STEM HAADF*

Figure 7: a) TEM analysis in the wear track area Ti-6Al-4V/Ti-6Al-4V, STEM HAADF; b) TEM analysis in the wear track area Ti-6Al-4V/Y-TZP, STEM HAADF

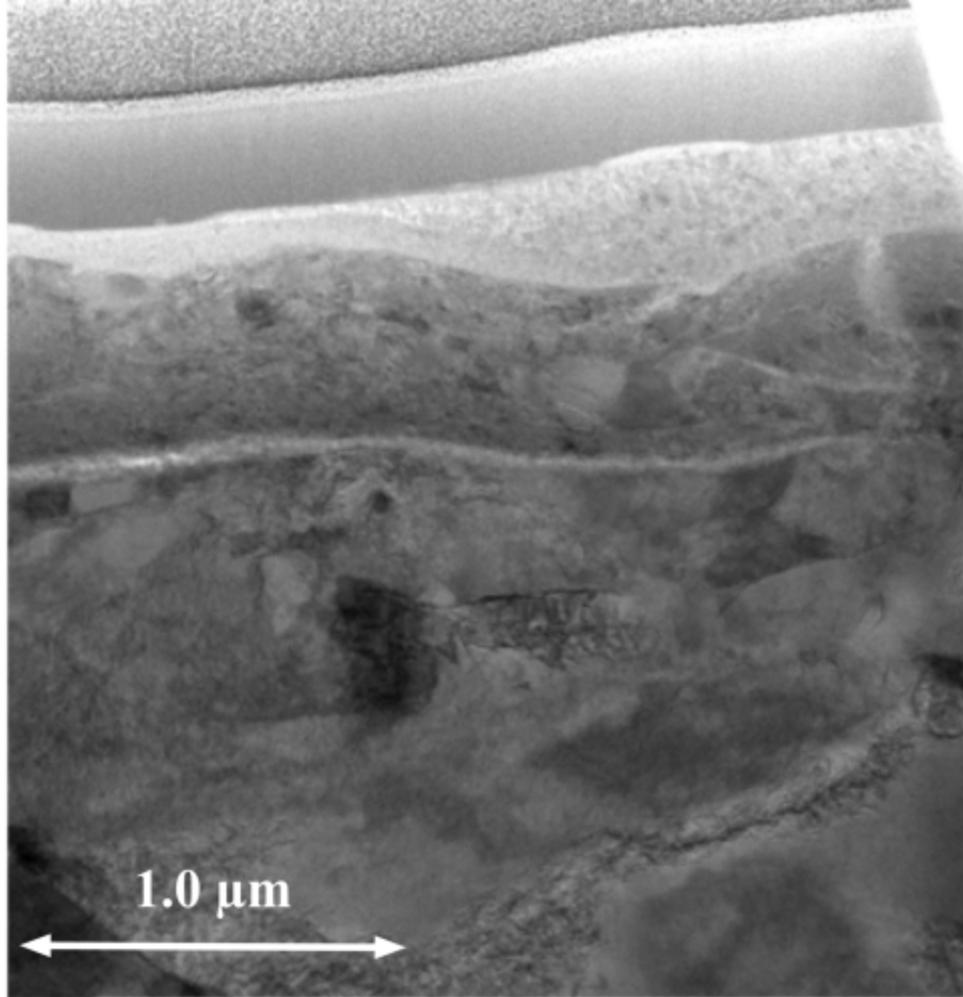
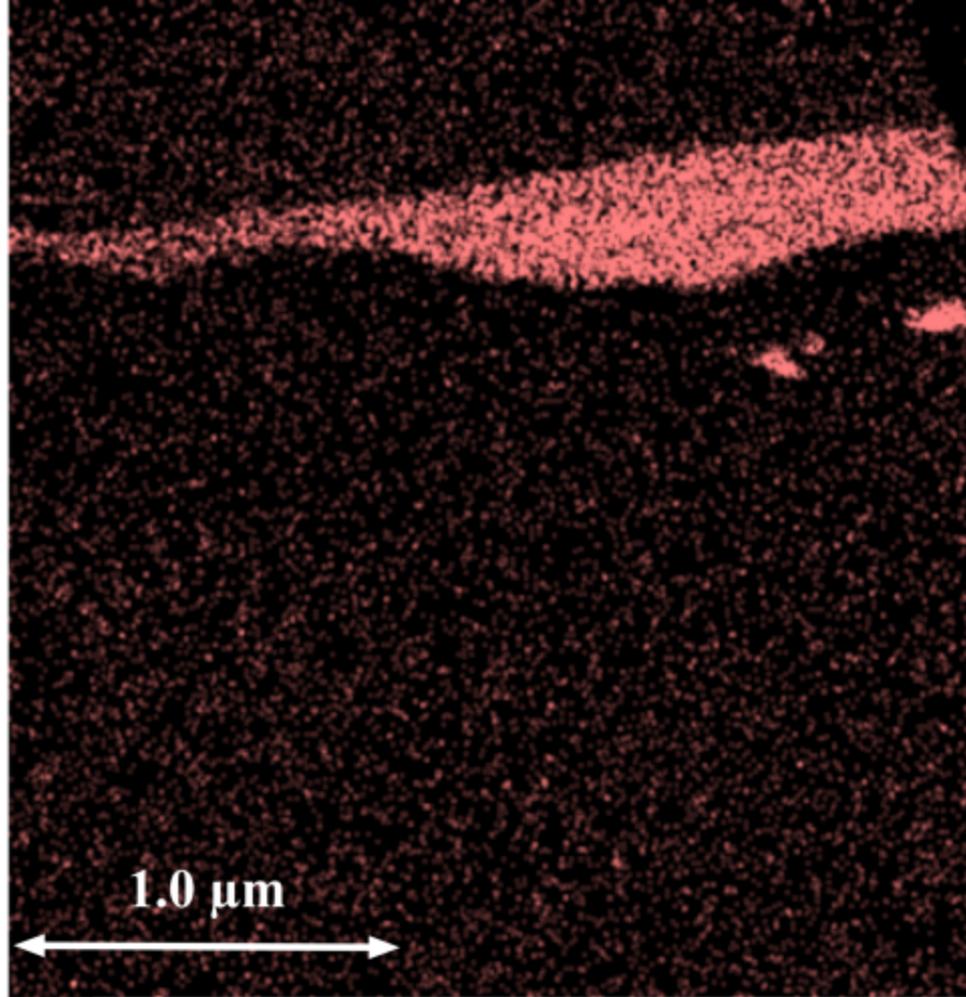
The Figure 9 is quite informative. On the contrary of Ti-6Al-4V, the Ti top surface was modified thanks to fretting corrosion experiments. The grain size did change, refinement, and the most relevant is, on the Figure 9b), some ceramic material is inserted in the TTS of the titanium sample.

*Figure 9: a) TEM analysis in the wear track area of Ti sample in the contact with Y-TZP, STEM HAADF; b) From the same image, EDS: the pink material is Zirconium.*

Figure 9: a) TEM analysis in the wear track area of Ti sample in the contact with Y-TZP, STEM HAADF; b) From the same image, EDS: the pink material is Zirconium.

After fretting corrosion, there is a kind of welding phase by mixing materials. Some zirconia was compacted on the top surface of Ti material. On Ti-6Al-4V, this insertion was
