Corrosion-Induced Degradation of Reinforced Concrete Elements: Preliminary Results, in: Service Life and Durability of Reinforced Concrete Structures

CORROSION-INDUCED DEGRADATION OF REINFORCED CONCRETE ELEMENTS: PRELIMINARY RESULTS

Keywords: reinforced concrete, corrosion, rust layer, cracks, electrochemistry

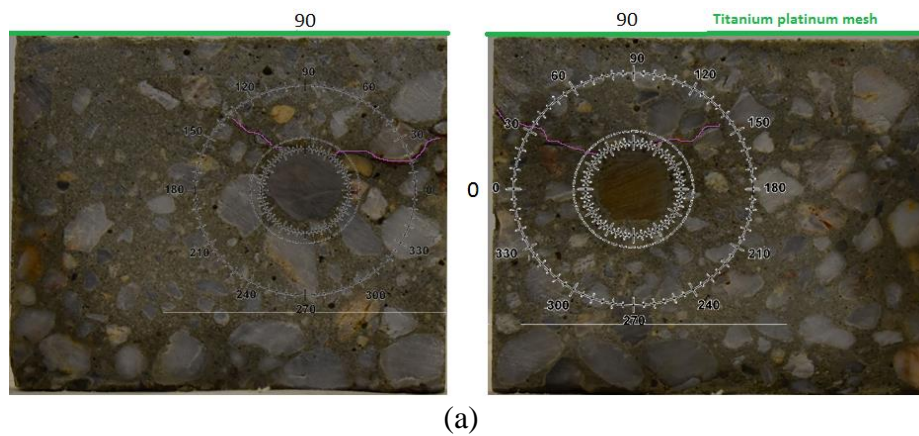
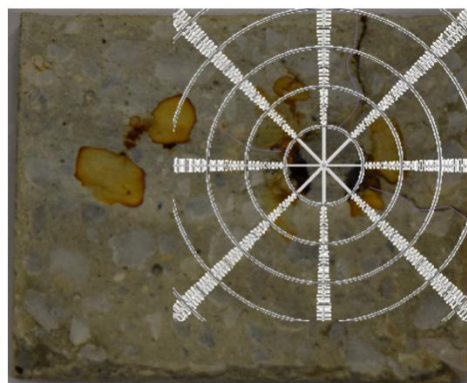
Figure 4. Determination of the crack angular position (a) and the crack length (b) after the accelerated corrosion test on the two sections of a slice

As shown in Figure 8-a, two groups of the position of the cracks near the steel surface are observed oriented close to 40° and 120° according to the graduated circle (see Figure 4-a). Two main cracks seem to be displayed. Two sets of crack lengths could be identified, the first one is about 3cm long (crack extending through the entire concrete cover) and the second one is between 1 and 2cm long, see Figure 8-b. The lengths tend to fluctuate because of the distribution of the aggregates which influences the crack path. The graph in Figure 8-c corresponds to crack widths and shows the observed general trend. The crack widths are around 0.1 and 0.3mm.

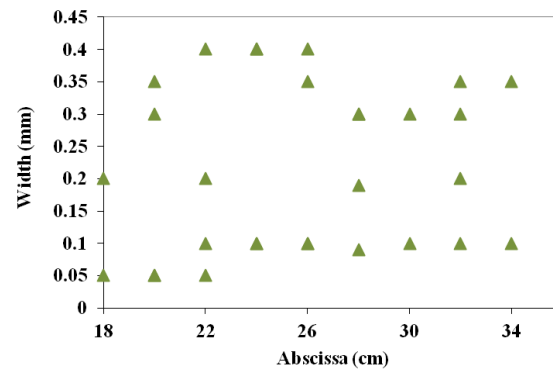
Figure 8 shows the evaluation of the crack patterns (angular position (a), length (b) and width (c)) for each of the 16 sides of the eight slices of specimen P-008-21d. The cracks propagate from the steel/concrete interface to the concrete surface.

Figure 8. Measurement results for the characterization of the internal cracks a) angular position, b) length and c) width

- After 7 days, an active state of corrosion is not clearly observed and this could be explained by the fact that a sufficient amount of chlorides to initiate corrosion has not reached the steel/concrete interface.
- After 21 days, the two cracks orientations ($40^\circ/120^\circ$), lengths (3 cm/1.6 cm) and width (0.3 mm/ 0.1 mm) are coherent for the same specimen.
- From Scanning Electron Microscopy results, corrosion products thicknesses are in the range of 56.6 μm / 276 μm .
- The corrosion-product spots on the surface of the concrete specimens do not reflect the internal corrosion state at the steel/concrete interface of the specimen.
