## **Physico-chemical stone-mortar compatibility of commercial stone-repair mortars of historic buildings from Paris**

P. Lopez-Arce, M. Tagnit-Hammou, Beatriz Menendez, J. D. Mertz, M. Guiavarc'h, A. Kaci, S. Aggoun, A. Cousture

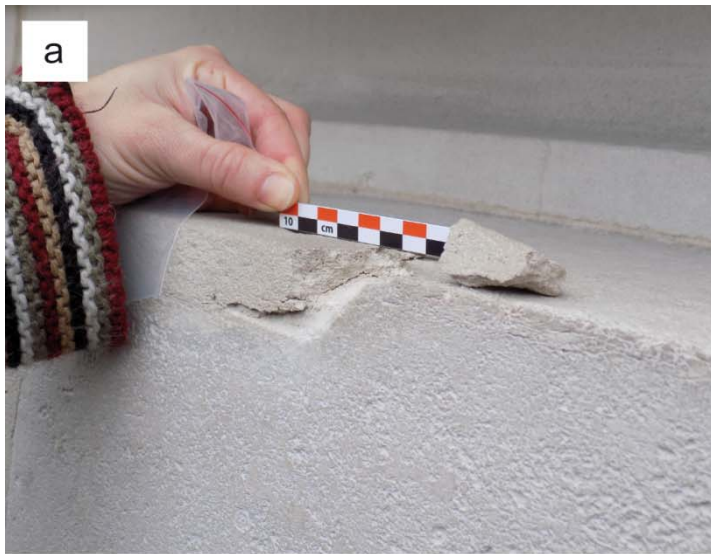
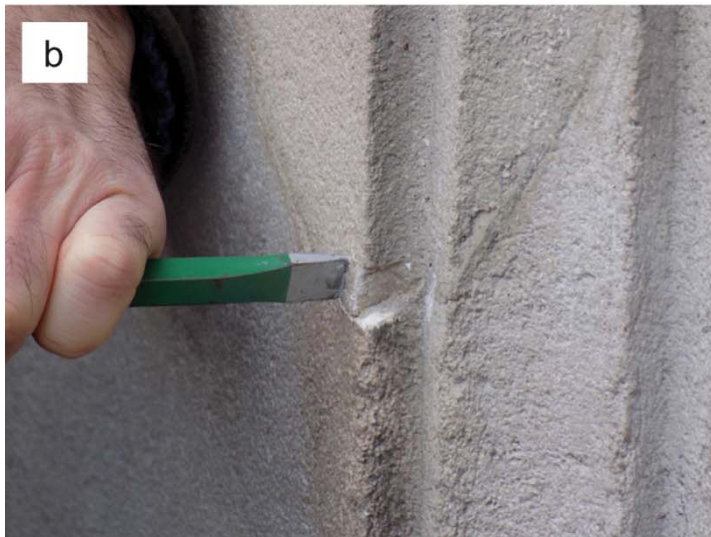
FIGURE 2

597 Lit mortar, classified as a NHL according to the manufacturer, displays a high amount  
598 of phyllosilicates that could have favour cracking of the mortar at the interface stone-  
599 mortar observed at the Grand Palais building when mortar samples were collected

600 (Fig.2). In the frame of Dimppa Project [32] on site measurements with non-destructive  
601 techniques were carried out in this building in the same type of mortar and stone. High  
602 salt index values were found at the interface between Lit mortar and Euville stone,  
603 together with large differences on the thermal behaviour between both materials.  
604 Restorers frequently use clay rich sands because they can increase workability and  
605 matching the right colour for the restoration mortar. However, the main effect of clay  
606 fines ( $<63 \mu\text{m}$ ) in aggregates is an increase of the water demand, due to their high  
607 surface area, for a constant mortar consistency that gives rise to a poor quality mortar  
608 [33]. However, it does not mean that NHL produce bad results in this type of restoration  
609 works, it just depends on the type, proportion and grain size of the minerals in the

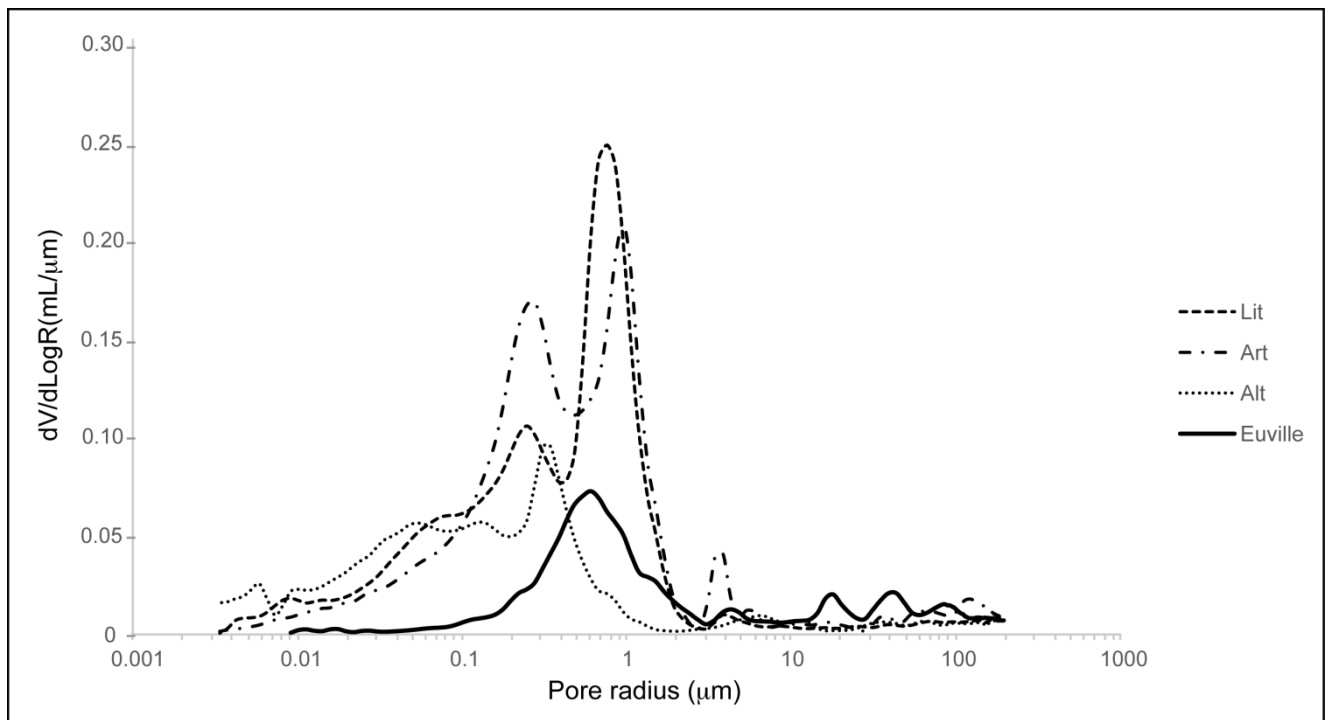
# FIGURE 12

914 **Figure 12.** Connected porosity and pore size distribution obtained by mercury intrusion  
915 porosimetry in 28 days hardened mortars and Euville stone.

530 Pore size distribution (PSD) is different for all the samples, where it can be considered  
531 two different cases. First, Lit and Art mortars display a clear bimodal PSD which is  
532 quite similar, with an average pore radius circa  $0.10\mu\text{m}$  for Lit and  $0.13\mu\text{m}$  for Art  
533 mortar; median pore radius are about  $0.5\mu\text{m}$  for Lit and  $0.4\mu\text{m}$  for Art, in both cases  
534 the median radius is higher than average radius. Alt mortar and Euville stone show  
535 average pore radius higher than median radius,  $0.04\mu\text{m}$  and  $0.01\mu\text{m}$  for Alt mortar  
536 respectively, and  $1.4\mu\text{m}$  and  $0.8\mu\text{m}$  for Euville stone, respectively. Euville limestone  
537 has larger pores than the mortars, above  $10\mu\text{m}$  (Fig.12). In all the mortars median  
538 radius is smaller than the modal pick, indicating a bias to the smaller pores; Euville
