## Durability of stone-repair mortars used in historic buildings from Paris

P. López-Arce, M. Tagnit-Hammou, Beatriz Menendez, J-D. Mertz, A. Kaci

P. López-Arce, M. Tagnit-Hammou, Beatriz Menendez, J-D. Mertz, A. Kaci. Durability of stone-repair mortars used in historic buildings from Paris. *Materials and structures*, 2016, 49 (12), pp.5097-5115. 10.1617/s11527-016-0846-0 . hal-03266054

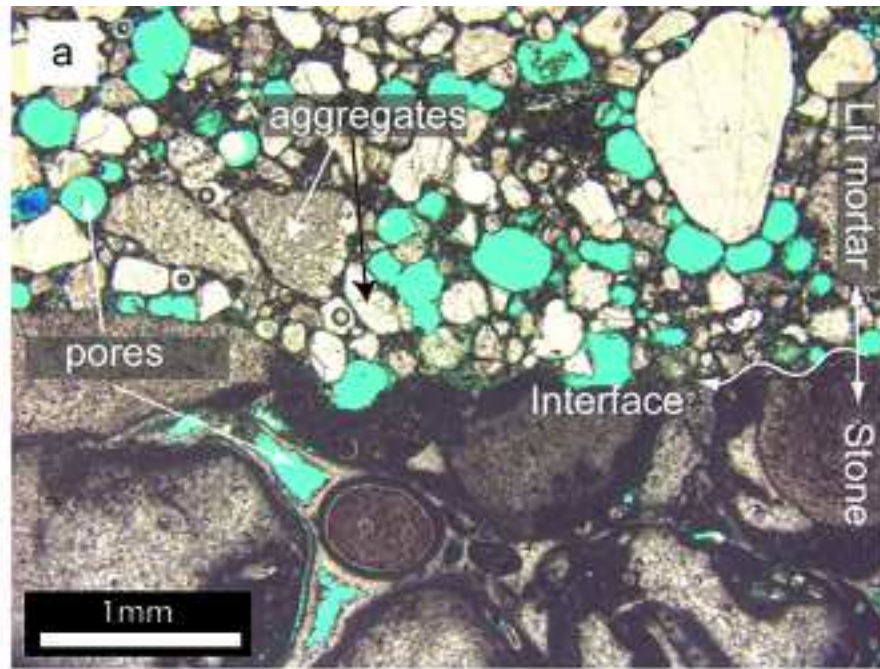
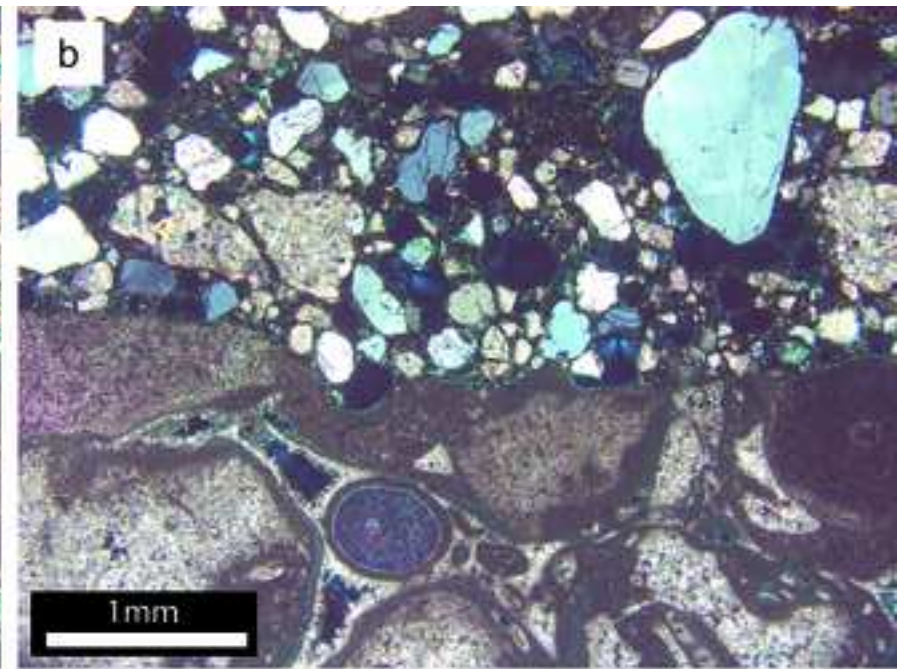
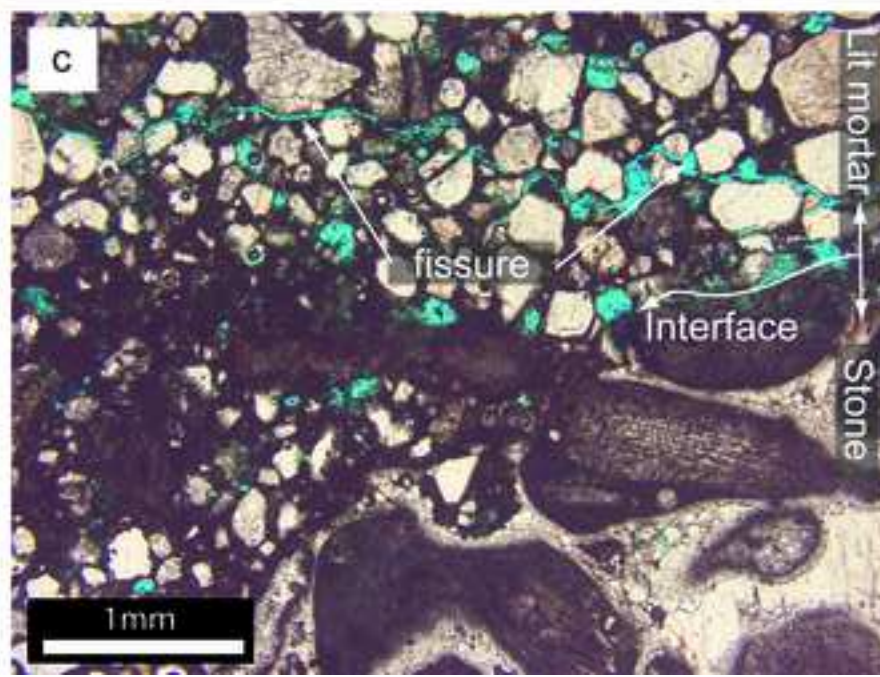
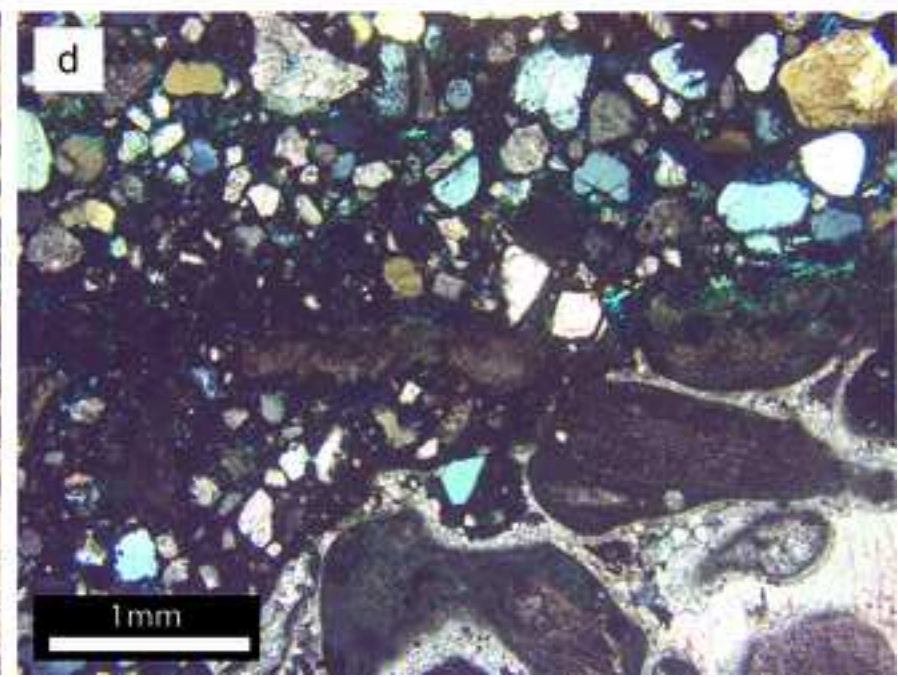
9  
10  
11 753 **Fig. 2.** Thin section images of Euville stone-Lit mortar specimens, with porosity in blue colour:  
12  
13 754 a) Euville in the bottom and Lit mortar in the top (control 2 specimen) showing the aggregates  
14  
15 755 and rounded porosity; b) same former image in cross nicols, c) Lit mortar (aged 1 specimen)  
16  
17 756 displaying a fissure close to the interface; d) same former image in crossed nicols.

306 A clear difference can be observed at the interface between Lit mortar and Euville stone  
307 in both control and aged stone-mortar specimens. In some parts of the interface the  
308 mortar penetrates in the larger pores of the stone. The most abundant aggregates with  
309 smaller sizes embedded in the lower crystalline matrix of the mortar compared to  
310 Euville are observed in Lit mortar which also displays higher porosity (Fig.2a and 2b).  
311 There are almost no differences between specimens from control 1 (submerged into  
312 deionized water) and control 2 (exposed to water vapour); except the higher quantity  
313 and larger porosity located in some parts at the interface of the former specimens. The  
314 interface of Lit-Euville specimens subjected to both ageing tests show clear differences  
315 between them. Whereas the interface of the specimens subjected to ageing 2 (exposed to

316 acid vapours) are quite similar to their corresponding control specimens. Those  
317 specimens subjected to ageing 1 (submerged in the salt solution) display fissures  
318 parallel to the interface. In this case, the pores (filled with the blue resin) are spotted due  
319 to the salt crystals that remained after the test (Fig.2c and 2d). There are almost no  
320 differences in the surface of Lit mortar from the two types of control specimens (both  
321 display cracking of feldspars).

499 composition and the possible presence of a water-repellent product in the mortar  
500 composition could explain the formation of fissures. These fissures are observed both at  
501 the interface of the stone-mortar repaired areas at the Grand Palais building [9] and  
502 close to the interface in the stone-mortar specimens (Fig.2c).

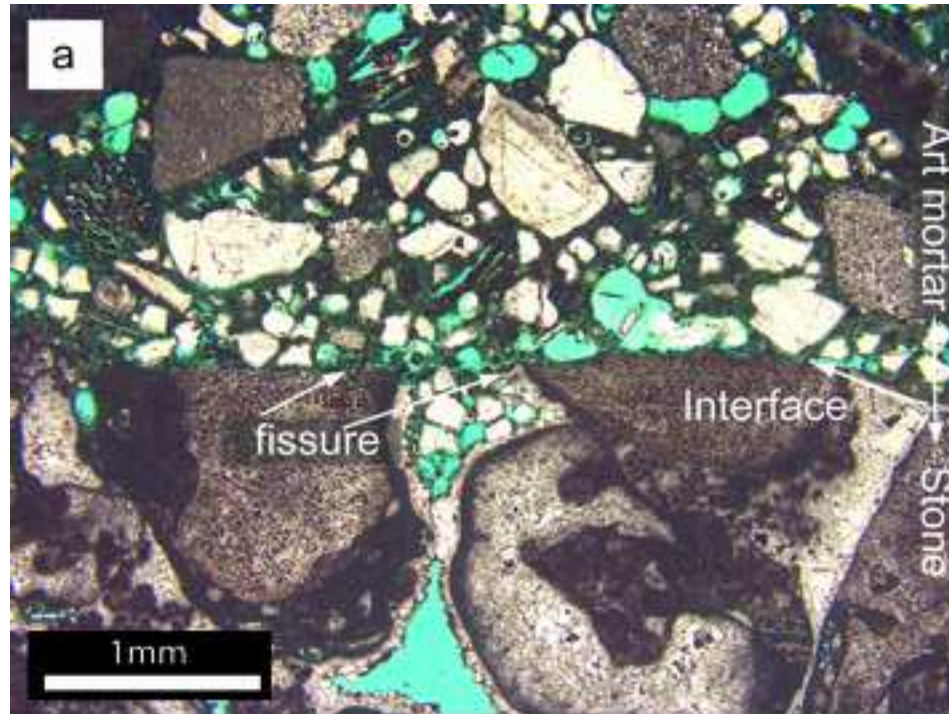
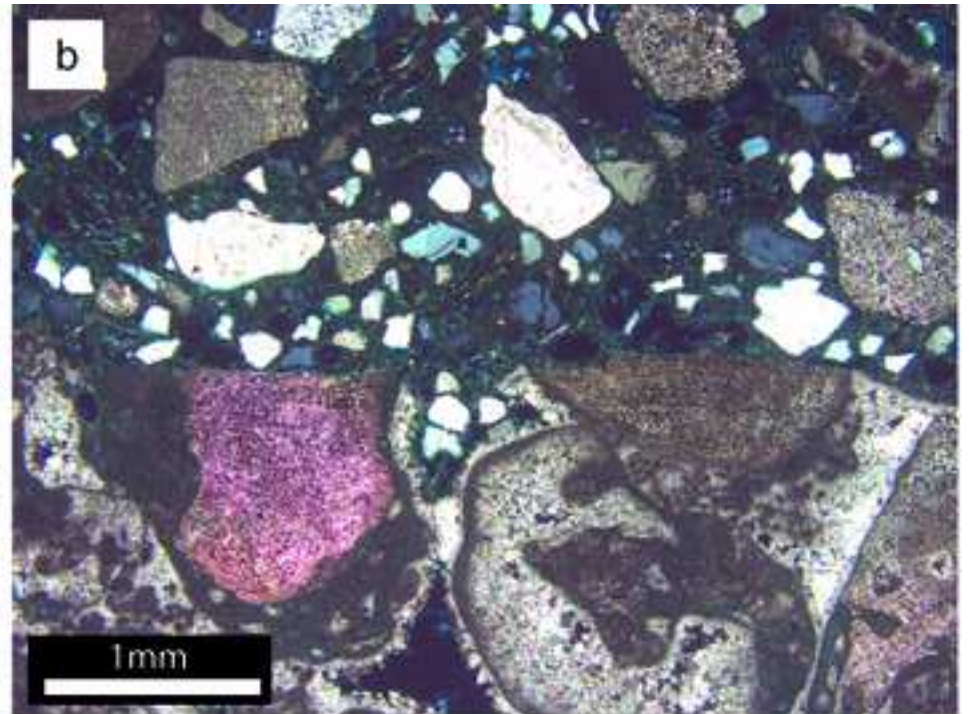
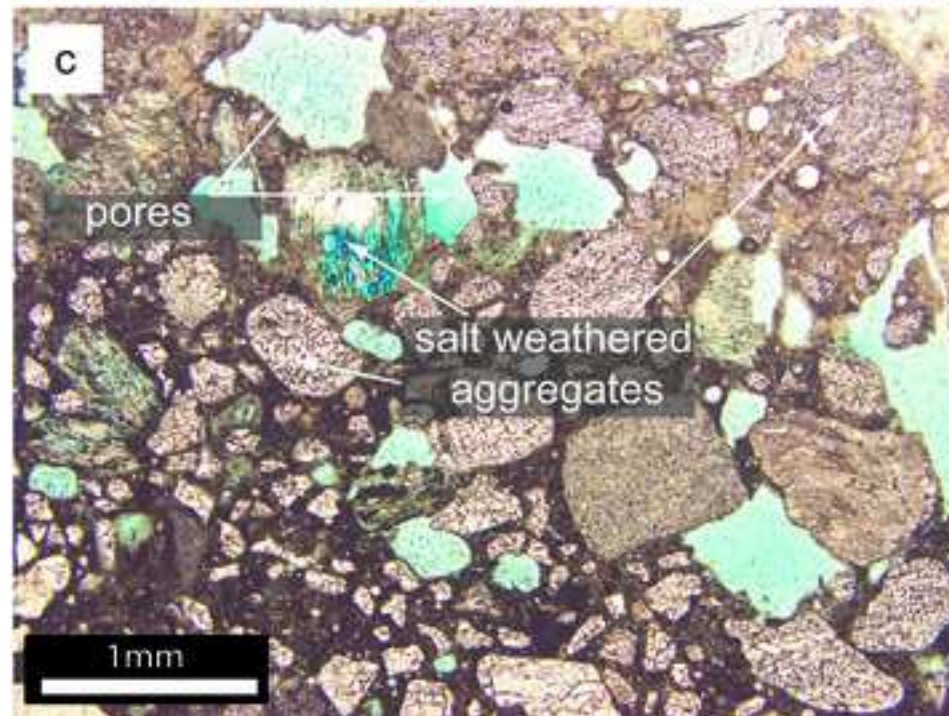
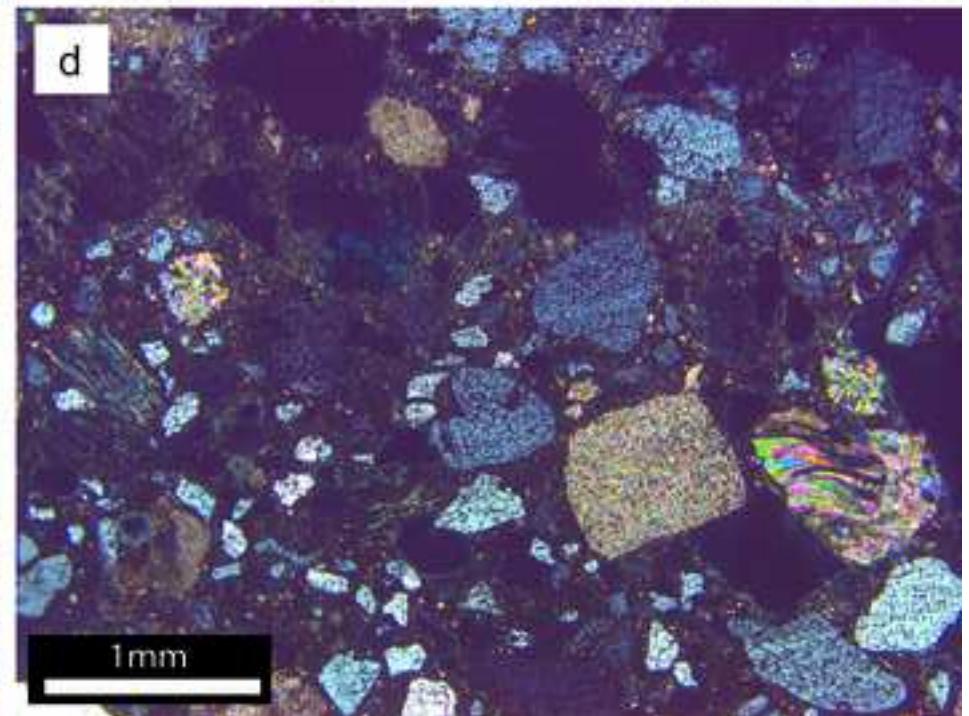
18  
19  
20  
21 757 **Fig. 3.** Thin section images of Euville stone-Art mortar specimens, with porosity in blue colour:  
22  
23 758 a) Euville in the bottom and Art mortar in the top (control 1 specimen) with a fissure along the  
24  
25 759 interface; b) same former image in cross nicols; c) Art mortar surface (on the top) of aged 1  
26  
27 760 specimen showing aggregates with signs of salt weathering; d) same former image in crossed  
28  
29 761 nicols.

322 Art mortar-Euville stone control specimens show greater textural differences between  
323 the limestone and the mortar compared to the other stone-mortar specimens. A thin  
324 fissure developed along the interface of both materials can be observed while some  
325 larger pores of the stone are filled with this mortar. This type of fissure can be clearly

326 distinguished in the control 1 specimens (Fig.3a and 3b), being this even more  
327 continuous along the interface of the aged 1 specimens. Salt crystals can be observed  
328 embedded in the blue resin that fills the pores of both mortar and stone. The fissure at  
329 the interface of both materials is not observed in the specimens exposed to water and  
330 acid vapours. Alteration of phyllosilicates, cracking of feldspar grains and  
331 disaggregation of limestone aggregates is observed in the mortar surface of the aged 1  
332 specimens (Fig.3c and 3d).

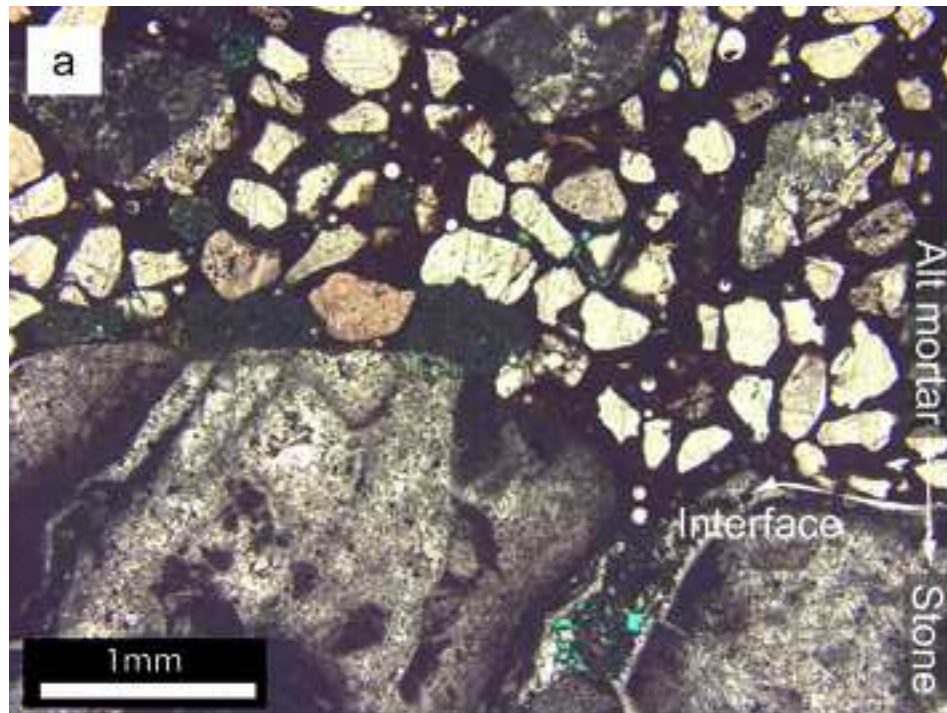
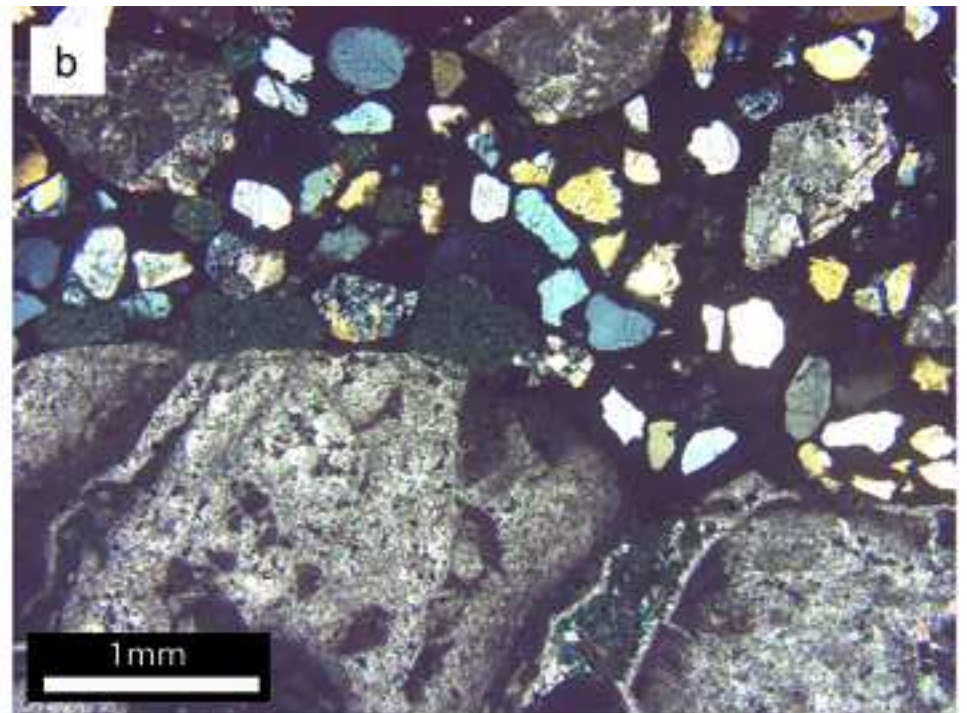
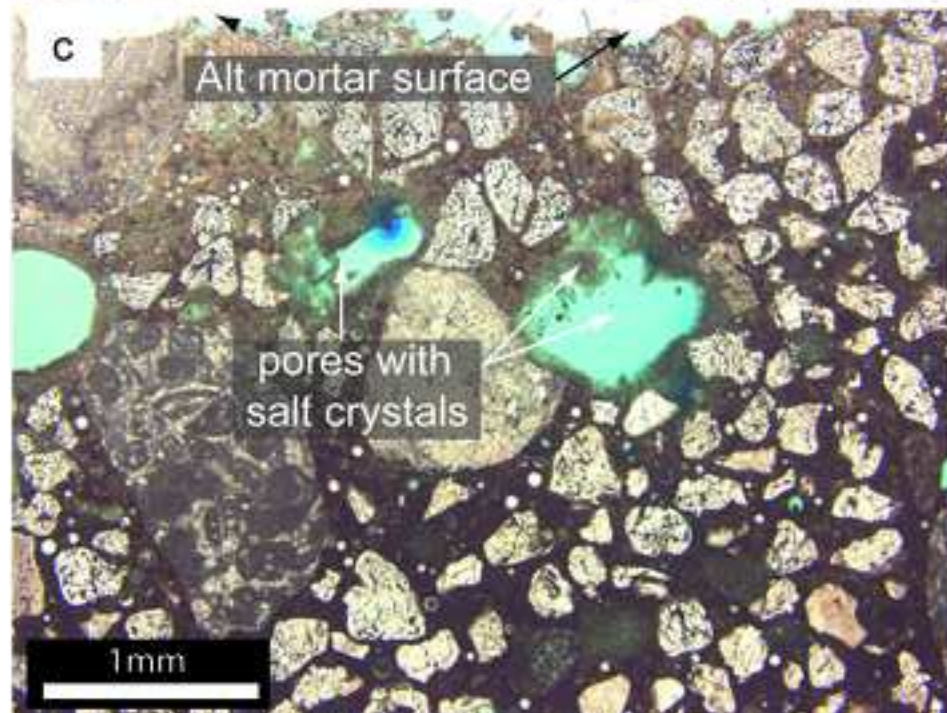
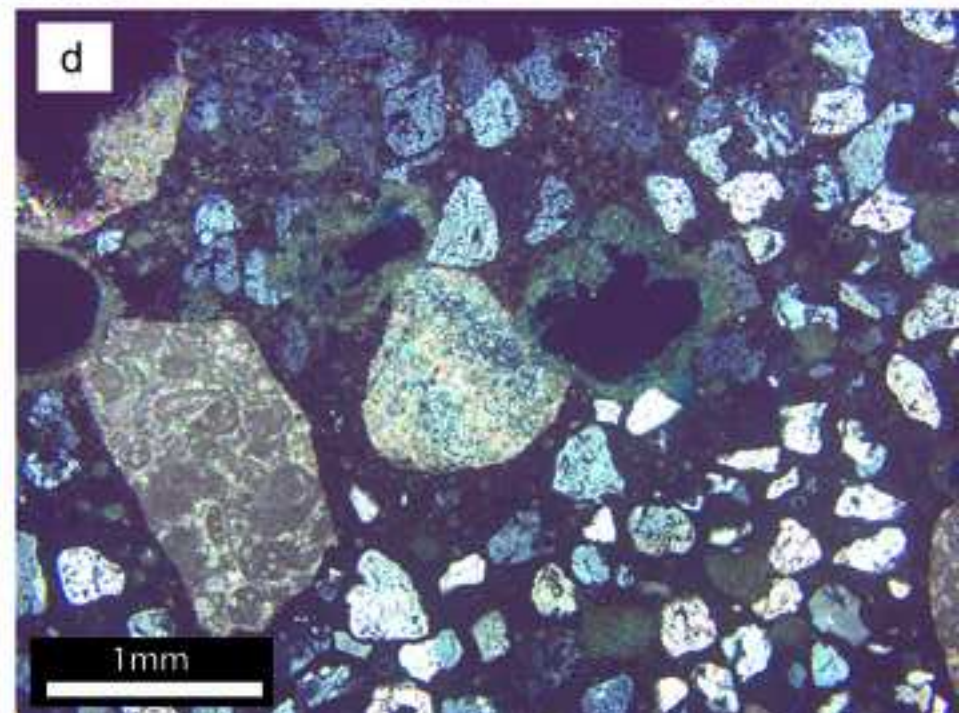
333 The interface between Alt mortar and Euville stone can be easily recognized by the  
334 different grain sizes of both materials. Although there is a high compaction degree of  
335 this mortar with almost no visible porosity (Fig.4a and 4b) in some areas higher  
336 porosity close to interface is observed only in the control 1 and aged 1 specimens. The  
337 main difference found in the surface of the mortars from the two control groups is the  
338 higher quantity and larger porosity in the specimens from control 2. The surface of the  
339 aged specimens shows cracking of feldspars, especially in the specimens from ageing 1.  
340 Higher porosity and larger pores compared to their corresponding control specimens are  
341 observed at the surface of aged 1 specimens. Salt crystallisation can be observed at the  
342 edges of the pores located at the surface of aged 2 specimens (Fig.4c and 4d).

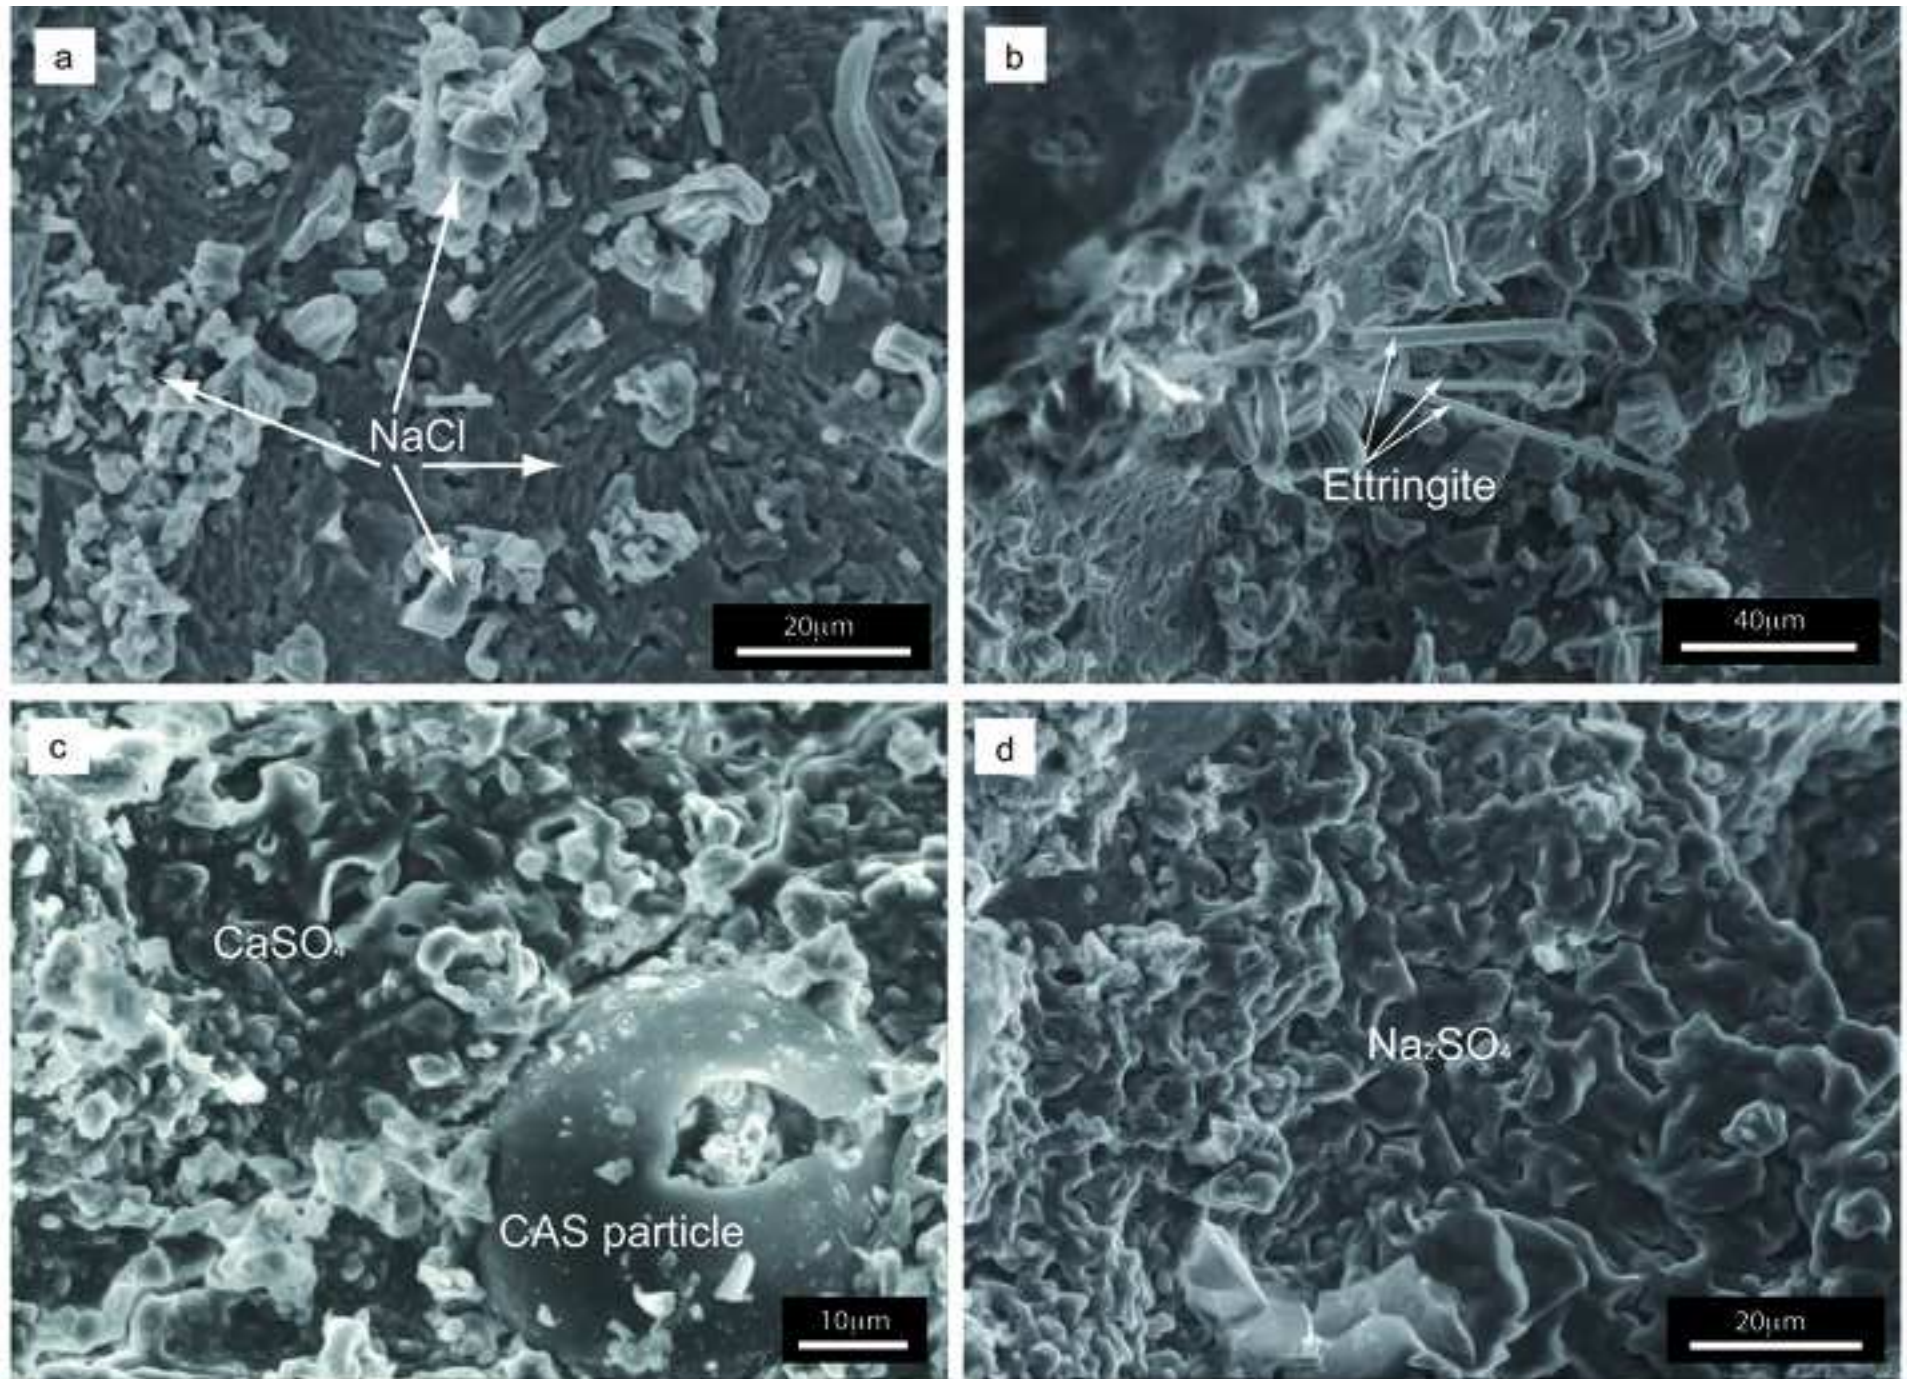
351 of salt crystallisation, especially of sodium chloride (Fig. 5a). This sample also shows  
352 acicular crystals that look like ettringite sulphates (Fig.5b). Plenty of portlandite re-  
353 crystallisation is observed in Alt control 1 specimens, while calcium sulphate crystals  
354 are observed close to calcium aluminosilicate (CAS) spherical particles with signs of  
355 cracking after acid exposure ageing test (Fig.5c). Lit mortar also shows calcium  
356 sulphate crystals on its surface. Sodium sulphate crystals, with some calcium and  
357 potassium, are also observed in this mortar and especially in Art mortar surface after the  
358 salt crystallisation test (Fig.5 d).

469 mainly observed after the acid test (Fig.5). Even though the specimens subjected to the  
470 salt crystallisation test were submerged in deionized for 24 h at the end of the last cycle  
471 of the test, these still contain salts that could not be ruled out. Art-Euville specimens are  
472 the most affected samples, which surfaces show a higher degree of salt crystallisation,  
473 especially of sodium chloride. Besides, acicular crystals that resemble ettringite

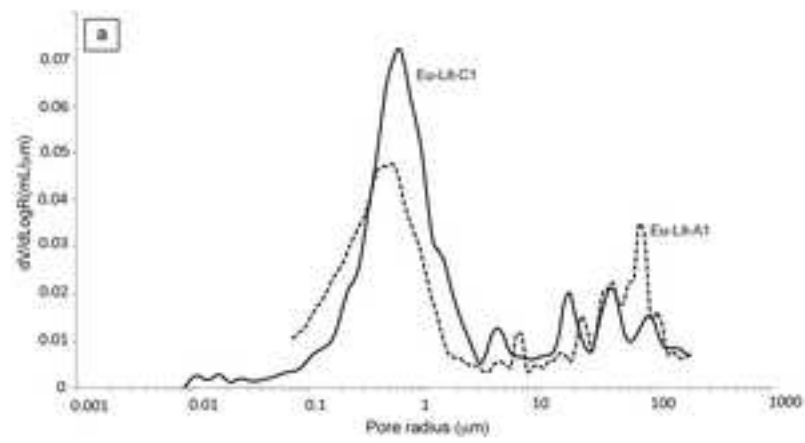
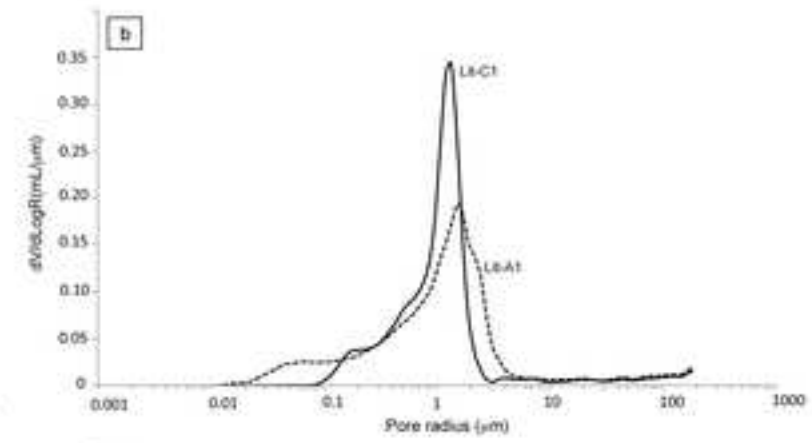
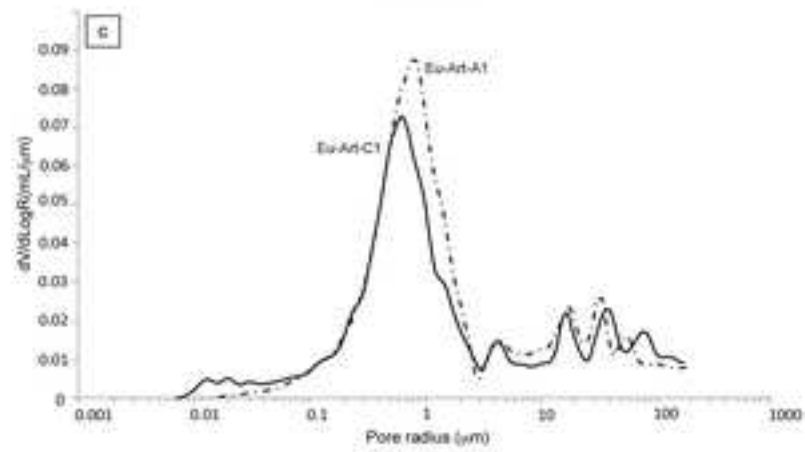
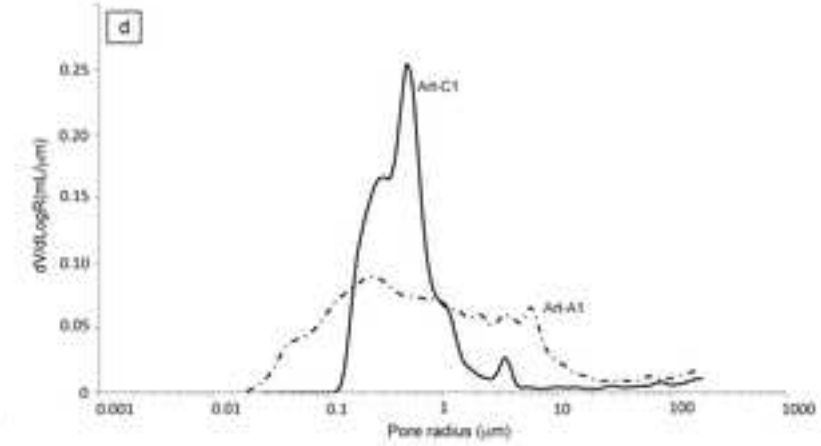
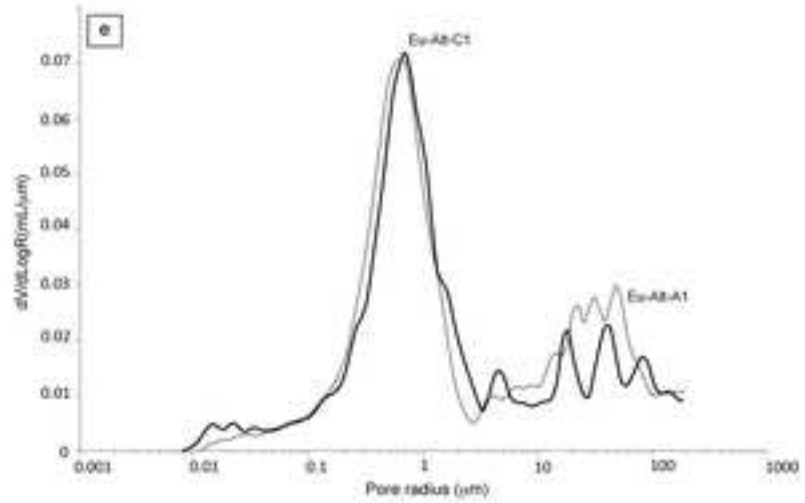
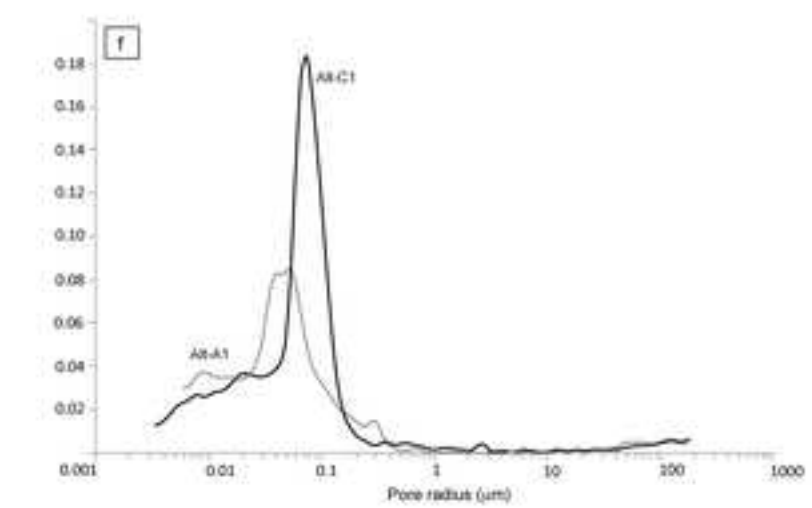
Fig.6

474 sulphates could explain the development and cracking of the thin crust on the surface of  
475 these specimens. The presence of gypsum and aluminate hydrate is a necessary  
476 condition for ettringite formation, controlled by the amount of water and soluble CO<sub>2</sub>,  
477 which could both determine the conditions of ettringite precipitation [18]. Lit mortar is  
478 the one less affected by this test, whereas Art mortar is the most affected due to a higher  
479 absorption of salt solution and hence a further greater extent of salt crystallisation inside  
480 the pores. This is related to its original composition, also prone to precipitate ettringite  
481 crystals, together with higher capillarity rates that eventually cause larger modifications  
482 of the pore system (PSD) and the increase of total porosity (Fig.6).
