The impact of ground-ice thaw on landslide geomorphology and dynamics: two case studies in northern Iceland

Costanza Morino, Susan J. Conway, Matthew R Balme, Jón Kristinn Helgason, Þorsteinn Sæmundsson, Colm Jordan, John Hillier, Tom Argles

Costanza Morino, Susan J. Conway, Matthew R Balme, Jón Kristinn Helgason, Þorsteinn Sæmundsson, et al.. The impact of ground-ice thaw on landslide geomorphology and dynamics: two case studies in northern Iceland. *Landslides*, 2021, 10.1007/s10346-021-01661-1 . hal-03280914

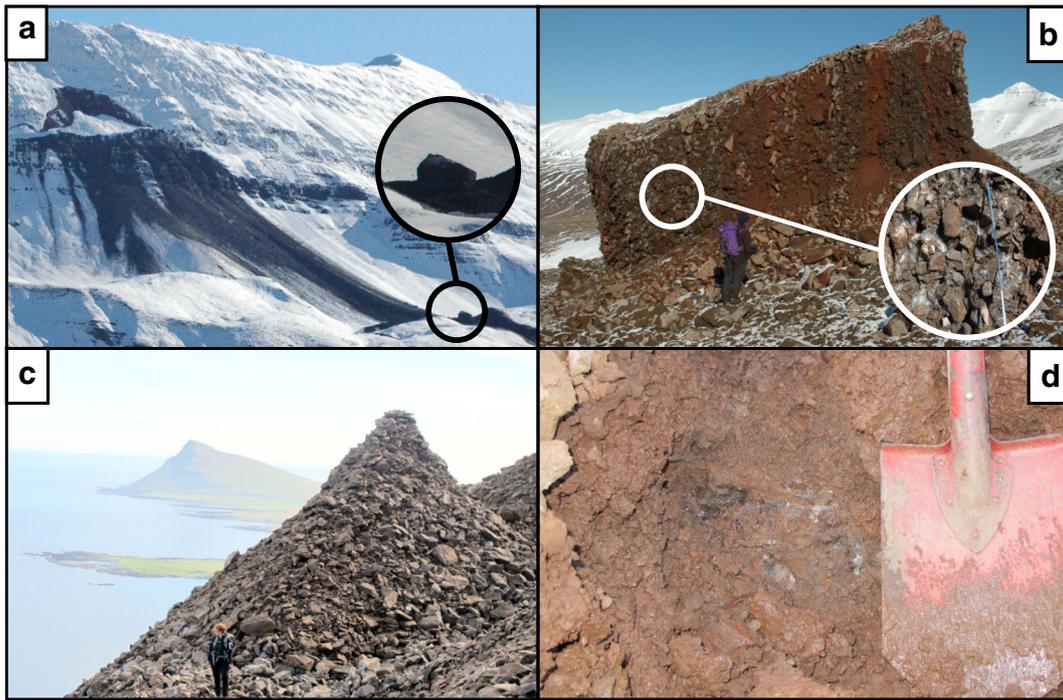
Fig. 1 Blocks and ridges of ice-cemented sediments. **a** An oblique view of the Móafellshyrna landslide on the day of its occurrence, with one of the blocks of ice-rich sediments found in its deposits (see circles). **b** A close-up photo of the block of ice-rich sediments shown in Fig. 1a, taken 9 days after the occurrence of the Móafellshyrna landslide (in the circles, a close-up image of the ground ice cementing the deposits with a walking pole for scale). **c** One of the ridges of ice-cemented deposits found 2 days after the Árnesfjall failure. **d** Ground ice found at 1 m of depth in the landslide deposits 2 days after the occurrence of the Árnesfjall landslide

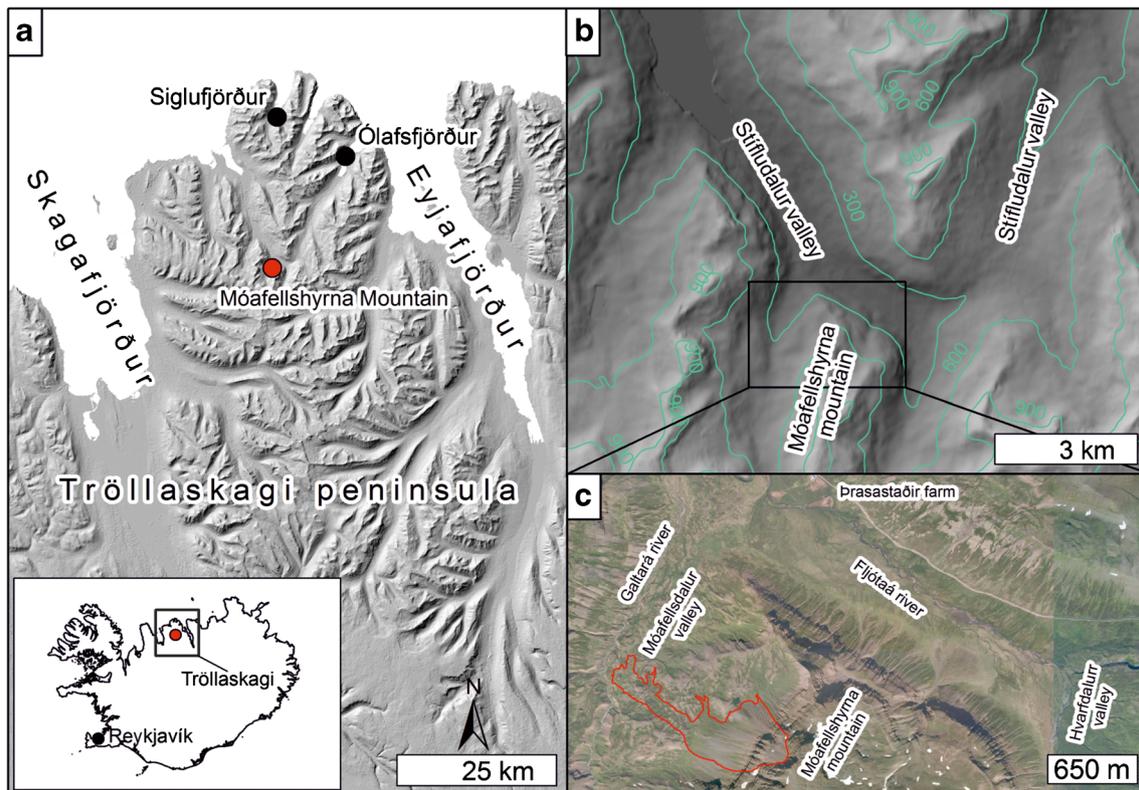
Fig. 2 The geographic setting of the Móafellshyrna site, Tröllaskagi peninsula, northern Iceland. **a** A hillshaded digital elevation model (DEM) showing the main geographic locations of Tröllaskagi peninsula and the Móafellshyrna Mountain (DEM source EU-DEM from the Global Monitoring for Environment and Security service for geospatial reference data access project (GMES RDA)). **b** Hillshaded DEM and contours (in green, m above sea level) of the Móafellshyrna region. **c** Aerial photograph (source samsyn.is) of the Móafellshyrna Mountain before the landslide (perimeter of the landslide marked by a red line) in 2012, showing some of the main geographic features of the area

The first case study is the Móafellshyrna landslide. The site is in the Tröllaskagi peninsula in northern Iceland, a mountain plateau with summits up to 1550 m high (Fig. 2a, b). The occurrence of the Móafellshyrna landslide was first witnessed by the Þrasastaðir farm residents (Sæmundsson et al. 2018), situated on the northern side of the Fljótaá river, facing the Móafellshyrna ridge (Fig. 2c).

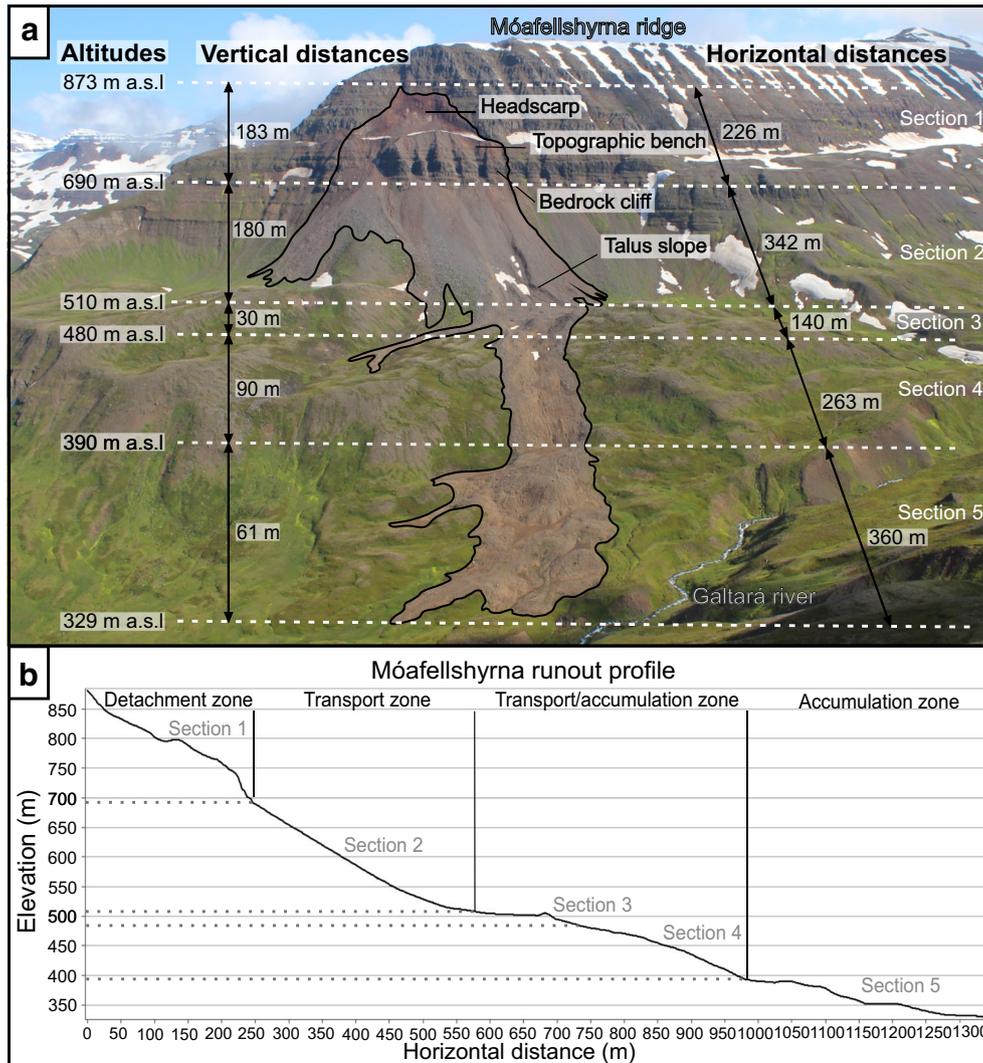
Fig. 3 The division of the Móafellshyrna landslide into sections based on topography and whether erosion, transport or accumulation dominates. **a** Oblique view, looking south-east, of the Móafellshyrna landslide with the different sections outlined. **b** Longitudinal topographic profile divided into five sections, corresponding to the detachment, transport, transport/accumulation and accumulation zones detailed in the text and marked in **a**

The detachment zone of the landslide (corresponding to Section 1 in Fig. 3b) is a 665-m-wide topographic bench on the north-western side of the Móafellshyrna Mountain. The failure mass consisted of talus deposits lying against the sub-vertical rockwall of the mountain (Fig. 7a). Only some of the talus deposits slid off the bedrock cliff, as remnants are still perched on a topographic bench in the source area, where ice and snow patches were observable 3 years after the occurrence of the slide (Fig. 7b). Nine days after the occurrence of the landslide, the remnant talus material appeared as rectilinear ice-cemented blocks of debris standing vertically at the edge of the bench (Fig. 7c). Their vertical dimension has been visually estimated to be 15–20 m, and some of them have degraded in place, as they are today still observable in

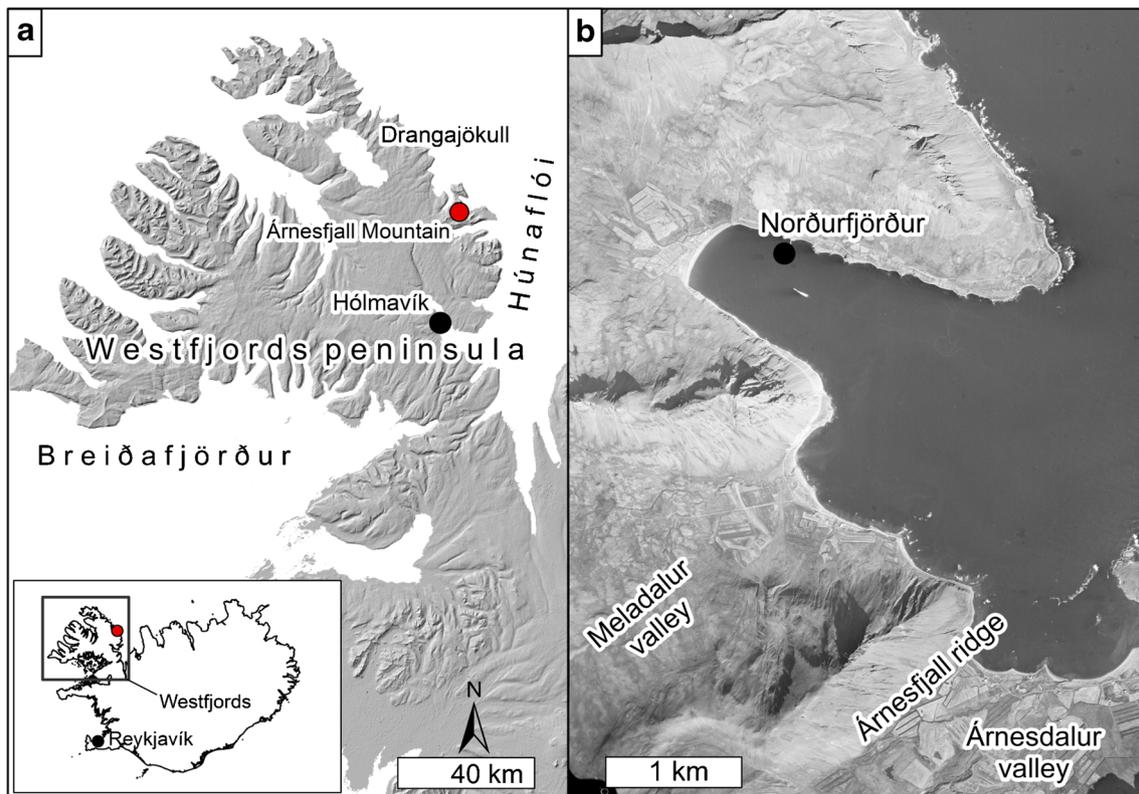
Fig. 4 The geographic setting of the Árneshjall site, on the Westfjords peninsula, north-western Iceland. **a** The hillshaded DEM showing the main geographic locations of the Westfjords peninsula and the Árneshjall Mountain (base map from the EU-DEM from the Global Monitoring for Environment and Security service for geospatial reference data access project (GMES RDA)). **b** Aerial photograph from 1981 (source National Land Survey of Iceland–Landmælingar Íslands) of the Árneshjall Mountain, showing some of the main geographic features of the area

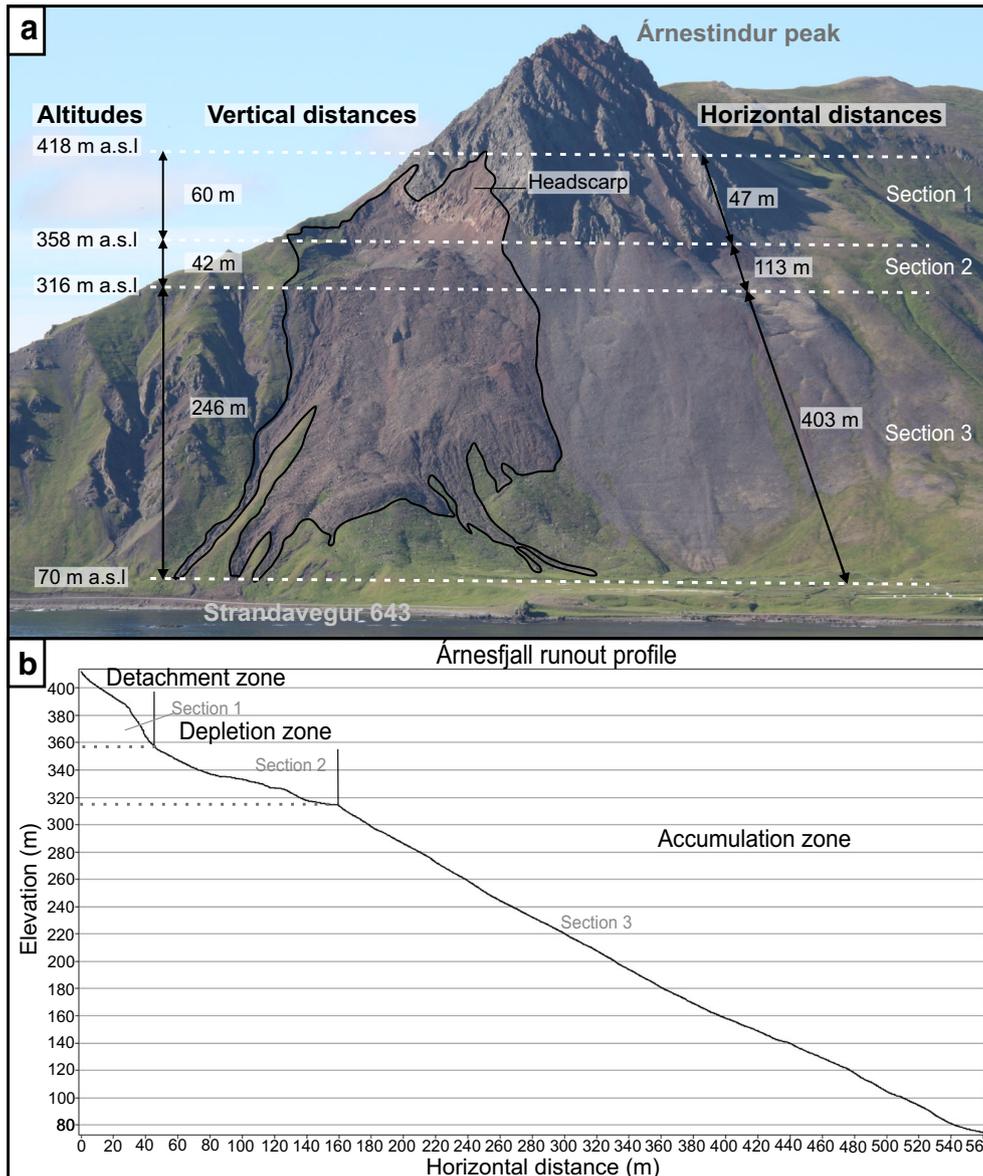
Fig. 5 The Árneshjall landslide divided into sections based on topography and dominant process. **a** Oblique view looking south towards the Árneshjall landslide showing its local geographic setting. **b** Topographic long profile divided into three sections, corresponding to the detachment, depletion and accumulation zones

In the depletion zone (corresponding to Section 2 in Fig. 5b), the source material was tilted downwards, but parts of the talus deposits are still perched in this area of the landslide (Fig. 12c). In particular, multiple elongated cones of talus deposits lie here (Fig. 12c, d), densely grouped ~ 40 –150 m below the top of the headscarp. They are up to 27 m long and almost 4 m high and are the result of the degradation of angular ridges composed of ice-cemented talus deposits that formed during the tilting downwards of blocks of source material during the failure, so they are recognised as molards. Four of these are located in the accumulation area downslope. On the downward-facing surfaces of the cones that are closest to the external edge of the depletion zone,

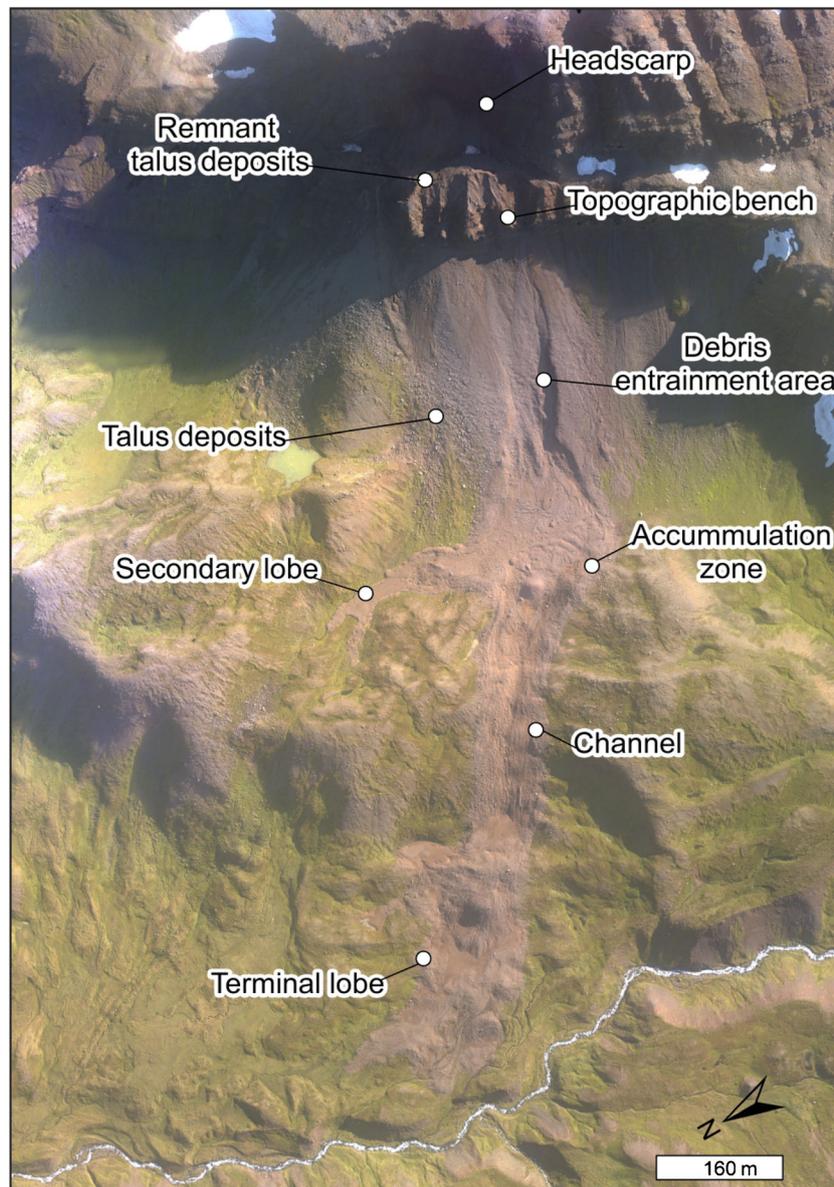
Fig. 6 The morphology of Móafellshyrna landslide. The main morphological features of the Móafellshyrna landslide. Lighting angle from south

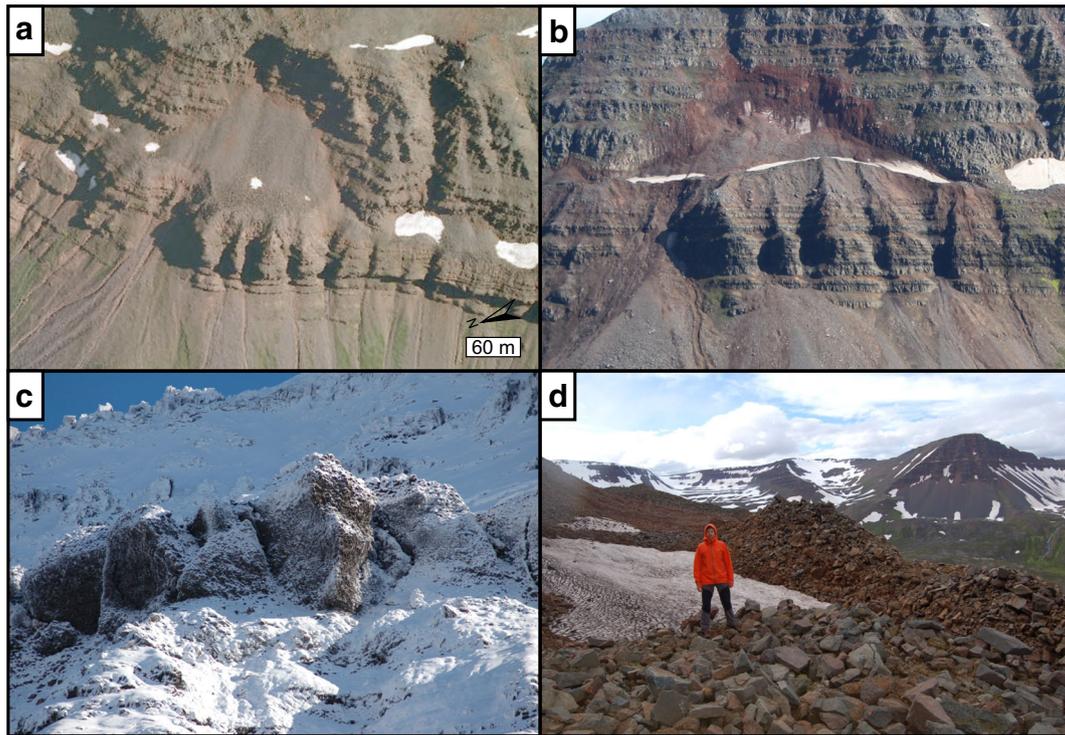
Fig. 7 The geomorphology of the Móafellshyrna landslide's source area. **a** Aerial photograph from 2007 (source samsyn.is) of the source talus deposits lying against the sub-vertical rockwall of the mountain Móafellshyrna Mountain before the landslide. **b** Oblique view of the headscarp of the Móafellshyrna landslide, with remnants of the source deposits lying against the rockwall and perched at the edge of the bench. **c** Unstable blocks of frozen talus deposits perched at the edge of the topographic bench 9 days after the failure. **d** Cones of deposits resulting from the degradation of blocks of ice-rich sediments, perched at the edge of the topographic bench (picture taken in July 2015).

angle of slope of the headscarp, where bedrock is fully or partially exposed, is generally $\sim 50^\circ$ and the slip surface in the source area is upwards concave.

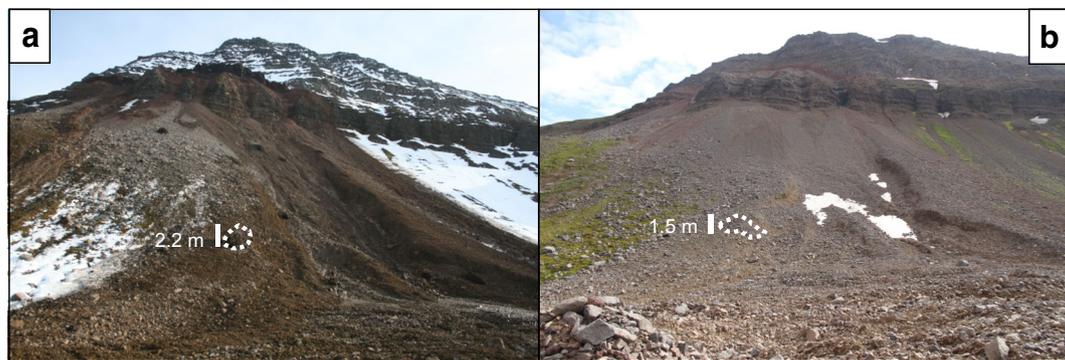
Fig. 8 Entrained talus deposits. **a** The erosional area as result of the entrainment of talus deposits by the initial mass (the picture was taken on 29th September 2012). **b** The same view of the erosional channel, partially re-filled by new talus material (the picture was taken in July 2015). Note the cone of debris as scale, resulting from the degradation of the ice-cemented block in panel a

a.s.l. The falling debris mass entrained new material from these talus deposits, and eroded a channel down the middle of the talus slope (Fig. 8b; corresponding to Section 2 in Fig. 3b). Visual estimates from photographs taken a few days after the occurrence of the failure show that the thickness of the talus debris entrained by the initial mass was much higher than the one observed from field inspection 3 years later (3 to 5 m; Fig. 8), and this channel has been partially re-filled by material that fell subsequently down the talus slope.

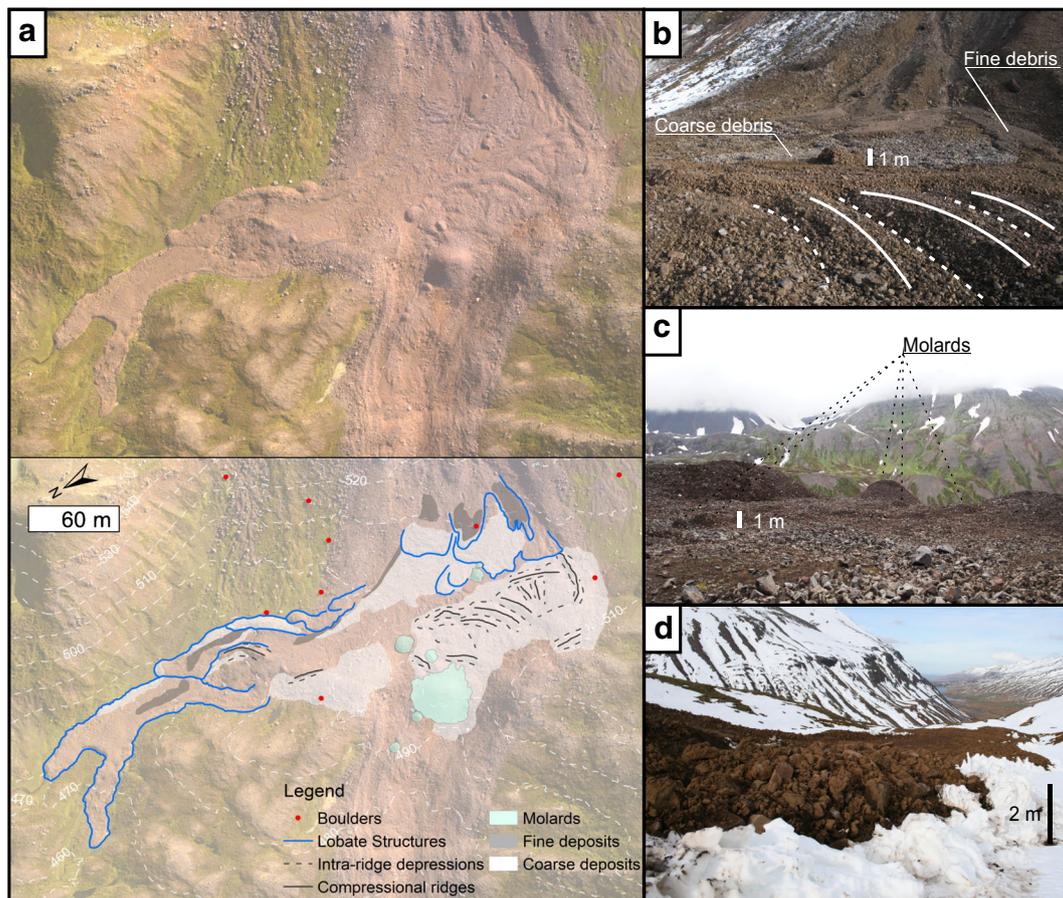
Fig. 9 a The main geomorphological features of the upper accumulation zone of the Móafellshyrna landslide. b Ridges (crests marked with solid lines) and intra-ridge depressions (white-dashed lines) in the first flat accumulation area encountered by the flow. In the background, discrete zones of coarse debris and lobes of fine debris are present. c Some of the cones of debris (molards) scattered on the accumulation area. d Snow bulldozed by the “fish tail” lobe (pictures taken 9 days after the landslide)

The debris mass then reached a low slope area at the foot of the talus slope, and then proceeded further downslope accumulating deposits in a nearly flat area (Fig. 9a; corresponding to Section 3 in Fig. 3b). In this accumulation area, there are thirteen 11–40-m-long compressional ridges, separated by depressions (Fig. 9b). These compressional ridges are partially parallel to the runout direction of the flow (NW to WNW), but those towards the centre of the accumulation area verge towards NE, probably because the flow encountered a topographic obstacle to the west. The ridges are rounded and sinuous, are 5–10 m wide, and from the bottom of the intra-ridge depressions to the crest of the ridge they are 0.5–1 m high on average (Fig. 9a, b). At the contact between the foot of the talus slope and the accumulation zone, there are lobate features, and discrete zones of well-sorted fine and coarse deposits (Fig. 9a). In this accumulation zone of the landslide, we found 17 cones of debris 4 to 39 m wide and tens of cm to 10 m high. We recognise these cones as molards (Fig. 9c), resulting from the degradation of blocks of ice-cemented talus deposits that were observable a few days after the landslide occurred. In this same zone of the landslide, at the foot of the talus slope, fresh boulders up to 1–3 m high are also present (Fig. 9a). In this accumulation area, a secondary lobe was deposited on the north-eastern side of the landslide, striking N260°. This secondary lobe has a distinctive “fish-tail”

Other smaller secondary lobate features are also present further upslope. The lobate deposits have a thickness of 1 m up to 3 m, and have abundant boulders and gravel in a fine (silty clay) matrix. There is a preferential distribution of coarse material towards the edges of the lobe, while fine debris tends to be found towards its centre. From observations made 4 days after the failure, the lobe bulldozed the snow as it travelled downwards on a slope of only 12° (Fig. 9d).

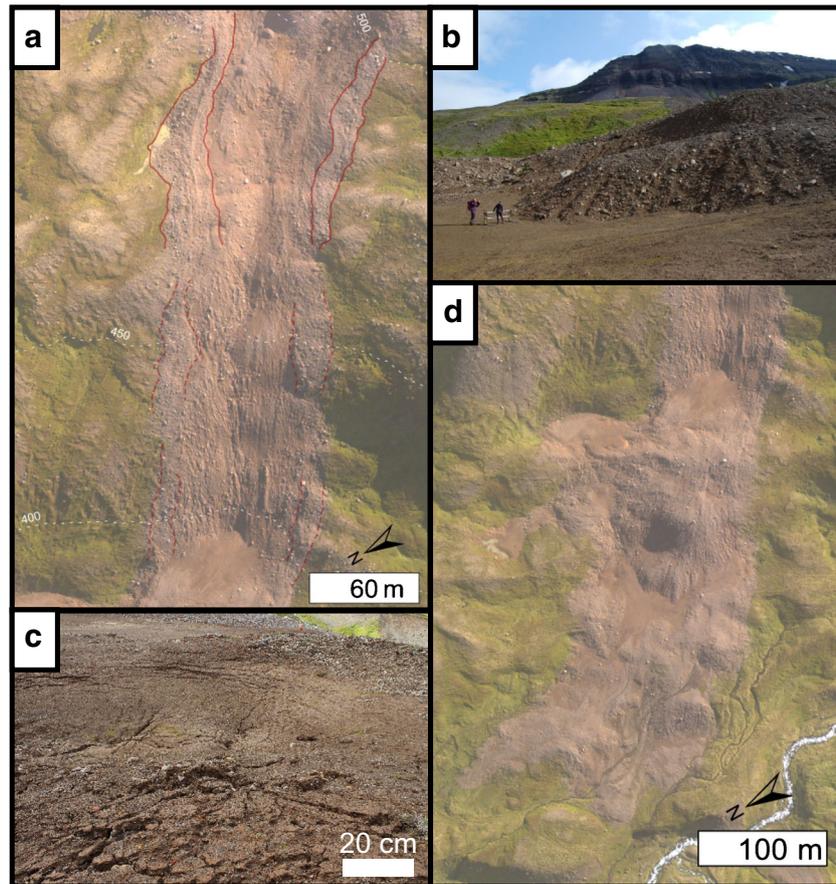
Fig. 10 The channel and the terminal lobe of the Móafellshyrna landslide. **a** The channel has lateral levees (red lines), which are not well defined downwards (dashed red lines). **b** View from south-east of part of the terminal lobe with ridges and furrows and where coarse 23oulder-gravelly deposits are dominant, in contact downslope with an area where silty-clay deposits are dominant. **c** View from south-east of sand boil structures in the terminal lobe, with the main zones where fine (silty-clay) and coarse (23oulder-gravelly) debris are dominant

and up to 107 m wide (Fig. 10a). This channel is not observed in the aerial images of the slope before the occurrence of the landslide. In the central part, it is characterised by ridges and furrows with

N145° direction. The lateral margins show a different granulometry, being mainly composed by blocks, forming poorly-defined lateral levees (Fig. 10a).

The debris mass ended its path on a gently sloping surface, almost reaching the Galtará river (Fig. 10d). The flow formed a terminal lobe 369 m long, up to 218 m wide and with a thickness of at most tens of centimetres (10–50 cm). This terminal accumulation zone of the landslide (corresponding to Section 5 in Fig. 3b) is characterised by discrete flat areas where silty to clay material segregated from the gravelly material, sometimes forming secondary lateral lobes with ponded water, or pools of muddy sand. These zones dominated by the fines show “sand boil” structures (4 to 5 m in diameter; Fig. 10c), which result from the liquefaction of water-saturated fine sediment, and cracks a few metres long (1–5 m). Where the topography is steeper, longitudinal ridges and furrows (up to 40 m long) were created by the transport of blocky material.

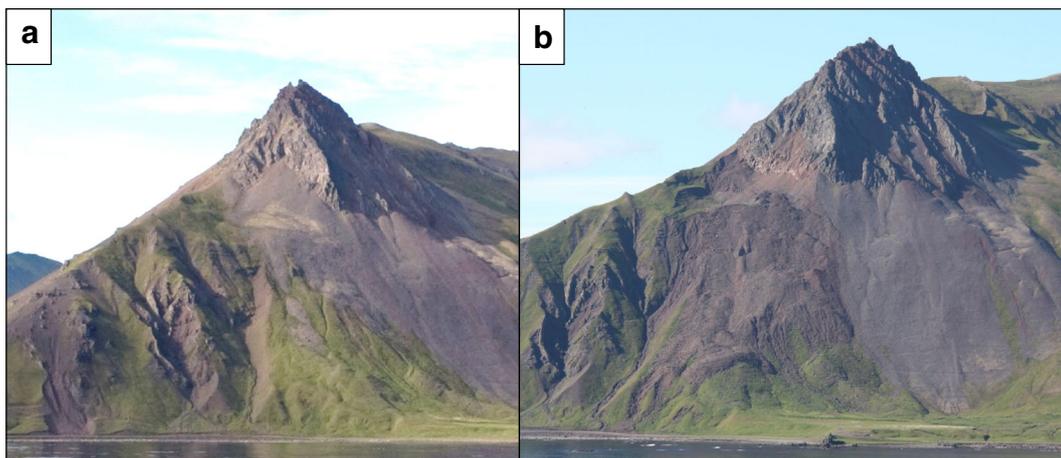
Fig. 11 **a** Oblique view from north-east of the Árnesfjall Peak (picture taken on 13-08-2008, courtesy of Ingvi Stígsson). **b** Oblique view from north of the Árnesfjall landslide (picture taken in July 2016)

The landslide deposits lie on a slope that was once uniformly covered by talus deposits (Fig. 11). Figure 17 shows the DEM of difference (DoD) for the source area (Fig. 17), obtained by subtracting the manually reconstructed pre-failure topographic surface from the post-failure topographic DEM. The volume of erosion calculated from this DoD is 77,400 m³. The thickness of the debris mantle in the accumulation zone is up to 5 m thick in the upper part, and in the terminal lobe just a few tens of centimetres near the western debris flow. From these field measurements, we estimated a volume of debris deposited in the accumulation zone, excluding the debris flows, to be 55,000–275,000 m³.

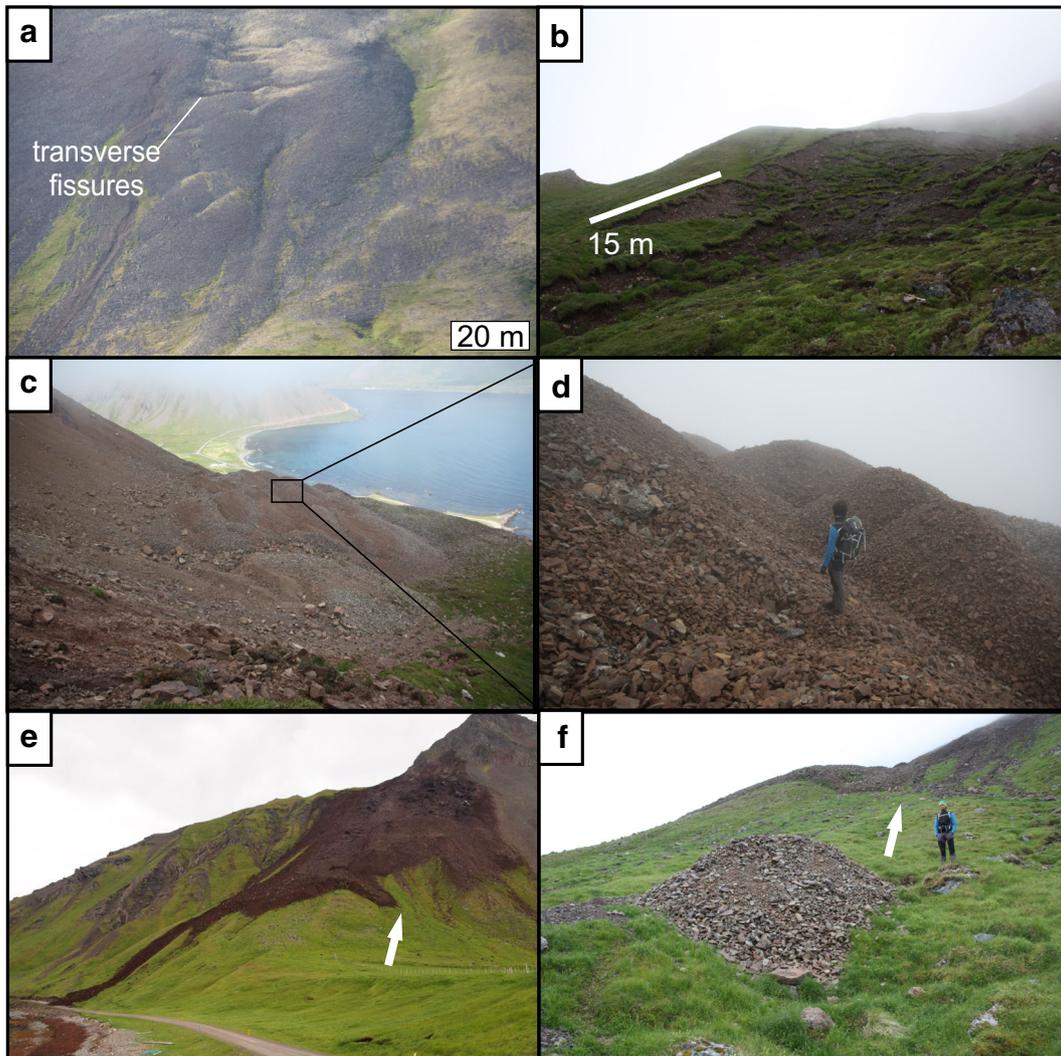
Fig. 12 The morphologies of the Árnesfjall landslide. **a** Reserved talus deposits next to the landslide that show deformation features probably due to permafrost creep. **b** Lateral minor scarps on the eastern side of the landslide. **c** The dense group of elongated molards perched below the headscarp. **d** Molards in the depletion zone are formed by talus deposits and can reach heights of 4 m. **e** A view from the road Strandavegur 643 of the landslide on the day of the failure. Note the square shape of the blocks of ice-rich sediments scattered on the landslide’ surface. The white arrow points to the same place as the arrow in the next panel. **f** An isolated molard at the foot of the western debris flow (absent in panel **e**), which developed from an isolated block that fell 2 days after the occurrence of the failure

The Árnesfjall landslide detached from the northern flank of the Árnestindur peak at 418 m a.s.l., and its toe extends to the bottom of the valley at 70 m a.s.l., with a lateral debris flow that reached the road (Strandavegur 643) at a few metres above sea level (Fig. 11a, b). The vertical distance H between the top and bottom of the landslide is 348 m, while the horizontal travel distance L was 560 m, giving a Fahrböschung of 32° . The landslide material ranges from clay to large boulders in grain size. Similar to Móafellshyrna, the main failure mass consisted of ice-cemented talus slope deposits, in this case lying against the north-facing, sub-vertical rockwall of the Árnestindur peak (Fig. 11a). Parts of the talus deposits were not mobilised by the landslide and still cover $75,000 \text{ m}^2$ of the northern side of the Árnesfjall Mountain (Fig. 11b). These preserved talus deposits show deformation features, such as transverse fissures (20–50 m long; Fig. 12a) probably due to permafrost creep. The basalt

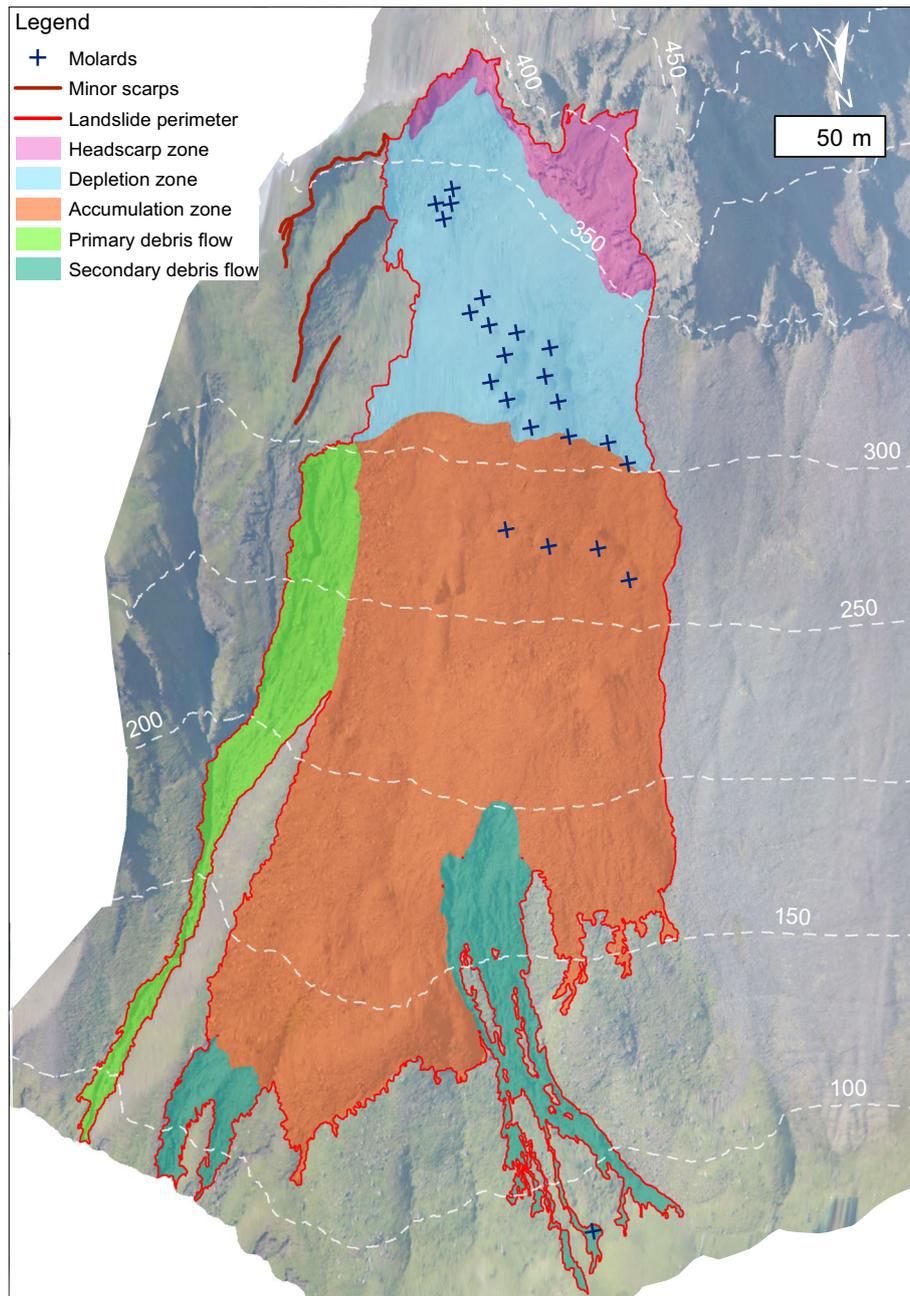
Fig. 13 Map of the main morphological features of the Árneshjall landslide

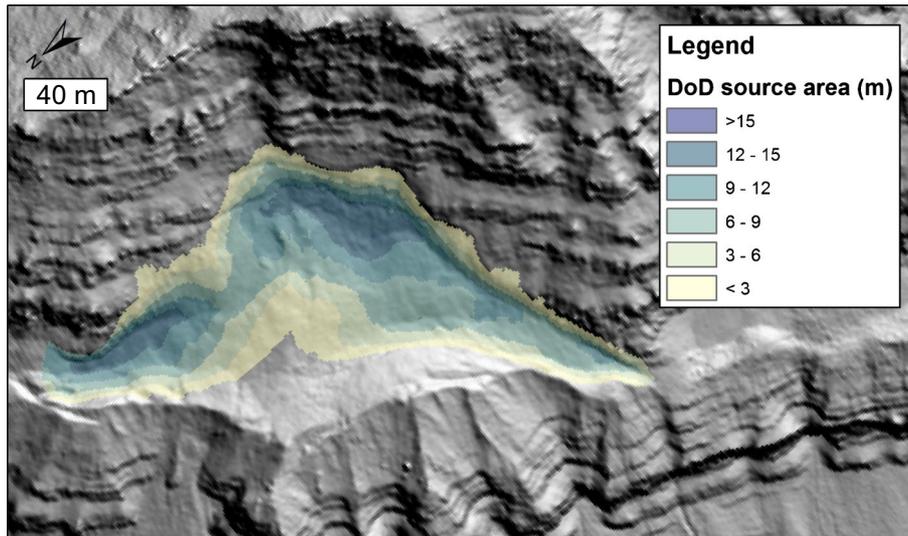
Fig. 14 DEM of difference (DoD) between the post-failure topography (1 m gridded DEM from airborne LiDAR from 2015) and the reconstructed pre-failure topography of the source area of the Móafellshyrna landslide. Background is the LiDAR hillshaded DEM

We reconstructed the pre-failure topography of the source deposits to quantify the talus deposit volumes that were perched on the topographic bench before the occurrence of the failure. Figure 14 shows the DEM of difference (DoD) for the source area, obtained by subtracting the manually reconstructed pre-failure topographic surface from the post-failure topographic surface. The volume of the talus deposits mobilised out of this area obtained through this calculation is 116,900 m³. Fifteen- to 20-m-thick debris is still perched at the edge of the bench; hence, this area remains unchanged despite material having been transported through it.

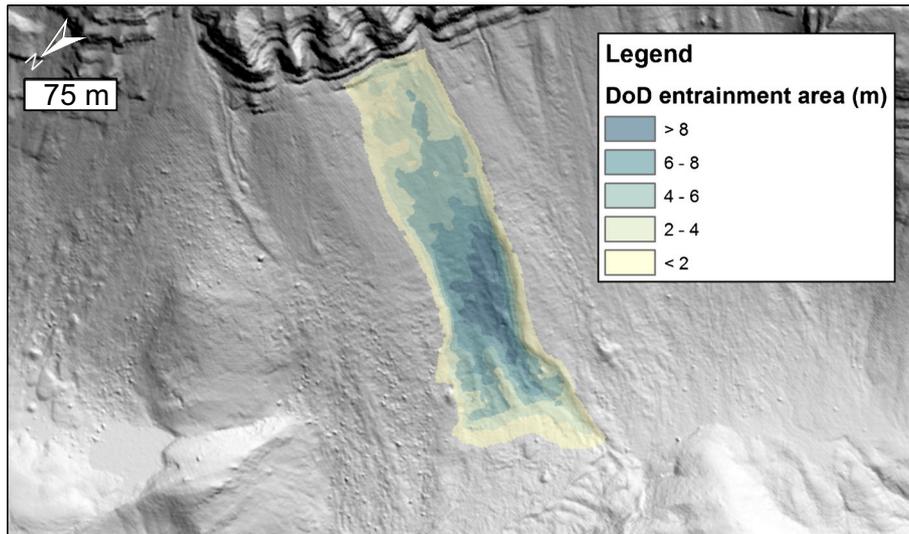
Fig. 15 DEM of difference (DoD) between the post-failure topography (1 m gridded DEM from SfM of post-slide photos controlled to LiDAR data) and the reconstructed pre-failure topography of the entrainment area of the Móafellshyrna landslide. Background is the LiDAR hillshaded DEM

The channel carved in talus deposits below the topographic bench shows that there was entrainment of this material by the source mass, or bulking of the landslide, as also shown in the DoD in Fig. 15, where there is up to 7.8 m of erosion. Assuming that the surrounding talus deposits were not mobilised, we have reconstructed the topography of the talus slope before the failure, calculating the volume of debris eroded by the failing mass. The calculated entrained mass is 110,800 m³ (Table 3), which corresponds to 35% of the total mobilised material. However, it is likely that the volume entrained was higher, since the visual estimations from the pictures taken a few days after the occurrence of the landslide reveal that the channel was more deeply incised than when the LiDAR data were collected—by at least 1 m on average. This leads to an estimate of roughly 10,000 m³ extra volume, considering the lower part of the channel where most of the material was eroded.

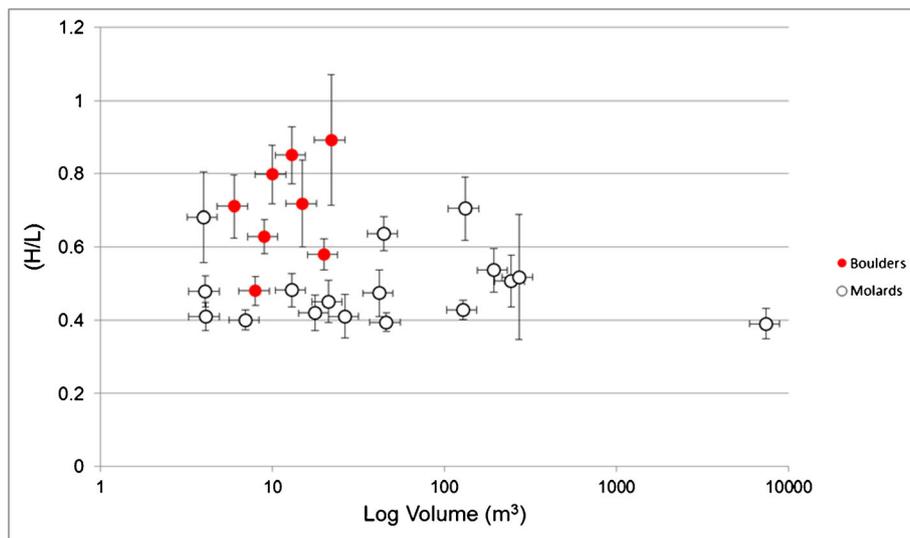
Fig. 16 Semi-logarithmic plot of block and molards volume (m^3) versus the tangent of reach angle (H/L). The vertical error bar is the propagation of errors of L (whose error is the standard deviation of the length of the various potential energy lines of fall) and H (whose error is the thickness of the bedrock cliff for boulders and the thickness of the deposits perched on the topographic bench for the molards in correspondence of the centreline path of fall). The horizontal error bar is calculated using an accuracy of 25% according to Conway and Balme (2014) for molards and is calculated arbitrarily using an accuracy of 20% of field and plan-view measurements for boulders

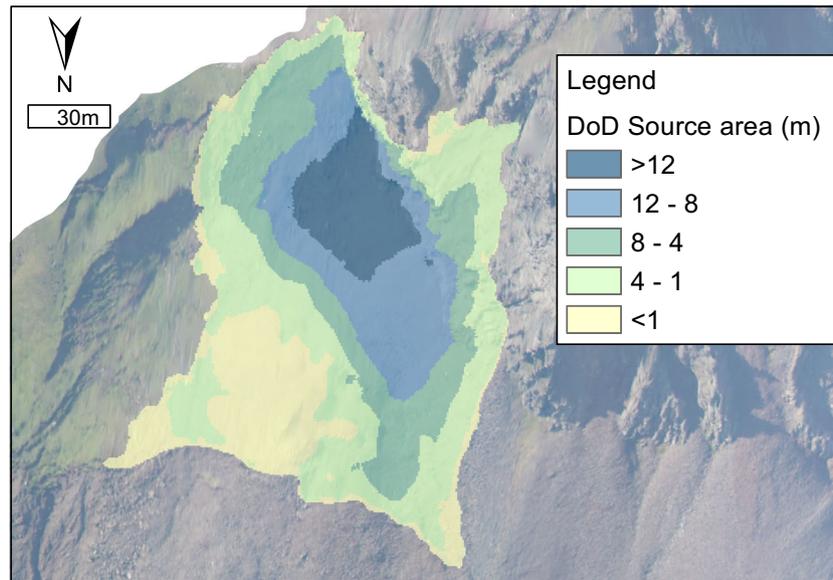
Fig. 17 DEM of difference (DoD) between the post-failure topography (18 cm gridded DEM from ground-based SfM from 2016) and the reconstructed pre-failure topography of the source area of the Árnesfjall landslide

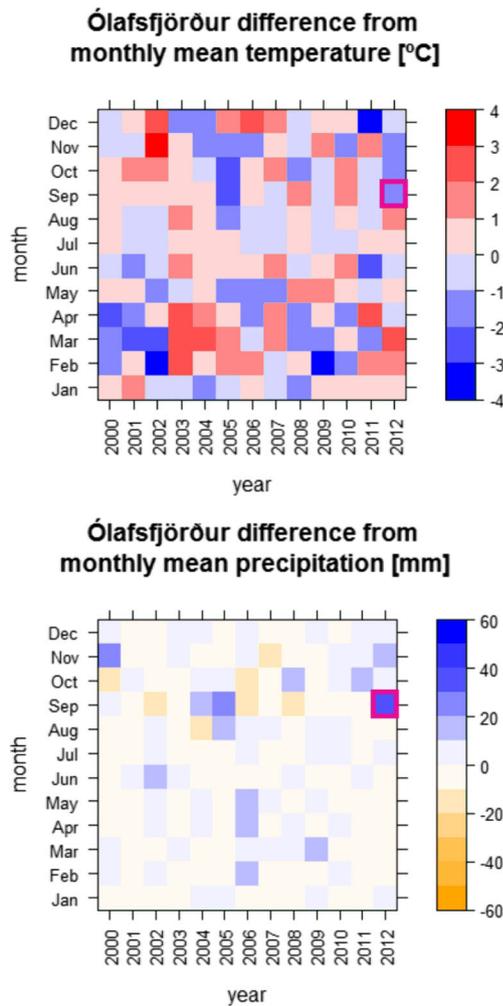
Fig. 18 Matrix plots of the difference between the average monthly temperature (top) and precipitation (bottom) and the average value for that month for the period 2000–2012 for the Ólafsfjörður station (data supplied by the IMO in 2016). The pink squares mark the month of the occurrence of the Móafellshyrna event. Modified after Sæmundsson et al. (2018)

Ólafsfjörður weather stations since 23rd July, which corresponds to 40–45% of the mean annual precipitation from 2000 to 2012 (Fig. 18). September was the month with maximum precipitation for any given year for the period 2000–2012, with a range between 70 and 250 mm.

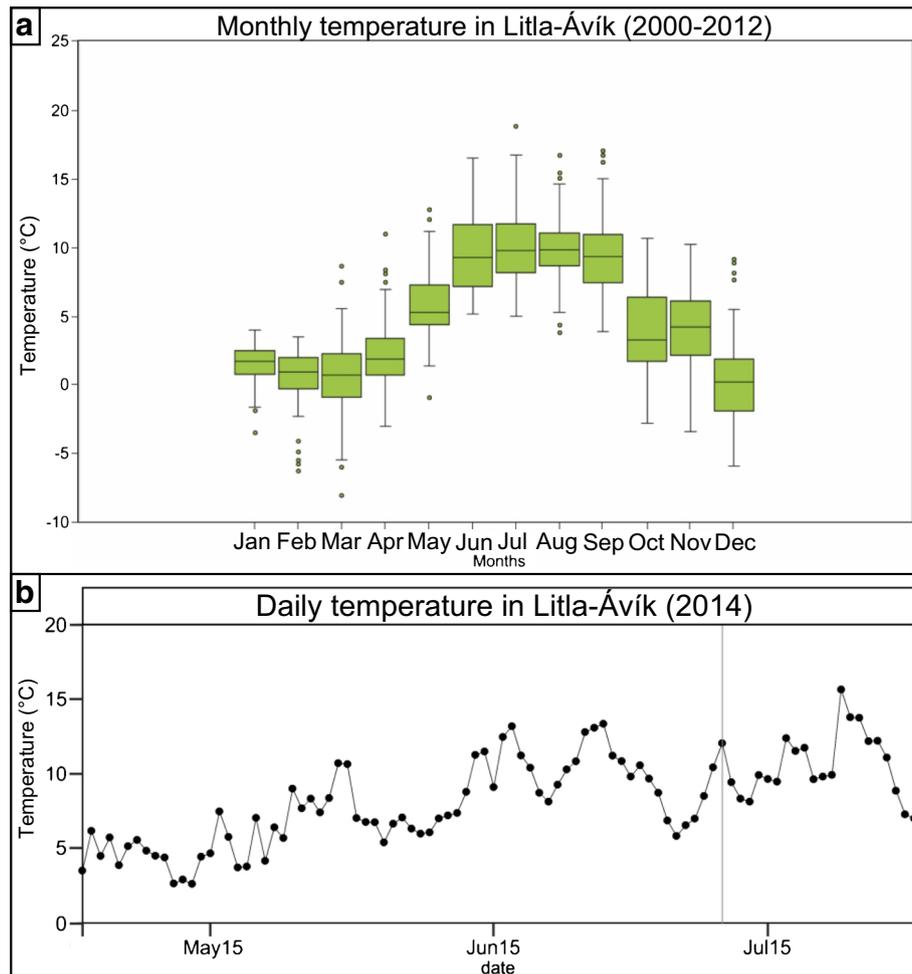
Fig. 19 Temperature data at Litla-Ávík. a A boxplot of the temperature data from the Litla-Ávík station for each month between the years 2000 to 2012 (data supplied by the IMO in 2018). The end of the lines is where the max and min values of temperature were measured for each month, excluding the outliers that are displayed as dots (outliers are defined as values which lie outside 1.5 times the interquartile range above the upper quartile and below the lower quartile). The green boxes are where the 50% of accumulated measured precipitation falls and the black lines are the medians of each month. b Daily temperature data from the Litla-Ávík (LTAV) weather station for the months of May, June and July 2014 (data supplied by the IMO in 2018). The vertical bar is the date of the Árnesfjall event

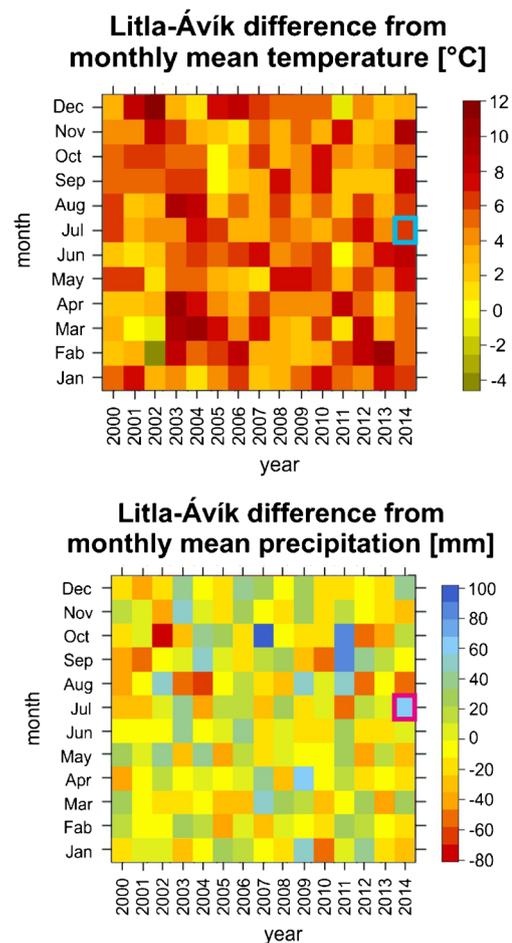
Fig. 20 Matrix plots of the difference between the average monthly temperature (top) and precipitation (bottom) and the average value for that month for the period 2000–2014 for the Litla-Ávík station (data supplied by the IMO in 2018). The blue and pink square marks the month of the occurrence of the Árnesfjall event

The spring months preceding the Árnesfjall event were dry (Fig. 20). From May to 30th June 2014, dry conditions prevailed in Litla-Ávík. Ten days before the occurrence of the failure, almost 90 mm of rain fell in the area close by the Árnesfjall mountain, of which 62 mm were recorded between 4th and 6th July (Fig. 21). From the beginning of May to 9th July, the cumulative precipitation in Litla-Ávík was 140 mm (Fig. 21). July was the month with the maximum precipitation registered for the year 2014 (Fig. 20), with the peak recorded in the 10 days before the landslide (Fig. 21). The station of Litla-Ávík is positioned on the west-south-western side of the Reykjanesfjall mountain, and most of the precipitation-carrying winds are north-north-easterly winds (Jónsson et al. 2004), so the orographic part of the precipitation is probably missing for this station, but it would not have been missing at Árnesfjall.

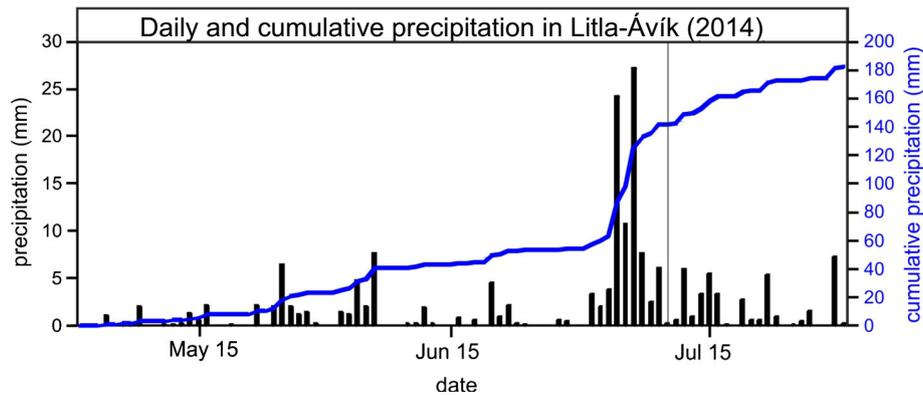
Fig. 21 Daily precipitation (black bars) and cumulative precipitation (blue lines) for precipitation measurements from the Litla-Ávík weather station for the months of May, June and July 2014 (data obtained from IMO in 2018). The vertical bar is the date of the Árnesfjall event

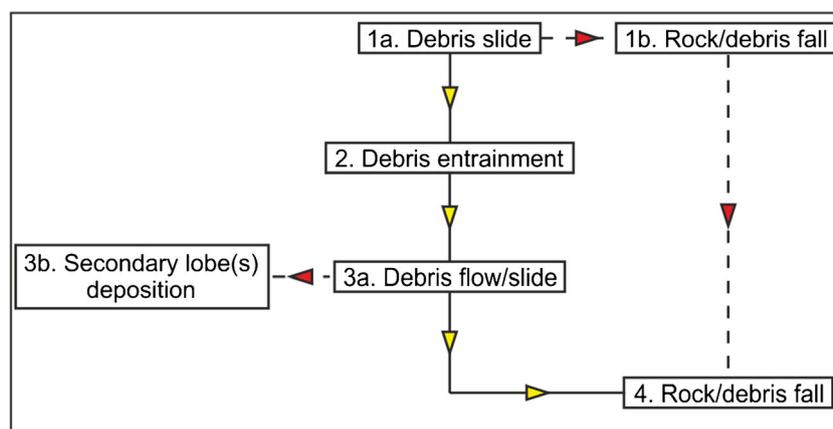
Fig. 22 Flow chart summarising the different processes that occurred during the Móafellshyrna landslide. The arrows in yellow indicate continuous and consecutive processes, while the dashed red arrows indicate intermittent and/or non-consecutive processes. Time goes from top to bottom of the diagram

Detailed morphological analysis of the 2012 Móafellshyrna landslide allowed us to infer the emplacement mechanisms. These give important information regarding the initiation, transport, deposition and evolution of the mass movement. We infer that the Móafellshyrna landslide evolved through three different types of dynamics: (i) bedrock constrained rotational debris slide, (ii) rock/debris fall and (iii) debris flow/slide (Fig. 22). The initial movement

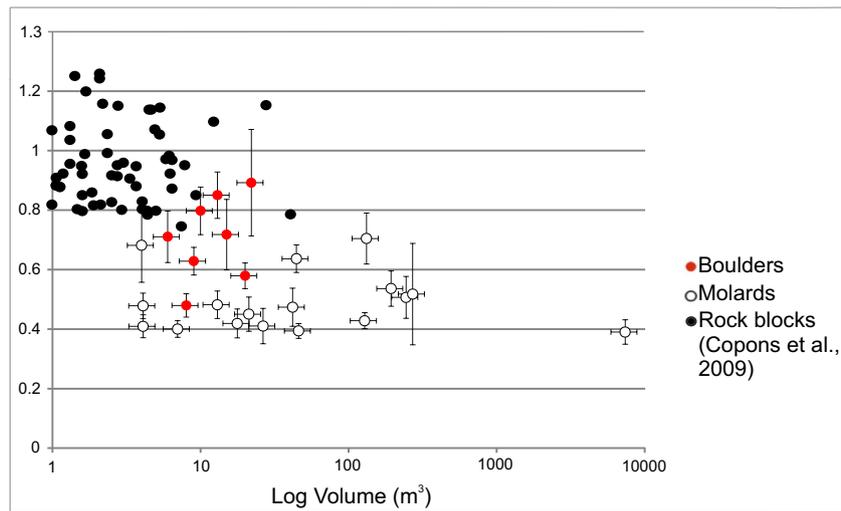
Fig. 23 Semilogarithmic plot of volume (m^3) versus reach angle for the molards and boulders of Móafellshyrna landslide (error bars are the same for Fig. 16) and reach angle of individual rock blocks from Copons et al. (2009).

Spain, where Copons et al. (2009) found that the rock fall size has a strong influence on the travel distance also for block size $< 10^5$ m³ (Fig. 23). Copons et al. (2009) plotted individual block volumes and the farthest boulders found at the study area, since they represent the largest volumes and largest travel distances from past rock falls at the same site. They found a negative relationship between block volume and the reach angle ratio value. Both boulders and molards in Móafellshyrna have high mobility, but consistent with the mobility of ‘normal’ rock-fall boulders analysed by Copons et al. (2009). In the case of molards, their higher mobility could also be partially attributed to a ‘compound’ transport mechanism, as it is possible that, once fallen, they landed on the still mobile landslide debris material. They might then have been rafted on the surface of a viscous flow (as shown by the compressional ridges) and transported to greater distances.
