## **Green Roof performance in sub-arctic climates: water quality and vegetation survival on a green roof in northern Sweden**

Anna Magnusson, Maria Viklander, Godecke-Tobias Blecken

Urban Water Engineering, Department of Civil, Environmental and Natural Resources Engineering, Luleå University of Technology, 971 87 Luleå, Sweden; annmag@ltu.se; marvik@ltu.se; godble@ltu.se

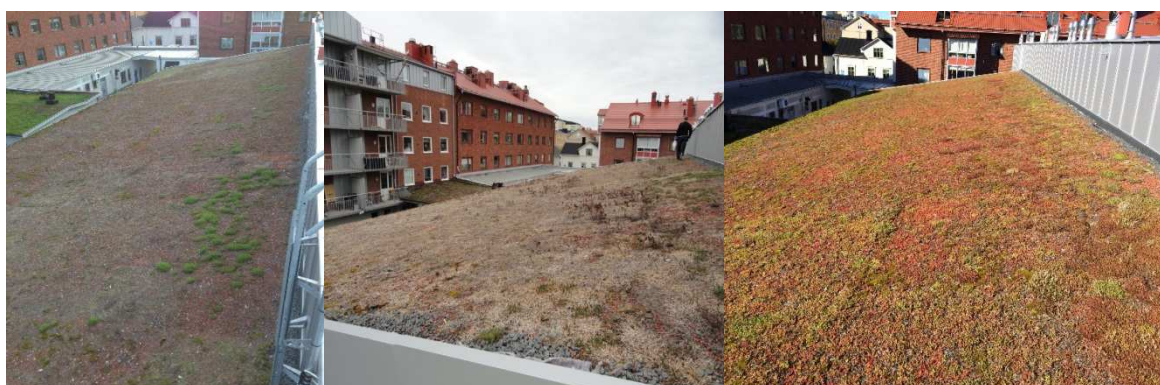
Figure 1: View of the same roof section. Left: end of May 2014, middle: early September 2014, right: early September 2015.

The visual inspections in both 2014 and 2015 revealed that only a few of these species (mainly *Sedum acre* and occasional plants of *Sedum album*) had survived on the roof in Luleå (Figures 1 and 2). *Sedum acre* is native to\*\* northern Sweden, (inter alia) in the Luleå archipelago. When laid, the turf had almost complete vegetation cover, but by August 2014 there was only about 20-30% cover, with an increase to 35-40% cover in August 2015, based on the images, (figure 1-3).

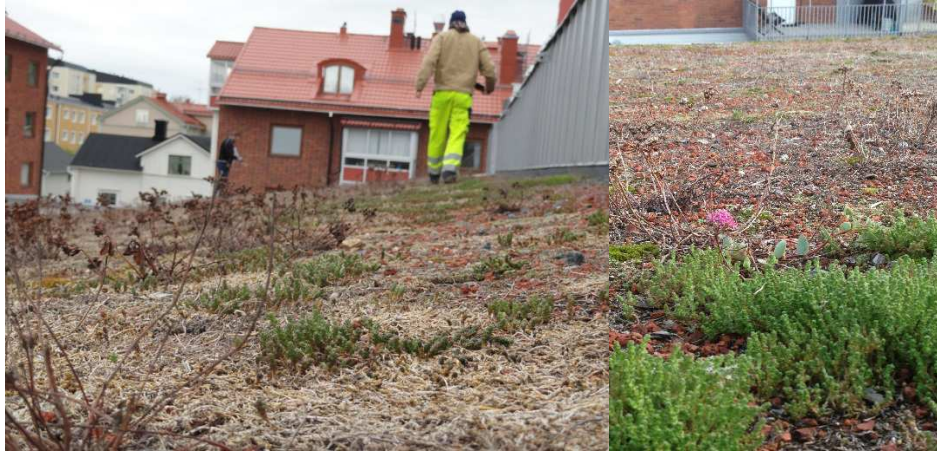
Figure 2: Detail of vegetation at the end of May 2014.

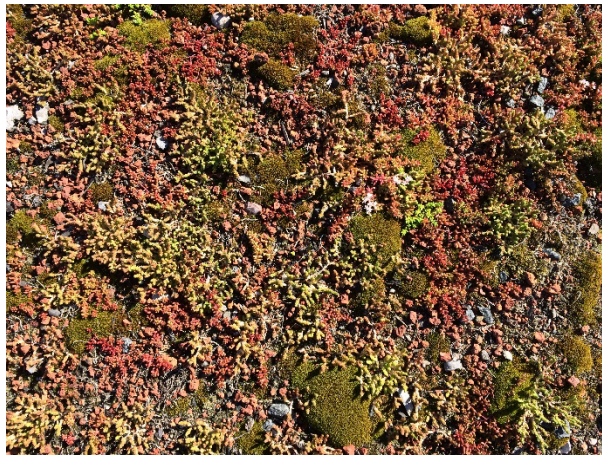
Figure 3: Detail of vegetation in September 2015.
