Analysis of differential heaving distress in soil-structure interactions due to degradation of founding soil by chemical contaminations

Present paper deals with a case study of distressed Reinforced Concrete Structure (RCC) founding on the soil contaminated with caustic liquor resulting from the process of manufacturing of Alumina (Hidalco Industries Limited in India 2017). For sake of brevity, chemical reactions and morphological process of swelling induces in soils have not been reported here.

A RCC tertiary thickener structure (figure 1) of Alumina plant rests on concentric columns got distress features in the form of upheaval of footings after four year of commissioning. The concrete and soil in the foundation area got contaminated with caustic liquor resulting in to the expansion of materials near to the foundation and creating differential heaving distress in the foundation and columns. This paper also deals the remedial measures and a methodology to make the structure stable and durable.

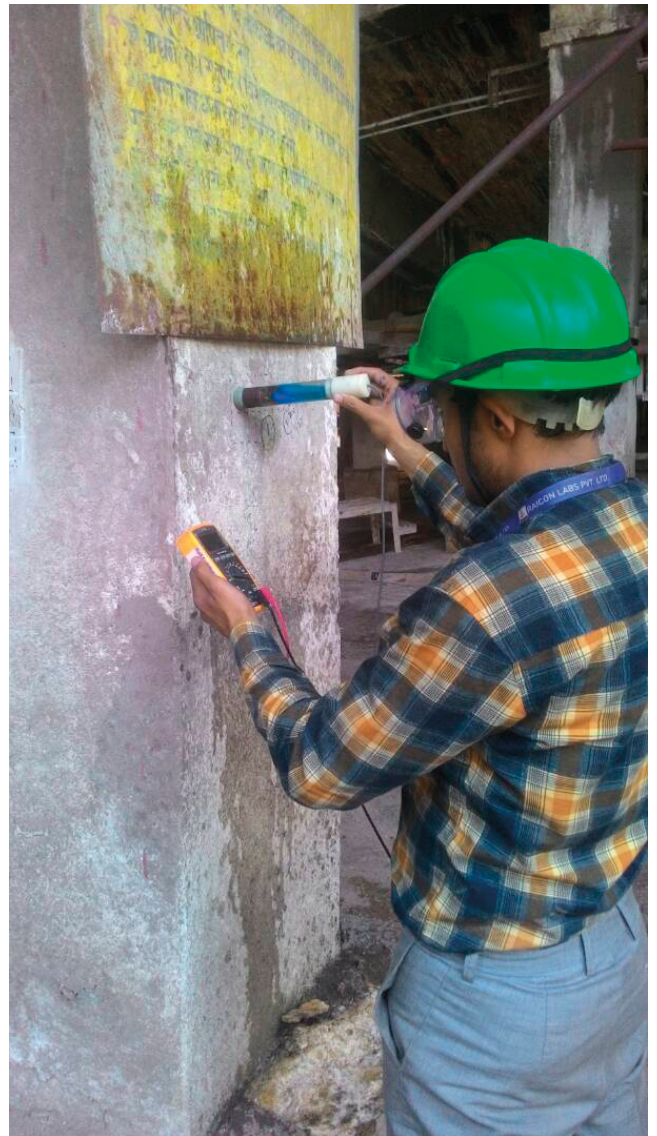
Half Cell Potential Test (figure 3) gives the extent of corrosion of the reinforcing steel in the concrete structure. It works on the potentials measures with the help of props at the two location on the surface of the concrete. If potentials over an area are more positive than -200 mV Copper Sulphate Electrode (CSE), there is a greater than 90 % probability that no reinforcing steel corrosion is occurring in that area at the time of measurement. If potentials over an area are in the range of -200 to -350 mV CSE, corrosion activity of the reinforcing steel in that area is uncertain and if potentials over an area are more negative than -350 mV CSE, there is a greater than 90 % probability that reinforcing steel corrosion is occurring in that area at the time of measurement (figure 6).

Figure 3. Half Cell Potential Test
