Analysis of differential heaving distress in soil-structure interactions due to degradation of founding soil by chemical contaminations

Present paper deals with a case study of distressed Reinforced Concrete Structure (RCC) founding on the soil contaminated with caustic liquor resulting from the process of manufacturing of Alumina (Hidalco Industries Limited in India 2017). For sake of brevity, chemical reactions and morphological process of swelling induces in soils have not been reported here.

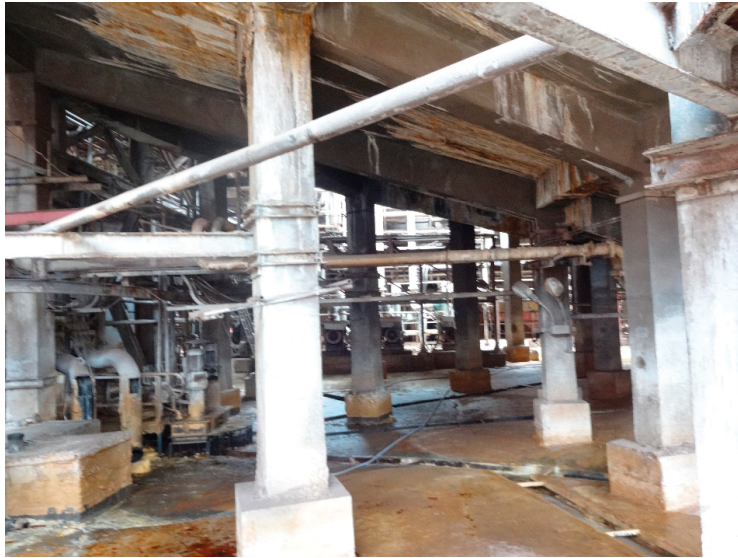
A RCC tertiary thickener structure (figure 1) of Alumina plant rests on concentric columns got distress features in the form of upheaval of footings after four year of commissioning. The concrete and soil in the foundation area got contaminated with caustic liquor resulting in to the expansion of materials near to the foundation and creating differential heaving distress in the foundation and columns. This paper also deals the remedial measures and a methodology to make the structure stable and durable.

Figure 1. A RCC tertiary thickener structure of Alumina plant rests on concentric columns

All the columns (outer three circumferential row of columns), except inner columns, should be braced at two levels (one at ground level and other at mid-level) with beams (size: 650 mm x 650 mm, Reinforcement: Top layer - 4 numbers of 20 mm diameter; Bottom layer - 4 in numbers of 20 mm diameter; Side face steel: 2 numbers of 20 mm diameter; Stirrups: 2-legged 10 mm diameter @ 150 mm centre to centre, Grade of Concrete M40 and Grade of steel: Fe500 D TMT steel) both circumferential and radial directions. The concrete cover of the columns should be chipped open at the footing level and at mid height to accommodate the longitudinal reinforcement of the beams. The chipped off surface should be cleaned thoroughly to remove any laitance and dust. Care should be taken for proper connection at the junction of brace beams and columns. Suitable bonding agent should be applied at the junction to make proper bond between fresh and old concrete. PCC pedestal of height not less than 750 mm should be cast around each column in the outer three circumferential row of columns on ground floor/slab. The pedestal (size: 1050 mm x 1050 mm) should be anchored to existing column with shear connectors (4 nos. with 12 mm dia @ 150 mm c/c) and 12 mm dia main bars.

The ground floor/slab surrounding the columns to be retrofitted properly with concrete not less than M40 to prevent the further penetration of caustic liquor in the foundation. Proper drainage system should also be provided on the ground slab. Some chemical may also be used to nullify the effect of expansive nature of liquor alumina.

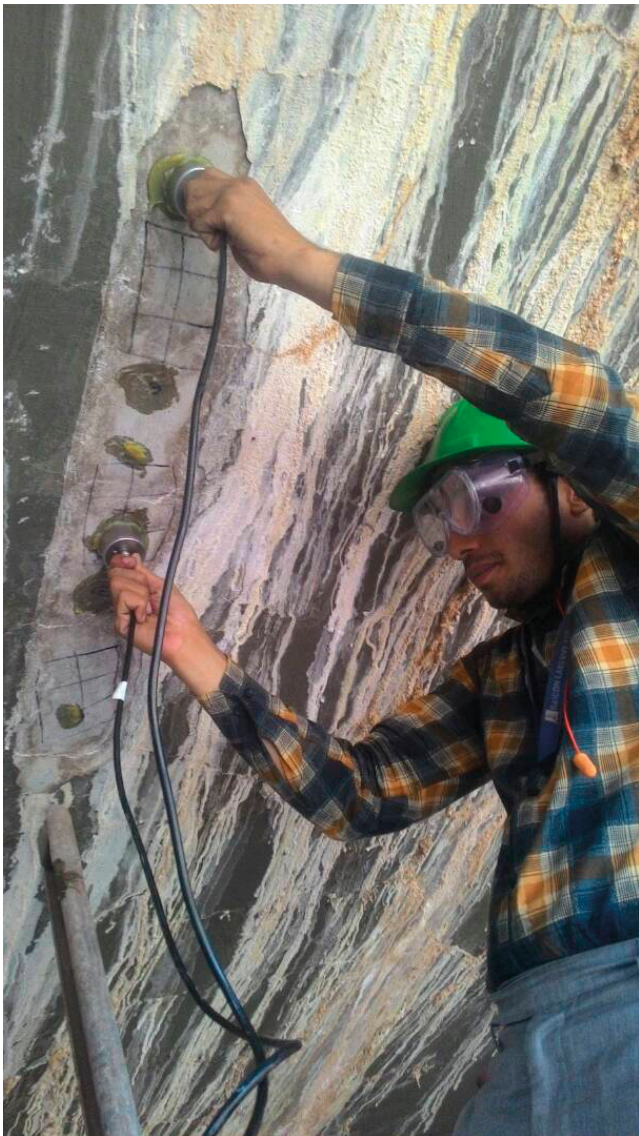
Ultrasonic pulse velocity (UPV) test gives the homogeneity of the concrete which establish the presence of cracks, voids and imperfection in the concrete. The quality of concrete depends upon the velocity of pulse, generated through UPV instrument (figure 2), passes through the body of concrete structure. If the velocity of pulse is above 4.5 km/sec, 3.5 to 4.5 km/sec, 3.0 to 3.5 km/sec and below 3.0 km/sec the quality of concrete will come in the category of excellent, good, average and doubtful category respectively (figure 4).

Figure 2. Ultrasonic pulse velocity test

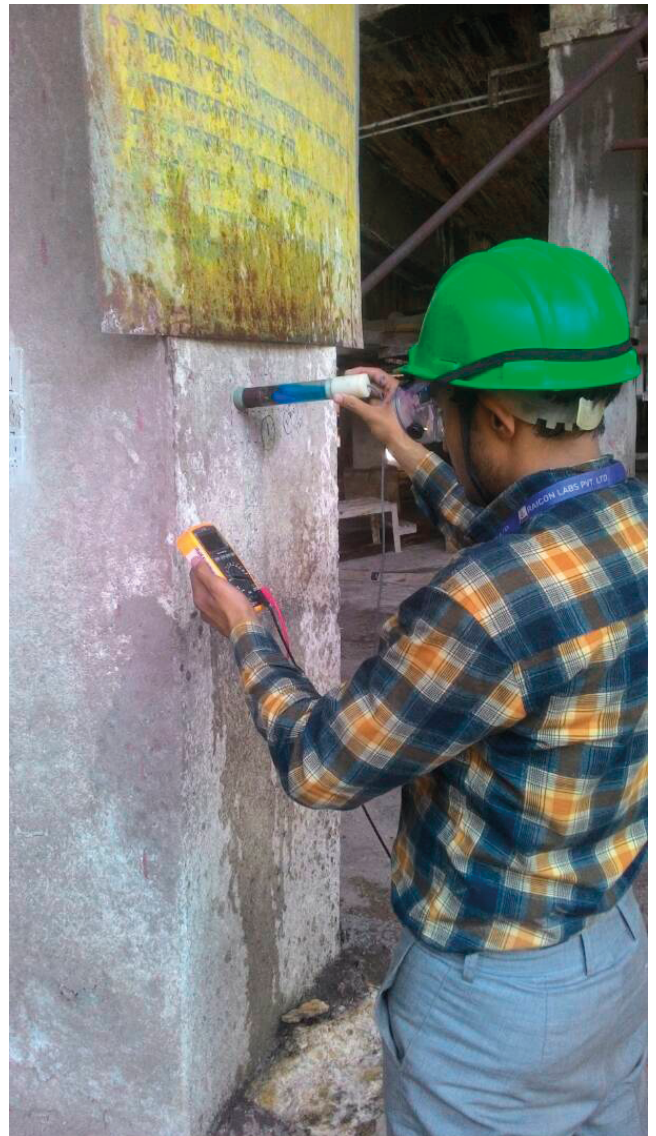
Half Cell Potential Test (figure 3) gives the extent of corrosion of the reinforcing steel in the concrete structure. It works on the potentials measures with the help of props at the two location on the surface of the concrete. If potentials over an area are more positive than -200 mV Copper Sulphate Electrode (CSE), there is a greater than 90 % probability that no reinforcing steel corrosion is occurring in that area at the time of measurement. If potentials over an area are in the range of -200 to -350 mV CSE, corrosion activity of the reinforcing steel in that area is uncertain and if potentials over an area are more negative than -350 mV CSE, there is a greater than 90 % probability that reinforcing steel corrosion is occurring in that area at the time of measurement (figure 6).

Figure 3. Half Cell Potential Test

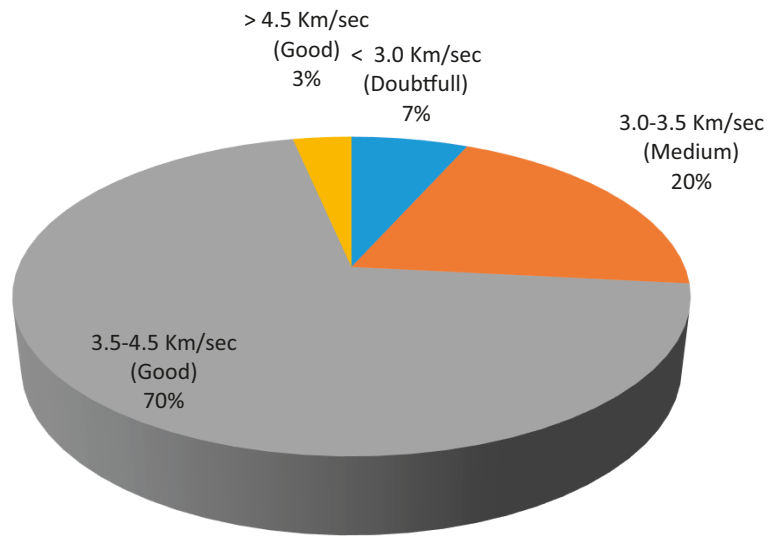
Figure 4. Ultrasonic Pulse Velocity test results for concrete

Ultrasonic test shows most of the concrete in sound condition with no honeycombing and 73 % falls in good category. Some sections are under medium quality, very few under doubtful which needs to be repaired with suitable material.

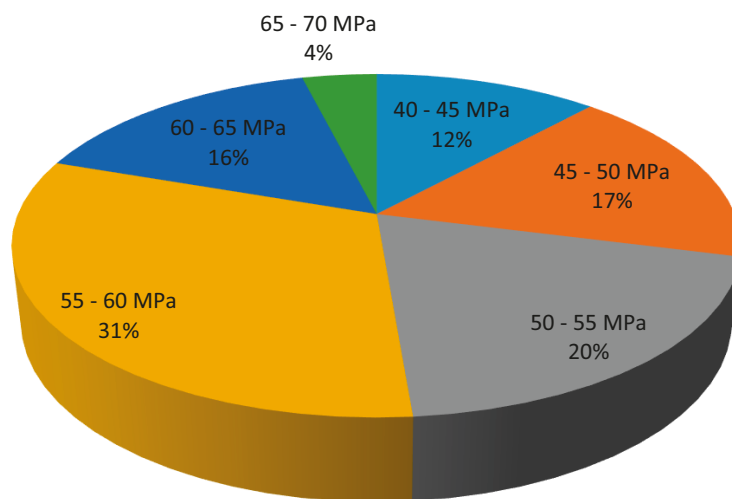
Rebound hammer test assess the compressive strength of concrete with the help of co-relation between rebound index and compressive strength. It works when the plunger of rebound hammer is pressed against the surface of the concrete. The spring controlled mass rebounds and extant of such rebound depends upon the surface hardness of concrete. The rebound is read off along a graduated scale and is designated as the 'Rebound Number' or 'Rebound Index' (figure 5). The probable accuracy of concrete strength in a structure is $\pm 25\%$.

Figure 5. Rebound Hammer test results

From rebound hammer test it has been observed that the compressive strength is good and found around M-50 grade with 84 % reading above 45 MPa.
