Seismic damage evaluation and decisions on interventions supported by UAV-based surveys

Valeria Croce, Dimitris Diamantidis, Miroslav Sýkora

Valeria Croce, Dimitris Diamantidis, Miroslav Sýkora. Seismic damage evaluation and decisions on interventions supported by UAV-based surveys. PROHITECH 2020, 4th International Conference on Protection of Historical Constructions, Oct 2021, Athènes, Greece. hal-03406144

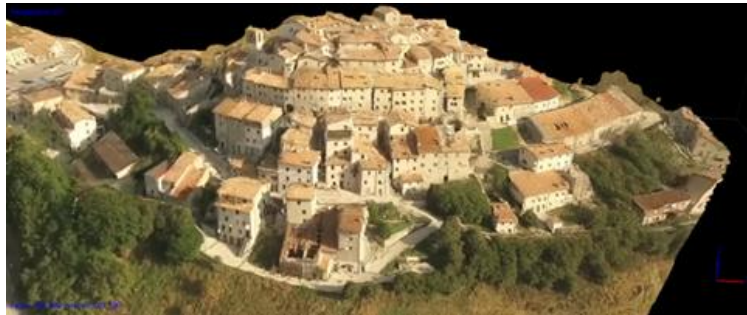
Fig. 3 3D model of the pre-earthquake phase.

5. Dense point cloud generation, mesh generation and texturing: the dense point cloud is generated, then a polygonal mesh model and a texture atlas are constructed both for pre-earthquake (Fig. 3) and post-earthquake (Fig. 4) models.

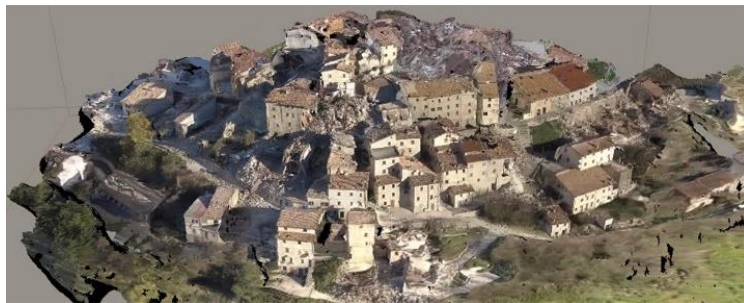
Fig. 4 3D model of the post-earthquake phase.
