## **A Geophysical Survey in Notre-Dame de Paris Cathedral: Revealing the Buried Past After the Disaster**

# A Geophysical Survey in Notre-Dame de Paris Cathedral: Revealing the Buried Past After the Disaster

**Keywords:** complex environment, electrostatic survey, GPR survey, Notre Dame de Paris Cathedral, urban archaeology.

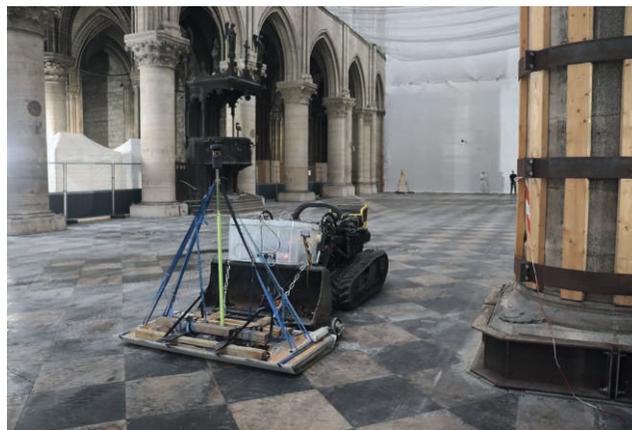
Figure 1. 3D-Radar survey with remote-controlled machine in the nave.

- A very high resolution GPR survey with a 3D-Radar step frequency multi-antenna radar (DXG1812 antenna; Fig. 1). This was carried out on the whole area to have a very detailed map of the near surface (70 cm – 1 m depth of investigation).

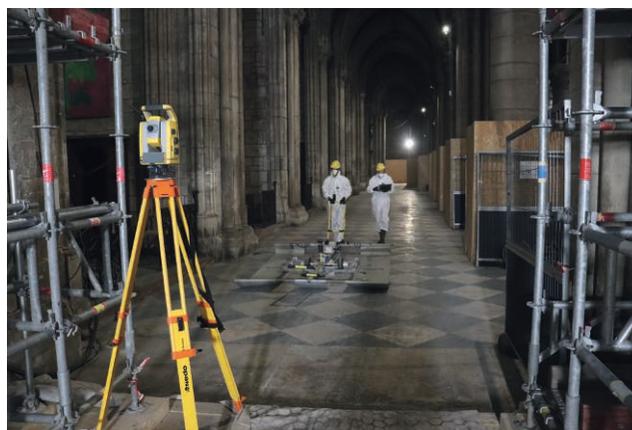
Figure 2. Electrostatic survey in the south side-aisle.

- An electrostatic survey for measuring electrical resistivity and dielectric permittivity of the soil. A MP3 prototype (Fig. 2; Flageul *et al.*, 2013) from UMR METIS (Sorbonne Université, Paris) was used with a V-shaped geometry and three different pole spacings (0.70/1.14/2 m).

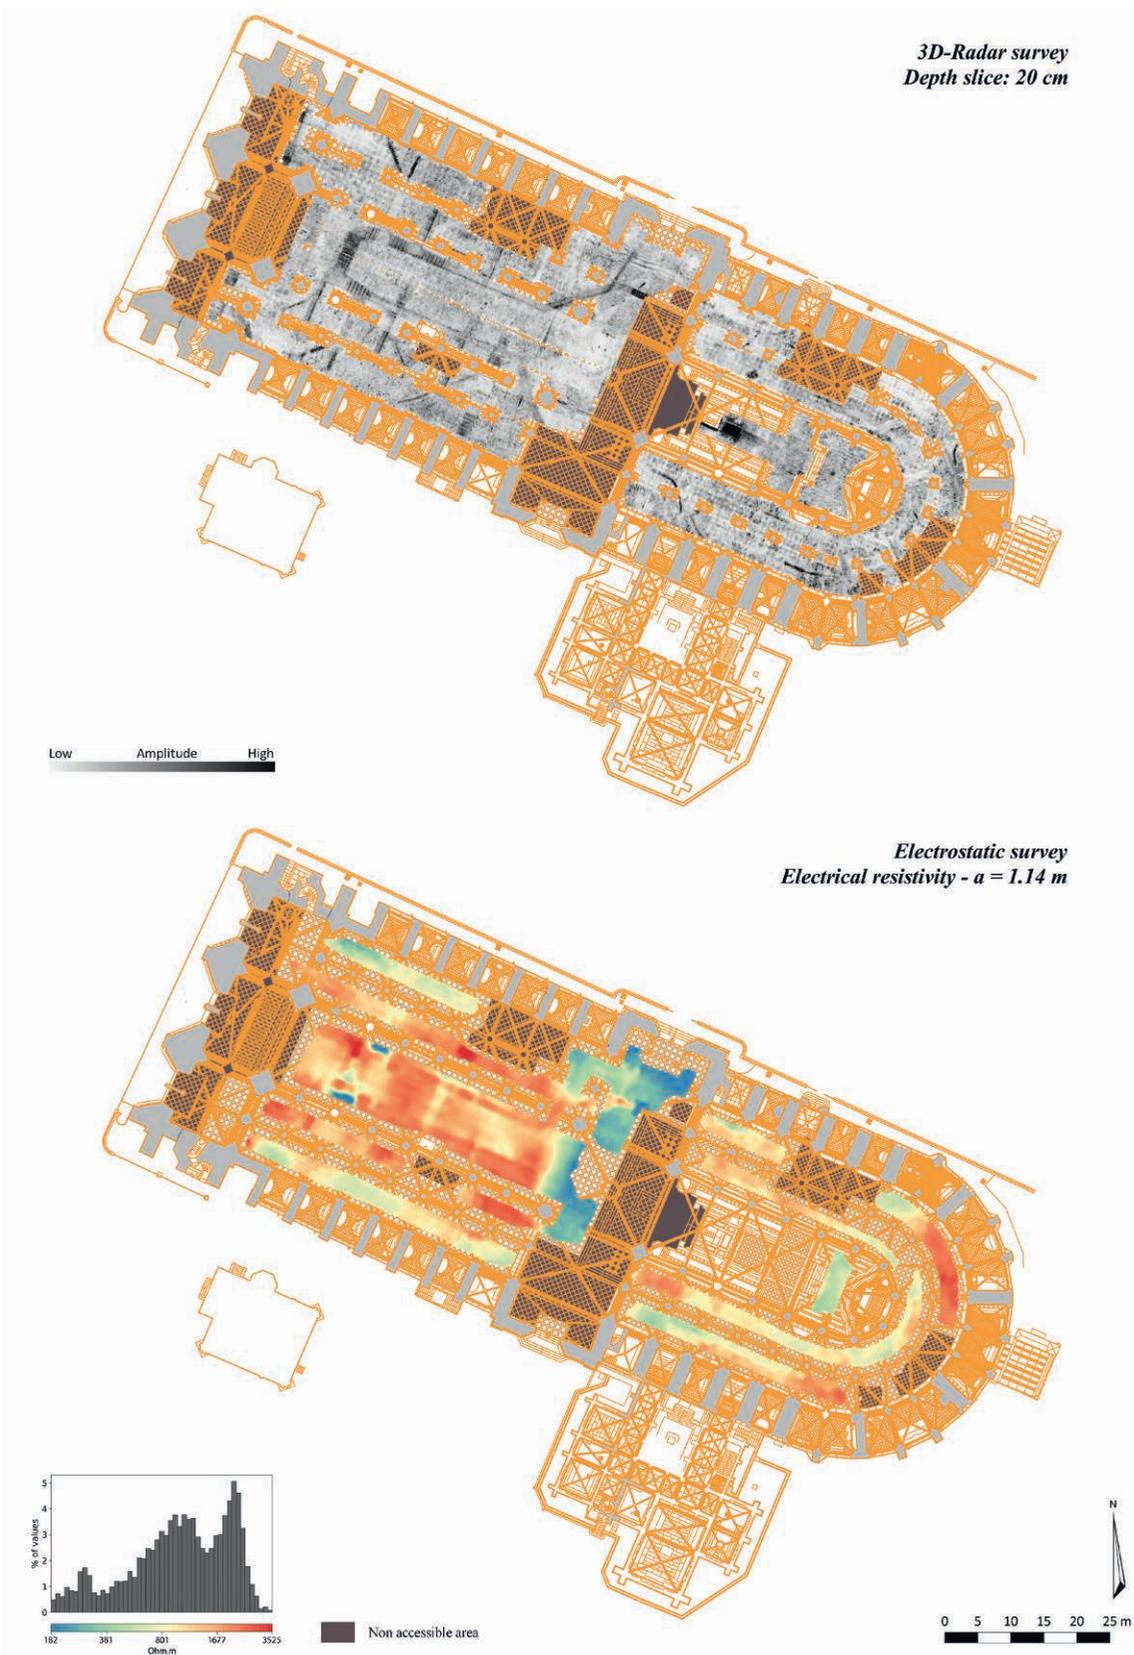
Figure 3. 3D-Radar and electrostatic maps (CAD: AGP/Inrap).

The different geophysical techniques revealed numerous anomalies (Fig. 3). This multi-device approach offered a global view of the cathedral's ground with a very good correlation. The various heating systems since the 19th century and onwards were found, as well as several sets of anomalies whose origin is undoubtedly related to the previous phases

of the building. Some of them can be clearly linked to previous excavations and an archaeological/historical analysis has begun.
