A Geophysical Survey in Notre-Dame de Paris Cathedral: Revealing the Buried Past After the Disaster

Highlights:

Keywords: complex environment, electrostatic survey, GPR survey, Notre Dame de Paris Cathedral, urban archaeology.

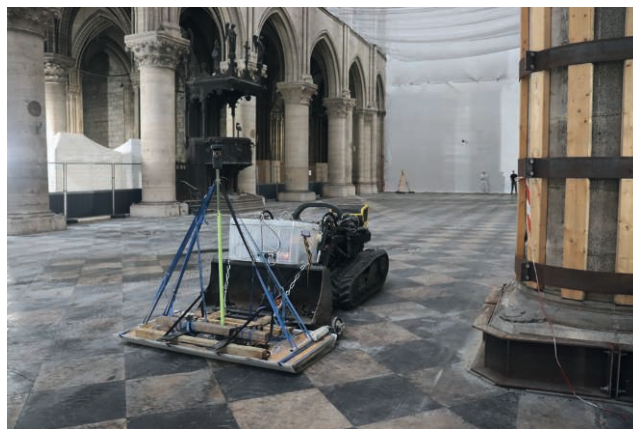
Figure 1. 3D-Radar survey with remote-controlled machine in the nave.

- A very high resolution GPR survey with a 3D-Radar step frequency multi-antenna radar (DXG1812 antenna; Fig. 1). This was carried out on the whole area to have a very detailed map of the near surface (70 cm – 1 m depth of investigation).
- A GPR survey with a GSSI 350 MHz HS antenna to investigate deeper anomalies. In some places, the depth of investigation reached up to 2.5 meters, especially in the side-aisles.
- An electrostatic survey for measuring electrical resistivity and dielectric permittivity of the soil. A MP3 prototype (Fig. 2; Flageul *et al.*, 2013) from UMR METIS (Sorbonne Université, Paris) was used with a V-shaped geometry and three different pole spacings (0.70/1.14/2 m).

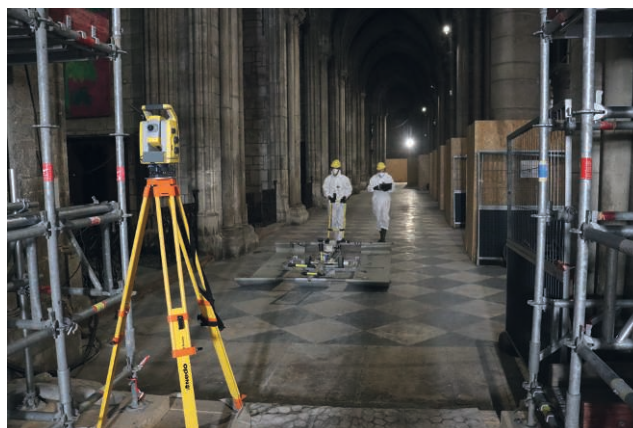
Figure 2. Electrostatic survey in the south side-aisle.

This technique gives information about the clay content of the soil and is a useful complement to GPR.

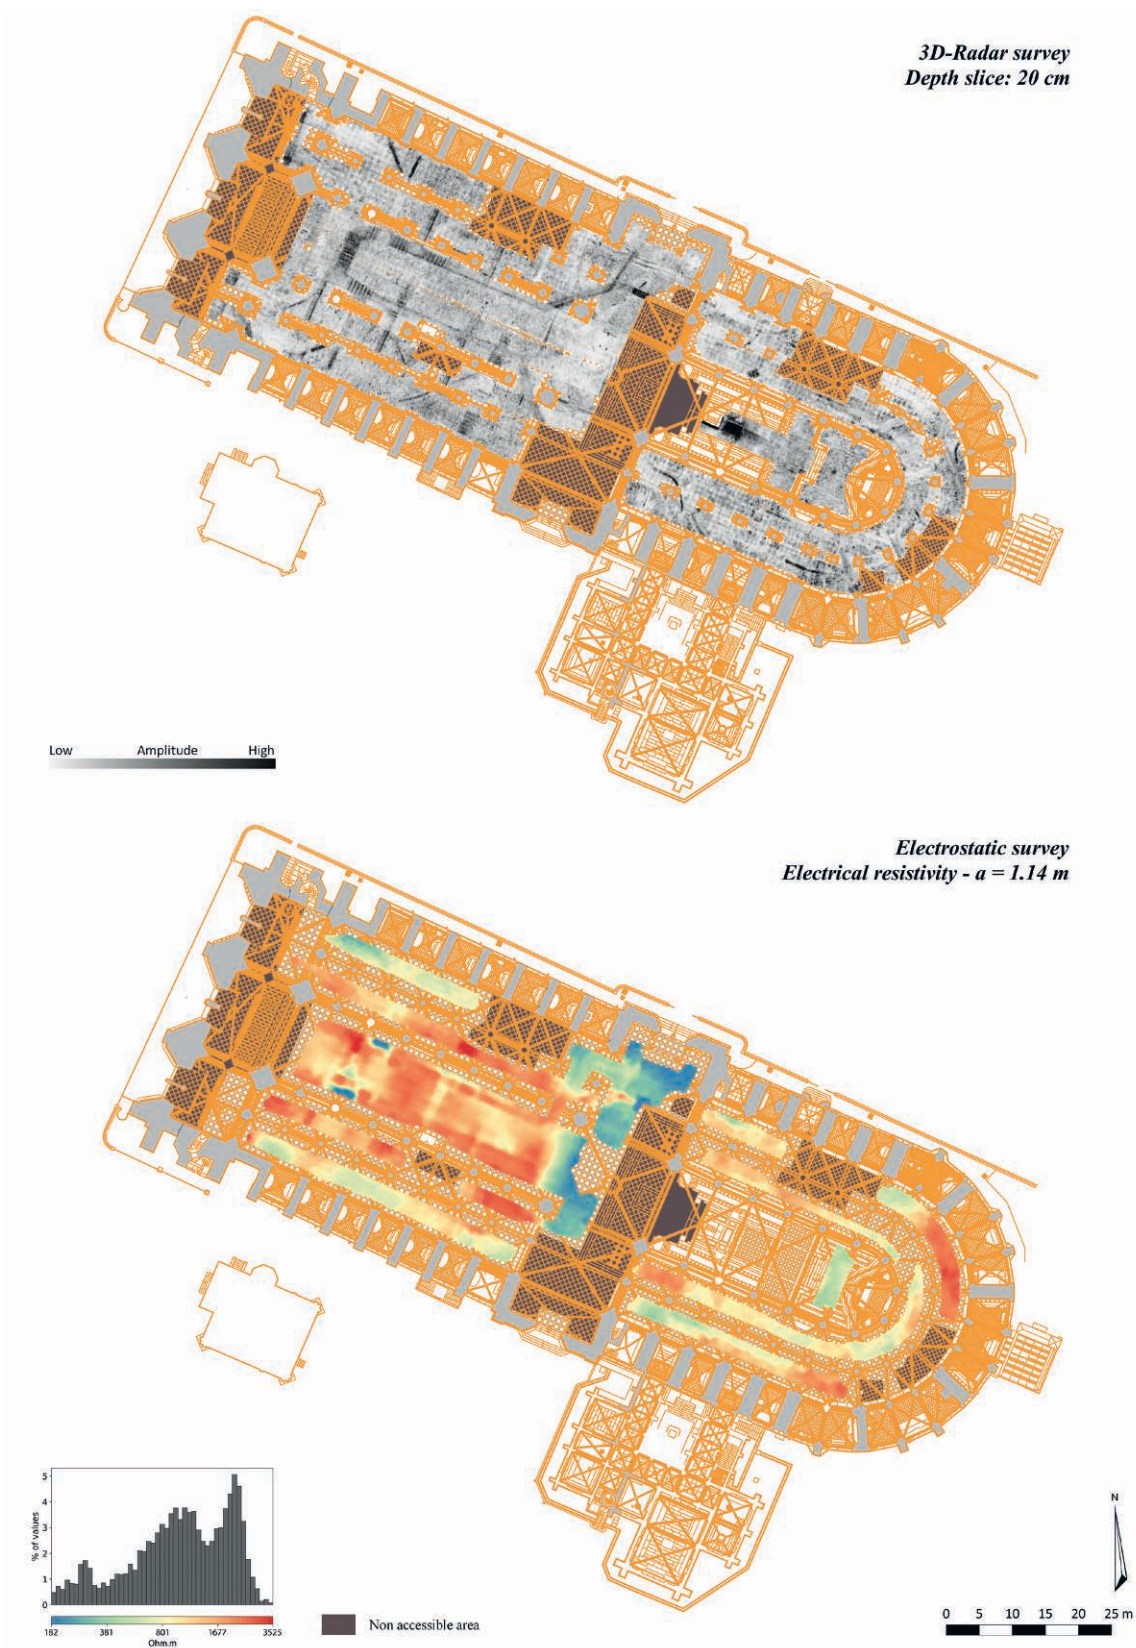
Figure 3. 3D-Radar and electrostatic maps (CAD: AGP/Inrap).

The different geophysical techniques revealed numerous anomalies (Fig. 3). This multi-device approach offered a global view of the cathedral's ground with a very good correlation. The various heating systems since the 19th century and onwards were found, as well as several sets of anomalies whose origin is undoubtedly related to the previous phases

of the building. Some of them can be clearly linked to previous excavations and an archaeological/historical analysis has begun.
