# Hydrogeological assessment of a deep-seated coastal landslide based on a multi-disciplinary approach (Villerville, Normandy)

guillaume.thirard@unicaen.fr Article published in "Geomorphology" in December 2020

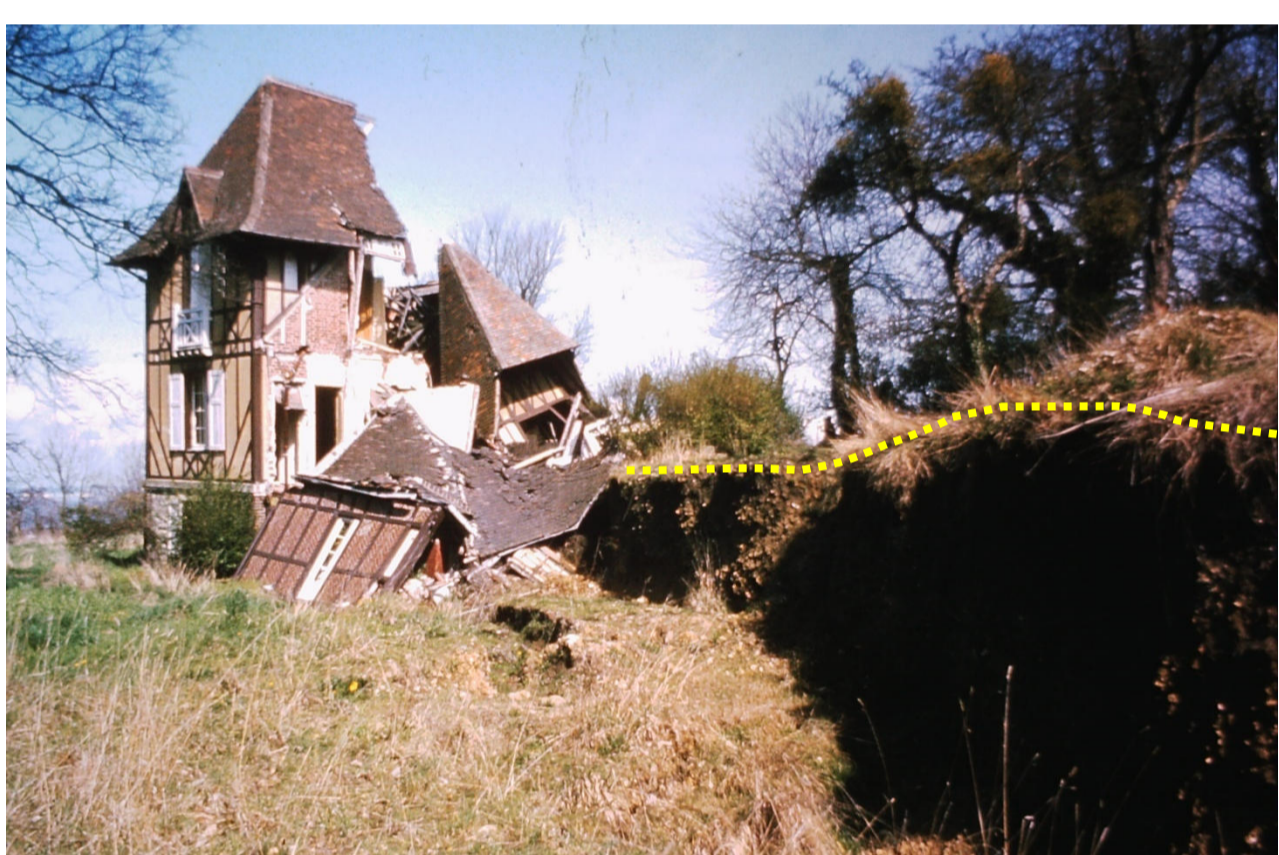
Fig. 2 - Destroyed building by the acceleration of January 1982 (Maquaire, 1985)

- A continuous spreading due to local readjustments (2 to 10 cm.yr<sup>-1</sup>);
- Intermittent accelerations (Fig. 2) with retrogressive dynamics (e.g. 1982, 1989, 1995 & 2001);
- A hydrologically-driven activity (relation rainfall-groundwater-displacements);
- Multiple water inputs (2 water tables + impluvium) and complex flows.

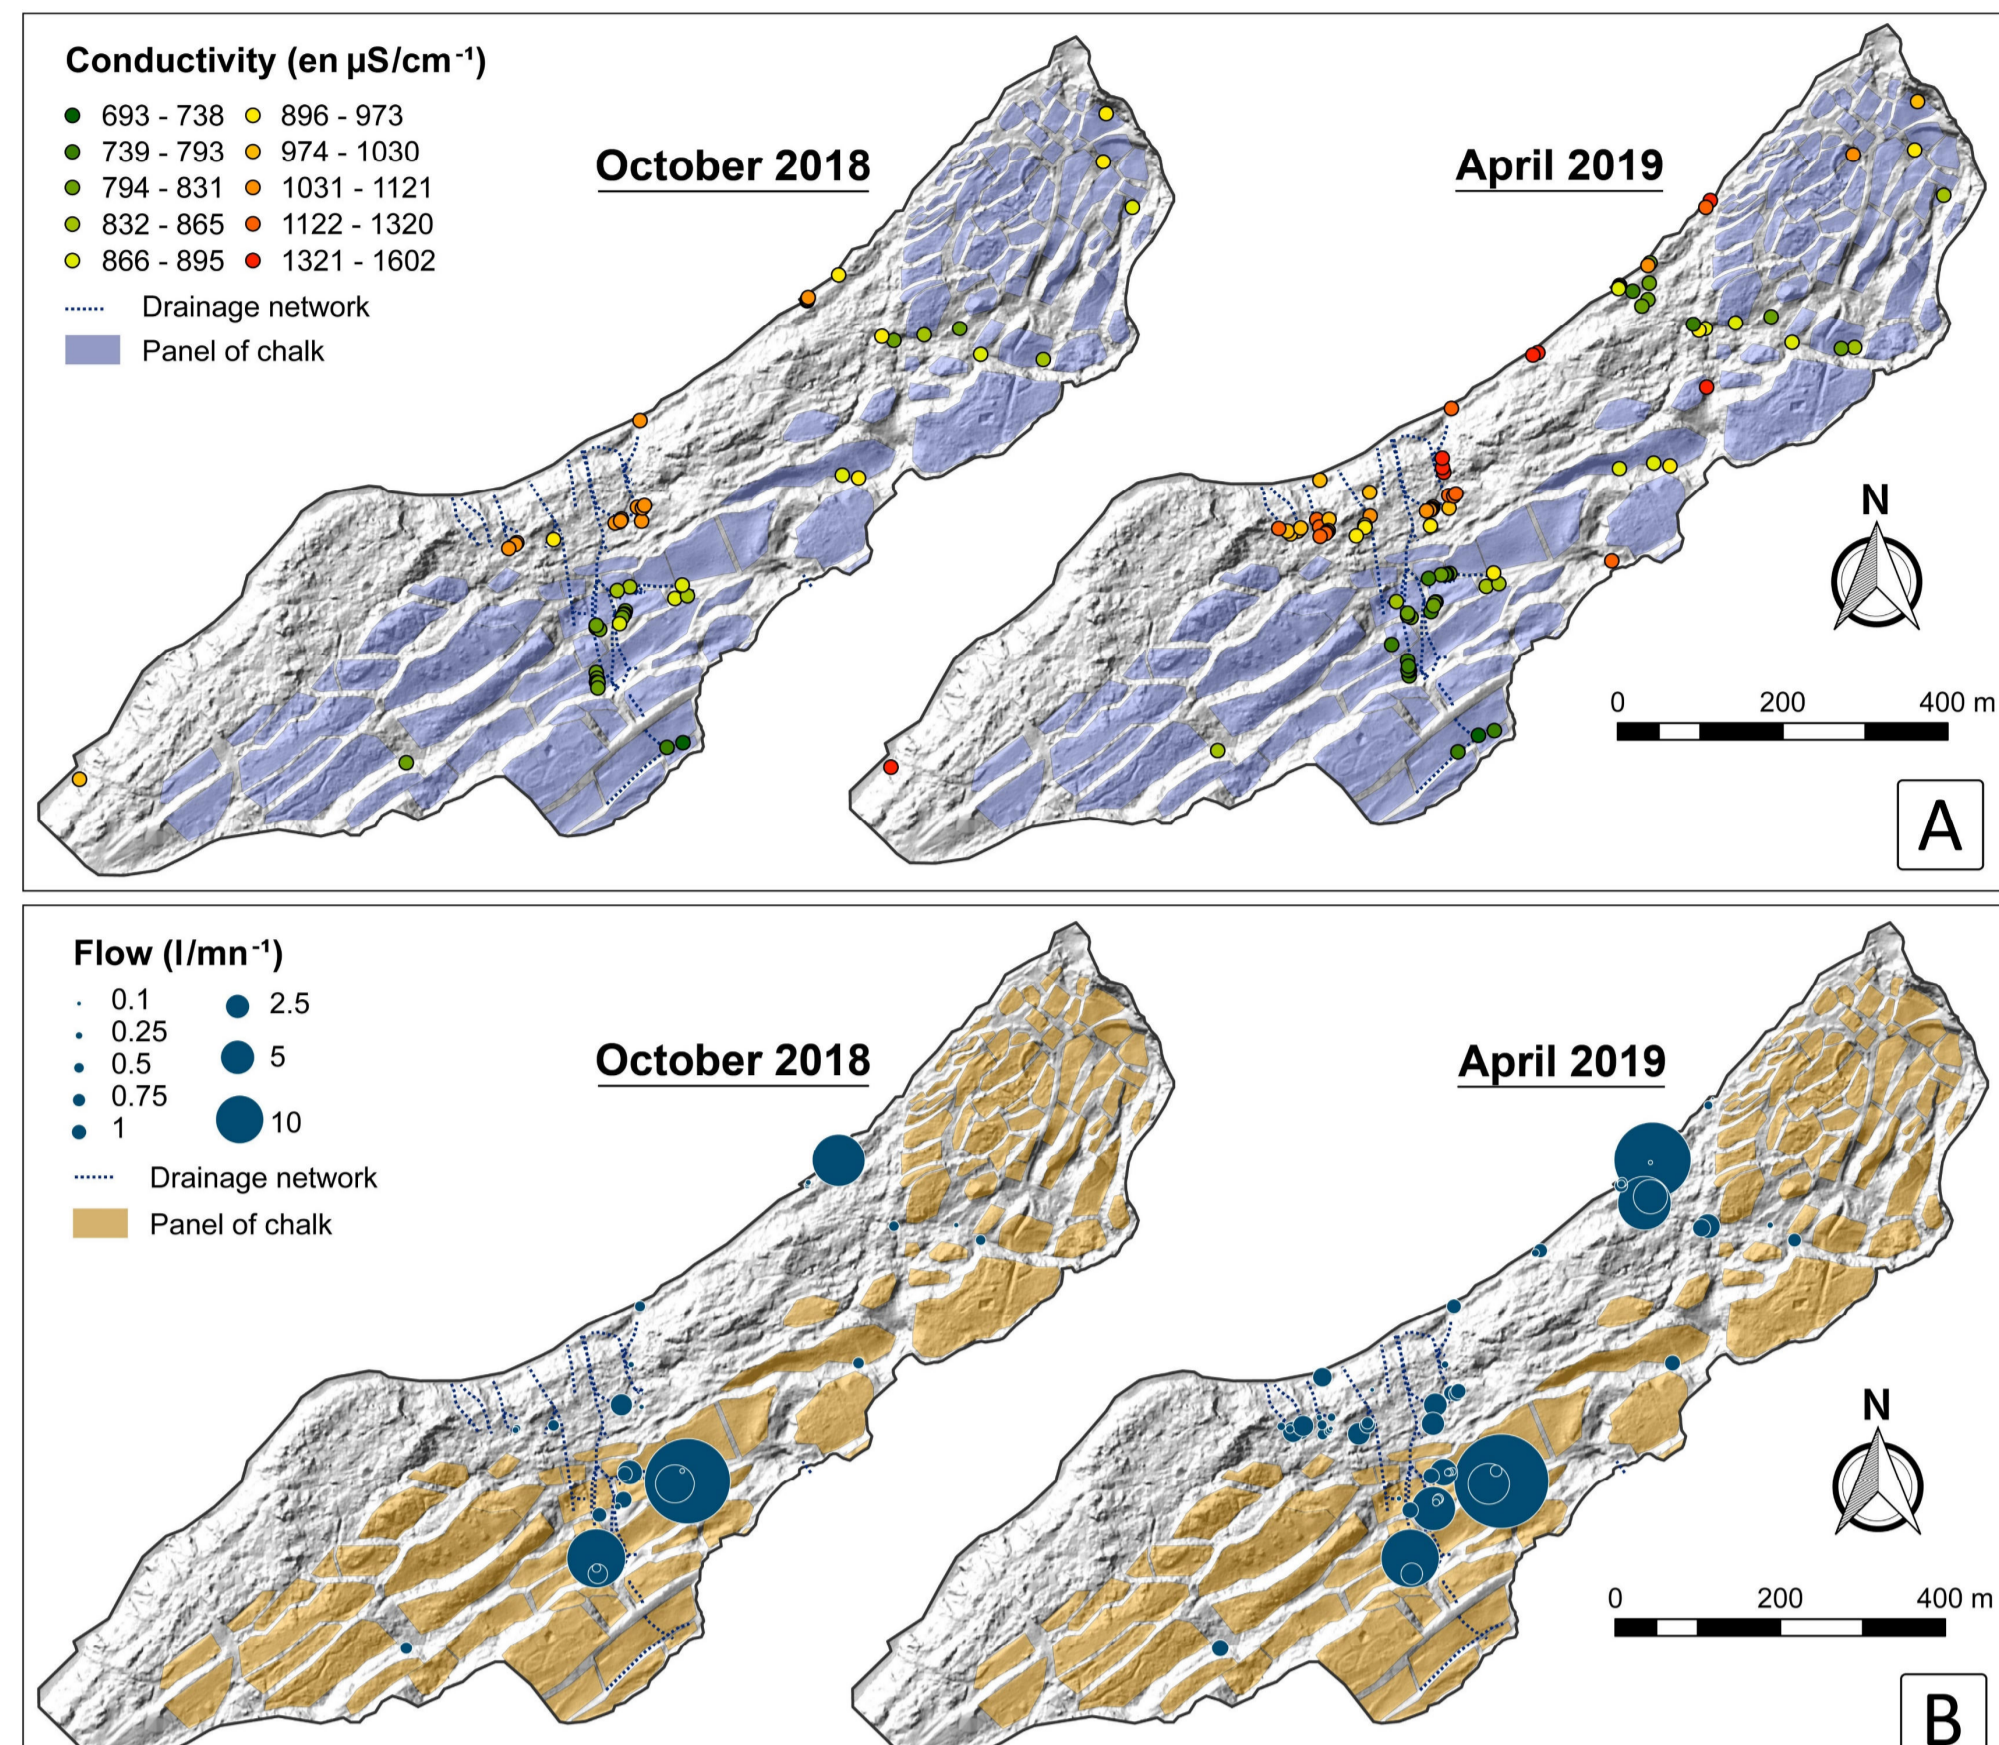
Fig. 7 - (A) Conductivity measured in springs, ponds, and drains and (B) water flow measured in natural springs at the Cirque des Graves during the field campaigns of October 2018 and April 2019

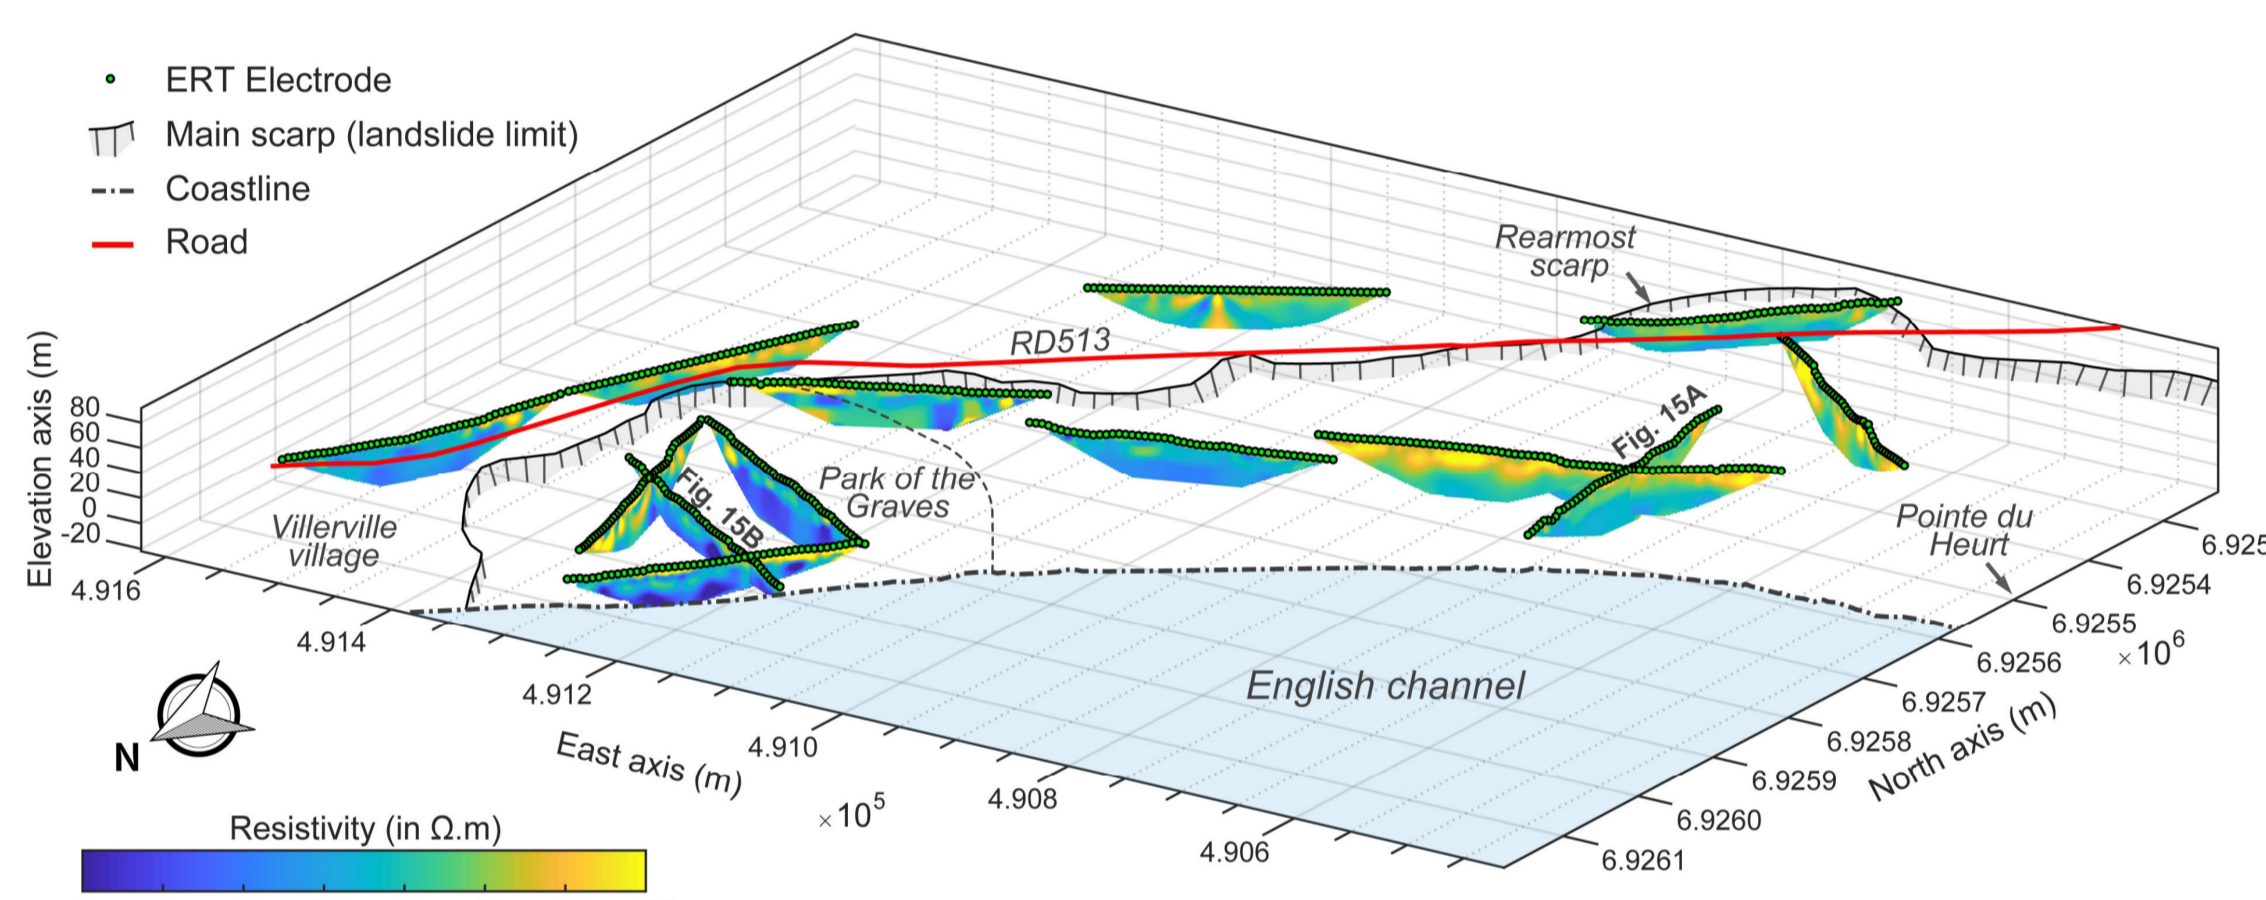
Fig. 8 - ERT (electrical resistivity tomography) profiles from the SISCA geophysical campaign (2008)

- **Resistivity decrease in the north-east direction** linked with chalk condition and topography (Fig. 8);
- **GW flow probably mixed-up in the east** (weakest ρ values = thin and weathered chalk).
