Hydrogeological assessment of a deep-seated coastal landslide based on a multi-disciplinary approach (Villerville, Normandy)

guillaume.thirard@unicaen.fr Article published in "Geomorphology" in December 2020

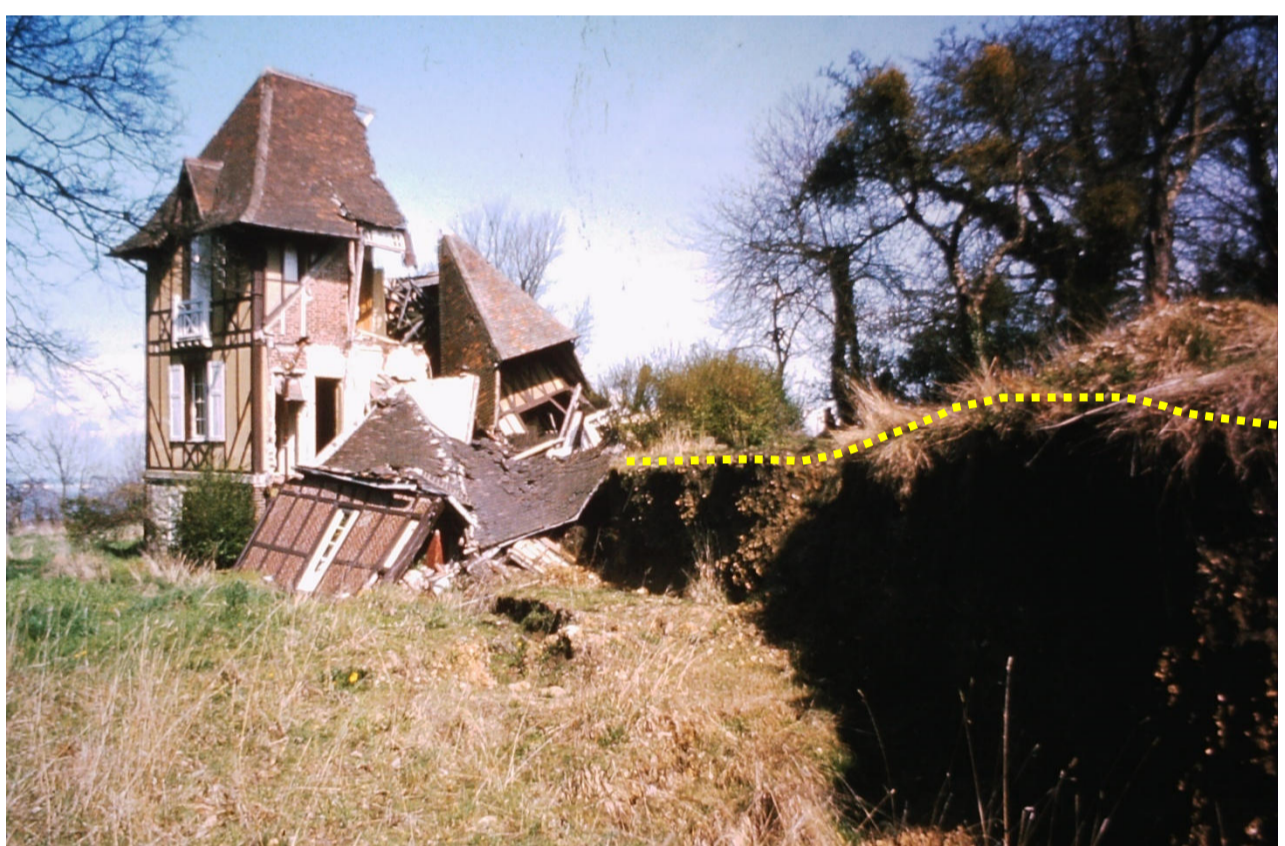
Fig. 2 - Destroyed building by the acceleration of January 1982 (Maquaire, 1985)

- A continuous spreading due to local readjustments (2 to 10 cm.yr⁻¹);
- Intermittent accelerations (Fig. 2) with retrogressive dynamics (e.g. 1982, 1989, 1995 & 2001);
- A hydrologically-driven activity (relation rainfall-groundwater-displacements);
- Multiple water inputs (2 water tables + impluvium) and complex flows.

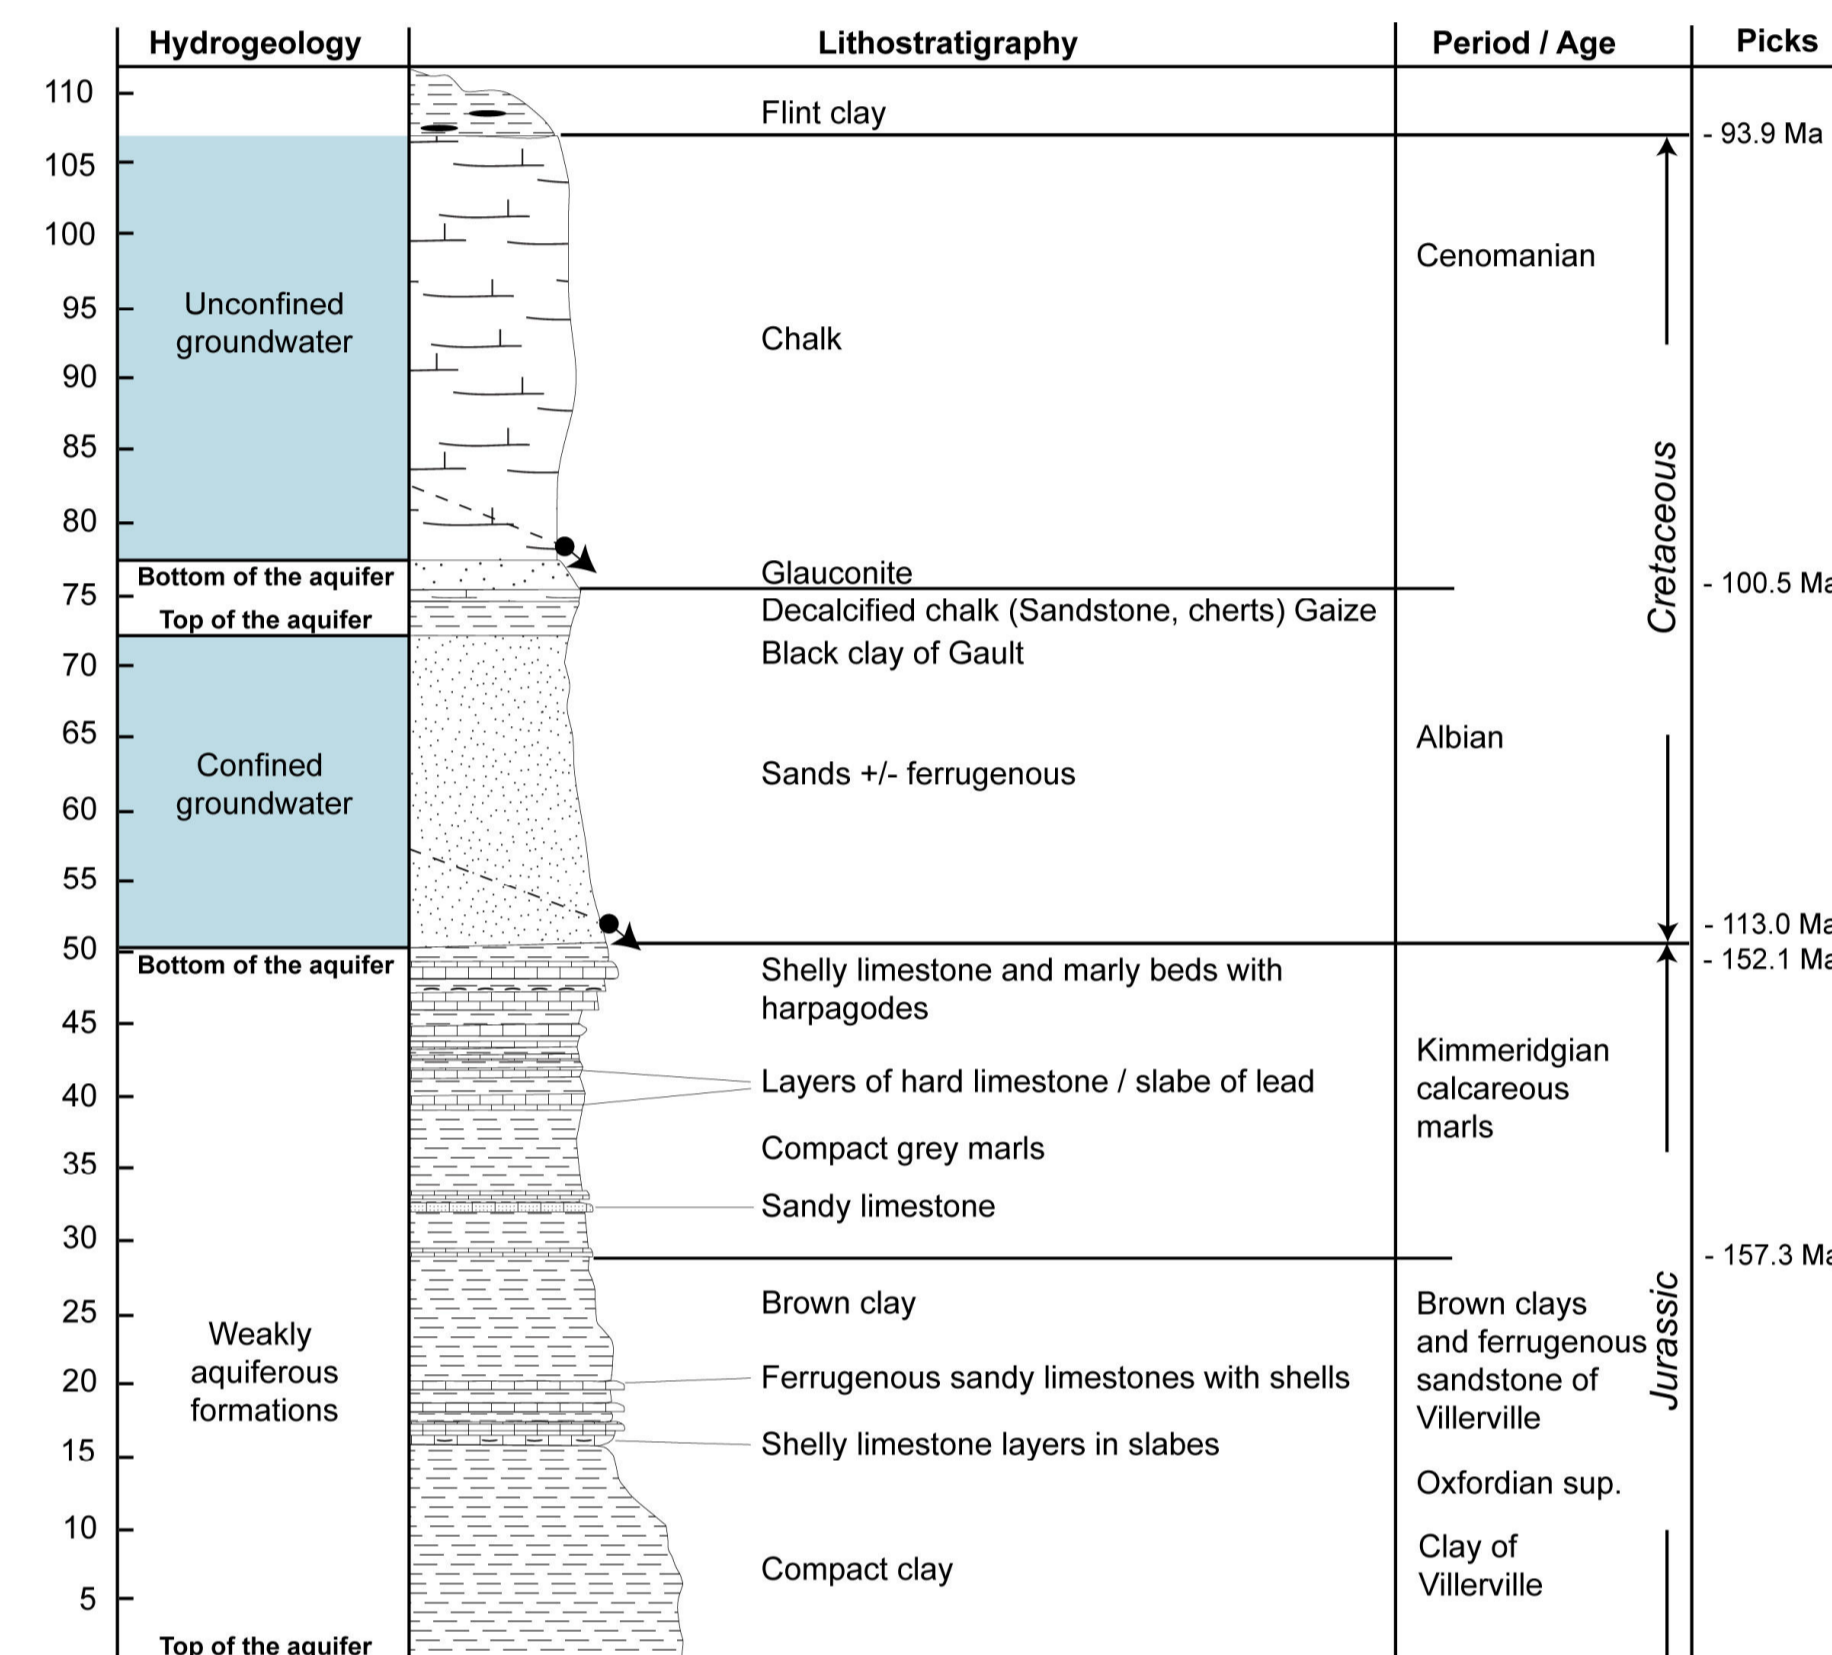
Fig. 3 - Synthetic lithostratigraphic section of the Villerville area and aquiferous characteristics (modified from Sinelle, 1989 and Lissak, 2012)

Located in the Pays d'Auge (Normandy), the Cirque des Graves is a **rotational-translational landslide** (Fig. 1) with **multiple nested slip surfaces**. It has an area of 47 hectares (450 m width x 1,600 m length). From top to bottom, the **stratigraphy is composed by 5 layers**: (i) Cenomanian chalk and glauconite; (ii) Albian clay and sands; (iii) Kimmeridgian clays & marls; (iv) Oxfordian marls; and (v) Upper-oxfordian sandstone (Fig. 3).

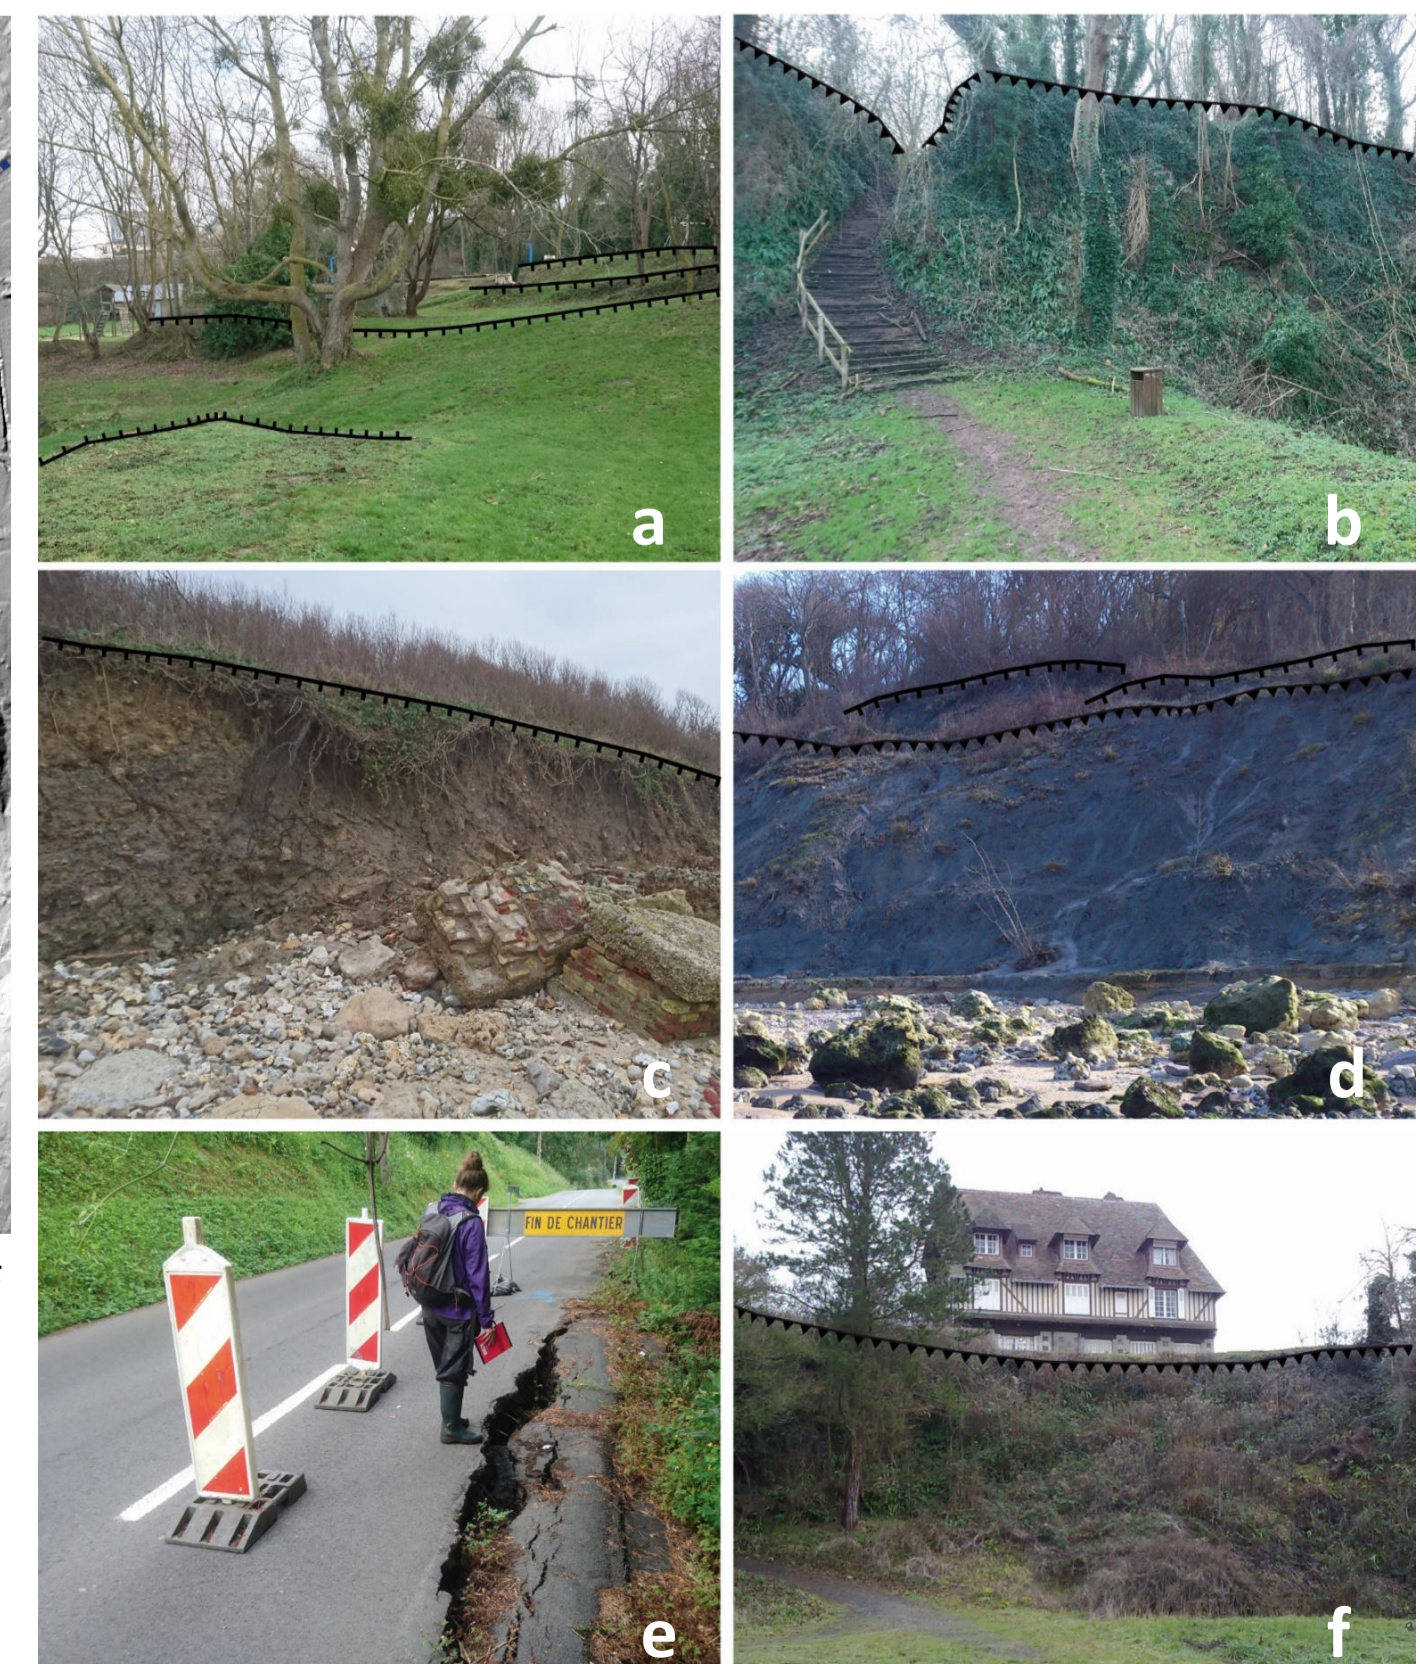
Fig. 6 - Main geomorphological features encountered in the Cirque des Graves (location given in Fig. 4). (a) Minor scarps and stairs morphology; (b) Main scarp of the cirque (chalk outcrop); (c) Heads (reworked formations) at the foot of the landslide; (d) Mudflows in Oxfordian marls on the coastline; (e) Recent crack on the RD513; (f) Building near a major scarp in the middle of the slide

- **Hummocky and complex geomorphology** (Fig. 6) which facilitate both water seepage (cracks and fracture porosity) or stagnation (clayey surficial formations, scarps & counter-scarps);
- **Thinner chalk** in the east and west borders, and particularly in the park (eastern extremity), with smaller chalk panels. Chalk is thicker (10-17 m) in the upstream central area (Fig. 5).

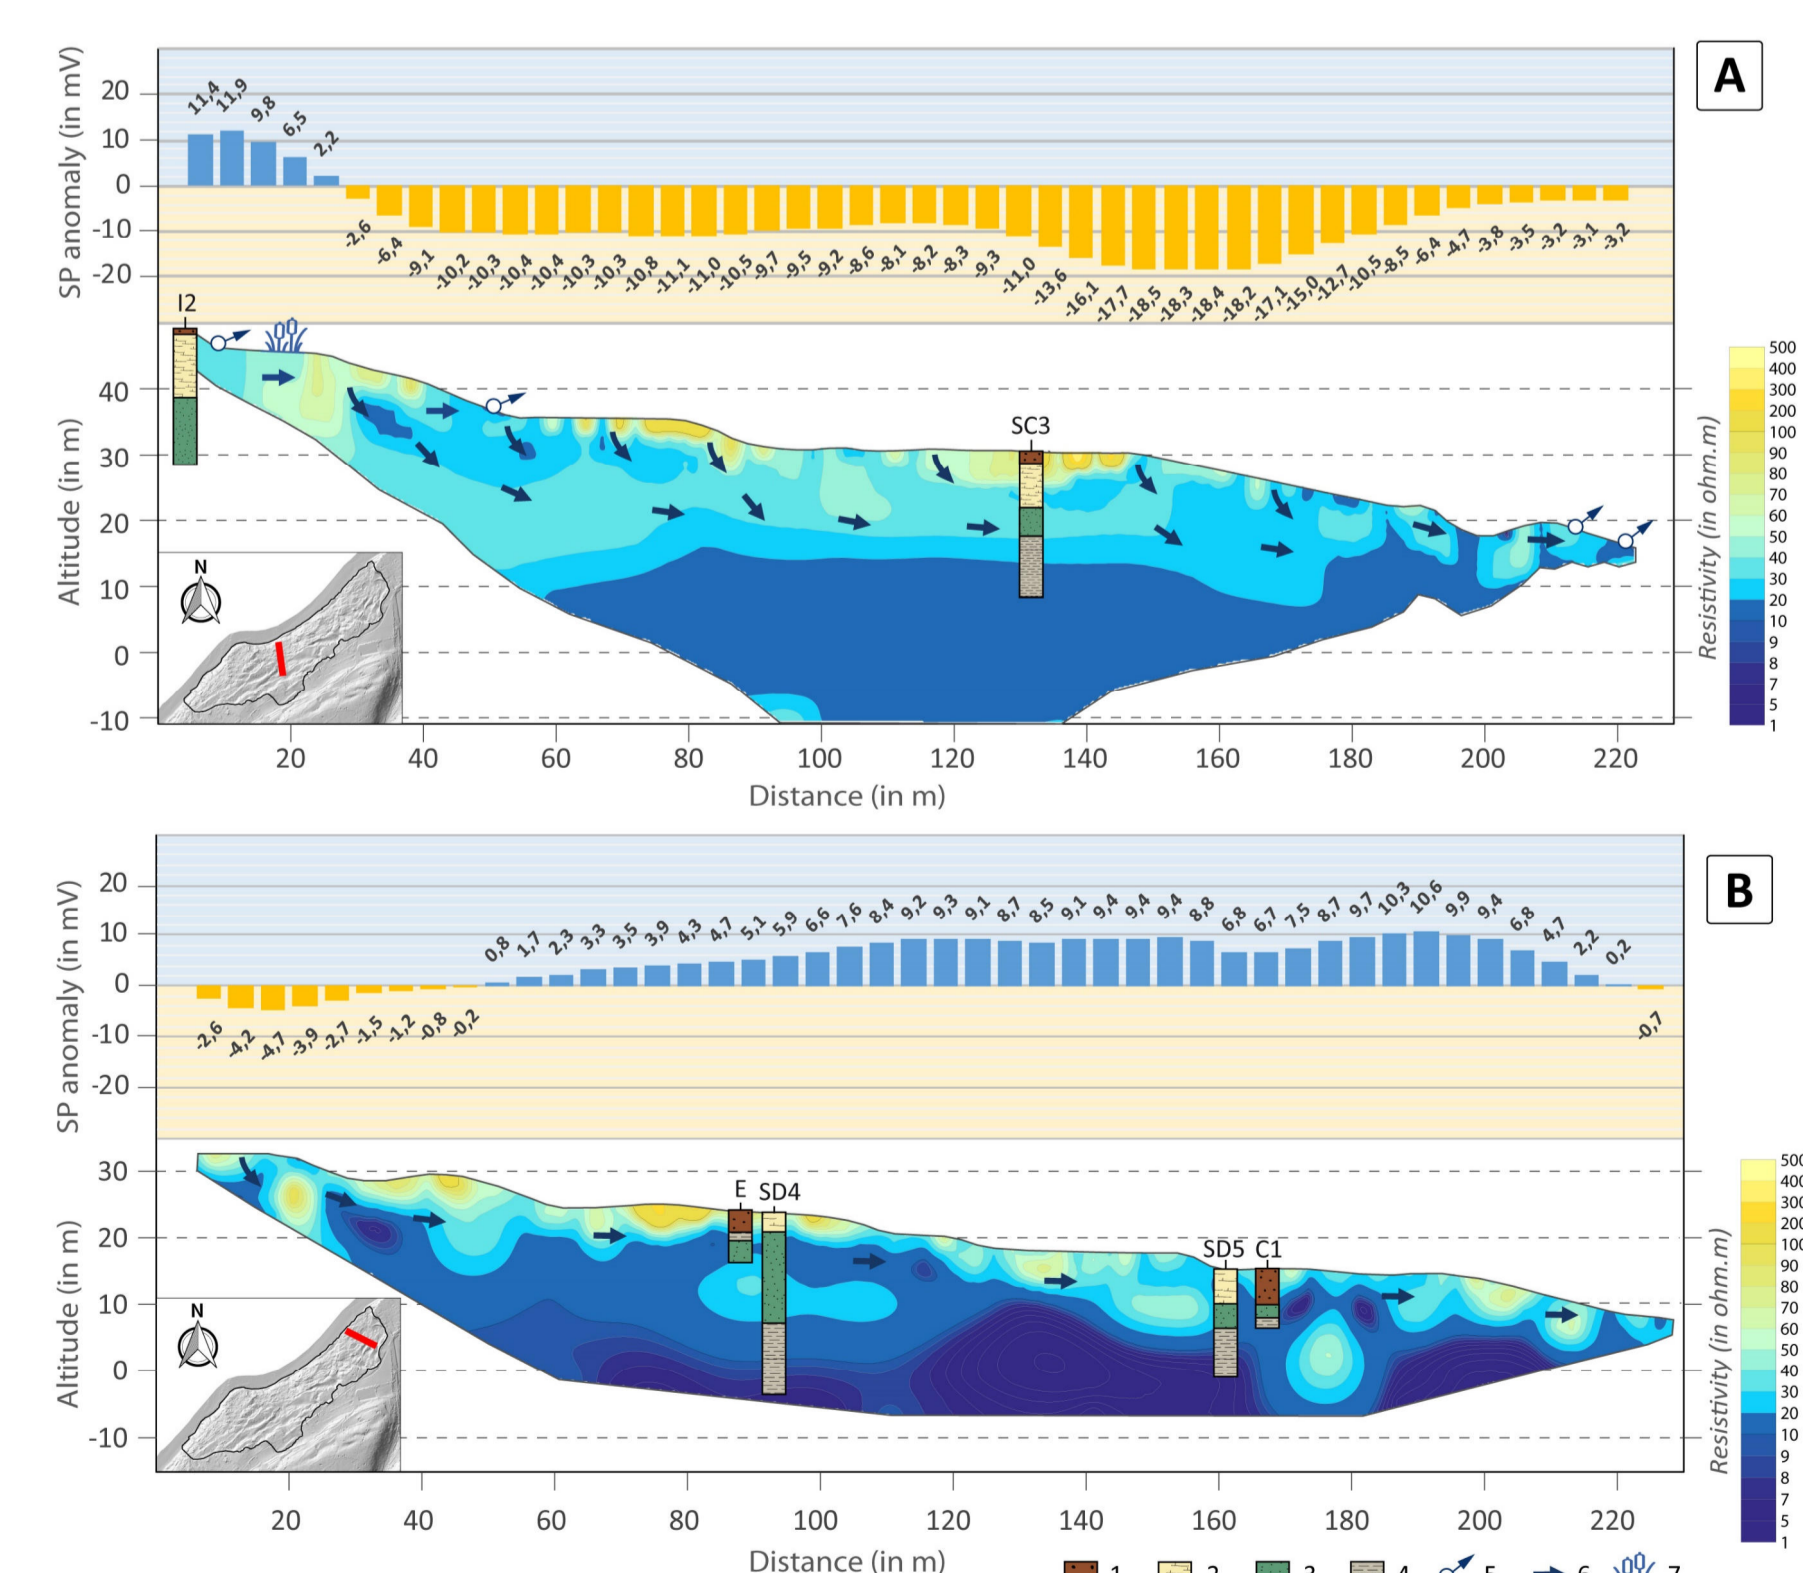
Fig. 10 - Comparison between the SP survey (2018) and the resistivity gradients from the ERT survey during the SISCA project (2007-2008) at (A) the middle-west part of the cirque and (B) the east part of the cirque (park)

- **Central area** (Fig 10A):

- ✓ Negative SP anomalies on slope breaks (downward waterflows following slip surfaces) correlated with strongest ρ values;
- ✓ Positive SP anomalies correlated with springs and water accumulation (upward waterflows) and lower ρ clusters (saturation).

- **Eastern area** (Fig 10B):

- ✓ Weak resistive thickness in surface (thinner and reworked chalk);
- ✓ Strong positive SP anomalies which underlines a parallel or upwards flow (no significant sinking of water).
