Archaeometrical contributions in the Japanese architecture in France

ARCHAOMETRICAL CONTRIBUTIONS IN THE JAPANESE ARCHITECTURE IN FRANCE: THE PAVILIONS OF ALBERT KAHN'S GARDENS (BOULOGNE-BILLANCOURT, FRANCE)

ABSTRACT:

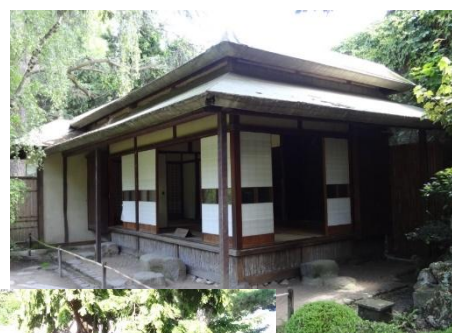
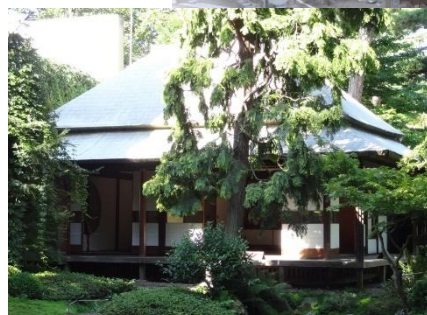
Figure 1: Left: West lodge; Right: East lodge

Albert Kahn's gardens are located in the Hauts-de-Seine, near Paris, in France. There have several buildings including two Japanese lodges brought back from Japan by Albert Kahn around 1900 (Figure 1). [1-3]

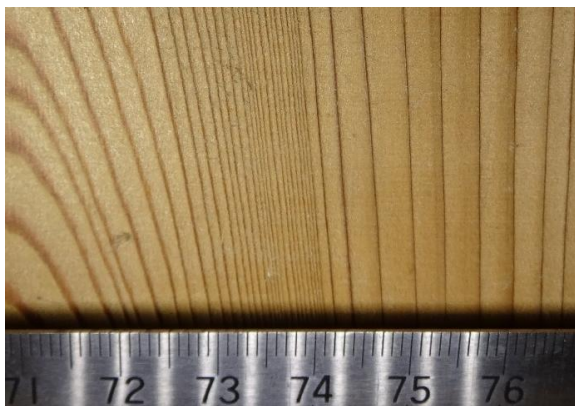
Figure 2: Detail of board 2, gate 1, East lodge.

In the case of Albert Kahn gardens' two pavilions, we used a non-invasive methodology adapted to wooden art works. After a manual light dusting of the surface, we realized, at first, a maximum of *in situ* data taking on non-dismantled buildings and carried out measurements on macrophotographs (Figure 2). They are done on longitudinal surface because the wood is perfectly split on radial way and they are coniferous species.

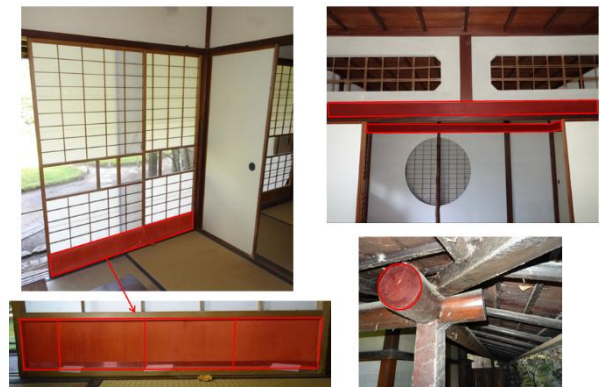
Figure 4: Example of measured timbers (in red). Left: the lower parts of shōji; Top right: tie beams; Bottom right: an outdoor round beam.

During the preliminary study, tree-rings measurements were performed on visible transverse faces of 4 outdoor round beams (two in each house), 8 tie beams of West lodge (East house have none) and on lower parts of 25 shōji² (12 in the East lodge and 13 in the West house) for a total of 87 boards with 81 measured (Figure 4).

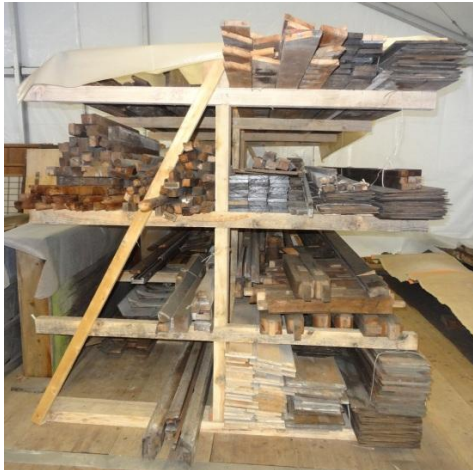
Figure 5: Part of the corpus of wood to be analysed.

During the restoration, the houses were totally dismantled and the woods were left to us for a short time (Figure 5) to take information. We then had to take a maximum data during this very short period of time. Only part of these timbers was analysed in the laboratory. Indeed, the photographs, around 1400, and the study of left wood not re-used would require nearly two years of work to a specialist only for their post-treatment. So we selected a number of woods meeting certain criteria in order to be as representative as possible for this first part of work:

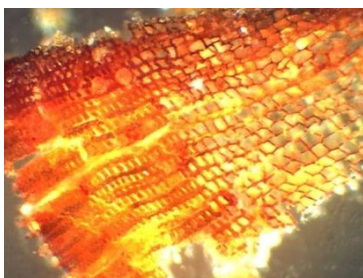
Figure 1: Sample D1: transverse, radial and tangential faces.

The xylogy determines the wood species. This requires making very fine cuts on the three faces of the wood: transverse, tangential and radial (Figure 6) and comparing with existing database. Mrs. Mechtild Mertz, Japanese wood specialist and Mrs. Victoria Asensi Amoros, from Xylodata, assist us in determining the species used.

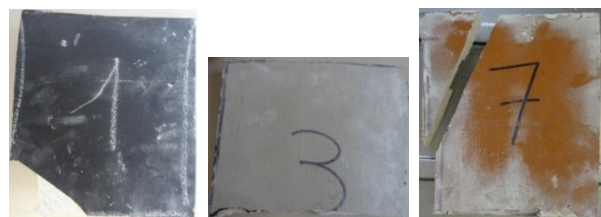
Figure 8: Examples of samples taken for this study during dismantling

During the restoration of the two houses, we took samples from these painted plasters to study the paintings in the laboratory (Figure 8). We decided to sample all the colours: sixteen samples from seven different colours were so studied. We then performed stratigraphical sections of these plasters and we observed them by optical microscopy. Considering the results, we decided to analyse some samples by SEM-EDS (scanning electron microscope coupled to energy-dispersive X-ray spectroscopy) to chemically characterize the interest for the restoration of the paintings.

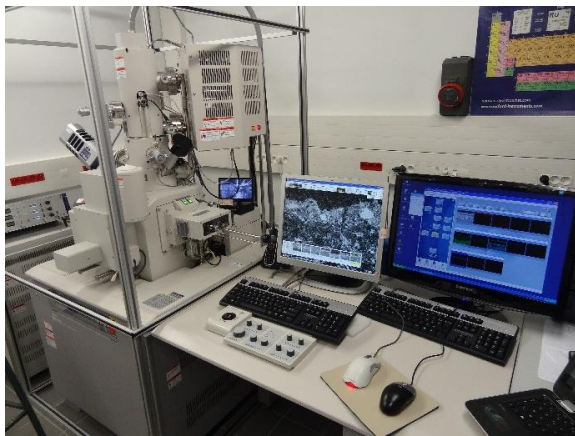
Figure 9: Analysis of samples by SEM-EDS in progress.

Analyses by SEM-EDS (Figure 9) permitted us to identify the chemical elements present in each layer of paint in each stratigraphical section. We chose to analyse the samples according to the results obtained by other methods, namely: the original paint composition to identify the pigment.

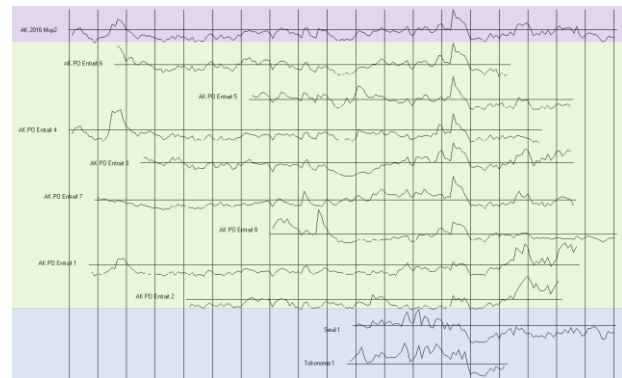
Figure 11: Mean "AK 2016 Moy 2" (in purple) incorporating elements from West house (in green) and East house (in blue).

Some averages contain wood from East and West houses proving that the timbers of these two buildings are from same areas and same periods. Both houses were probably built at the same time and with the same wood (Figure 11). At the moment, they did not allow us to establish the date of the construction of these houses. We need more samples. It will be done during restoration by

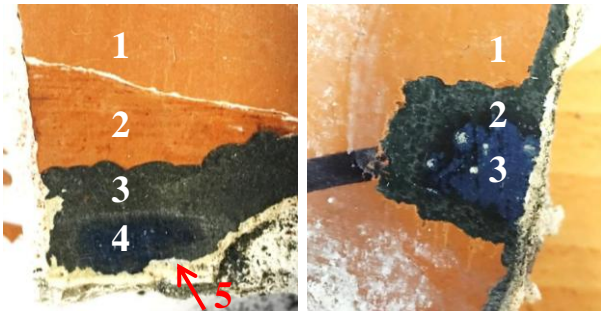
Figure 2: Left: we have scoured only 5 of the 10 layers; Right: only 3 from 8 present layers.

We were able to realize many colorimetric measurements on different layers which gave us a better insight of the colors from the successive restorations (Figure 13). However, these data cannot be directly used during the restoration as it is not possible to properly
