Archaeometrical contributions in the Japanese architecture in France

ARCHAOMETRICAL CONTRIBUTIONS IN THE JAPANESE ARCHITECTURE IN FRANCE: THE PAVILIONS OF ALBERT KAHN'S GARDENS (BOULOGNE-BILLANCOURT, FRANCE)

Muriel Bordessoulles¹, Catherine Lavier², Elsa Van Elslande², Laurence De Viguerie²
In collaboration with Jean-Sébastien Cluzel¹, Victoria Asensi Amoròs³, Mechtild Mertz⁴,
Takumi Mitsutani⁵, and Rémi Brageu²

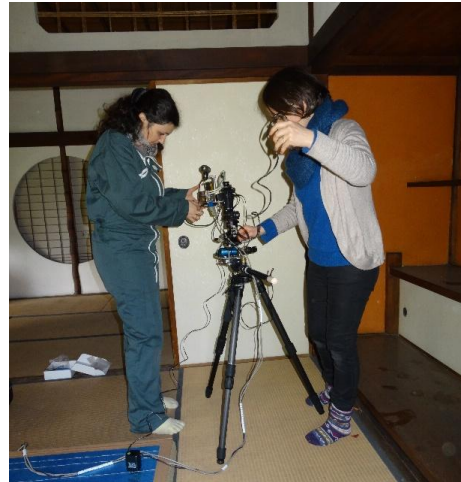
Figure 7: Preparation of the fluorescence X machine for in situ measurements. (Photo : C. Lavier)

To better characterize these paintings, we decided at first to perform XRF analysis *in situ* (Figure 7) to try to identify the chemical elements present. Colorimetric measurements were also performed. These methods were chosen because they are non-destructive, portable, fast and commonly used.
