## Archaeometrical contributions in the Japanese architecture in France: the lodges of Albert Kahn's gardens (Boulogne-Billancourt, France)

# Archaeometrical contributions in the Japanese architecture in France: the lodges of Albert KAHN's gardens (Boulogne-Billancourt, France)

## AKAHN project

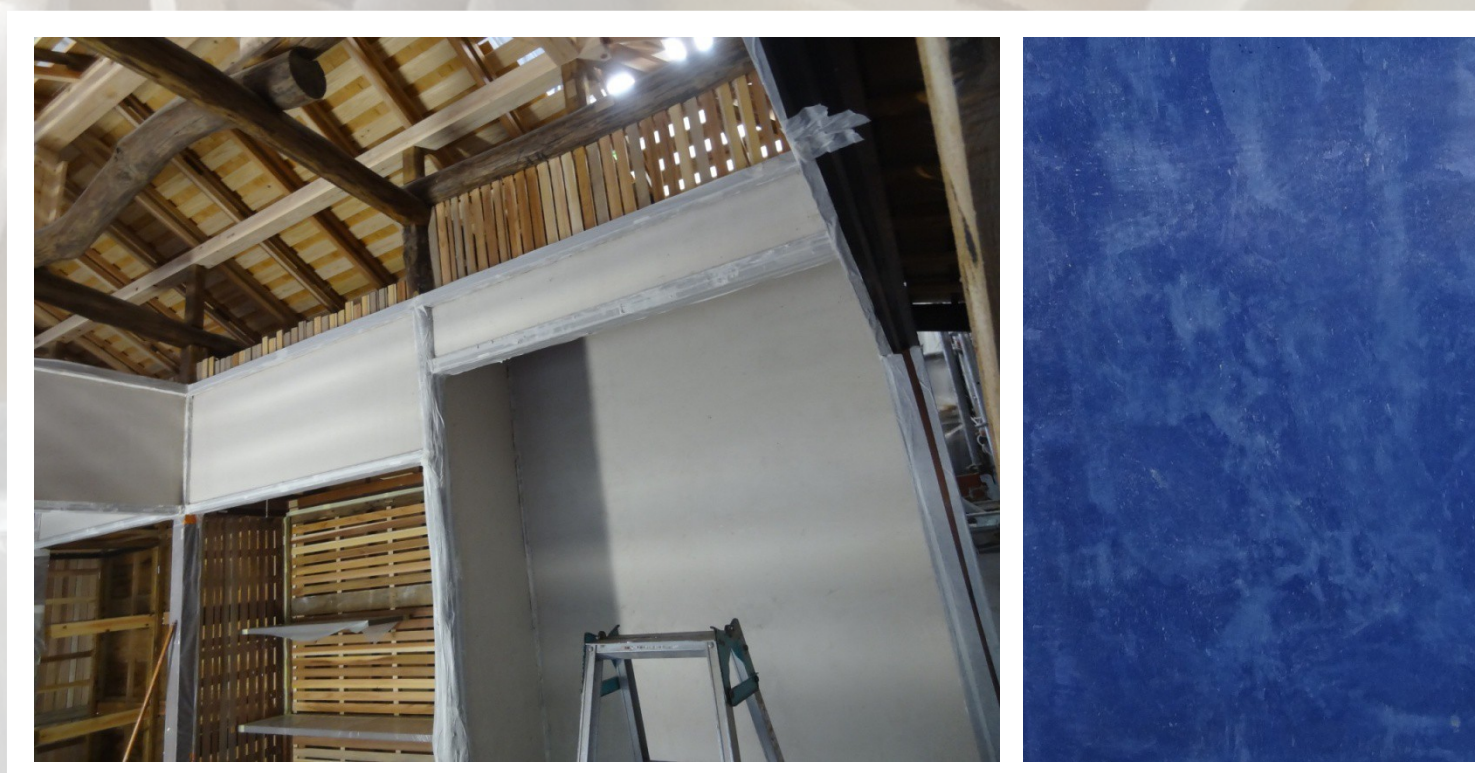
Left: East lodge being restored; Right: Blue paint test on plasterboard present on site.
