# Non-Destructive Techniques Applied to Monumental Stone Conservation

Beatriz Menendez

Beatriz Menendez. Non-Destructive Techniques Applied to Monumental Stone Conservation. Non-Destructive Testing, InTech, 2016, 10.5772/62408 . hal-03475810

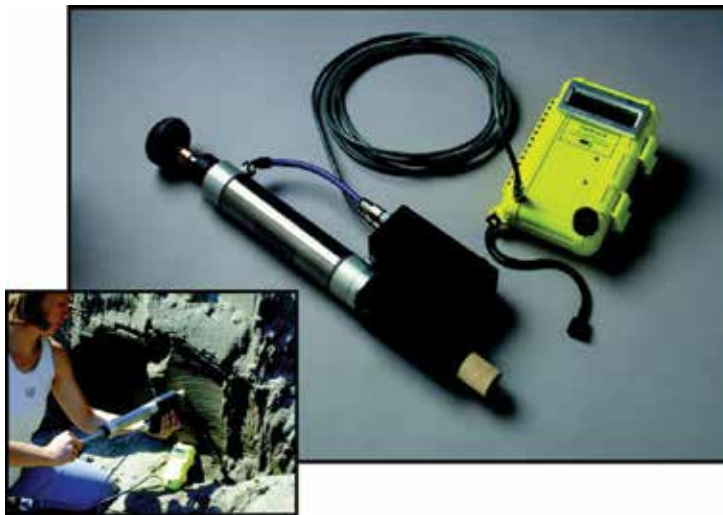
**Figure 5.** Tiny Perm (New England Research Inc.) taken with the permission from Brown and Smith [40].

Brown and Smith [40] do a review of the different gas permeameters used in laboratory and field applications. They have developed a portable syringe air permeameter to be used on rock outcrops and cores. This permeameter induces a vacuum on the surface of the stone by suddenly increasing the volume of a chamber in contact with the stone surface. Air flows from the stone to the chamber gradually increasing the pressure on the chamber. Air pressure is registered as a function of time and from this pressure variation air permeability is estimated. This device was originally thought to measure rock permeability inhomogeneity in outcrops but it is actually used for “in situ” permeability measurements on buildings. This device is actually commercialized as TinyPerm by New England Research, Inc. (**Figure 5**). “In situ” air permeability measures have been done with this permeameter in two buildings of Paris (France) restored with lime mortars in order to check the compatibility of repair mortars with the original stone, the Euville limestone [41]. Similar measurements have been performed on laboratory samples of the same materials. It was found that the stone permeability is higher than the permeability of mortars by a factor between 1.5 and 15, despite the high scatter in the data. This method is a very convenient way of having ‘in situ’ estimation of materials permeability and its inhomogeneity.

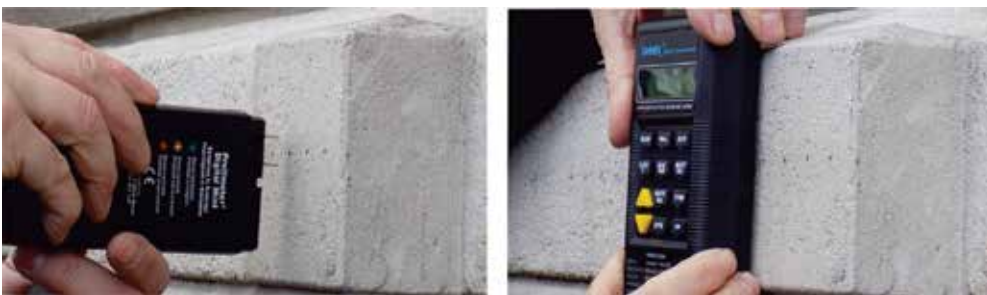
**Figure 6.** Left: Pin moisture meter (Protimeter), right: pinless moisture meter (Tramex).

As “in situ” amount of water contained in a building material cannot be measured directly without sampling, different properties, which values change as a function of water content, can be used to estimate it. In order to validate the procedures, values of the measured properties in materials with well-known water content are used as standard for comparison. There are several kinds of moisture meters originally designed to estimate the humidity of wood that are now used on other built cultural heritage materials. Usually, they are not calibrated for stone but they can be used to estimate humidity variability in a site. The obtained results are affected by several factors such as the weather (especially humidity), the degradation of the surface, the presence of biological colonisation and so on [44]. There are two basic families of devices, one based on the measurement of the electrical resistivity of the materials, called “pin meters”; and a second group based on the measurement of the impedance, also called “pinless meters” or electromagnetic wave meters (**Figure 6**). In pin meter, a small electrical current is passed between two pin tips, therefore, the measurement provides information only on a very thin line between both pins. Pinless moisture meters use a larger sensor pad that emits electromagnetic signals; therefore, the measures correspond to a larger area of the surface than in pin meters. The pin moisture meters need less access area than the pin-less one. In the same study, on Paris buildings previously described, we found better correlation between the nature of the studied material (mortar or stone) and water content with a pinless meter than with a pinless meter.

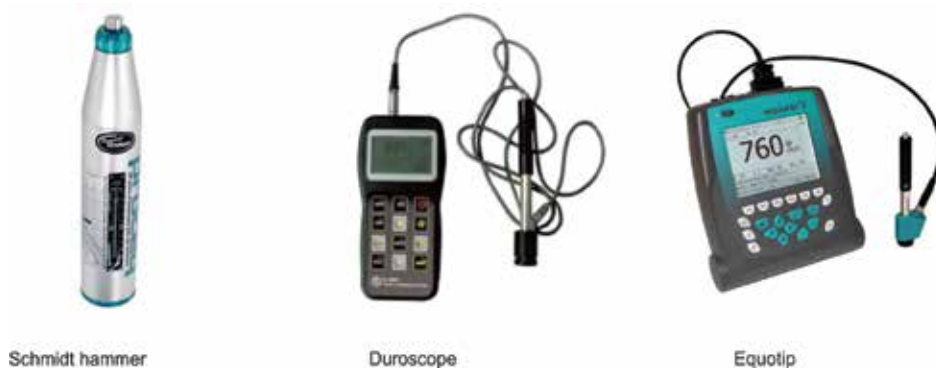
**Figure 7.** Different systems to measure surface hardness. Schmidt hammer (Proceq), Duroscope (Hitec Enterprises Inc) and Equotip (Proceq).

Hardness of the surface is another property usually considered to determine the conservation degree of building materials. It is measured mainly by the Schmidt Hammer or sclerometer. The Schmidt Hammer was originally devised for carrying out “in situ”, non-destructive tests on concrete [50]. It gives an immediate indication of the compressive strength of the material using the linear calibration curve supplied with each instrument [51]. It measures the height of rebound of a plunger impacting the surface at a defined pressure. There are different kinds of Schmidt hammer. The most employed in rock outcrops and building stones is the ‘N’ type with an impact energy of 2.207 Nm. Another type used in weak stones is the ‘L’ type with an impact energy of 0.735 Nm. More details about the use of Schmidt hammer and its correlation to uniaxial compressive strength can be found in the study of Aydin and Basu [52]. This test is very common on built cultural heritage studies. The Duroscope has a similar mechanism of operation but with a smaller and pointed plunger and a smaller spring-loaded mass. It can be used for surfaces with low strength. With Duroscope, the precision of the measure depends on the smoothness of the surface [53].

The Equotip is another device to test the mechanical properties of stone surfaces. In this case, a ball hits the surface with a fixed energy, and the velocity of the ball as it rebounds is recorded. There are different kinds of Equotip devices depending on the nature of the ball (tungsten carbide, ceramic and polished diamond), its size (2.8, 3 and 5 mm) and the impact energy (3, 11 and 90 Nm). The Equotip type D has been used to measure surface hardness changes of common Portland limestone, Cornish granite and a standard marine concrete exposed to coastal environment in the work of Coombes et al. [54]. They found that the durometer can detect changes on the surface hardness after short exposition period (months). This information indicates that it should also be useful in studying weathering in buildings environments. **Figure 7** shows pictures of a Schmidt Hammer, Duroscope and Equotip.

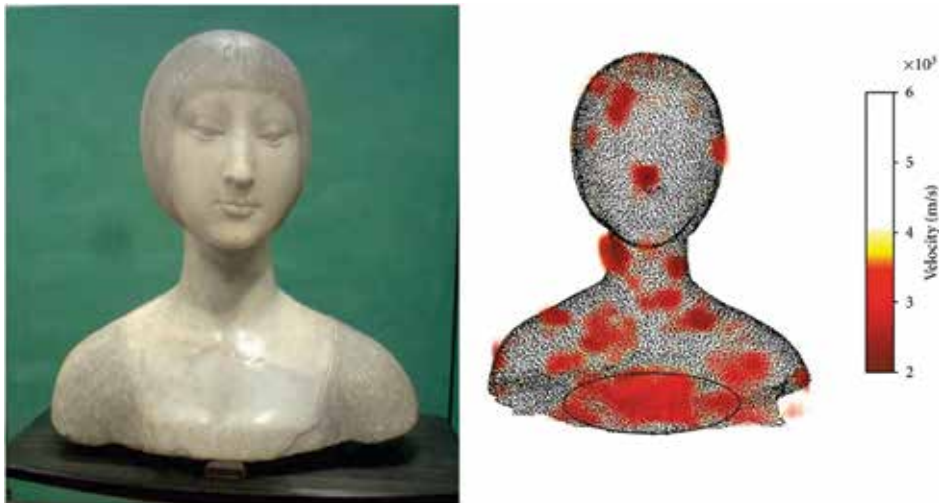
**Figure 13.** 3D ultrasonic travel time tomography on the Eleonora d'Aragona statue. Adapted from Cosentino et al. [4].

One example of acoustic tomography in the sculpture of Leonora d'Aragone (Francesco Laurana) is presented in the study of Capizzi et al. [68]. This sculpture (22 cm x 40 cm x 43 cm) is carved from a unique block of microcrystalline marble and presents possible crack problems. High-resolution ultrasonic tomography was the most appropriate technique to monitor the structural continuity of a possible fracture and to investigate the internal marble conditions. A 3D ultrasonic tomography was obtained from 157 measurement points spaced from 2 to 5 cm (1832 raypaths). Extensive signal processing has been done before inversion. **Figure 13** shows some of the results obtained.

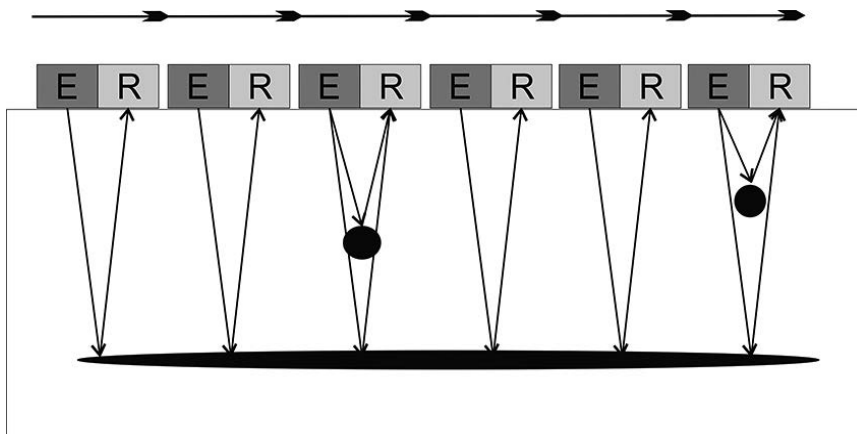
**Figure 18.** Principle of ground penetrating radar (GPR).

This technique is similar to the acoustic technique but with another kind of waves. This technique is also an adaptation of a geophysical on site technique. In this case, electromagnetic pulses (frequency 500–2500 MHz) are injected into the material by an antenna (**Figure 18**). The most common experimental setup is the reflection mode with the antenna moving in one direction on the surface and the receiving antenna moving at the same time as the transmitter. Both antennas are usually placed on the same device. In transmission mode, the receiver is placed on an opposite surface of the objet. This method is less common and generally is only used to measure the signal velocity for calibration of the test.
