Anode defects' propagation in Polymer Electrolyte Membrane Fuel Cells

Salah Touhami, Marie Crouillere, Julia Mainka, Jérôme Dillet, Christine Nayoze-Coyne, et al.. Anode defects' propagation in Polymer Electrolyte Membrane Fuel Cells. *Journal of Power Sources*, 2022, 520, pp.230880. 10.1016/j.jpowsour.2021.230880 . hal-03476636

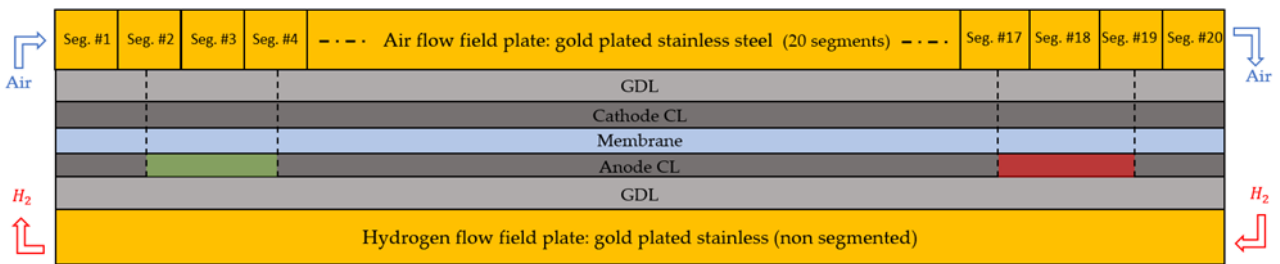
Figure 2. Up: anode -before transfer on the membrane- with -or without- a lack of CL at one end. Below: longitudinal sectional view of the segmented cell. The location of the defect is situated either at the anode inlet (in green) or outlet (in red).
