## Archaeoseismological study of the Cherichira aqueduct bridge, Kairouan, Tunisia

Klaus-G. Hinzen, Mustapha Meghraoui, Nejib Bahrouni, Yassine Houla, Sharon Reamer. Archaeoseismological study of the Cherichira aqueduct bridge, Kairouan, Tunisia. *Mediterranean Geoscience Reviews*, 2021, 10.1007/s42990-021-00062-9 . hal-03483339

# Archaeoseismological study of the Cherichira aqueduct bridge, Kairouan, Tunisia

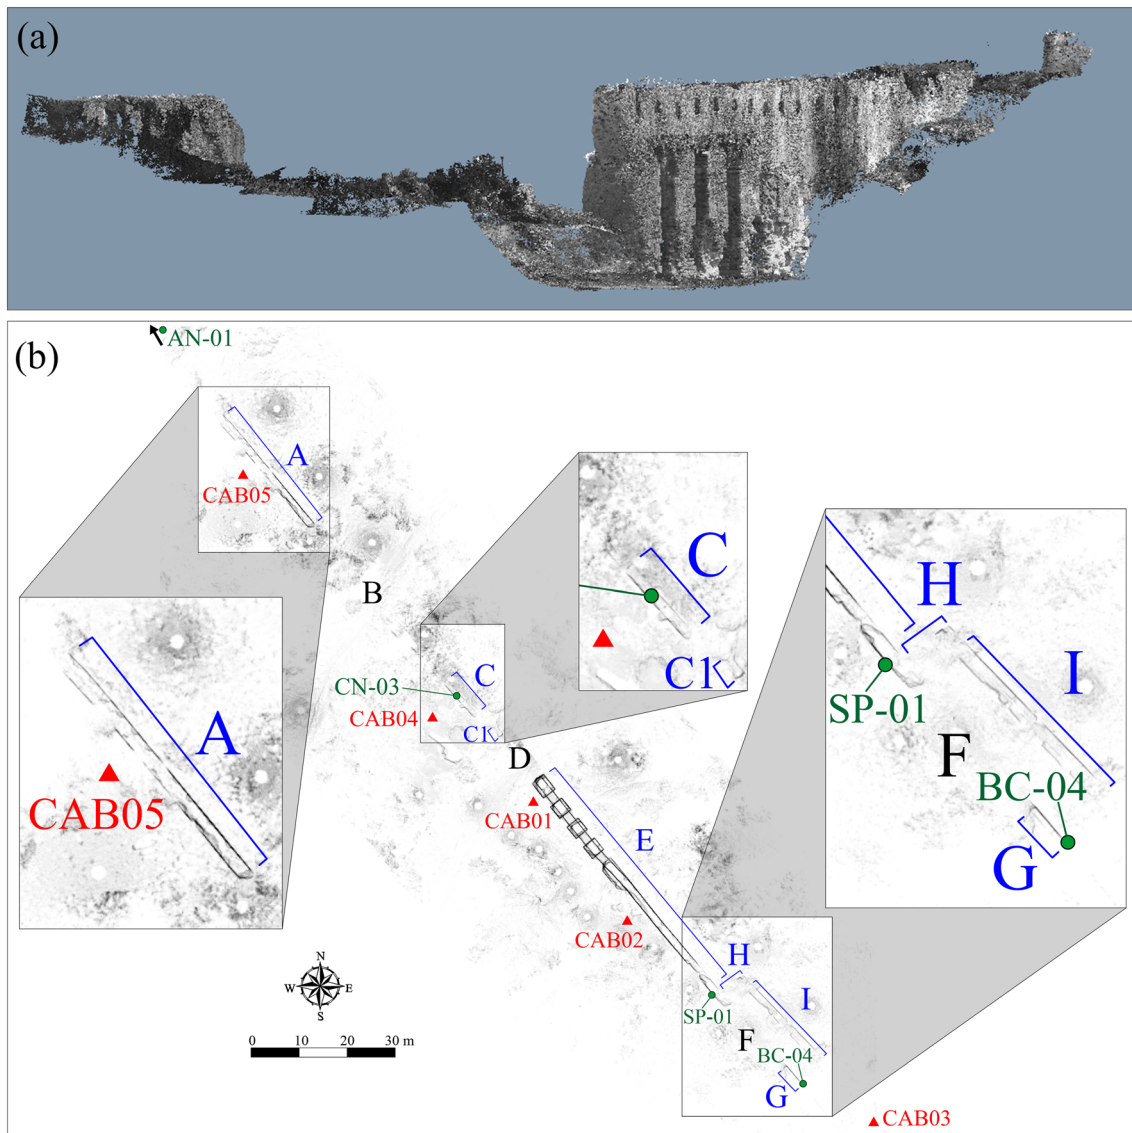
**Fig. 4** **a** Perspective view from NW to the CAB 3D scan model. Total length of the model is 180 m. **b** Overview map of the scanned Cherichira aqueduct. Individual sections are marked with blue capital letters starting from NW; black letters indicate the gaps between sections. An arrow on the top left points towards a small pool about

100 m outside the map area. Three zoom-windows show more details; the scale bar applies to the main map; the labeled red triangles mark positions of HVSR measurements and the labeled green dots give locations of C14-dating samples

In the following, the explored part of the CAB is divided into nine sections labeled A to I from NW to SE, where B, D, and F are gaps without major visible remains of the original construction (Figs. 4 and 5). The height of the ruins aboveground in section A increases from NW to SE from 1.5 m to 4.3 m due to sloping terrain. Section C shows severe damage, and the remaining height aboveground is about 2 m. Some 5 m south of section C, a small fraction (C1) extrudes from the slope within the gap labeled D; however, the elevation of C and C1 differs by at least 4 m from rest of the bridge. In the neighborhood of C and C1, several large debris piles are visible within the bushes, including remains of a water channel. The best-preserved part of the bridge in section E has a maximum remaining height above the (current) ground of 11.1 m. Towards the SE, the height decreases as dictated by the natural slope to about 2.7 m. Section G rises to 2.2 m aboveground and then descends in section I to about 1.1 m. Section H was heavily overgrown by shrubs, and the estimated existing height is 1.4 m. Table 1 summarizes the dimensions of the sections.

Section A (Figs. 4b and 5a) is the most northern of the examined area of the CAB. It is roughly 30 m long, the

Section F is the gap between the southern end of the bridge, section E and section G (Fig. 4b). Here, the trend of the aqueduct structure is well visible on the ground surface; however, the structure is leveled to the ground with no rising wall remains.

Section G (Fig. 4b) shows two distinct differences to the rest of the ruins of the CAB: (1) the wall is wider (~2.0 m) compared to the other sections, and the canal with ~0.8 m width is larger. The elevation of the canal does not fit the elevation of all other sections, e.g. the water channel in section

Section H constitutes a short deviation and connection between section E and I with a trend nearly perpendicular to the other two sections (Fig. 4b). Section I then continues with a common trend (N131°E), but about 5.5 m further east along a line connecting the bridge (section E) and section G (Fig. 9a–d). Section I shows heavy damage; in particular, segments of the western side of the water canal broke away and were shifted westward by ~ 0.22 m, but are still in place (Fig. 9c and d). Three cracks cut through the whole canal causing warping, a damage pattern that could well be of seismogenic origin.

Measurements of ambient noise at five locations (CAB01–CAB05, Fig. 4b) were made to determine horizontal to vertical component spectral ratios (HVSR); these can give some basic ideas of the frequency of ground amplifications due to soft surface layers (e.g. Mucciarelli and Gallipoli 2001; Lunedei and Malischewsky 2015). Measuring procedure and results are given in the electronic supplements (Fig. S1). Except for an impedance contrast correlated to the base of the sediment fill in the wadi center, no indications for major site effects were found.

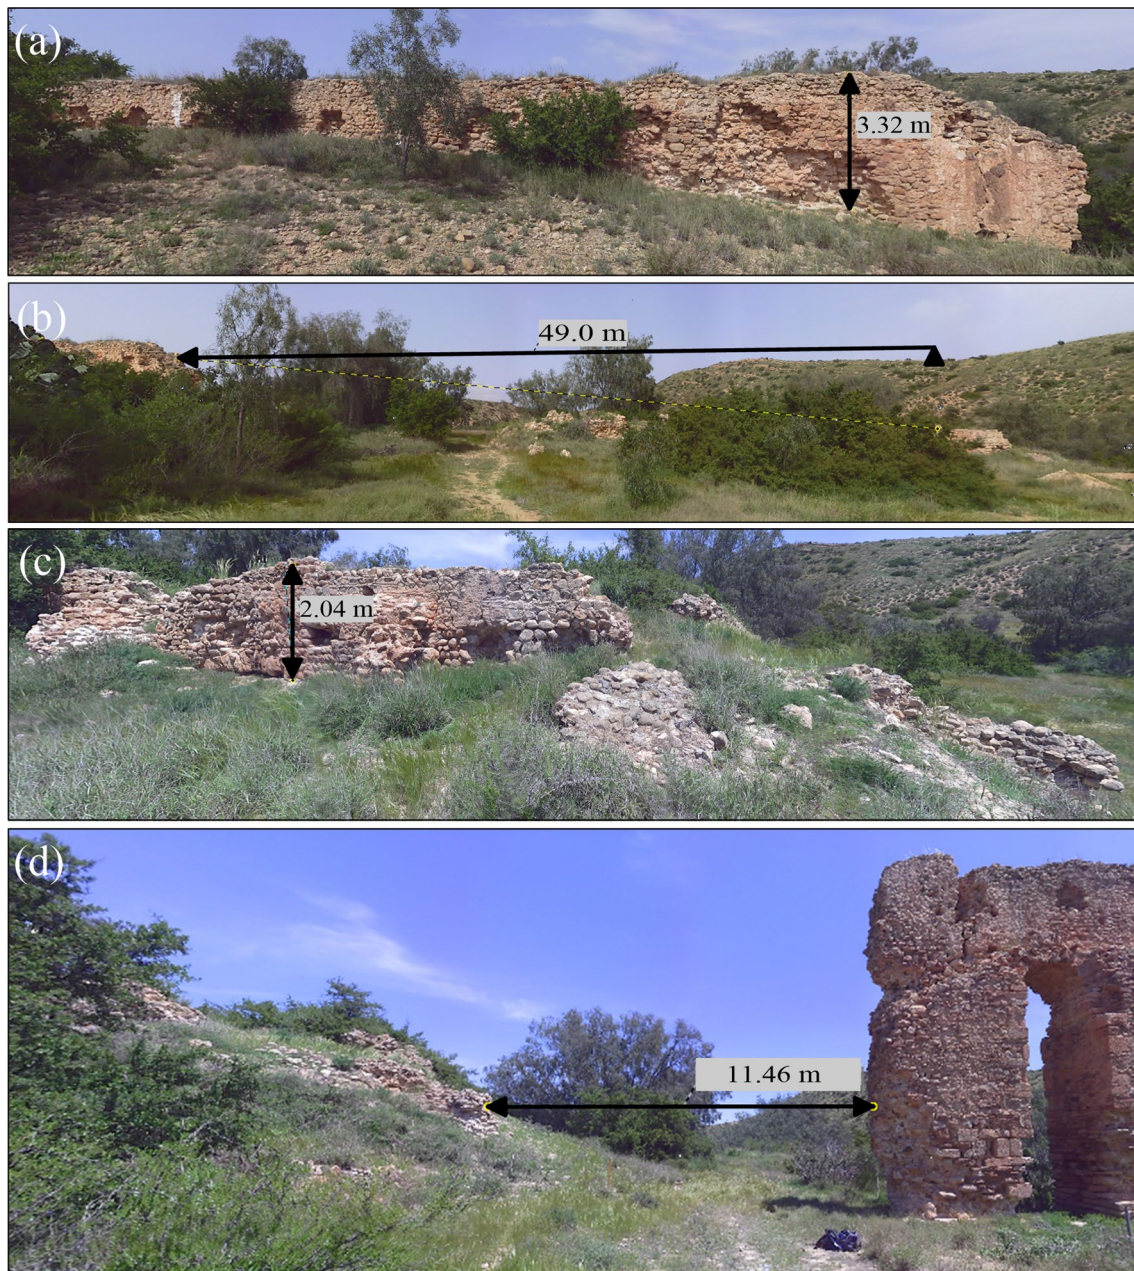
**Fig. 5** View from west to sections A (a), B (b), C (c), and D (d) of the CAB 3D scan model

height of the remains aboveground is  $\sim 1.5$  m and 4.3 m at the northern and southern end of the section, respectively, and the width at its top is 1.49 m. On both sides of the wall, about a dozen niches exist. These are 1.0-m wide, 0.75-m high and 0.3–0.5-m deep. The average distance between niches in section A is  $2.17 \pm 0.15$  m. At the southern end of section A, massive fractures cut almost vertically throughout the structure, accompanied by several centimeter-thick tufa deposits.

Section B is the more than 40-m-long gap between sections A and C (Figs. 4b and 5b). While it contains some rubble and heavily degraded parts of the aqueduct, the vegetation prevented a more thorough study of this section.

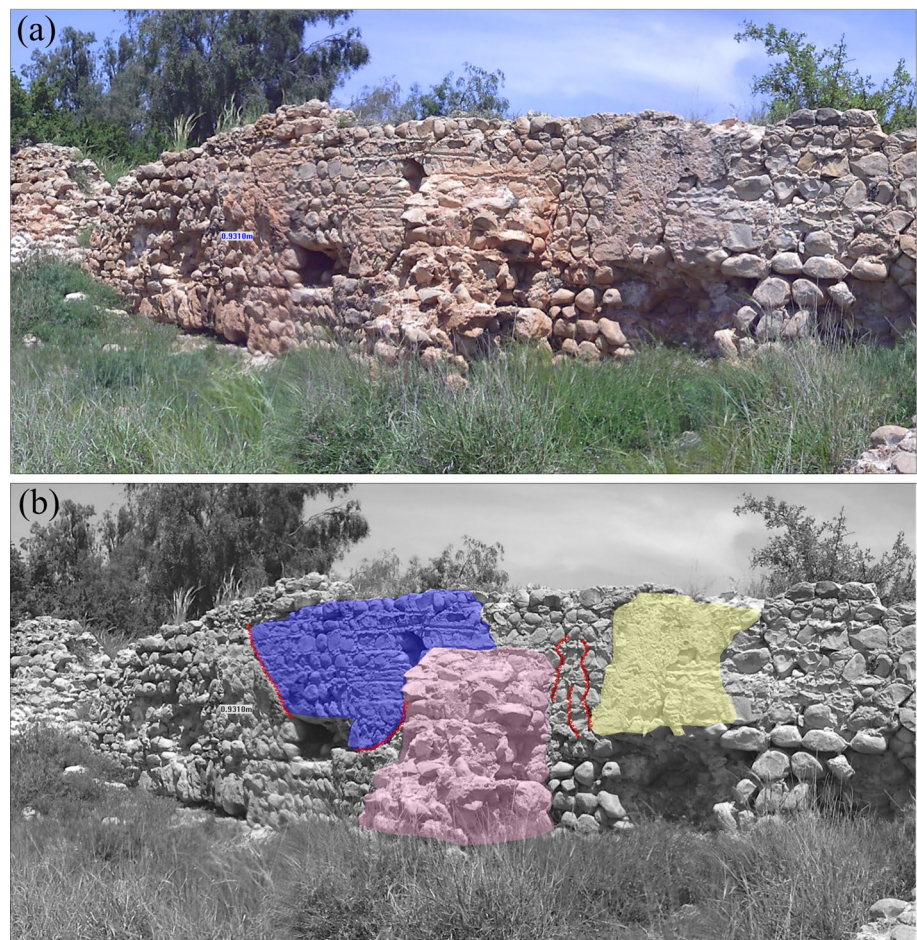
**Fig. 6** View from west to section C. **a** Colored 3D scan, **b** same view as in (a) with a buttress shaded red, tufa deposits in yellow and a segment of the wall with trowel lines in blue. Red lines mark major cracks in the wall

with a 6.15-m-wide gap in between; no evidence exists for a masonry bond to the wall they support, a sign which could indicate a later addition to give the canal support. Later, the buttresses collapsed together with the canal. In Fig. 6a and b, one of the buttresses is indicated by the red shading. Another sign of repair is a part of section C which shows clear trowel lines on both sides of the wall, filling a stretch of at least 3 m length and minimum 1 m height. This type of construction has not been found anywhere else along the scanned section of the CAB and could be attributed to a repair, possibly together with the buttress construction. Further indicated in Fig. 6b are major cracks, some of which trend along the edge of the inserted part with the trowel lines and one with tufa deposits on the outside of the wall.

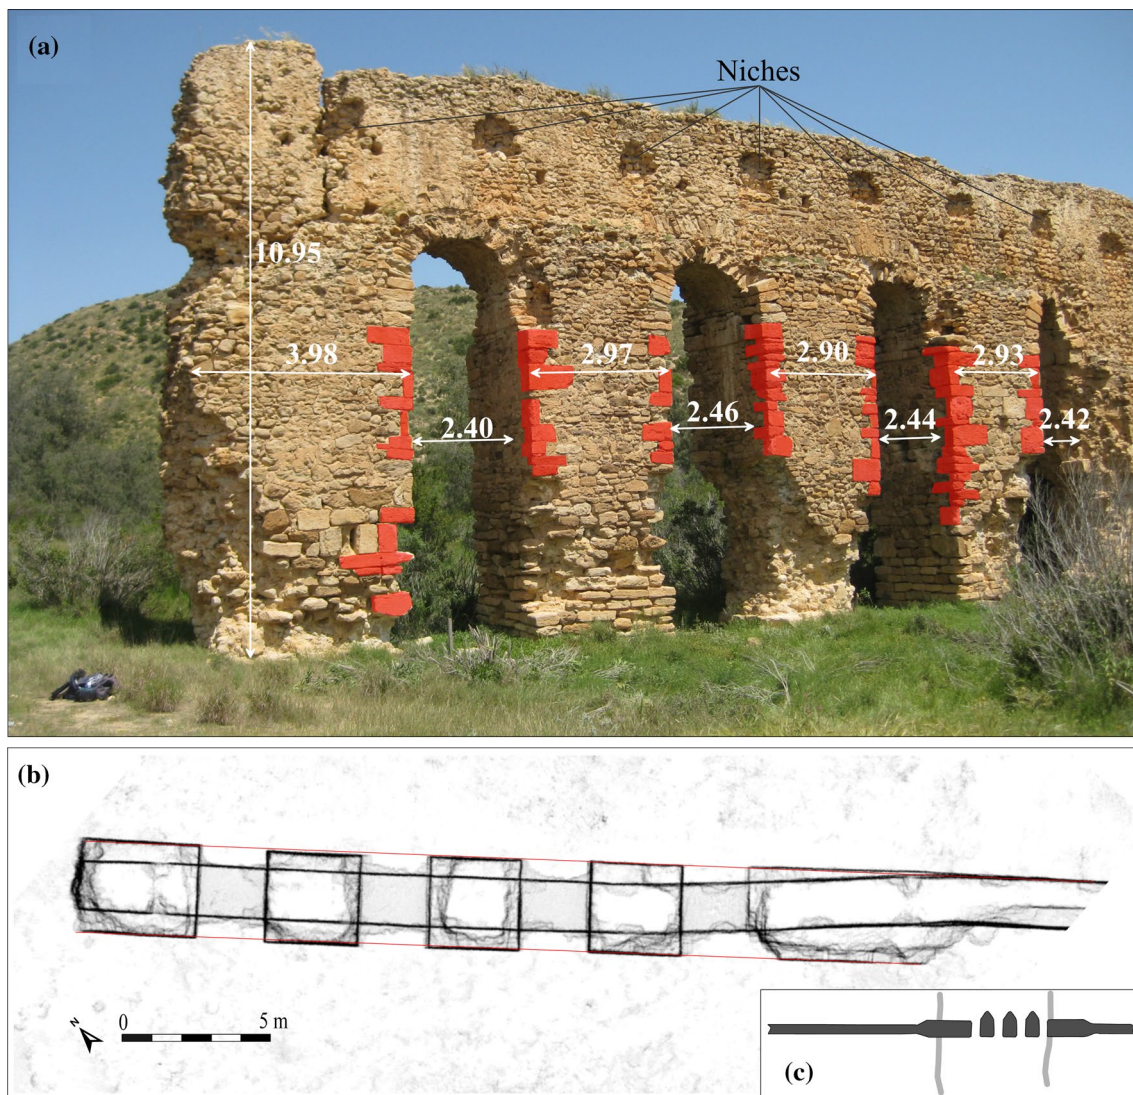
**Fig. 7** **a** Photo of the western side of section E of the CAB; all measures given in meters were taken from the laser scan model. Larger worked ashlars at the pillar-edges are indicated in red. **b** Orthographic top view of the scan of the pillars in section E which appear as black rectangles. The two parallel red hairlines are straight and fitted to the

southern part of the base, black lines indicate the trend of the curved top part of the bridge with the water channel. The insert **c** shows the ground plot following the reconstruction of Gauckler (1900) (photo K.-G. Hinzen)

Figure 7a shows a photo of the bridge seen from the west (building dimensions reported in Table 2). Pillars 2, 3, and 4 show similar dimensions (as also with the four gaps between pillars); however, the first pillar (from the left) is of different

size. While the width in EW direction of 2.90 m ( $\sim 2$  *passus*) agrees with the other three pillars, the extension in NS direction (parallel to the trend of the bridge) is at least 3.98 m, and thus diverting significantly from the almost square cross section of the other pillars. As seen in Fig. 7b and c, the northern face of pillar 1 is a breaking edge supporting the reconstruction suggested by Gauckler (1900) which infers that pillar 1 extended all the way to the northern riverbank, similar to the substructure at the southern side. A supporting argument for this assumption comes from the construction of the edges of all pillars (including the southern face of

aligned. But towards pillar 4, the superstructure is curved and meets pillar 4 as well as the following three pillars in their middle. This indicates that the superstructure was adjusted in its trend during the construction on top of the existing substructure and pillars, so the channel would be centered on the pillars; a post-construction deformation of the superstructure is unlikely, thus negating a seismogenic cause for this bending of the channel.

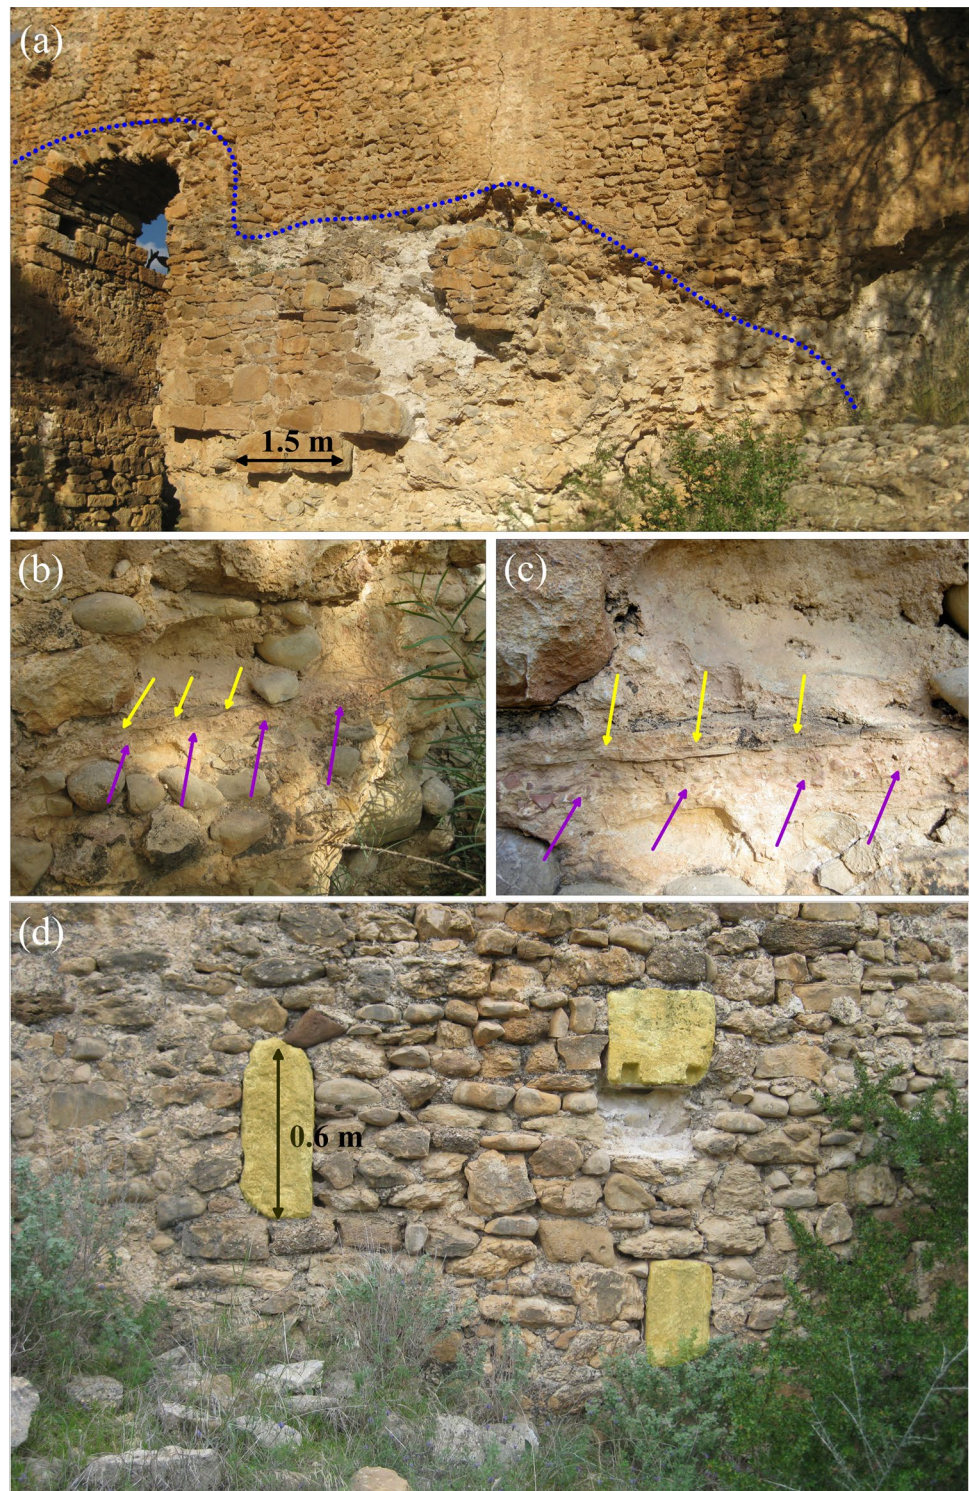
**Fig. 8** **a** Photo of the western side of section E of the CAB with the most southern arch at the left side. The dotted blue line shows the border between the 3.0-m wide substructure and the narrower 1.5-m wide wall on top. The photos in **(b)** and **(c)** show some spolia visible in the parts, where the outer shell of the wall broke off. Pink and yellow arrows point to remain of water tight canal lining (*opus signinum*) and attached tufa deposits, respectively. The photo in **(d)** was taken on the opposite (eastern) site of the bridge; the yellow shade indicates three large blocks used as spolia (photo K.-G. Hinzen)

and c). On the eastern side of the bridge, some large worked ashlars, probably of Roman origin, are found within the outer shell of the wall which is otherwise

made from crude stones (Fig. 8d). In the river bed, south of the bridge, we also found a large fragment of a Roman column.

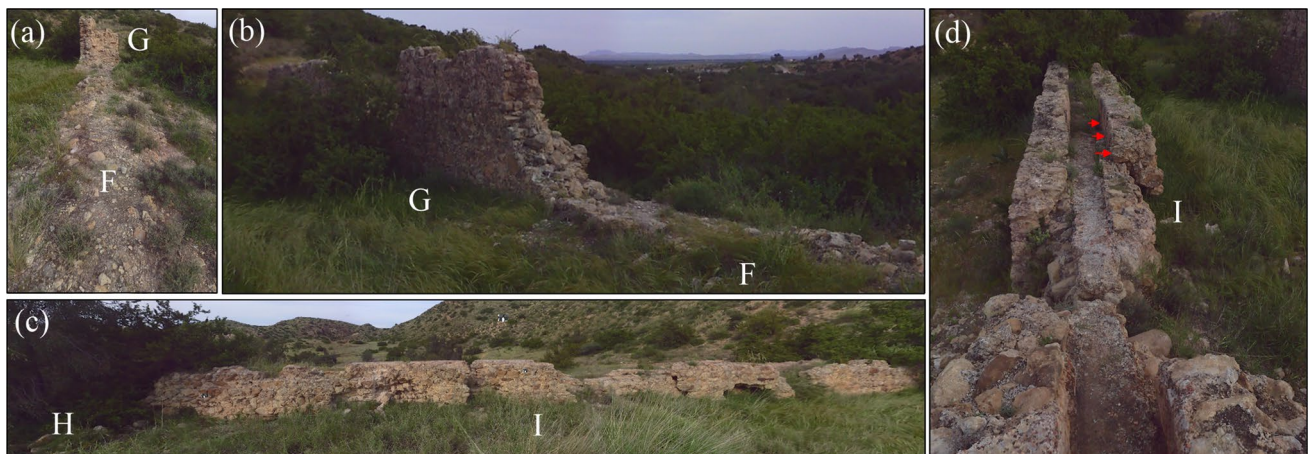
**Fig. 9** Planar views to the laser scan of sections F–I at the southern end of the CAB. **a** View towards south along section F to section G; **(b)** oblique view to sections F and G; **(c)** eastward view to section I,

section H is hidden under the shrubs on the left side; **d** view in flow direction towards south along section I, the red arrows indicate a 0.22 m shift of the broken western wall of the canal

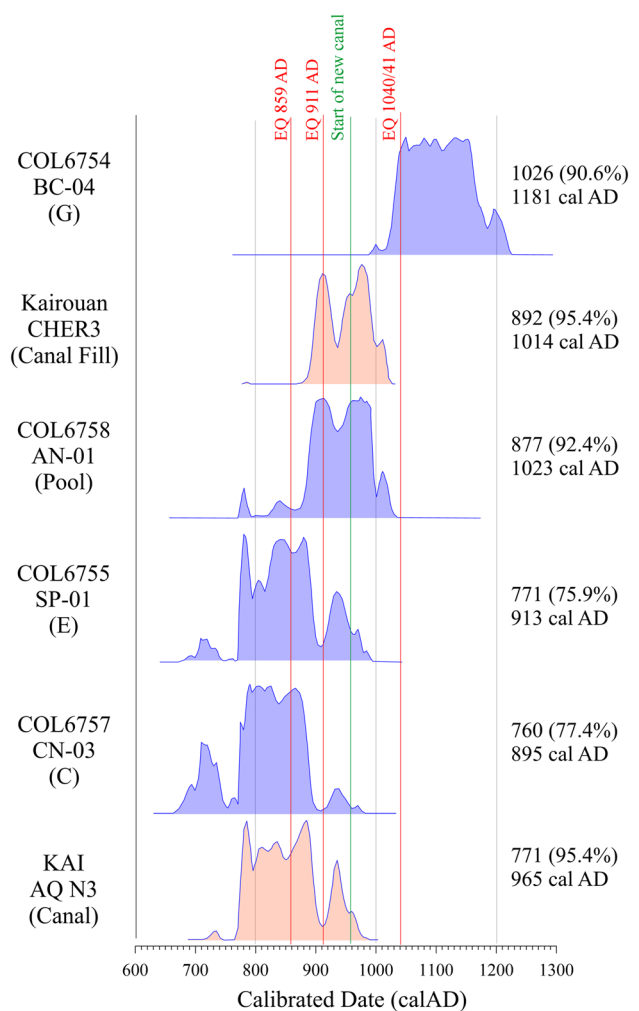
**Fig. 12** Results of C14 radiocarbon dating of samples from the CAB. Name of sample and location of sampling (in brackets) is given on the left side and in Fig. 5b. The two red shaded curves are from Bahrouni et al. (2020a, 2020b) the blue shades one from this study. Dates on the right side give the  $2\sigma$  uncertainty range; the historically documented time of three earthquakes (Ambraseys 2009; Kharrat et al. 2019; Bahrouni et al. 2020a, b) and the inferred start of construction of the new canal are indicated by red and green lines, respectively

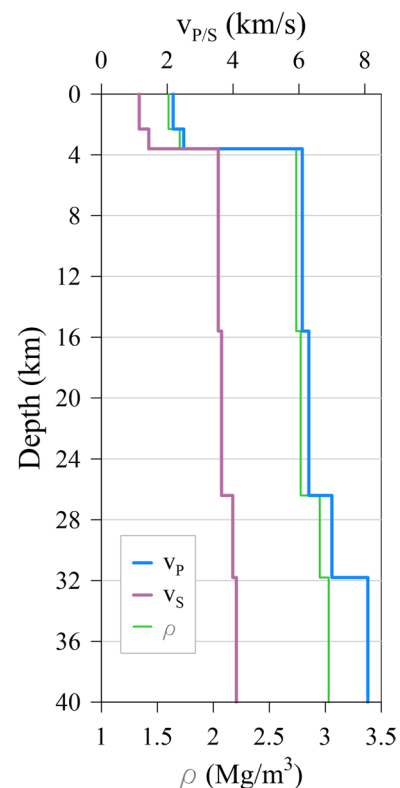
Fig. 13 1D velocity and density model for the Kairouan area

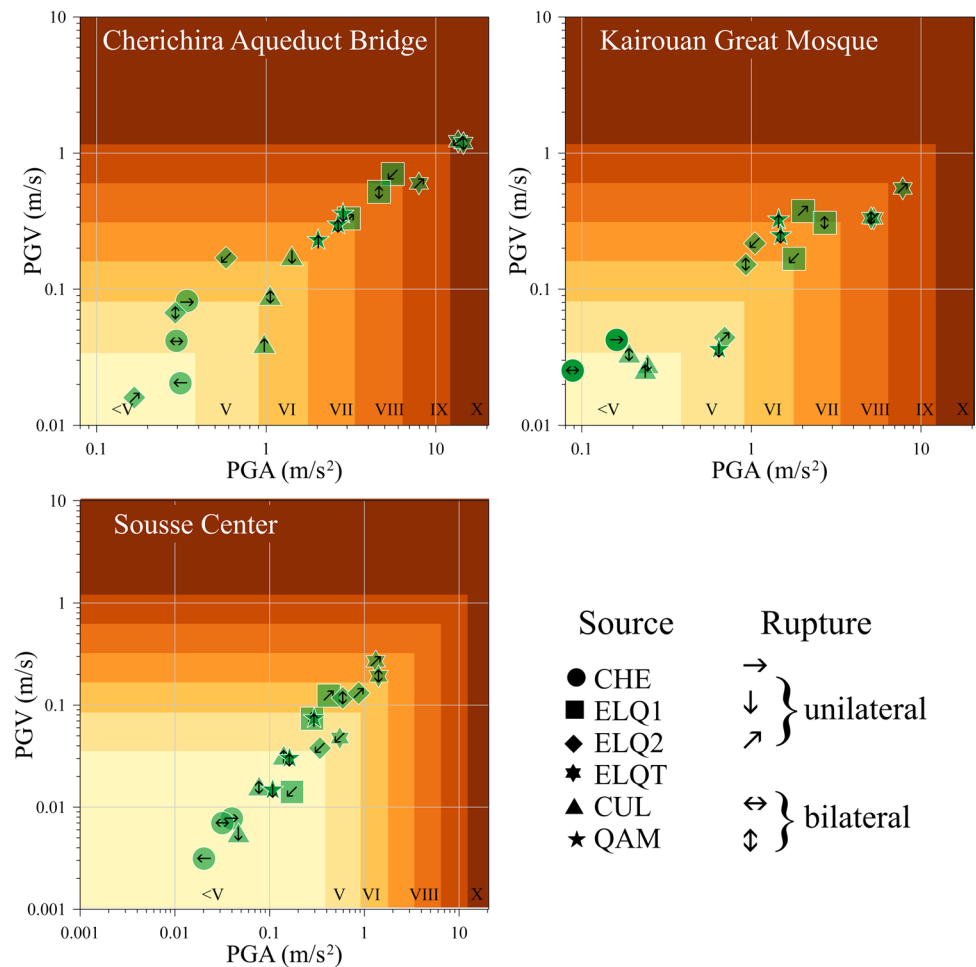
**Fig. 16** RMS values of the peak ground (PGV) velocity of the two horizontal components plotted in relation to RMS values of the peak ground acceleration (PGA) from synthetic seismograms for six source models; the left, middle, and right graphs show values for the CAB, the location of the Great Mosque in Kairouan, and the center of the old city of Sousse, respectively. The symbol type indicates the source as shown in Fig. 14. Arrows within the symbols indicate the rupture direction, unilateral or bilateral, as shown in the legend. Roman numerals in the color-shaded areas give the range of MM intensities following the model of Wald et al. (1999). The lower intensity scale in the bottom graph for the Sousse Center

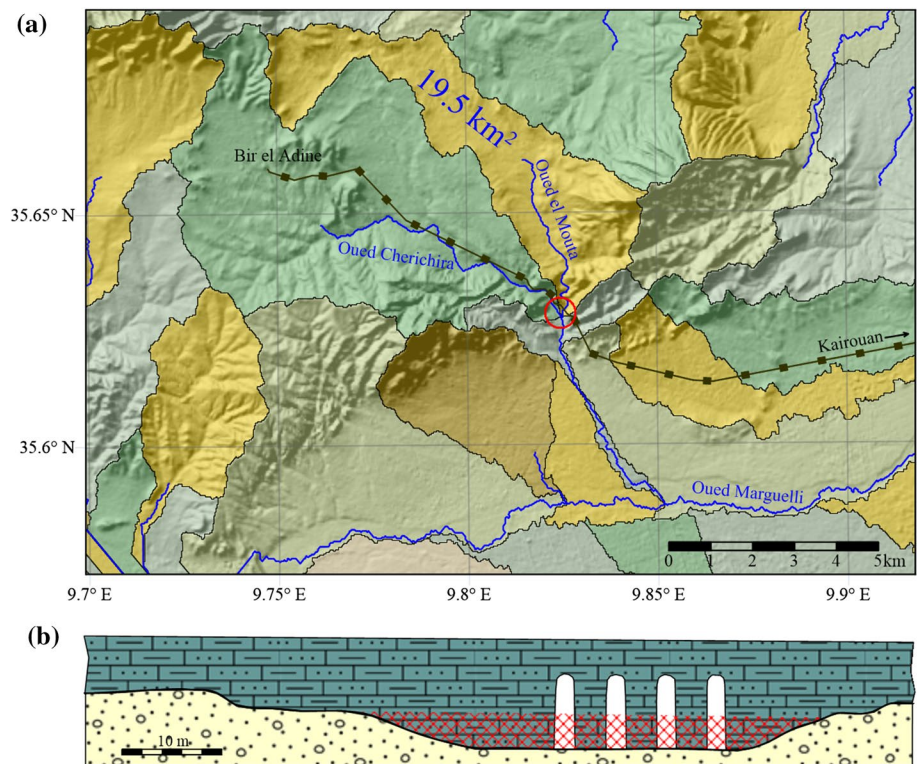
**Fig. 18** **a** Terrain model of the Cherichira area west of Kairouan overlain with the result of a watershed analysis with rivers in blue and color-shaded basins with black border lines. The trend of the Cherichira aqueduct is shown by the line with square dots. The red circle marks the location of the CAB at the junction of the Oued Cherichira and the Oued Mouta. Further indicated is the surface size of the basin draining into the Oued Mouta. **b** Simplified crosscut at the CAB. The contour of the river bed follows the terrain model in Fig. 4a; the red-hatched section ( $h=3.5$  m) of the river bed comprises a crosscut area of  $140\text{ m}^2$

of 20% total rain volume, the water crossing the bridge is  $800,000 m^3$  in 30 min equivalent to  $444 m^3/s$ .

Our rough estimate of the damaging potential of a flash flood in the Oued el Mouta (under the CAB) and eyewitness reports about recent floods, which were even larger than the one we assumed, show that a high water level and related flow rate may well have harmed the integrity of the CAB during its long history. The heavily damaged corners of the lower part of the pillars look more like the consequence of streaming water than ground motion from earthquakes, e.g. the consistent height of the damaged section could well be explained by horseshoe vortexes in the currents between the pillars. However, the cause of the total collapse of section C and the gap of section D are still unresolved. When the water flow of a stream is forced through a narrowing, e.g. a bridge, scouring effects occur, the severity of which depend on the strength of the water flow and the soil conditions along the embankment (Arneson et al. 2012). Particularly during sudden flooding events, flow concentration and boundary interactions lead to turbulence which in turn can cause scour destabilization of the channel bank. A contributing factor in flash floods can also be floating debris (tree stems, etc.) partially blocking the passage. A possible scenario at the CAB would be a washout of the embankment north of pillar 1 and eventually a slope failure causing the collapse of the abutment in section C. Arneson et al. (2012) also point out, that repeated floods cause accumulating effects and the

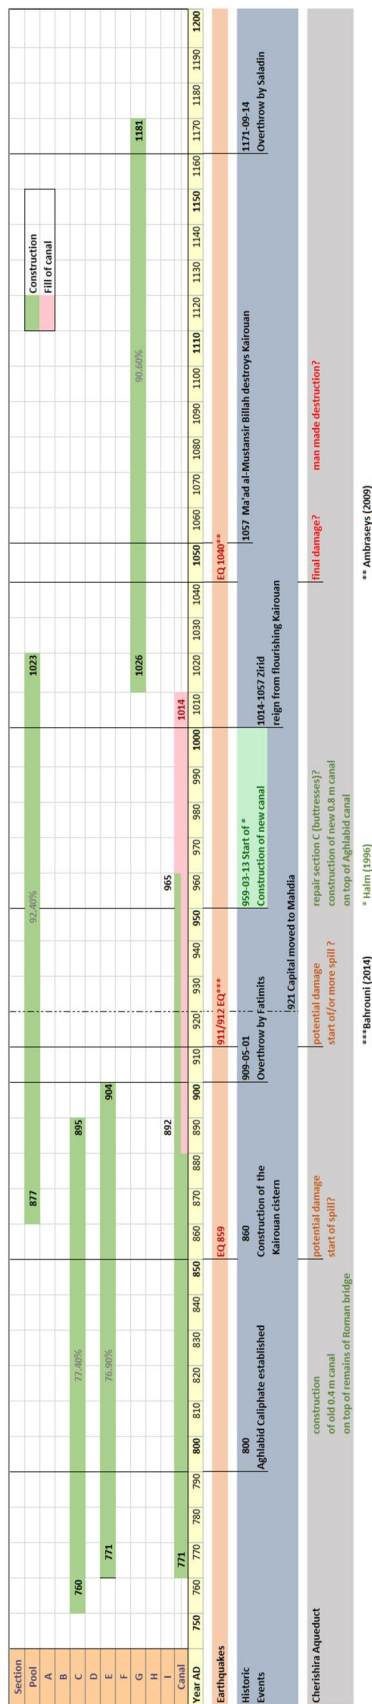
Fig. 19 Timeline of the sequence of events at the CAB from 8th to 12th century AD. Green and pink shaded lines indicate the 2-sigma intervals of C<sup>14</sup> dating in sections of the CAB given on the left. Further indicates is the time of three earthquakes (red shading) and historic events in the blue shaded row. At the bottom (gray) events at the CAB are indicated

To shed more light on the fate of the CAB, the observations, measurement results, and historic reports have to be sorted according to approximate dates. Figure 19 shows a timeline with results of  $C^{14}$  dating, historic events and data from the earthquake catalogs. Due to the relative short time span during which the (repeated) damage and repair intervals of the CAB and the uncertainty in the physical dating (Figs. 12 and 19), a clear temporal delamination of the events is not presently possible. However, the radiocarbon dating brackets a few events. With high probability, the canal section south of the bridge (Bahrouni et al. 2020b) was built contemporaneous with the canal of section C and the wall in section E during the Aghlabid period and before the earthquake of AD 859. The small pool, a few hundred meters upstream from the bridge (Fig. 4b), can be assumed to be contemporary with the initial filling of the canal south of the bridge as the two-sigma ranges of the samples from each correlate: AD 892–1014 and AD 877–1023, respectively. It can be reasoned that after a damaging event, the CAB was dysfunctional, and the canal south of the bridge started to fill with sediment, but the water flow in the section north of the bridge was still working. The pool was then constructed to collect and distribute water locally, e.g. as a cattle watering tank. The uncertainty in the dating prevents discrimination between the AD 859 and the AD 911 earthquake or both as

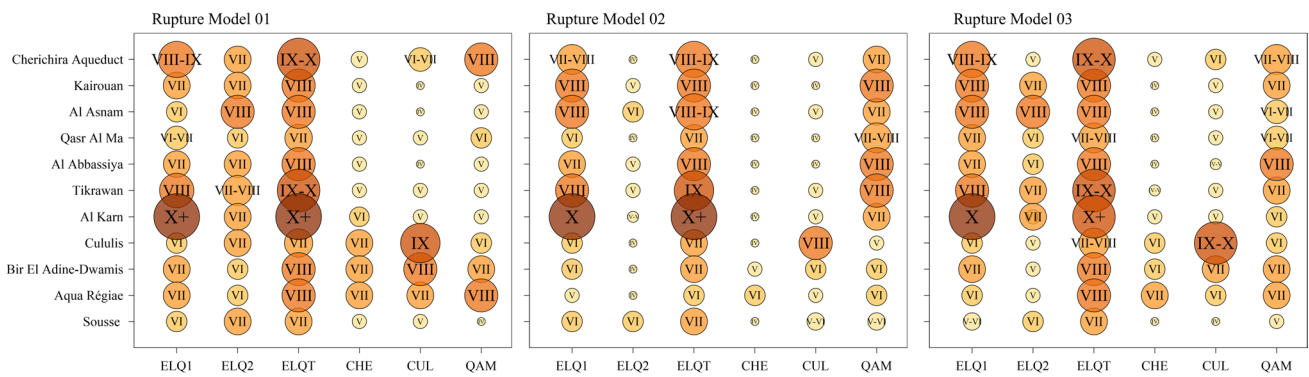
**Fig. 20** Summary of the estimated MM intensities for 11 sites (names on the left axis) and the 18 earthquake scenarios; the rupture models and the related directivity are given above the graphs and as in Fig. 16; circle size scales with the intensities given in Roman numerals

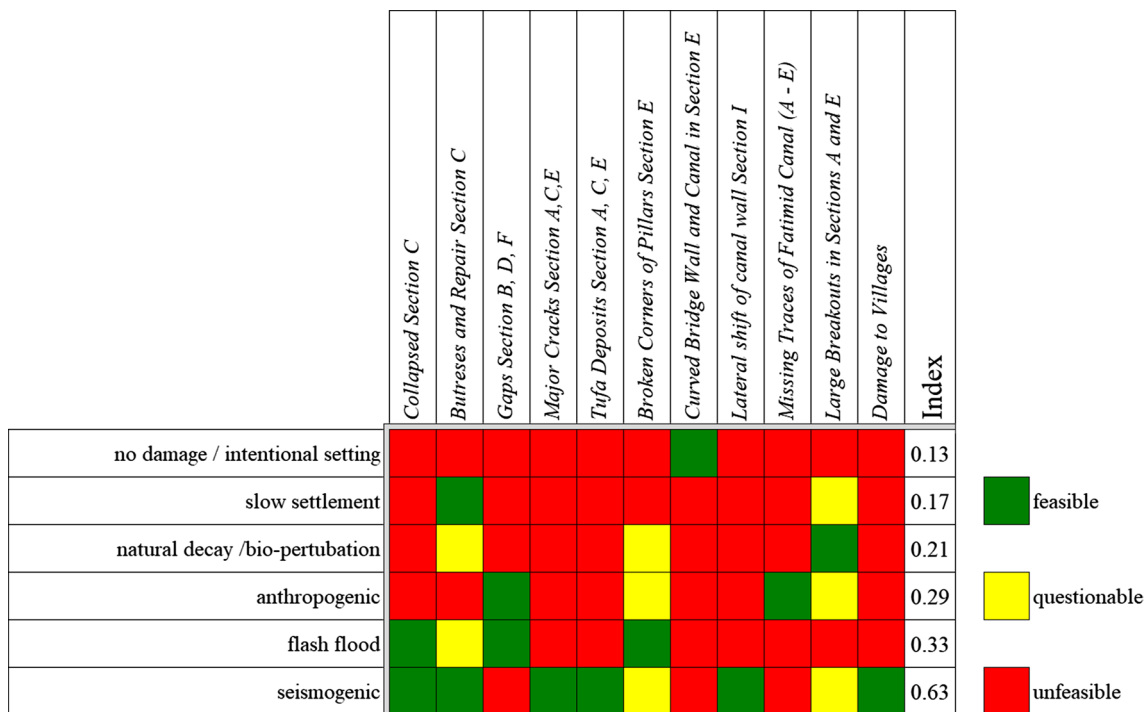
**Fig. 21** Plausibility matrix linking six potential causes of damage (rows) with 11 observations or damage descriptions of the CAB and its surrounding. The index is a measure of plausibility of a single cause in terms of all observations and damage descriptions (Hinzen et al. 2012)

Most but not all observations of damage at the CAB can be related to earthquake ground motions. Figure 21 summarizes the plausibility of observed damage and potential cause for the CAB in the form a matrix (Galadini et al. 2006; Hinzen et al. 2012) categorizing the damage/cause relation simply feasible, questionable, or unfeasible. Plausibility is then quantified by a number between 0 and 1 (Hinzen et al. 2012), meaning that none or all of the observations can be explained by a particular cause, respectively. Six causes are linked to 11 observations which have been discussed above with the highest score of 63% possibility assigned to a seismogenic origin.
