## Fatigue damage mechanisms in steel cable under bending loading

Matthieu Bonneric, Véronique Aubin, Damien Durville

Matthieu Bonneric, Véronique Aubin, Damien Durville. Fatigue damage mechanisms in steel cable under bending loading. *Engineering Failure Analysis*, 2019, 106, pp.104184 -. 10.1016/j.engfailanal.2019.104184 . hal-03489021

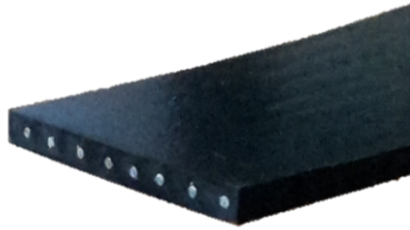
Figure 2: Transverse cut of a composite specimen

The specimens used for fatigue testing are parallel steel cables immersed in an elastomer layer of 3 mm thickness (figure 2). These specimens are obtained by calendaring before vulcanizing the elastomer matrix, with the cables in the middle of the specimen thickness. The presence of the elastomer impacts on wire

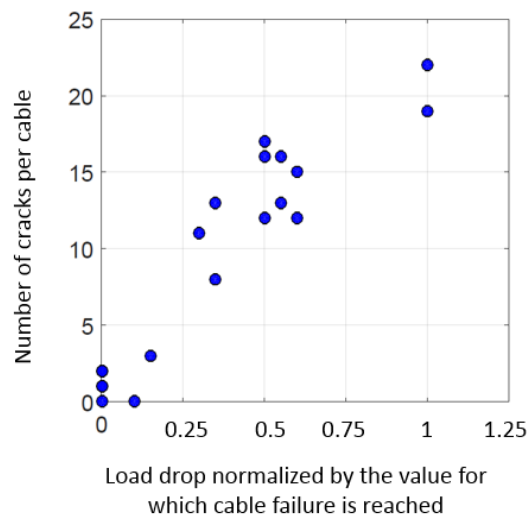
Figure 6: Evolution of the number of the detected cracks in specimens containing one cable with respect to load drop

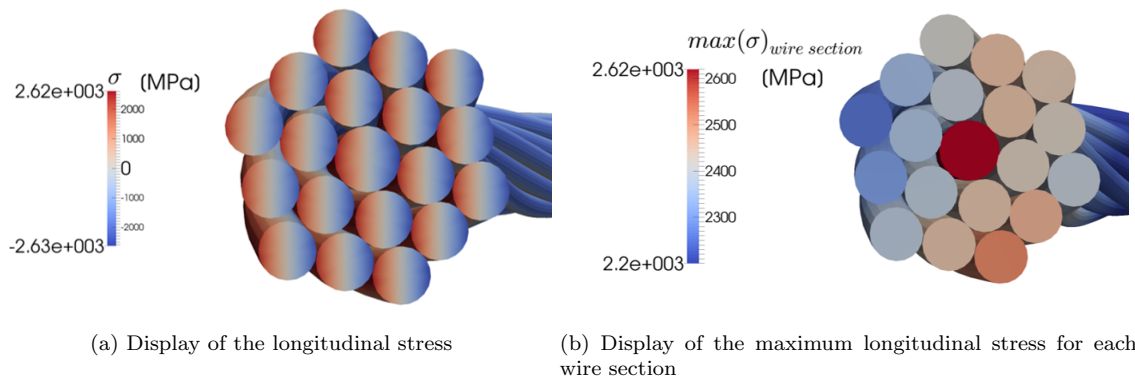
Figure 12: Visualization of the spatial distribution of the longitudinal stresses within a transverse section of cable in the middle of the bent area

Figure 12a shows the typical distribution of the longitudinal stresses in the middle of the specimen when the cable is highly bent. One can see that every wire is subjected to a significant bending, and that the stress varies from several thousands of MPa within wire section. The bending of wires being predominant,

the following analysis only focuses on the longitudinal stresses in wires. In particular, attention is paid to the maximum longitudinal stresses at the surface of wires. In order to dispose of an appropriate scale to compare the maximum stresses from different wires, the value of the maximum stress in each wire section is attributed to the whole wire section when displaying the results. This results in a single color for each wire section on the viewing, as shown in figure 12b.

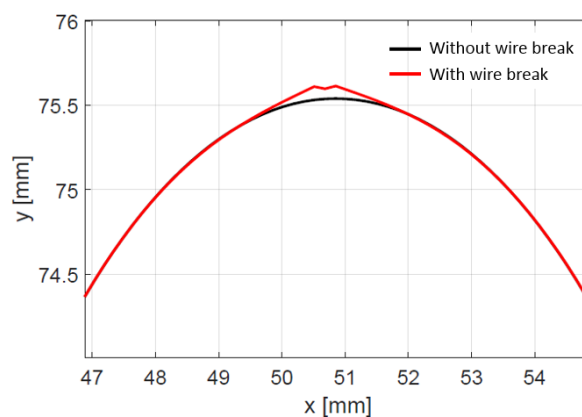
Figure 15: Modification of the trajectory taken by the core wire after its break for the case of moderate bending

Previous analysis showed that the core wire is highly stressed all over the bent area for moderate bending, whereas the stress in other wires barely exceeds the fatigue limit, and only in some specific regions. Based on simulation results, it can therefore be assumed that the first wire that is likely to break in case of moderate bending is the core wire. Besides, 2 additional fatigue tests interrupted at an early stage of damage, before any drop in the load measurement, have been performed. X-ray tomography observations of the cables then confirmed that the first wire to break is the core wire. In order to account for the first wire break in the simulation, the stiffness of a beam element of the core wire located in the middle of the bent area was set to zero. The break was introduced in the bent position after 2 cycles corresponding to moderate bending,

and an additional cycle was performed with the broken wire before analysing stress distribution. Although this modelling of the wire break does not account for the separation of the two ends of the broken wires, it is assumed that it provides an acceptable description of the broken wire within the bent cable, the presence of the neighboring undamaged wires limiting the separation of the 2 broken ends. Figure 15 shows how the trajectory taken by the core wire within the bent cable is affected by the break. Although the curvature is lower on both side of the break, it is locally increased at the level of the break. This local increase in cable curvature results in a significant increase in the stress at the level of the cable section corresponding to the break. This can be observed in figure 16 that provides 3D views of the stress distributions in the cable section in the middle of the bent area obtained respectively with and without the wire break, for the case of moderate bending. One can note that the wires on the top of the cables are stressed above the fatigue limit, confirming that crack initiation is possible once the core wire is broken. Besides, it can be seen in figure 16b that this increase in stress only concerns the damaged cable section, and that the stress in wires is much lower apart from this section. This is consistent with the distribution of cracks observed with X-ray tomography for moderate bending, for which cracks were localized at the level of a single cable section.
