Tribological behavior of glass fiber reinforced-PA66 in contact with carbon steel under high contact pressure, sliding and grease lubricated conditions

Takeshi Kunishima, Yasuharu Nagai, Takanori Kurokawa, Gaëtan Bouvard, Jean-Christophe Abry, Vincent Fridrici, Phillippe Kapsa

Keywords: Polyamide, Glass fibers, Wear, Grease, Composite, Worm gear

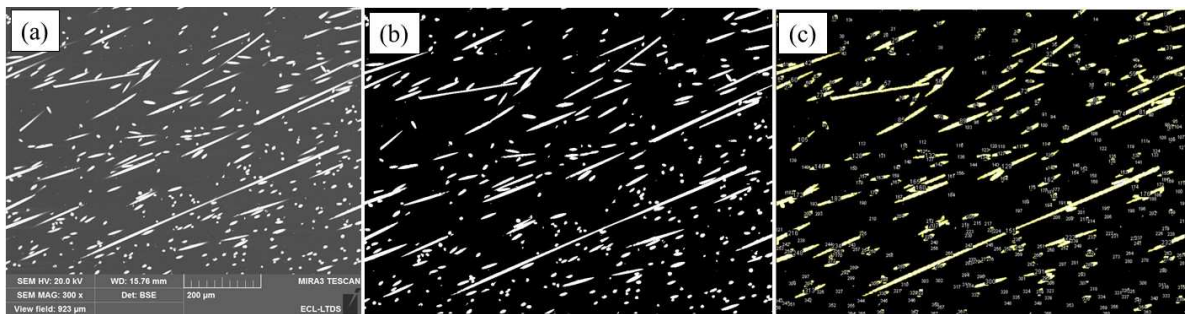
Fig. 14 Image analysis

(a) SEM image; (b) Binarization of image; (c) Particle analysis

To better understand the differences in wear for each area of the steel, the differences in fiber orientation in the composite ring were evaluated quantitatively with an image analysis of the sliding surface of a composite ring. First, the polished sliding surface of the composite ring was prepared using #4000 polishing paper, and three BSE images of the inner/center/outer areas at a magnification of x300 were obtained, as shown in Figure 13. Afterward, the GF and PA66 areas were separated by binarization using the software package imageJ (produced by Wayne Rasband) as shown in Figure 14, and the total area of GF and the total perimeter of GF (corresponding to the total length of the contact between GF and PA66) were calculated. Furthermore, the distribution of the circularity of each GF was calculated. Circularity indicates the orientation of GF in the sliding

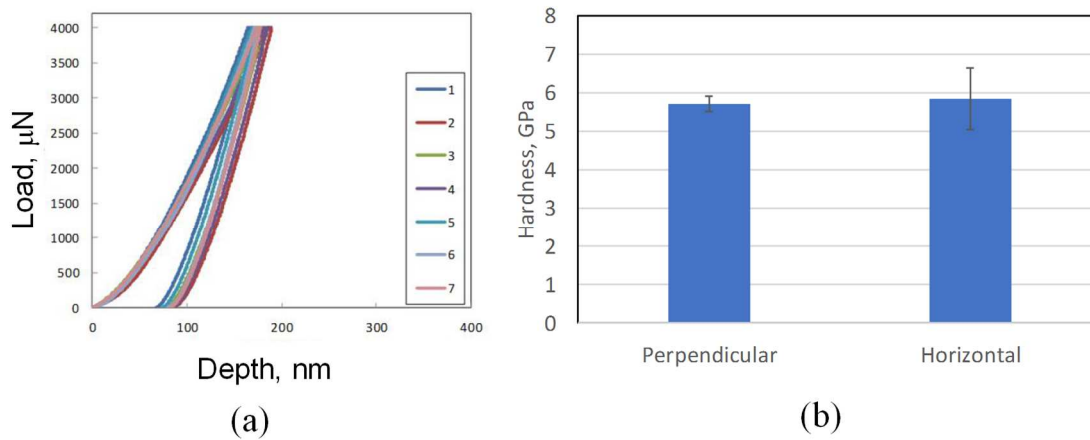
Fig. 25 (a) Load-displacement curves obtained using nano indentation measurements and (b) measured hardness of GF in each direction (average values in 7 measurements).

These results are explained by the difference between the hardness of the GF and the counterpart steel cylinders. The hardness of GF was measured using the following process. First, the GF were embedded in epoxy resin in the horizontal or perpendicular direction, as presented in Figure 24(a), and the epoxy resin was cured. Then, the surface of the epoxy resin was polished and the hardness of the GF in each direction was measured using a nano indentation process; the normal load used for the measurements was 4,000 μN . Figure 24(b) shows the AFM images after the hardness measurements, and the indentations are observed on the surface of the GF. Figure 25 shows the load displacement curve for the measurements and the obtained hardness of the GF in each direction. No difference in hardness was observed between the horizontal and perpendicular directions, and the value was close to the hardness of steel with a hardness of 5.36 GPa.
