Towards a more effective and reliable salt crystallisation test for porous building materials: Experimental research on salt contamination procedures and methods for3 assessment of the salt distribution

The RILEM TC ASC-271 is developing a new laboratory test to assess the durability of porous building materials to salt crystallisation. The test encompasses two phases: salt accumulation and damage propagation. This paper focuses on designing a procedure for the accumulation phase; this is considered successful when salts crystallise at the material's evaporative surface (common situation observed on site) without the occurrence of damage. Two procedures were developed and tested on two limestones with different porosity: (1) capillary absorption of a salt solution followed by drying, and (2) continuous capillary absorption. Sodium chloride or sodium sulphate solutions were used. Several methods for assessing the salt distribution were employed: ultrasonic pulse velocity, drilling/scratching resistance, hygrosopic moisture content, ion chromatography, scanning electron microscopy, and micro X-ray fluorescence. The results enabled the selection of the most effective protocol for the

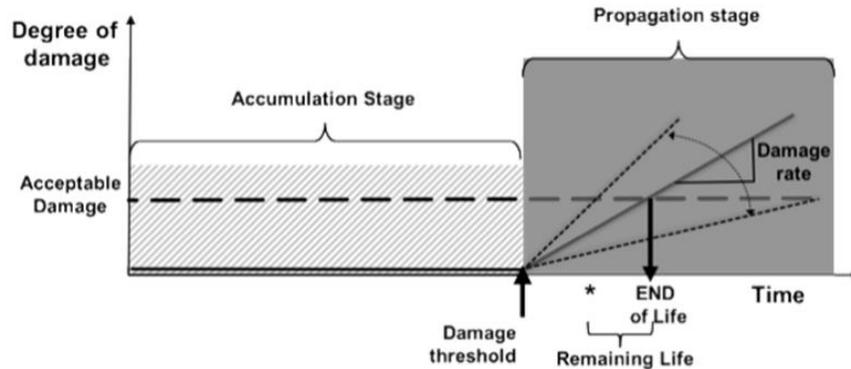
Figure 1: Schematic representation of durability of a stone, subject to salt damage, adapted from the concept proposed by Tuutti [10] to describe the durability of reinforced concrete (image from [11] provided by Robert J. Flatt (ETH Zurich)).

71 TC ASC-271 proposes a new approach to salt crystallisation tests, which differs from existing weathering
72 procedures in this field. In this approach, which is derived from the field of concrete durability [10], as
73 described in Flatt et al. [11], the salt crystallisation damage process consists of two phases: (i) the
74 induction phase, in which salts accumulate in the pores of the material (but the degree of pore filling is
75 not high enough to initiate damage); and (ii) the propagation phase, during which
76 dissolution/crystallisation cycles lead to (increasing) damage (Figure 1).

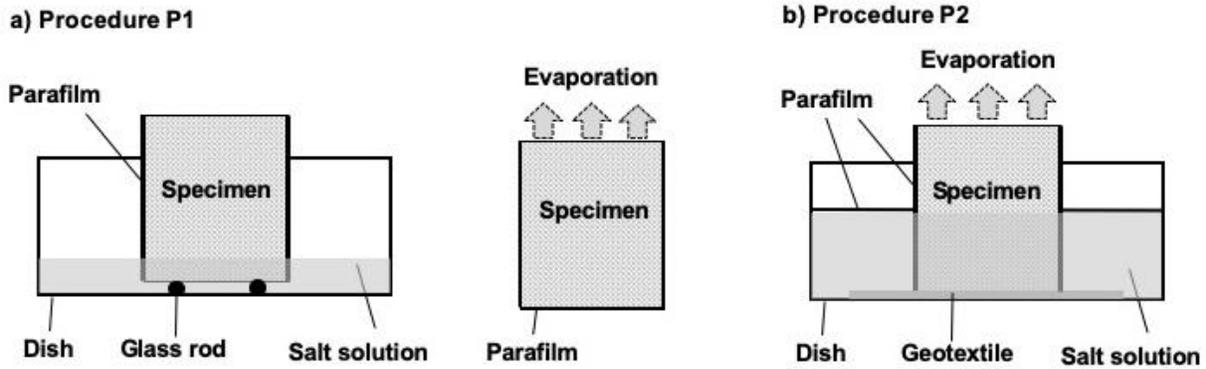
Figure 2: Experimental setup used in the contamination experiments: (a) capillary absorption followed by drying (P1), (b) continuous capillary absorption (P2).

51
52 206 In this procedure, the salt solution was poured into a contamination dish with a geotextile layer on the
53 207 bottom (ca. 1 mm thick), and the bottom of the specimen was placed in contact with the solution (Figure
54 208 2.b). The amount of water used in the preparation of the solution was the same as the total amount of
55 209 water used in procedure P1-2W, i.e., the sum of water used during the initial salt contamination (P1-1S)
56 210 plus the water used in the two following rewetting cycles to achieve the same amount of salt (1 wt.%)
57 211 with respect to the dry weight of the specimens.

Drying occurred only through the top surface of the specimen at 20°C and 10% RH. Evaporation of the solution from the dish during the test was prevented by covering it with a parafilm sheet. After complete absorption of the salt solution, the bottom of the specimens was sealed, and the specimens were left to dry (20°C and 10% RH) until 80 wt.% of the water absorbed evaporated. Afterwards, the specimens were dried at 60°C to constant mass before assessing the salt distribution.

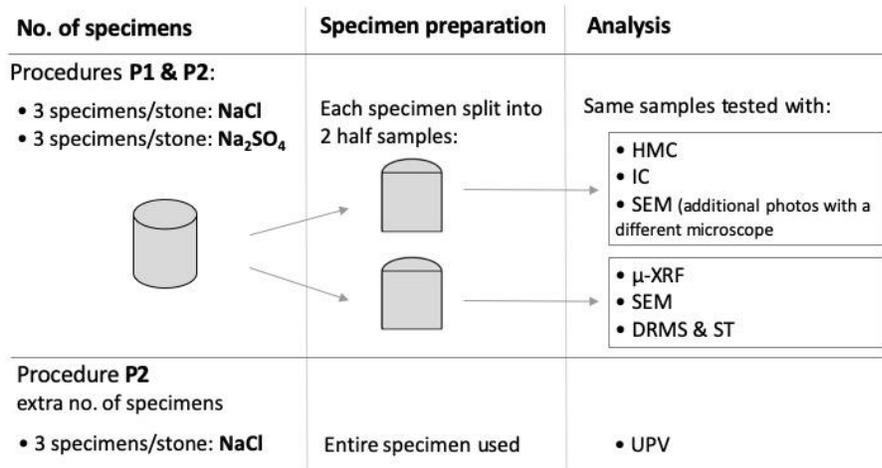
Figure 3: Summary of the number and type of specimens tested with each procedure and analysis performed.

After the accumulation phase tests, the specimens were split into two halves, using a hammer and chisel, for analysis with the mentioned methods, except for the specimens subjected to UPV measurements. Figure 3 shows a scheme summarizing the number and type of specimens and respective analyses performed with each method of assessment of salt distribution.

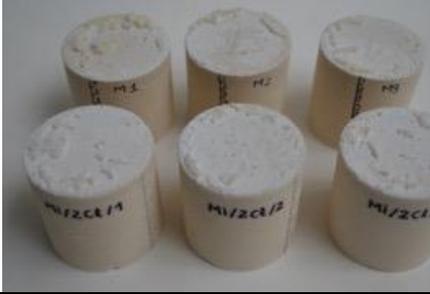
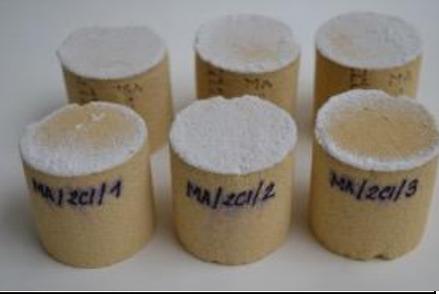
| Procedure | | Migné - NaCl | Maastricht - NaCl |
|---|---|---|--|
| | Damage/alteration | Efflorescence | Efflorescence |
| | Salt efflorescence | Powdery | Powdery |
| | Damage severity | No damage | No damage |

Figure 4: Summary of the macroscopic visual observations on the specimens contaminated with NaCl. Scores of severity of damage: low (+) to high (++++). Scores of extension of damage: small (+) to large (++++) surface area.

40 380 Samples contaminated with NaCl with both procedures developed only salt efflorescence, and no visible
41 381 damage was detected (Figure 4). The type and amount of salt efflorescence (Figure 6.a) varied according
42 382 to the procedure followed and type of stone used: a lower amount of NaCl efflorescence developed in the
43 383 less porous stone (Migné) with procedures P1-1S and P2, but the amount was still slightly higher than for
44 384 the more porous stone (Maastricht) with procedures P1-1W and P1-2W. The results of mass loss (Figure
45 385 7.a) can be considered negligible (lower than 0.05 wt.%) and confirm the visual observations.

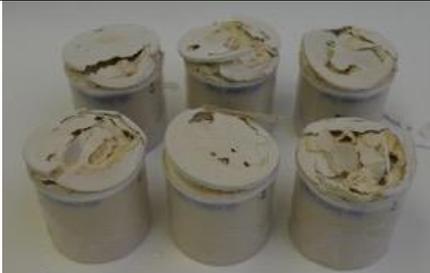
| Procedure | | Migné – Na ₂ SO ₄ | | Maastricht – Na ₂ SO ₄ | |
|---|---|---|---|--|---|
| | Damage/alteration | Bursting with subflorescence | | Granular disintegration with subflorescence | |
| | Salt efflorescence | Crust | | Crust | |
| | Damage severity | ++++ | | ++ | |
| | Damage extension | ++++ | | ++++ | |

Figure 5: Summary of the macroscopic visual observations on the specimens contaminated with Na₂SO₄. Scores of severity of damage: low (+) to high (++++). Scores of extension of damage: small (+) to large (++++) surface area.

In the case of the more porous stone (Maastricht), samples contaminated with Na₂SO₄ with procedure P1-1S developed slight granular disintegration and scaling, leading to 0.7 ± 0.4 wt.% mass loss (Figure 7.b). After one rewetting (P1-1W), the amount of salt efflorescence increased significantly; the amount of efflorescence reached almost 90 wt.% of the salt introduced, whereas mass loss was ca. 1.1 wt.%. The 2nd rewetting step (P1-2W) induced more damage (ca. 2 wt.% of mass loss) and slightly more salt efflorescence. In contrast with Migné, damage occurred in Maastricht samples contaminated with Na₂SO₄ with procedure P2.

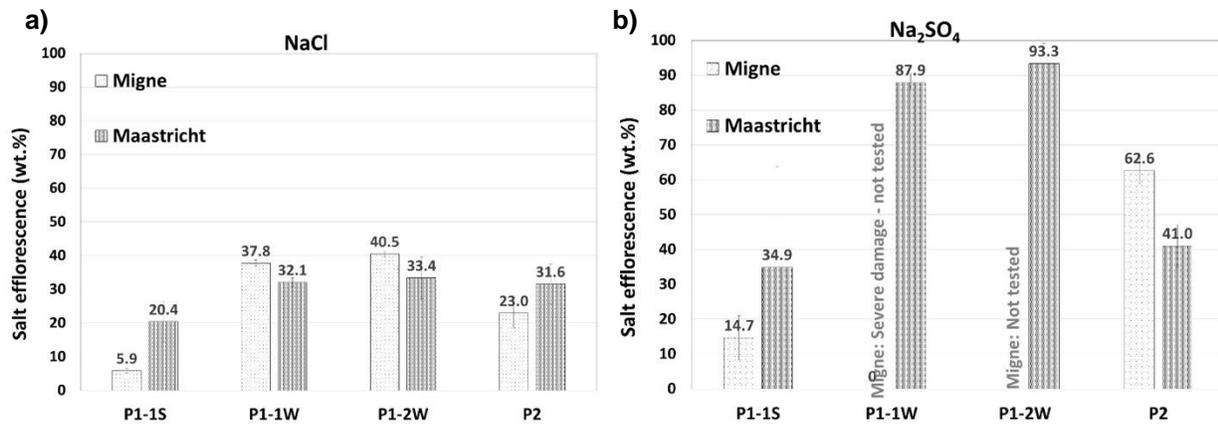
Figure 6: Mass of salt efflorescence registered after the salt accumulation test with procedures P1 and P2 expressed as the percentage relative to the total salt amount introduced in the specimens: (a) stones contaminated with NaCl, (b) stones contaminated with Na₂SO₄.

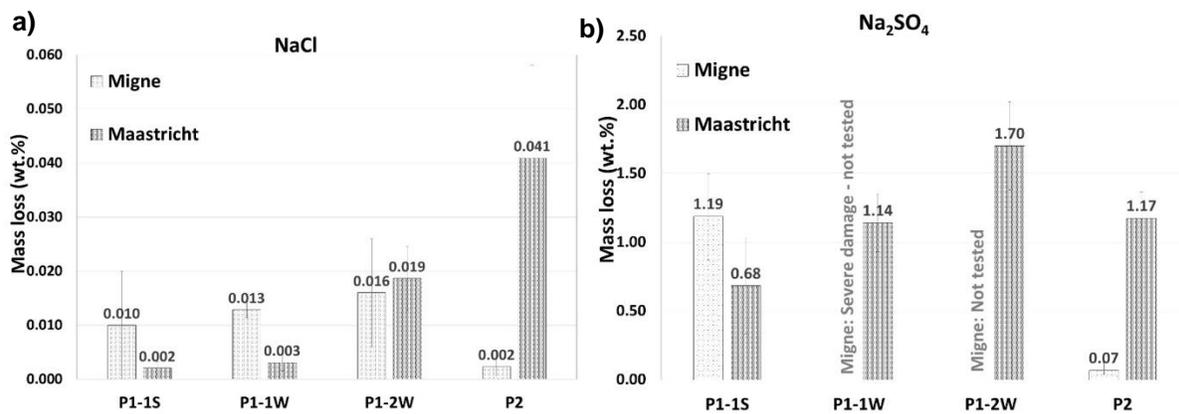
Figure 7: Mass loss of stone material registered after the salt accumulation test with procedures P1 and P2, expressed as the percentage relative to the dry weight of the specimens: (a) stones contaminated with NaCl, (b) stones contaminated with Na₂SO₄.

Both types of stones contaminated with Na₂SO₄ showed damage with all procedures (Figure 5). Minor damage was observed in Migné after Na₂SO₄ contamination with procedure P1-1S, leading to ca. 1 wt.% of mass loss (Figure 7.b); the amount of salt efflorescence observed was very low and concentrated close to the evaporative surface. After one rewetting, Na₂SO₄ contaminated Migné specimens (P1-1W) suffered rapid and severe damage (within 24h of drying). For this reason, the planned second rewetting was not performed, and these specimens were not subjected to the analysis of salt distribution.

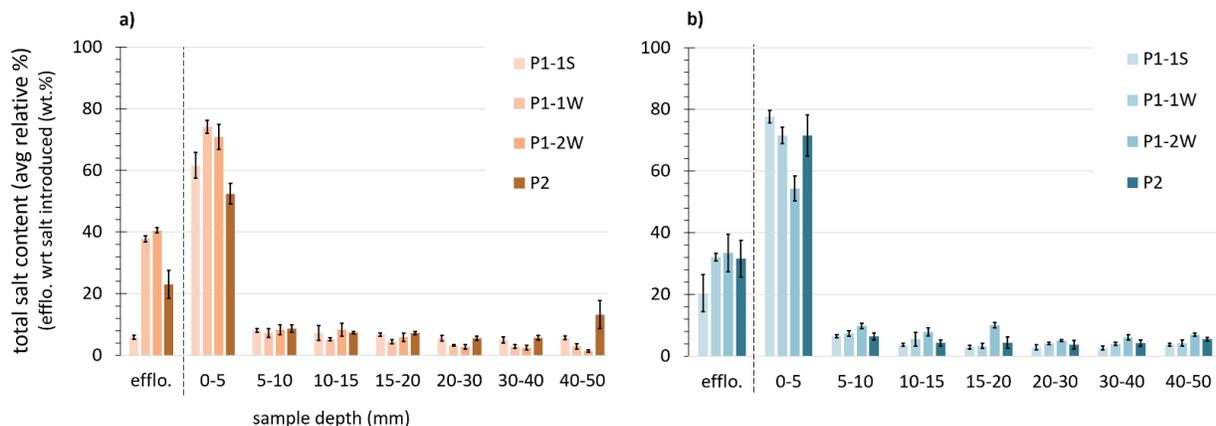
Figure 8: Mean relative percentage of NaCl distribution assessed with IC in Migné (a) and Maastricht (b) after contamination with procedures P1 and P2. The values are the average of 3 specimens; the graphs include the amount of salt efflorescence (efflo). The legend from top to bottom represents the different procedures, which sequentially correspond to the columns from left to right.

551 as in the optimised μ -XRF map, suggesting some redistribution of the salt content with water absorption
 552 and possibly some salt escaping the sample as efflorescence; this is in line with the amount of salt
 553 efflorescence formed, as well as the IC data (Figure 8).

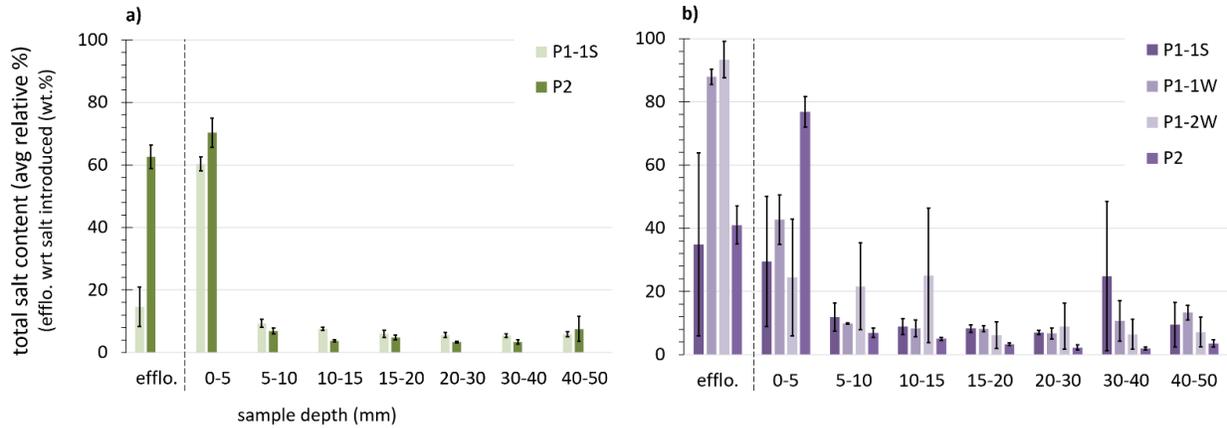
Figure 9: Mean relative percentage of Na_2SO_4 distribution assessed with IC in Migné (a) and Maastricht (b) after contamination with procedures P1 and P2. The values are the average of 3 specimens; the graphs include the amount of salt efflorescence (efflo). The legend from top to bottom represents the different procedures, which sequentially correspond to the columns from left to right.

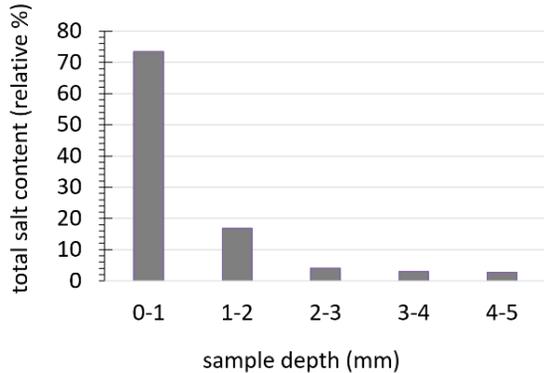
Figure 10: Relative percentage of Na_2SO_4 distribution in the first millimetres of Maastricht contaminated with procedure P1-1S.

A more detailed analysis was carried out on the first 5 mm of a sample of **Maastricht** contaminated with **Na₂SO₄** according to procedure **P1-1S** (Figure 10). The results indicate that 73.5 wt.% of the total salt content was located within the first millimetre of the specimen. Deeper in the stone, the concentration dropped significantly, with 16.8 wt.% between 1 and 2 mm, and 2.6 wt.% between 4 and 5 mm. Considering the open porosity, bulk/skeletal density of the stone, mass of salt in the stone, molar mass/volume of thenardite or phase III, it is possible to estimate that 10 % of the volume of the pores in the outer 1 mm were filled with salt (assuming a homogeneous distribution of salt, including a thin salt crust on the surface of the sample).

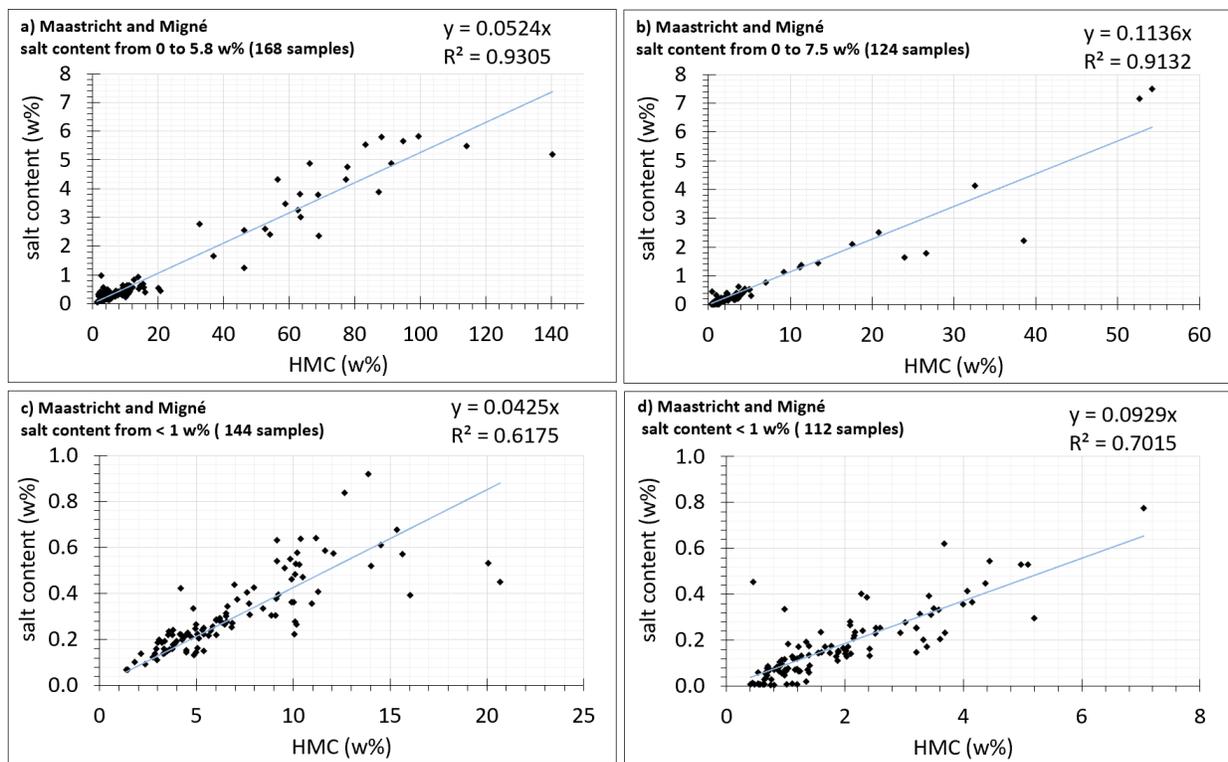
Figure 11: Correlation between HMC values and salt content (R^2 = coefficient of determination): Maastricht and Migné with NaCl (a) and Na_2SO_4 (b) content (full range detected between 0 and 5.8 or 7.5 wt.%) and with NaCl (c) and Na_2SO_4 (d) content below 1 wt.%.

The salt distribution results obtained with HMC are in line with those measured by IC. The correlation of determination between HMC and IC salt content was used in this study to check whether HMC could give reliable semi-quantitative results. Considering 168 samples with a wide range of salt contents (Figure 11.a), a good correlation was derived ($R^2 = 0.9305$). However, when considering a salt content below 1 wt.% (144 samples), the correlation dropped significantly ($R^2 = 0.6175$) (Figure 11.c). In samples with such a low salt content and weight (ca. 0.928 g), the experimental error increases. Next to the experimental error, minimal changes in RH in the climatic chamber can have a significant impact on the HMC values, especially in the case of high RH and hygroscopic salts, such as NaCl.

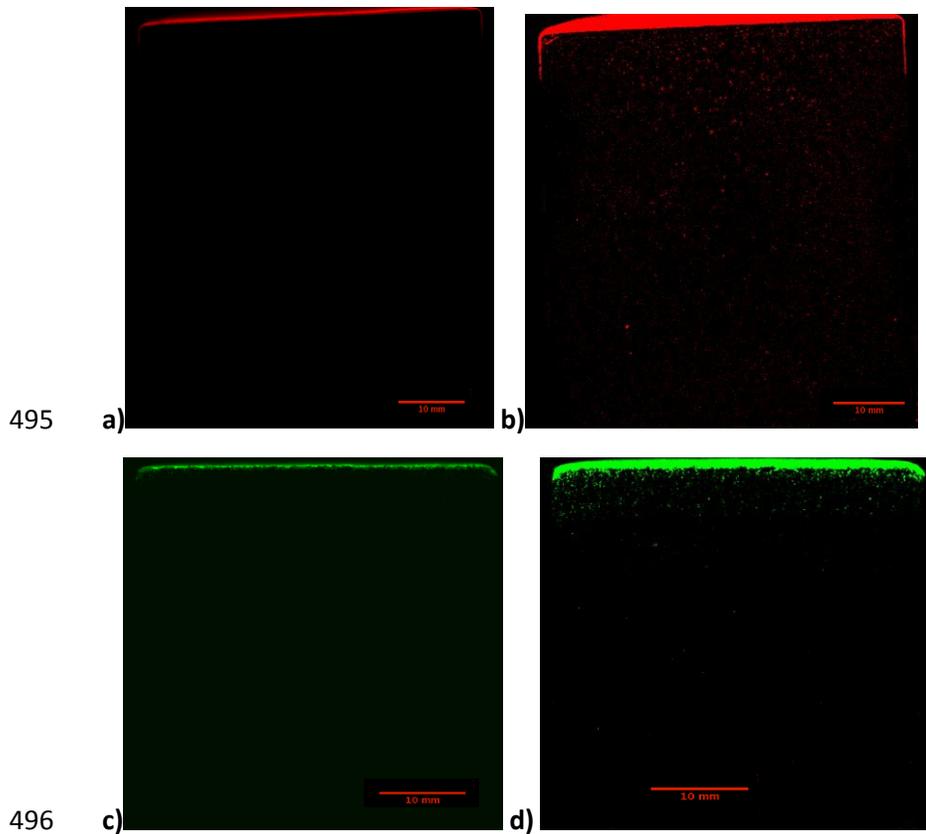
Figure 12: μ -XRF chloride maps of Migné and Maastricht contaminated according to procedure P1. Migné contaminated according to procedure P1-1S: (a) original map, (b) enhanced map by Image J software; the dense red layer on the top of the sample is an image artefact. Maastricht contaminated according to procedure P1-1W: (c) original map, (d) enhanced map by image J software; the dense green layer on the top of the sample is an image artefact.

SEM gives a more precise assessment of the thickness of the salt layer and salt distribution than the μ -XRF maps, although the salt distribution can be quite non-homogeneous. Therefore, a thickness interval is probably more appropriate rather than a single value. The representativeness of the sample observed with SEM can also be an issue; e.g., no salt layer was observed under SEM with Maastricht contaminated with procedure P1-1S with NaCl, but a salt layer up to 1 mm thickness was observed in the μ -XRF maps.

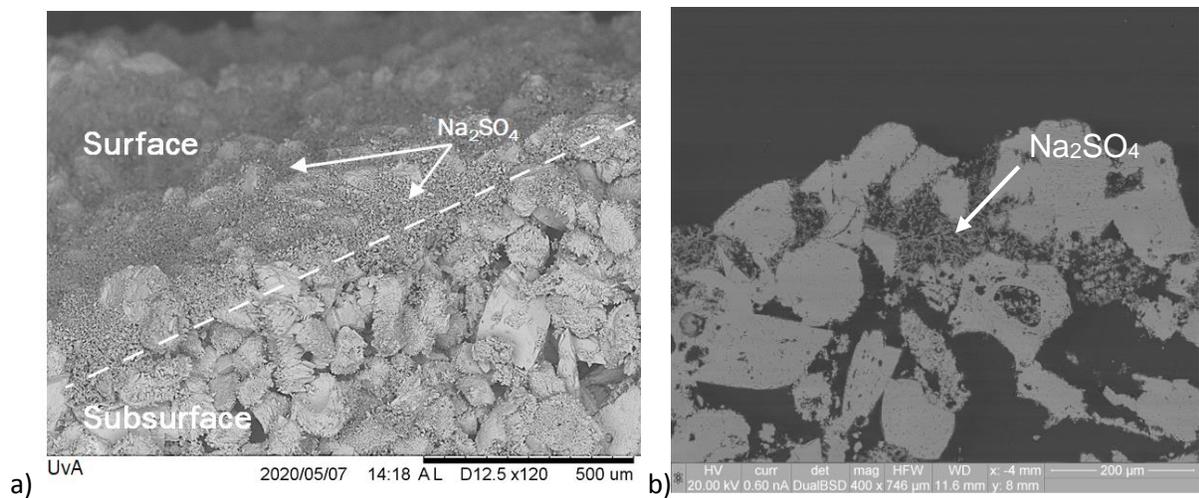
Figure 13: Maastricht contaminated with Na_2SO_4 according to procedure P1-1S: (a) SEM image of the ground surface. (b) BSE image on polished section showing a layer of Na_2SO_4 crystals filling the interparticle porosity just beneath the evaporative surface (the arrow indicates the location of salt as analysed with EDX).

| Procedure | Method | Migné - NaCl | Maastricht - NaCl | Migné – Na ₂ SO ₄ | Maastricht – Na ₂ SO ₄ |
|---|---|---|---|---|--|
| | BSE images | - Salt layer up to 200-500 μ m depth (Figure 14) | - No salt layer observed - Scattered salt crystals | - Salt layer up to 50 μ m depth - Salt crystals up to 2 mm depth | - Salt layer up to 200 μ m depth (Figure 13) - Most of the salt up to 400-500 μ m depth. - Scattered salt crystals up to 2mm depth |

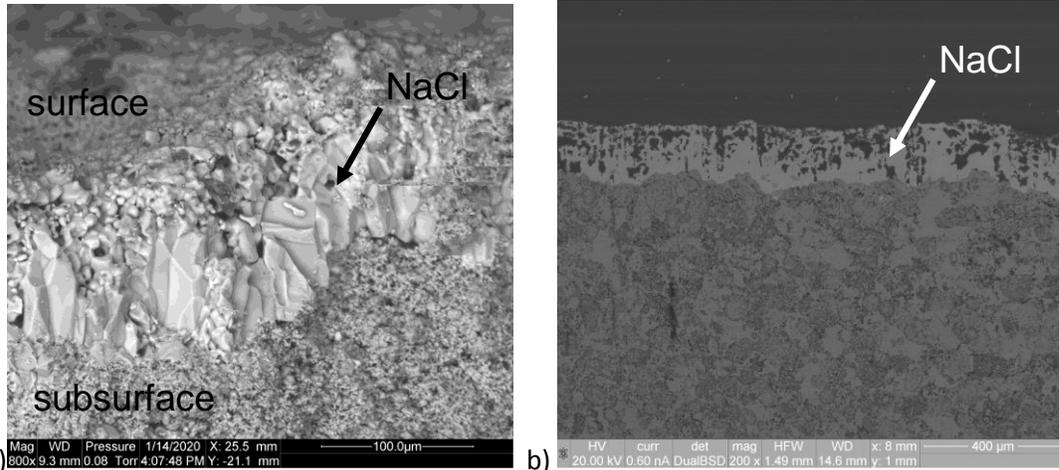
507 a) 508 **Figure 14:** Migné contaminated with NaCl according to procedure P1-1W: (a) SEM image of the ground
 509 surface, (b) BSE image of the polished section.

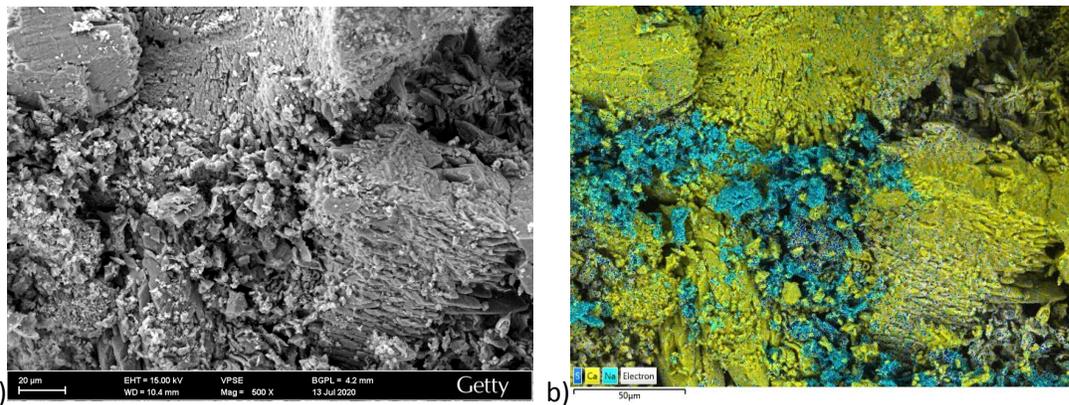
519 a) 520 **Figure 15:** SEM images of the fresh fracture close to the evaporative surface of Maastricht contaminated
 521 with Na₂SO₄ according to procedure P1-1S: (a) BSE image, (b) False colour image after EDS analysis,
 522 showing the distribution of calcium (yellow), sodium and sulphur (cyan and blue respectively).

510 The additional SEM analysis of Maastricht contaminated with Na₂SO₄ with procedure **P1-1S** showed only
 511 partial filling of the pore spaces and a higher concentration of the salt close to the evaporative surface.
 512 Images of the fresh fracture showed that the salt crystallizes as porous clusters within the inter-particle
 513 spaces (Figure 15). Such a crystallisation pattern was confirmed by the cross-section observation and
 514 mapping of the salt distribution (Figure 16). The salt was mostly concentrated up to 400-500 μm from the
 515 evaporative surface, showing a rather irregular distribution. The presence of salt was detected at least up
 516 to 2 mm depth, as isolated clusters of salt crystals formed along the grain borders of the stone. These
 517 observations are in line with the IC results on the same sample (Figure 10) in which ca. 70% of the salt was
 518 detected up to 1 mm depth and ca. 20% of salt was detected between 1.5 and 2 mm depth.

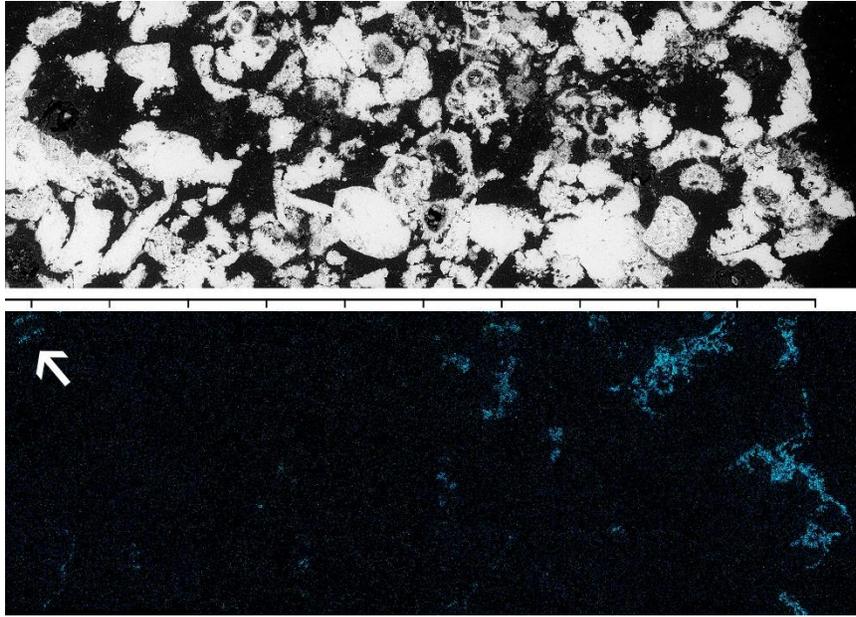
Figure 16: Maastricht contaminated with Na_2SO_4 according to procedure P1-1S. In both images, the evaporative surface is located on the right side. Above: BSE image of the cross-section. Below (same cross-section): EDS false-color map showing the salt distribution according to depth (sodium and sulphur are shown in cyan and blue, respectively; contrast has been enhanced for better clarity) with the presence of salt clusters up to 2 mm depth (arrow). Scale segments = 200 microns.

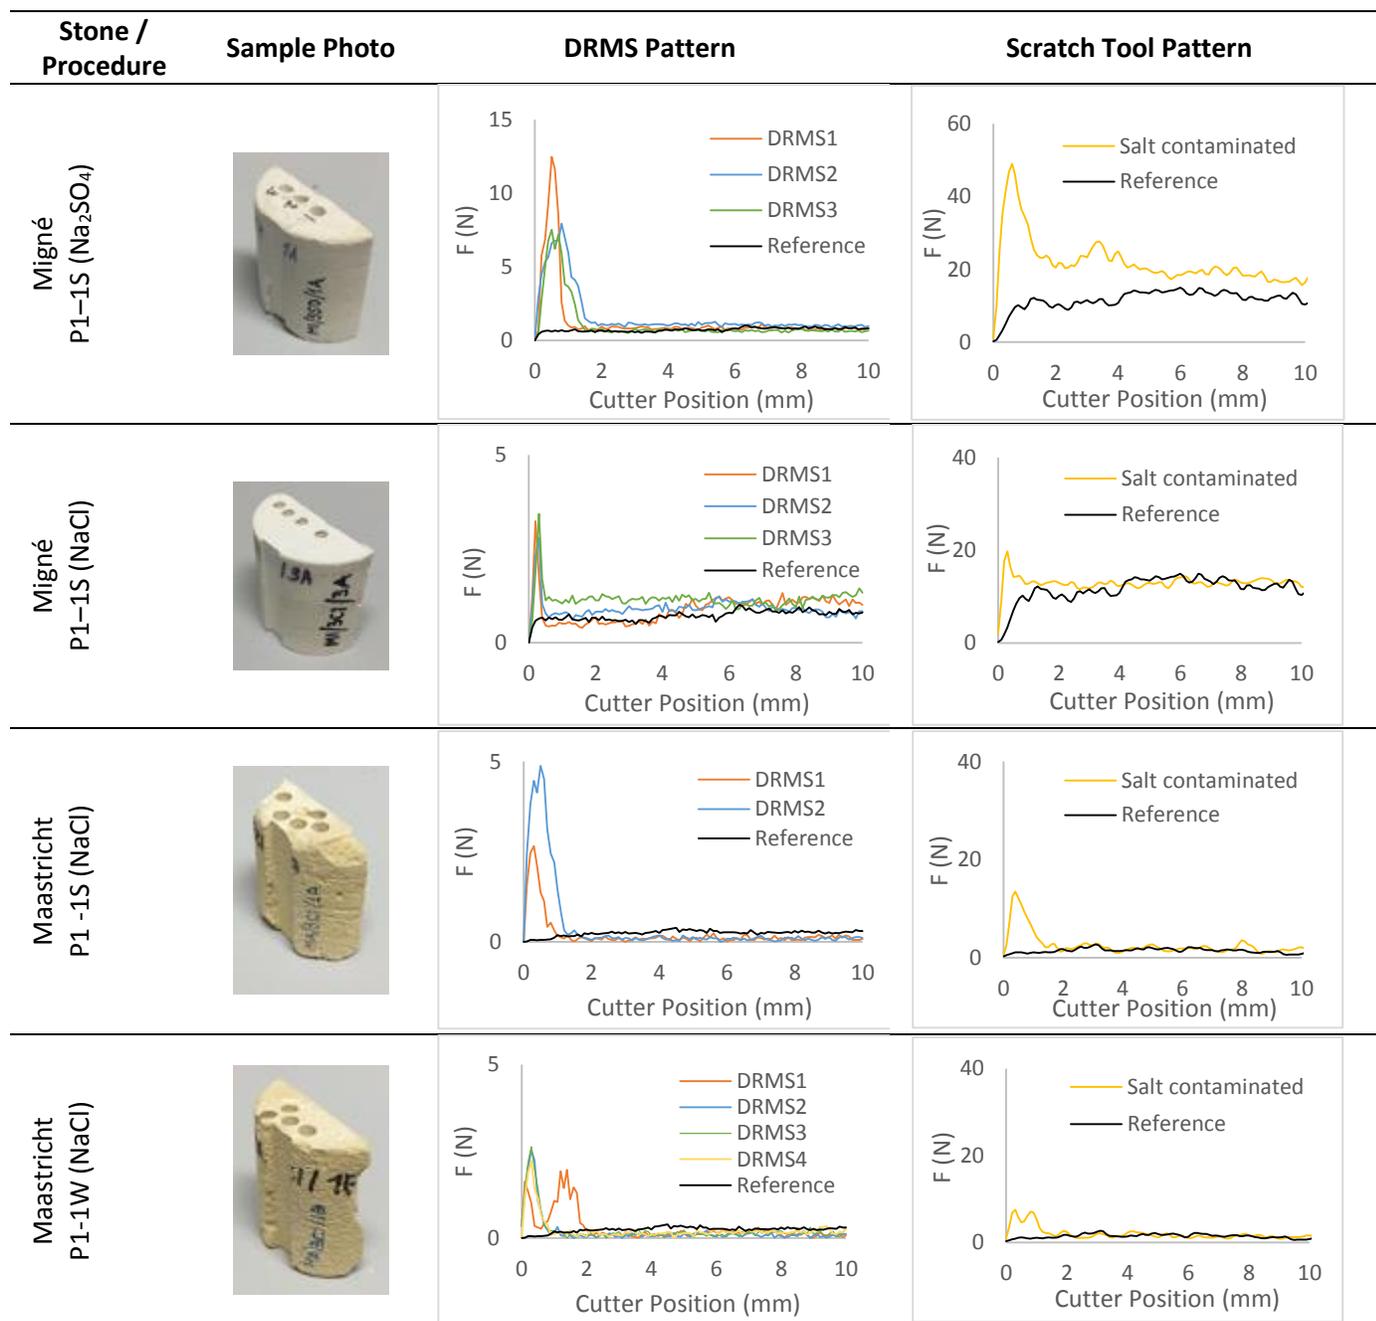
554 **Figure 17:** DRMS and average ST patterns for samples contaminated according to procedure P1
 555 (coloured lines) and reference samples (black lines).

The scratching and drilling force (F) patterns versus the cutter position (depth of the sample) are provided in Figure 17. From these, evident changes in the microstructure of the salt contaminated samples (i.e., pore clogging resulting in increased cutting resistance areas) can be observed. In particular, in all the patterns derived after salt contamination and drying, localized peaks in material resistance to cutting were recorded very close to the evaporative surface (ca. 0 - 2 mm). These peaks, which are not observed in the reference specimens, are prominent both in the ST and the DRMS patterns and suggest pore filling by the salts.

The peak cutting resistance recorded in the case of **Migné** contaminated with Na_2SO_4 with procedure **P1-1S** is much higher, compared to the corresponding sample contaminated with **NaCl**. This is in line with the μ -XRF and SEM results (Table 3), which suggest that Na_2SO_4 has a tendency to crystallise more locally, closer to the evaporative surface, as opposed to **NaCl** which shows higher dispersion. The localised crystallisation of Na_2SO_4 usually leads to more damage [16], as was indeed the case in the visual observations hereby reported (Figures 4 and 5). In the case of the much weaker and porous **Maastricht** stone, the peak resistance recorded for the sample contaminated once (**P1-1S**) with **NaCl** was again rather low. Upon rewetting with water (**P1-1W**), the peak resistance was further reduced. In contrast, the thickness of the salt-rich layer (i.e., increased cutting resistance area) appears broader, albeit not as broad

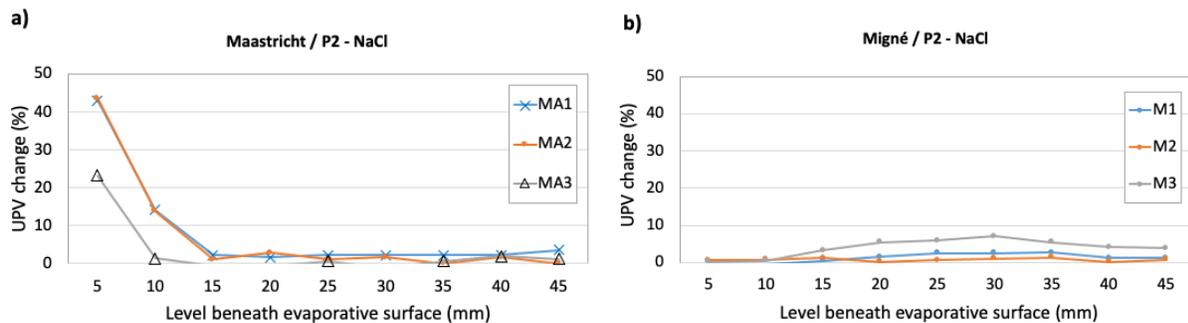
Figure 18: UPV results registered in **NaCl** contaminated specimens with procedure **P2** before and after salt contamination: (a) UPV changes in Maastricht stone measured at 5 mm intervals from the surface, (b) UPV changes in Migné stone measured at 5 mm intervals from the surface.

The UPV results before and after contamination with **NaCl** with procedure **P2** are shown in Figure 18; the values given correspond to the percentage change before and after contamination. After salt contamination, a significant UPV increase is observed in Maastricht at 0-10 mm depth from the evaporative surface; UPV values at 5 mm increased by 44%, compared to the same specimen without salt. These results indicate that salt accumulated in the first 5 mm of the specimen. In contrast, a very slight difference in UPV values before and after salt contamination was detected in Migné stone contaminated with **NaCl**. Figure 18.b) shows only 7% UPV increase after Migné salt contamination; these results suggest that salt has evenly precipitated throughout the depth of the specimen, which is not in line with the IC and HMC results.
