Environmental Durability of an Optical Fiber Cable Intended for Distributed Strain Measurements in Concrete Structures

Ismail Alj, Marc Quiertant, Aghiad Khadour, Quentin Grando, Karim Benzarti. Environmental Durability of an Optical Fiber Cable Intended for Distributed Strain Measurements in Concrete Structures. *Sensors*, 2022, 1 (22), 43 p. <10.3390/s22010141>. <hal-03519473>

Abstract: The present study investigates the environmental durability of a distributed optical fiber sensing (DOFS) cable on the market, commonly used for distributed strain measurements in reinforced concrete structures. An extensive experimental program was conducted on different types of specimens (including samples of bare DOFS cable and plain concrete specimens instrumented with this DOFS cable) that were exposed to accelerated and natural ageing (NA) conditions for different periods of up to 18 months. The instrumentation of both concrete specimens consisted of DOFS cables embedded at the center of the specimens and bonded at the concrete surface, as these two configurations are commonly deployed in the field. In these configurations, the alkalinity of the surrounding cement medium and the outdoor c

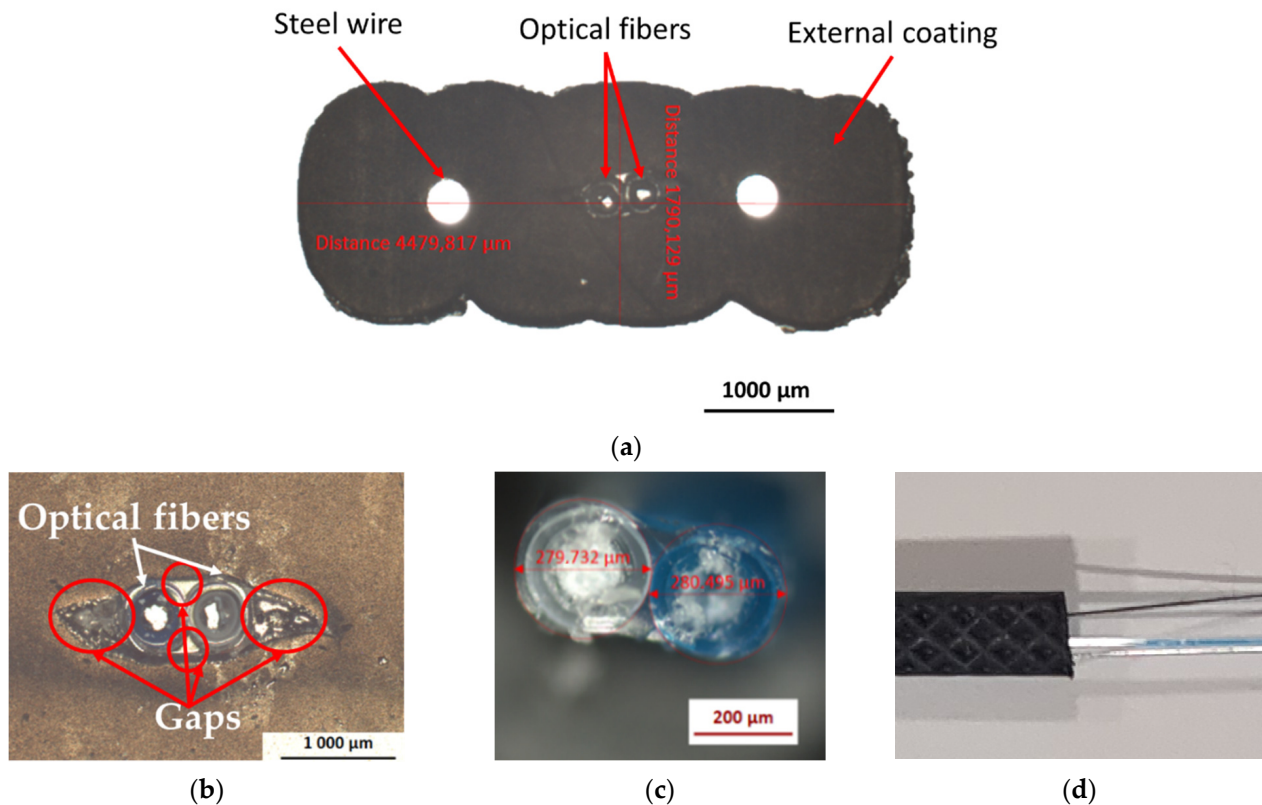
Figure 1. Optical microscope observations of (a) the cross-section of the DOFS cable, (b) the cross-section of the central part of the cable, and (c) the cross-section of the two central OFs; (d) picture showing the external surface relief of the cable, as well as an uncoated segment.

of the DOFS cable (i.e., the sensing element). Meanwhile, the interfaces between the steel wires and the external coating are sound, and do not present any visible defects.

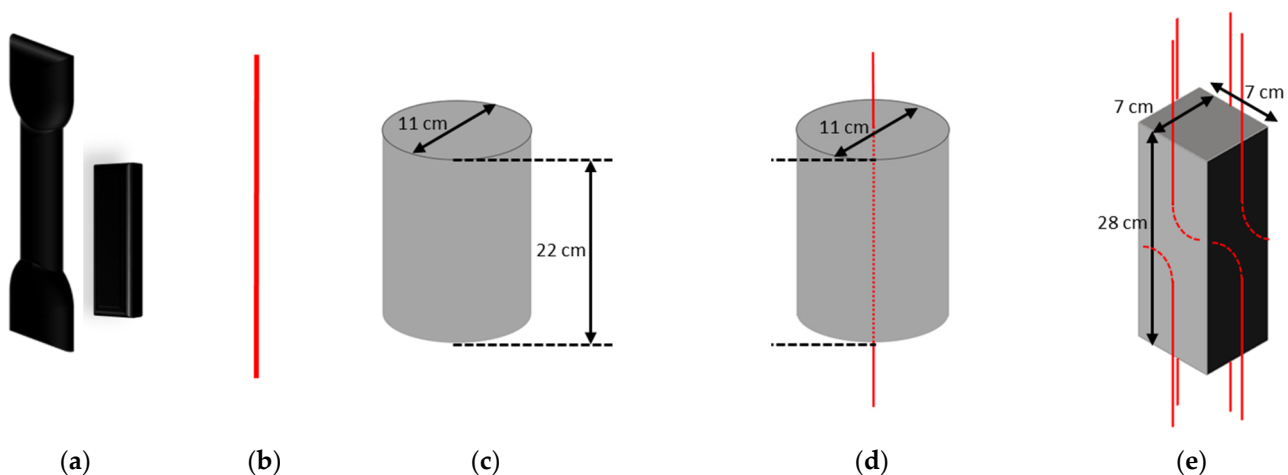
Figure 2. Schematic descriptions of the different specimens: (a) samples of bulk adhesive (b) samples of DOFS cable, (c) concrete cylinders, (d) concrete cylinders with embedded DOFS cables and (e) concrete prisms with DOFS cables bonded on the 4 lateral faces.

The samples of DOFS cable (Figure 2b) were intended for conducting tensile tests on the component materials (external coating and reinforcing steel wires), as well as pull-out tests on internal interfaces (i.e., external coating/OF and external coating/steel reinforcement interfaces). They were also used for the physico-chemical characterizations. The DOFS cable was stripped in order to prepare external coating and steel wire specimens for tensile tests, or partially stripped to prepare specimens intended for external coating/OF and external coating/steel wire pull-out tests.

- Instrumented concrete cylinders (diameter 11 cm, height 22 cm) containing a DOFS cable embedded along the central axis (Figure 2d) were subjected to pull-out tests for determining the bond characteristics of the cable/concrete interface in the embedded cable configuration. Here, again, a 3-month curing period in water at room temperature was applied prior to initial characterizations on control specimens and the conditioning of exposed specimens in their ageing environments (=time T0),

- Instrumented concrete prisms (dimensions $7 \times 7 \times 28 \text{ cm}^3$) bearing DOFS cables bonded on each of the four lateral faces (Figure 2e) were used for pull-out tests to evaluate the bond properties between the bonded cable and the host structure (i.e., at the cable/adhesive or at the adhesive/concrete interfaces, depending on the pull-out failure mode). The cables were bonded a few days after the demolding of the concrete prisms (see the bonding procedure in the next paragraph), and the instrumented prisms were again cured for 3 months in water at an ambient temperature until time T0. It is worth noting that the samples of bulk X120 adhesive introduced previously were also subjected to an immersion period of 3 months, in order have the same history at time T0 compared to the adhesive joints of instrumented concrete prisms.

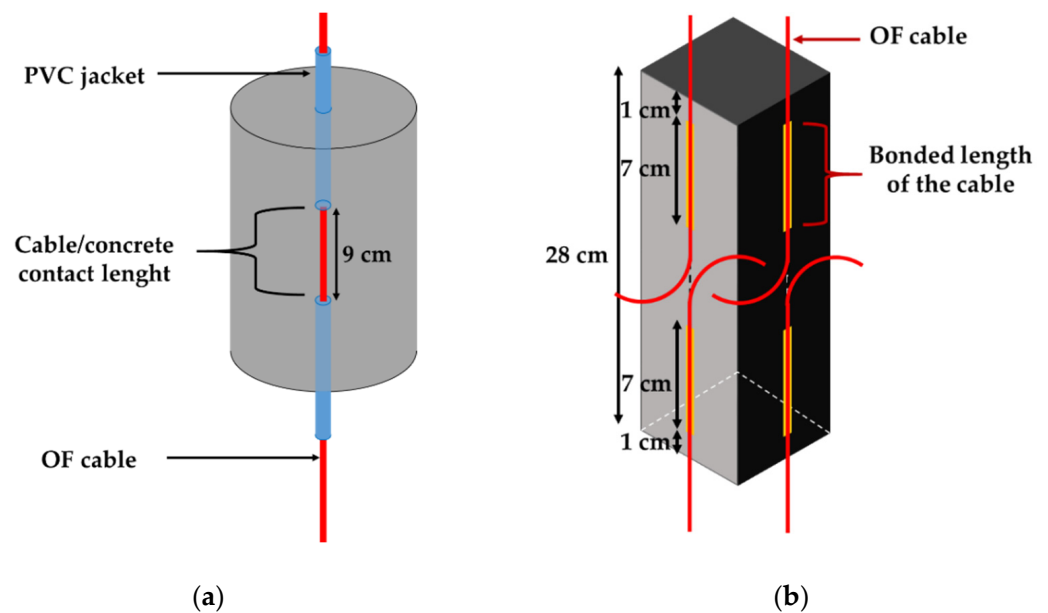
Figure 3. Schematic descriptions of (a) a concrete cylinder instrumented with a DOFS cable embedded over a length of 9 cm; (b) a concrete prism equipped with two DOFS cables per face, bonded over lengths of 7 cm.

bonded configurations, respectively. A PVC jacket was used as a “bond breaker” to set the embedment length in the cylinder specimens (see Figure 3a). Regarding the bonded configuration, two DOFS cables were bonded on each face of the prismatic specimens (see Figure 3b). The bonding procedure is detailed in [11] and requires engraving grooves at the concrete surface (approximate depth and width of 2 mm) prior to sealing the cables in the grooves using the X120 epoxy adhesive, in order to ensure better adhesion. For each face, the two cables were inserted in a same unique groove, but they were sealed at the opposite extremities of the prism over a contact length of 7 cm and 1 cm away from the edges. One prismatic specimen was thus equipped with a total of 8 bonded cables, allowing us to perform 8 separate pull-out tests.

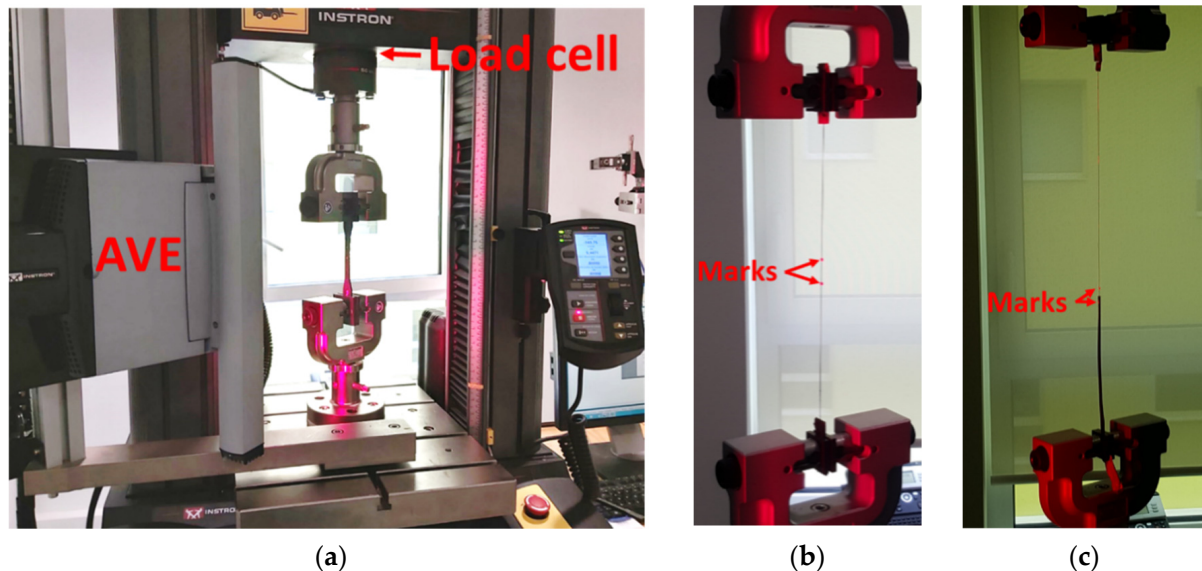
Figure 4. Tensile tests on (a) a dumbbell sample of X120 adhesive and on (b) a steel wire reinforcement (showing the two marks used for AVE monitoring); (c) typical pull-out test setup used to determine the bond properties at the external coating/steel wire interface (showing the two marks used to measure differential displacement between adherents).

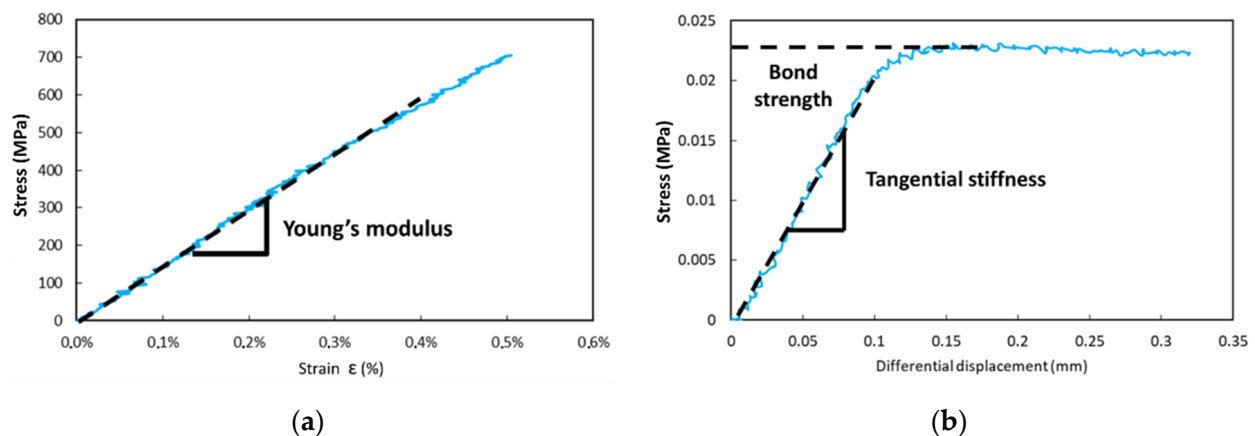
Figure 5. (a) Typical tensile curve for a steel wire reinforcement, and (b) typical pull-out curve for the external coating/OF interface in the initial state (unaged sample).

A typical pull-out curve obtained for the external coating/OF interface is illustrated in Figure 5b. From the slope of the initial linear part of the curve, one can determine a tangential stiffness of the considered interface (in MPa/mm), while the maximum stress value provides the bond strength (in MPa). Results were averaged over a series of 3 tests. It should be mentioned that the preparation of specimens and their clamping in the UTM grips was not easy, and might sometimes have induced slight damage to the samples. Therefore, the results of these pull-out tests should not be considered as absolute quantitative data, but rather as a way to highlight variation trends during ageing.

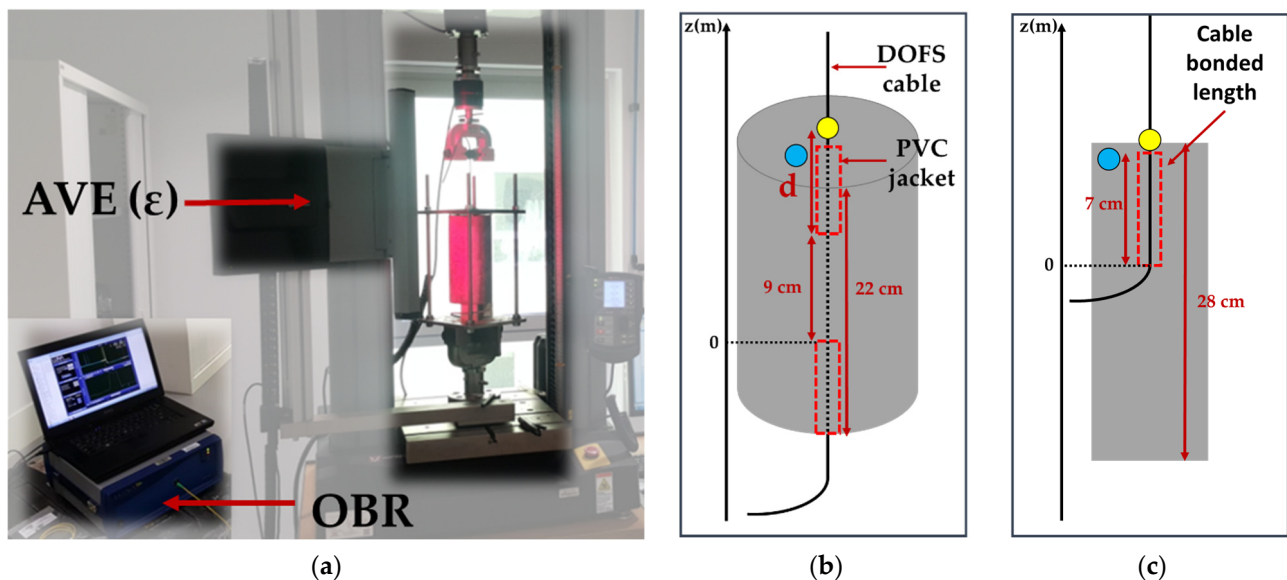
Figure 6. Characterization of the bond properties between the DOFS cable and the host concrete specimens: (a) pull-out tests setup, and location of the marks tracked by the AVE for (b) the embedded cable and (c) the bonded cable configurations.

(at T0) and after different ageing periods as well. Both concrete cylinders with embedded DOFS cables and concrete prisms with bonded DOFS cables were tested using the same Instron 5969 UTM equipped with the AVE system. A specific steel frame was designed to hold the concrete specimens during pull-out tests, with holes drilled on the upper plate to let the DOFS cable pass through. The frame was attached to the fixed lower grip of the UTM, while the cable was clamped in the mobile upper grip, as shown in Figure 6a. All pull-out tests were performed at a displacement rate of 1 mm/min, and the displacement was stopped for 1 min every 20 N load step. During these periods, one of the two OFs of the cable was interrogated using a Rayleigh Optical Backscatter Reflectometer (OBR), model 4600 from LUNA Innovations (Roanoke, VA, USA). Such measurement provides a continuous strain profile along the OF. In addition, for AVE tracking, two marks are placed on the test specimen: one mark is fixed at the top face of the concrete specimen (see the blue mark in Figure 6), and a second is placed on the cable part subjected to pull-out load (yellow mark in Figure 6). The differential displacement u_d between the two marks is continuously monitored using the AVE camera. Regarding the embedded cable configuration (Figure 6b), u_d results from the contribution of two parts: the slip at the cable/concrete interface, denoted as u_i , and the displacement u_t related to the tensile strain of the cable length d between the yellow mark on the cable and the location where the cable exits from concrete. The interrogation of the cable using the OBR device enables the calculation of the cable stiffness, the deduction of u_t and finally the extraction of the bond slip $u_i = u_d - u_t$, whose evolution with load describes the cable/concrete interface behavior. For the bonded cable configuration, the situation is simpler, as u_d is actually equal to u_i , as illustrated in (Figure 6c). These pull-out experiments enabled us to plot bond stress/slip curves which have a typical aspect very similar to that of Figure 5b (note that the bond stress is calculated as the ratio of the applied load to the embedded/bonded surface area, in N/m²). The initial slope of the curve gave then access to the tangential stiffness of the interface (in MPa/mm), while the maximum stress reached just before the sliding of the cable corresponded to the bond strength (in MPa). Here, again, all values were averaged over 3 repeated tests.

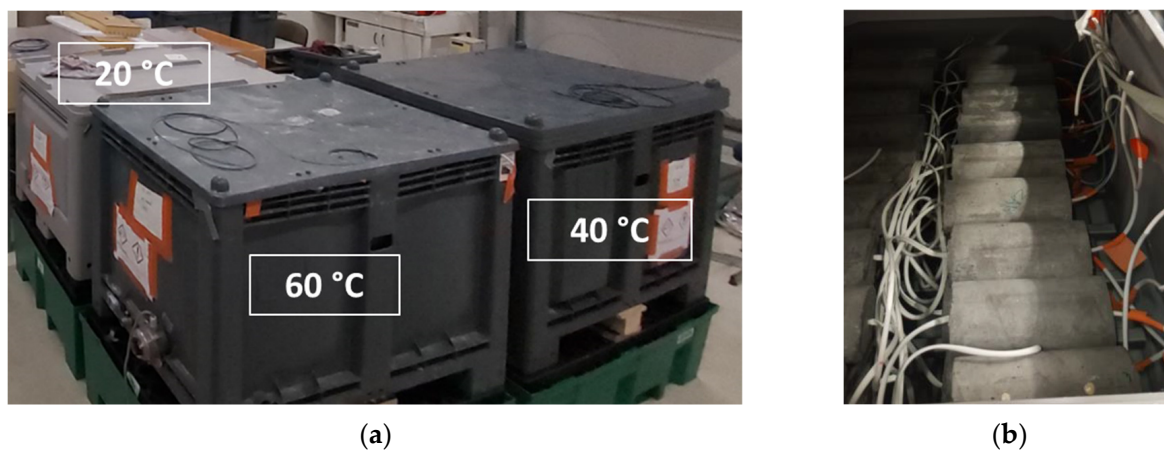
Figure 7. Conditioning in the alkaline ageing environment: (a) thermo-regulated tanks filled with the alkaline solution, and (b) instrumented concrete cylinders immersed in the solution.

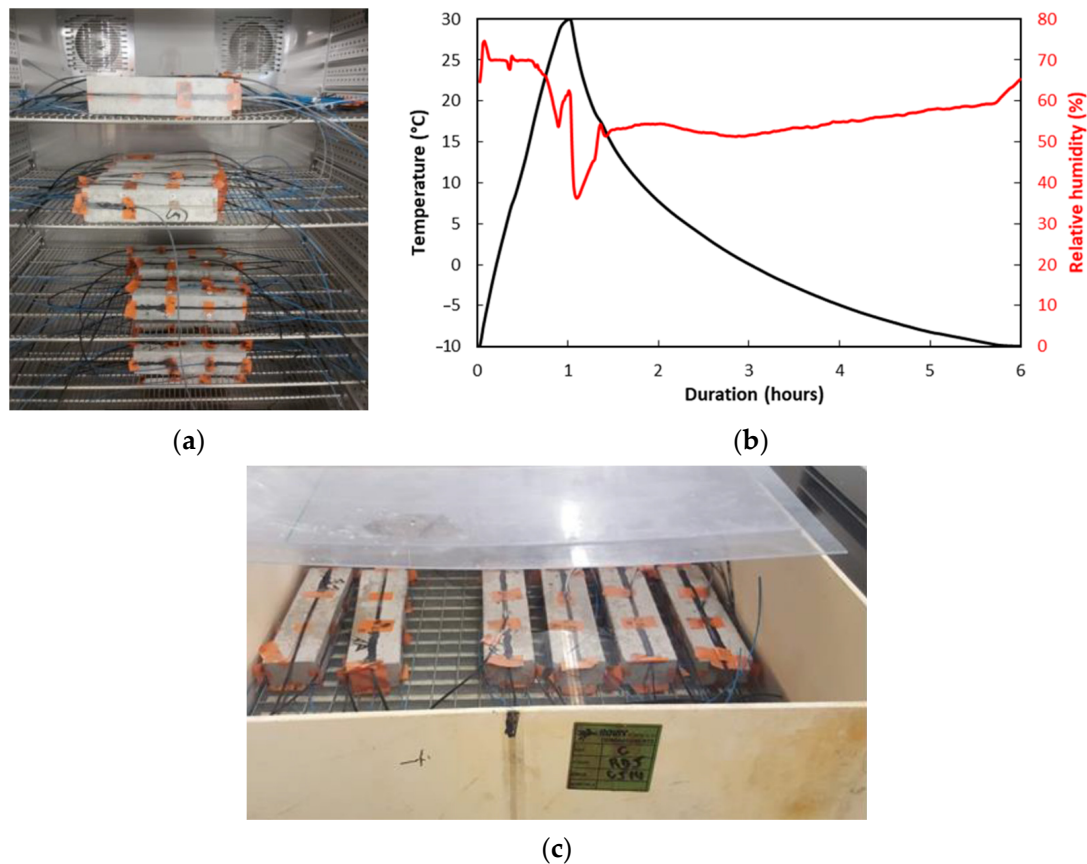
Figure 8. Application of cyclic conditions: (a) specimens subjected to F/T cycling in a climatic chamber and (b) Temperature/RH variations recorded in the chamber over a F/T cycle. (c) Specimens exposed to I/D cycling in a tank.

manner (cycles of 6 h, corresponding to an acceleration rate of 4 compared to daily alternation). Typical temperature/humidity variations recorded during a F/T cycle are displayed in Figure 8b. One can note that a duration of 5 h was necessary to achieve cooling from 30 to -10 °C, as the chamber was not able to maintain a constant cooling rate in the whole domain. In addition, the RH level was only controlled in the heating phase (RH~70%), but could not be regulated during the cooling phase.

The protocol of I/D cycles consisted of alternating a one-week immersion period in a water tank at room temperature with a one-week drying period in ambient air (Figure 8c). Water was renewed in the tank at each cycle, to favor the leaching of concrete. An overall exposure period of 18 months was initially scheduled (as for the other accelerated conditions), but it was finally reduced to 16 months due to the COVID-19 pandemic. Here, again, T0 denotes the starting date of exposure.

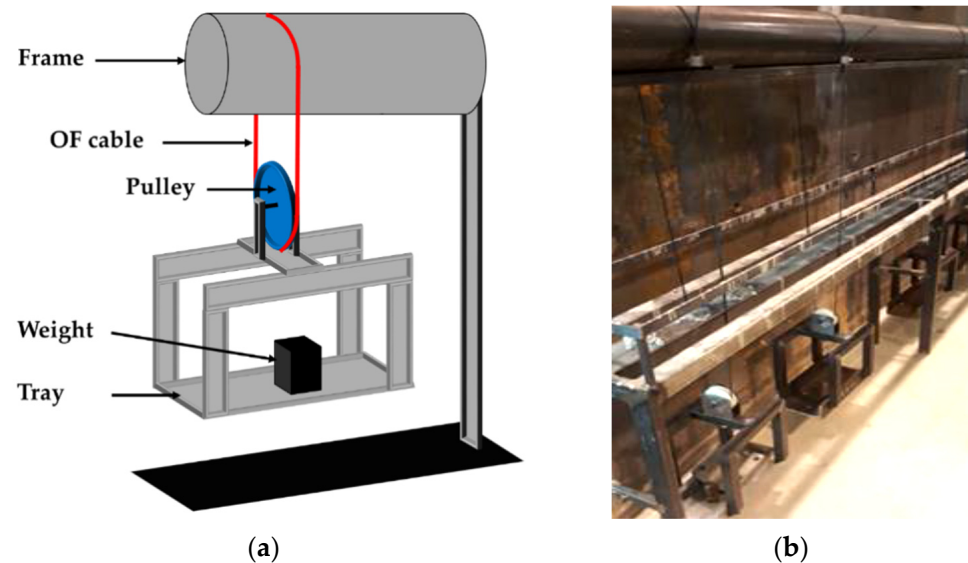
Figure 10. Creep test setup: (a) Schematic description and (b) picture of the setup.

In addition to the previous environmental factors, civil infrastructures are also subjected to sustained load, mostly due to their own weight (dead load). Consequently, both embedded and bonded DOFS cable instrumentations may undergo creep loading under service conditions. It was therefore decided to include a specific creep test (denoted Cr) in this experimental program, in order to study possible creep-induced changes in the mechanical and geometrical properties of the DOFS cable. This test consisted of applying a constant tensile load to the DOFS cable for a total period of 15 months. To this purpose, three metallic setups were specifically designed and manufactured in the laboratory, as illustrated in Figure 10. Each setup was equipped with a tray to hold the weights used for the application of sustained load. This tray is connected to a pulley that ensures load

balancing in the DOFS cable forming a closed loop. Each tray holds a weight of 7.5 kg, all included.

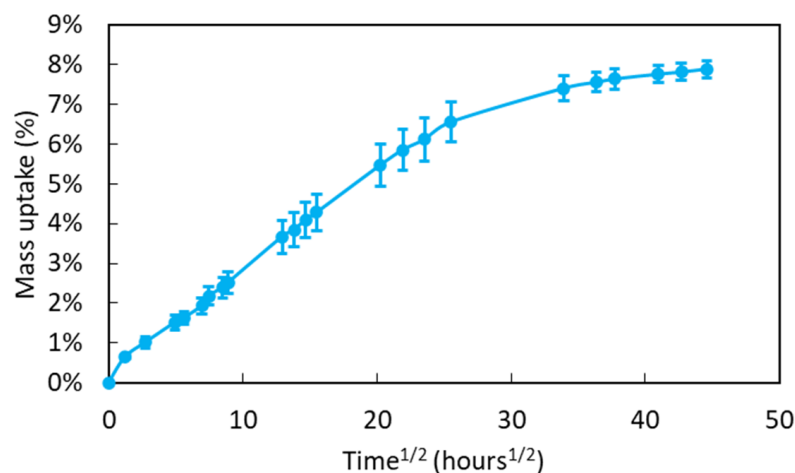
Figure 11. Absorption curve of the bulk adhesive samples immersed in water at 20 °C.

80 days of exposure, the mass uptake is close to 7.8%, and the saturation plateau is not totally reached. From the apparent trend, one can expect an equilibrium water content in the range of 8–8.5%.

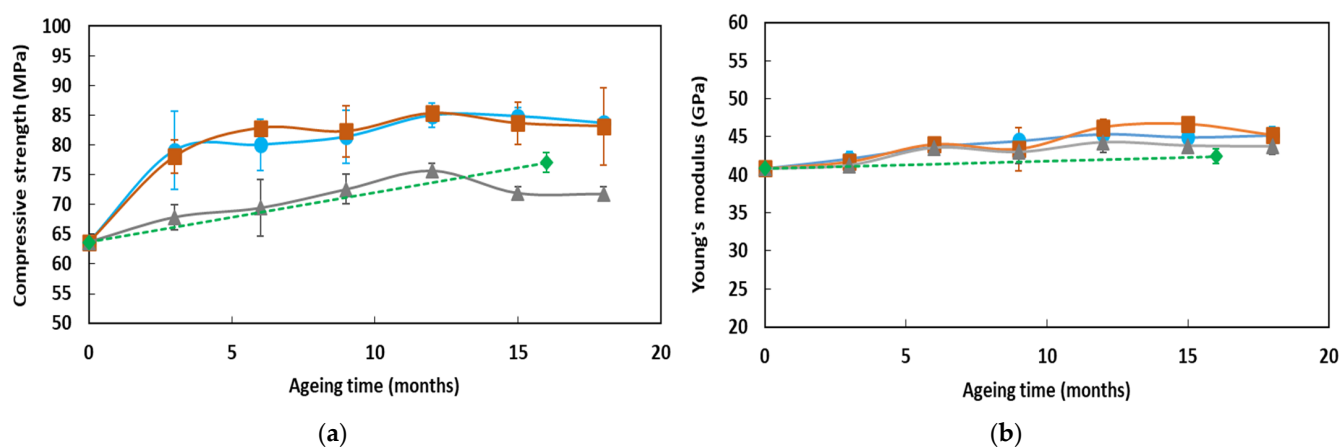
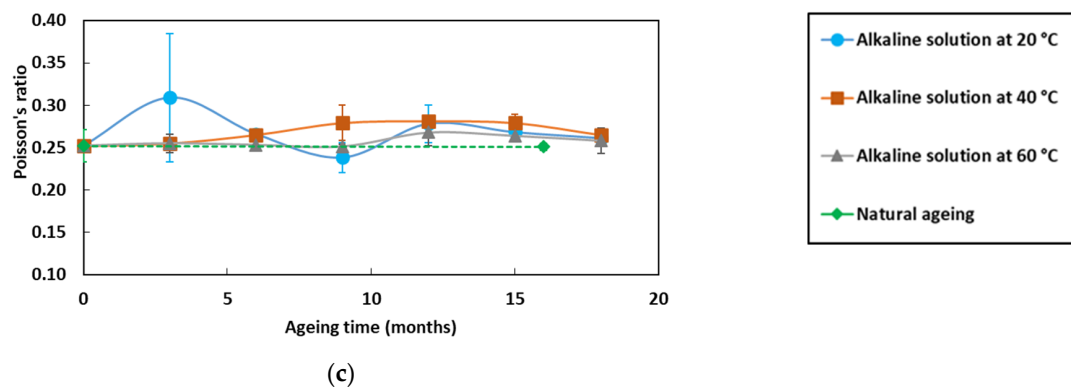
Figure 12. Cont.

Figure 12. Evolutions of the mechanical characteristics of concrete over exposure in the alkaline and NA environments: (a) compressive strength, (b) Young's modulus and (c) Poisson's ratio.

- Alkaline environments at 20 and 40 °C favor the hydration process of the cementitious matrix and lead to an increase in compressive strength over time [40], up to a maximum value in the range 80–85 MPa. In the solution at 60 °C, and during NA that generally includes periods with low RH levels, the compressive strength also increases over time, but to a lower extent as the maximum values are in the range 70–75 MPa;
- Changes in the Young's modulus and Poisson's ratio during ageing remain limited and seem little dependent on the type of ageing condition. Only a slight increase in Young's modulus is observed over time, while the Poisson's ratio does not vary significantly.

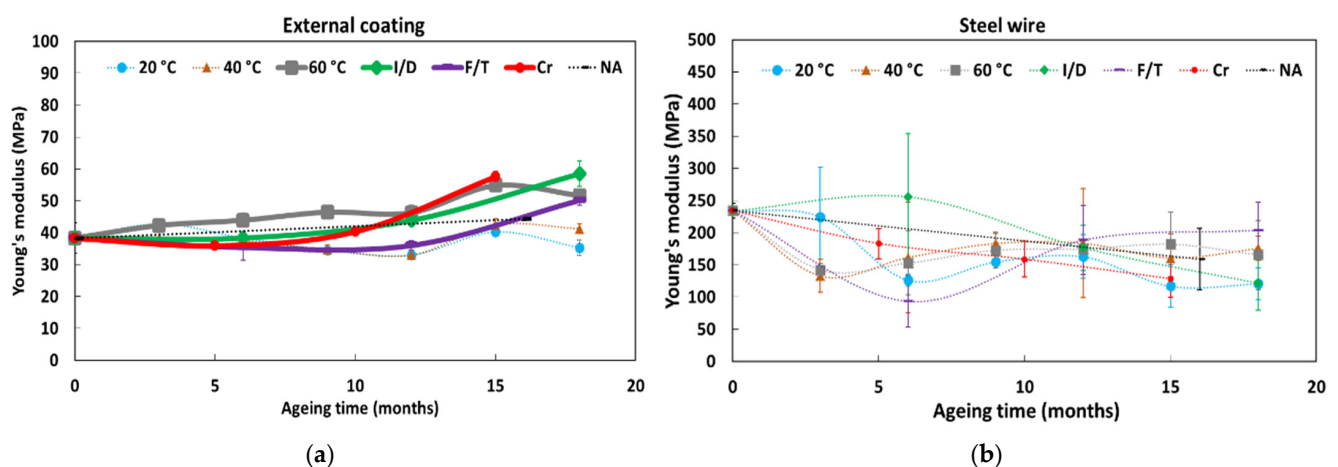
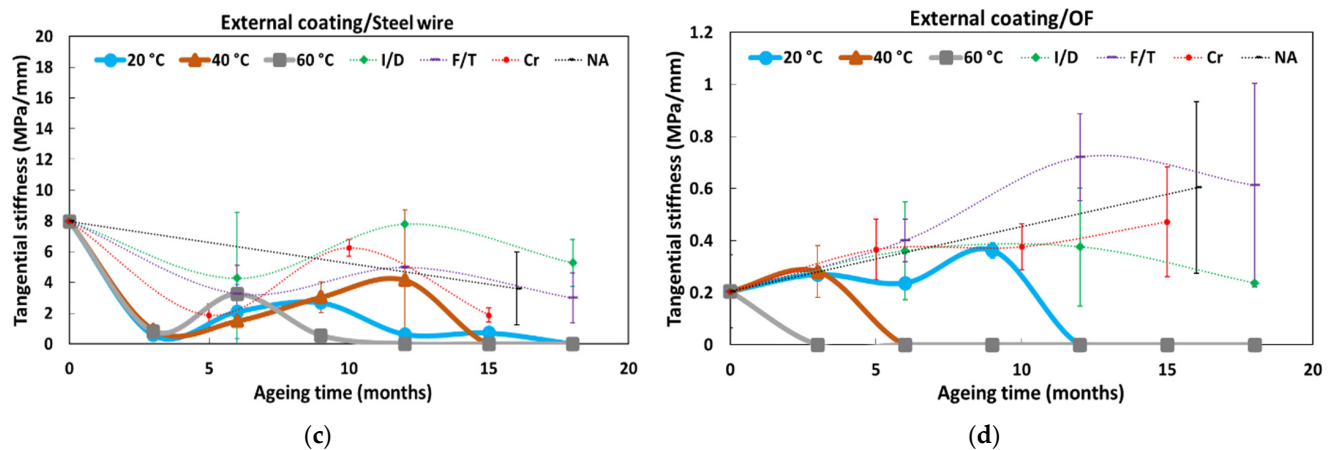
Figure 13. Cont.

Figure 13. Changes in the mechanical properties of the component materials and internal interfaces of the DOFS cable over exposure in the various ageing environments: tensile Young's moduli of (a) the cable coating and (b) the steel wire reinforcement; tangential stiffness of the (c) coating/steel wire and (d) coating/OF interfaces.

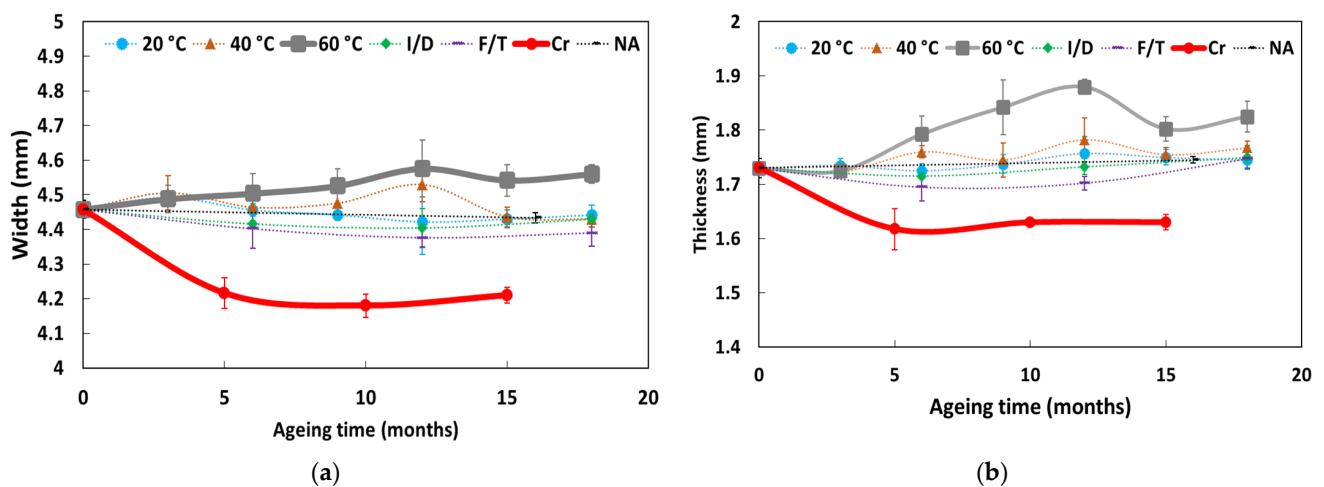
Figure 14. Dimensional changes in the DOFS cable cross-section versus exposure time in the various ageing environments: (a) width and (b) thickness.

In addition, Figure 14 depicts the dimensional changes in the DOFS cable cross-section as a function of exposure time in the various ageing environments. A relative dimensional stability can be observed after ageing, with the exception of the cables immersed in the alkaline solution at 60 °C or subjected to Cr. In the former case, a progressive swelling of the cable is indeed observed, the cause of which will be investigated later by complementary physico-chemical analyses. For samples subjected to Cr, the cross-section of the cable decreases significantly during the first 5 months and then stabilizes; this phenomenon can be attributed to a plastic elongation of the flexible coating of the cable by Poisson's effect, under permanent tensile load.

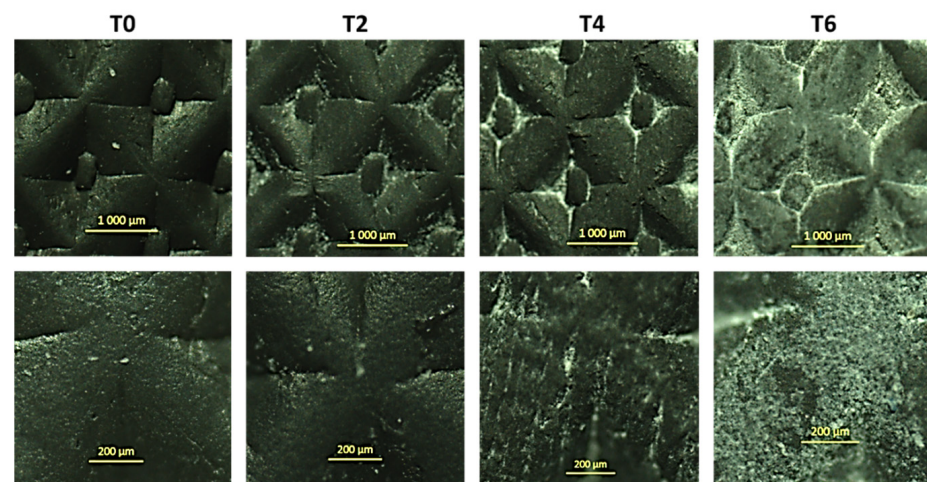
Figure 15. Optical micrographs at different magnifications, of the surface of the DOFS cable in the initial state (T0) and after 6 months (T2), 12 months (T4) and 18 months (T6) of exposure in the alkaline solution at 60 °C.

Observations of the external coating of DOFS cables by optical microscopy did not reveal any significant change in the surface aspect after ageing, except for samples conditioned in the alkaline solution at 60 °C. Figure 15 shows the external surface of the DOFS cable after different exposure periods in this peculiar condition.

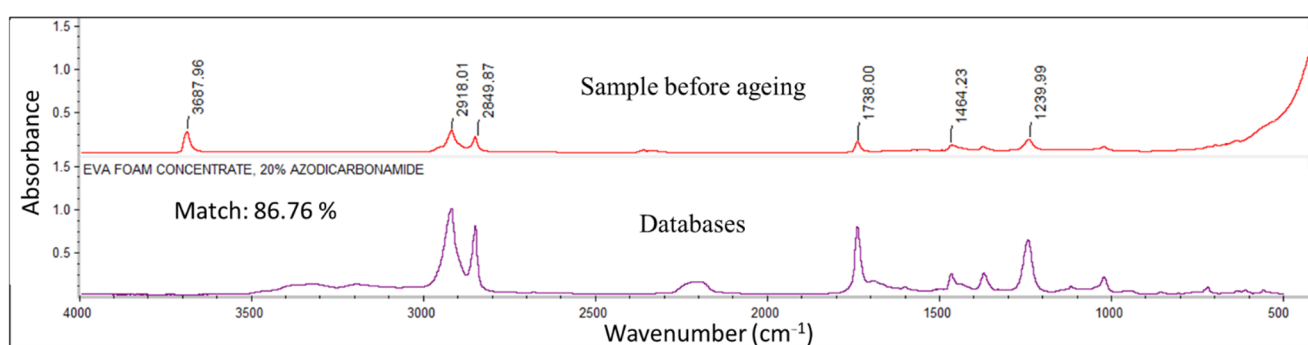
Figure 16. FTIR-ATR spectrum obtained for the external coating of the unaged DOFS cable (at session T0), together with the spectrum from FTIR databases providing the best match.

Figure 16 shows a typical FTIR-ATR spectrum of the surface of the unaged DOFS cable, as well as the spectrum identified from available FTIR databases that provides the best correspondence.

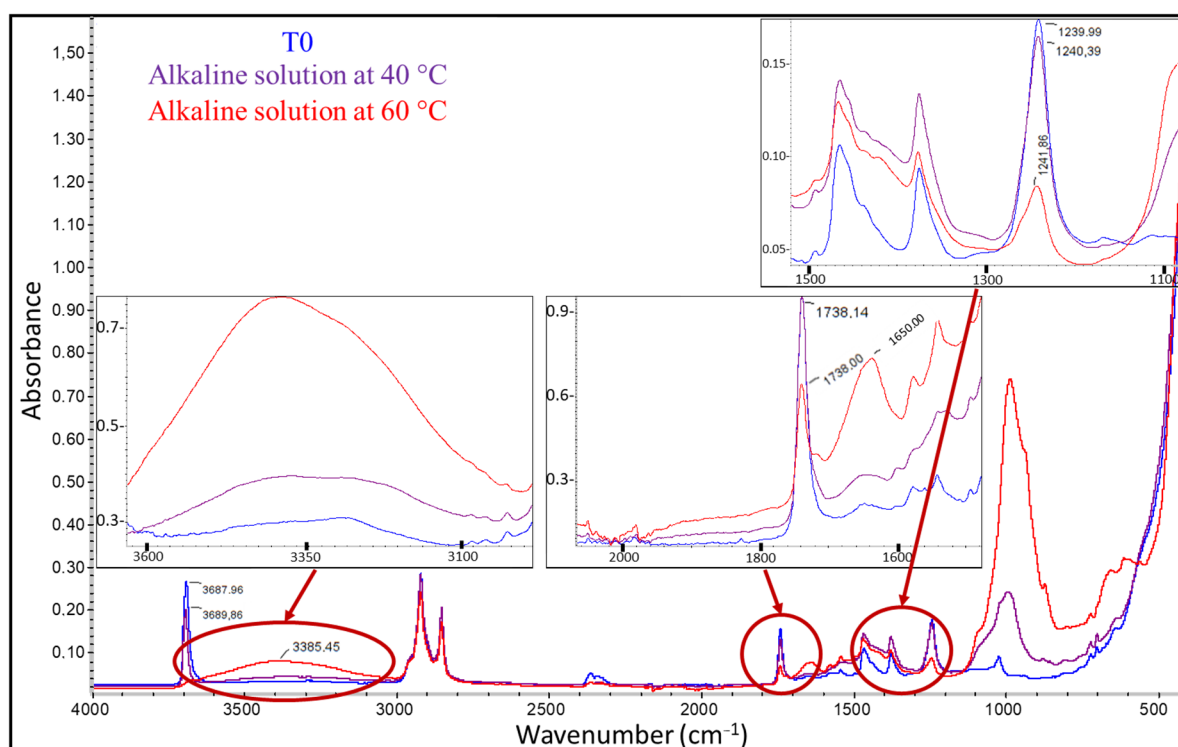
Figure 17. FTIR-ATR spectra obtained for the unaged cable coating (T0) and after 12 months of ageing (T4) in the alkaline solution at 40 and 60 °C.

FTIR analyses were then performed on the external coating of DOFS cables that had been exposed to the various ageing environments. In general, the spectra did not reveal any significant alteration of the chemical structure of the coating after ageing, except for cables immersed in the alkaline solution at 40 and 60 °C. Figure 17 shows the typical FTIR-ATR spectra obtained for the external coating of cables after 12 months exposure (T4) to these two peculiar conditions, as well as the spectrum of the unaged coating for comparison. Zooms corresponding to specific regions of interests of these spectra are also displayed in this figure.

In addition, the FTIR spectra of the aged samples also show the appearance of a broad band in the region of 3000–3600 cm^{-1} whose amplitude increases with the temperature of the alkaline solution. This band may be ascribed to an additional degradation process by hydrolysis of the acetate groups, leading to the formation of hydroxyl groups according to the mechanism described in Figure 18 [44,45]. This decomposition process of acetates would contribute, similarly to thermal degradation, to decreasing the intensity of the peaks at 1738 and 1250 cm^{-1} . Moreover, this hydrolysis phenomenon may also be responsible for the swelling observed for cables aged in the alkaline solution at a high temperature (see Figure 14) [45].

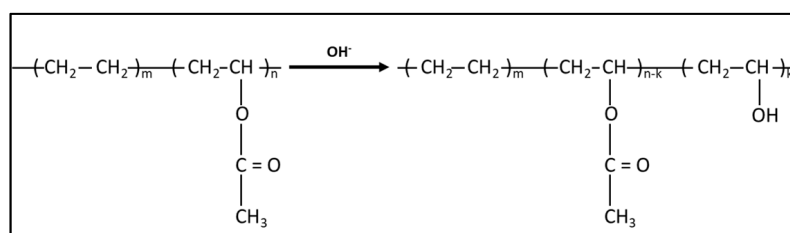
Figure 18. Hydrolysis of EVA copolymers, according to [45].

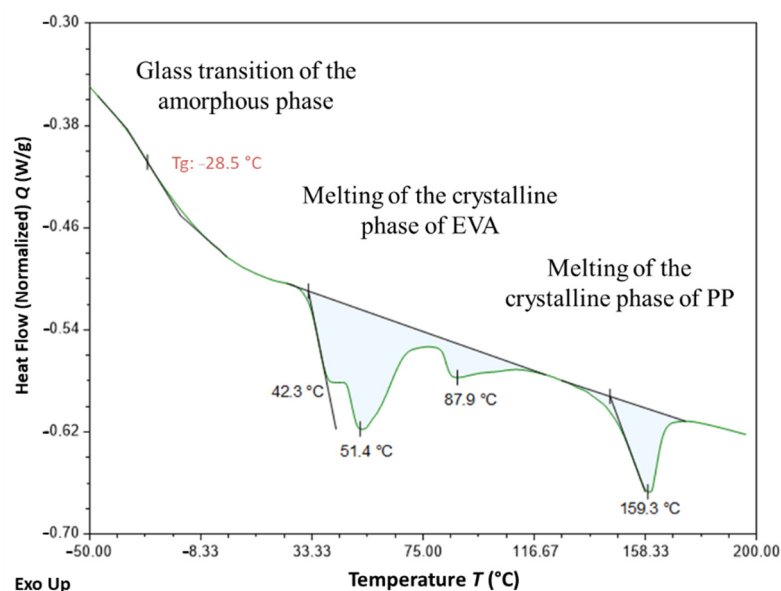
Figure 19. DSC thermogram of the unaged cable coating (T0).

- An enthalpic jump is visible around -30 °C, which can be attributed to the glass transition of the amorphous phase of the EVA copolymer;
- A large endothermic region is observed between -30 and 110 °C, from which three distinct peaks emerge at approximately 40 , 50 and 90 °C. This domain corresponds to the melting temperature range generally reported for the crystalline phase of EVAs [42,43,46]. The presence of multiple peaks reveals the existence of several populations and sizes of crystalline lamellae.
- Another endothermic peak is observed at a higher temperature, around 160 °C, which is not characteristic of the EVA crystal structure. This temperature range is usually associated with the melting of polypropylene (PP), which suggests that the cable coating is actually composed of an EVA/PP copolymer [47].

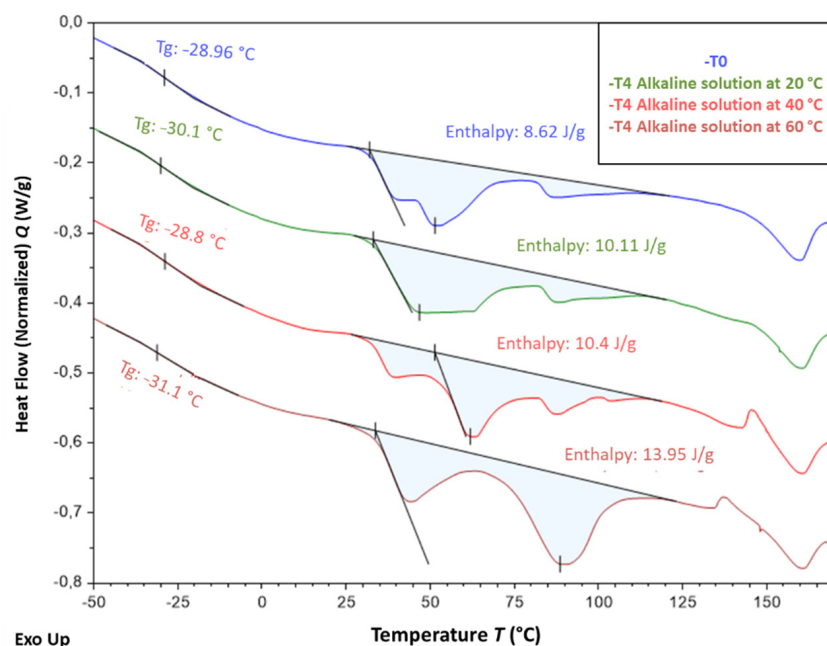
Figure 20. DSC thermograms of the cable coating conditioned for 12 months (T4) in the alkaline solution at different temperatures, and thermogram of the control sample (T0).

It is well known that the mechanical properties of semi-crystalline polymers are mainly controlled by the degree of crystallinity of the material, since crystalline lamellae play a reinforcing role for the amorphous phase. Based on previous DSC results, one can thus assume that the increase in tensile Young's modulus observed after ageing for the bulk coating material (cf. Figure 13) results from an increase in the overall crystallinity degree of the EVA copolymer due to recrystallization processes.

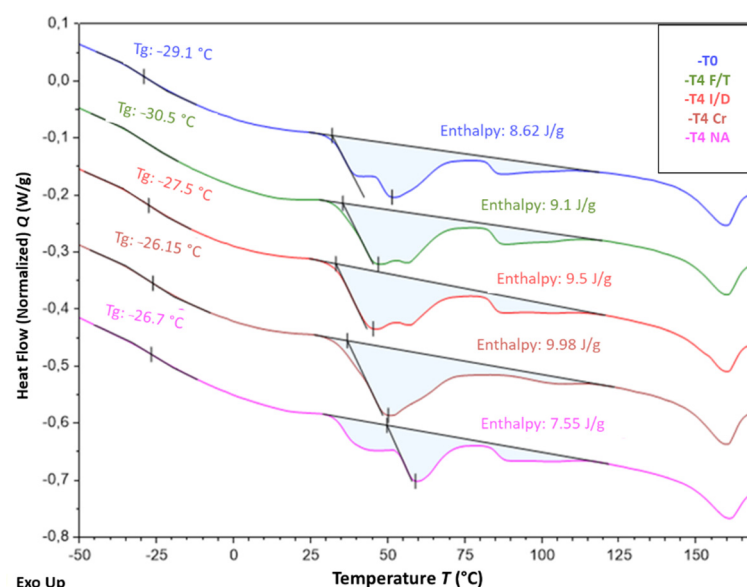
Figure 21. DSC thermograms of the cable coating after 12 months exposure (T4) to F/T, I/D, Cr and NA conditions. The control sample (T0) is also displayed for comparison.

Figure 21 presents the DSC thermograms obtained for samples that were exposed for 12 months to the other ageing environment, i.e., F/T and I/D cycling, as well as Cr and NA conditions. As before, alterations of the melting peaks of aged specimens can be detected on the thermograms, attesting for changes in the lamellae size distribution associated with the crystalline structure of EVA. However, these changes seem less important than those observed after ageing in the alkaline solution at a high temperature. In the case of NA condition, such transformations of the crystal structure are generally activated by photo-oxidation [46].

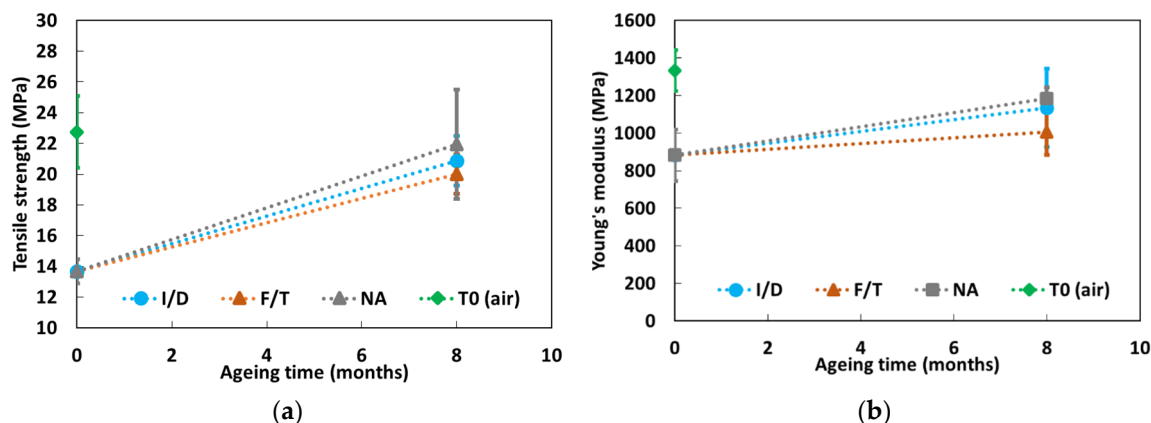
Figure 22. Values of (a) the tensile strength and (b) Young's modulus of the X120 adhesive before and after exposure to I/D, F/T and NA conditions for a period of 8 months (T3). The initial state corresponds to preliminary conditioning in water (or in air) for 3 months.

As previously discussed in Section 3.1.3, the preliminary conditioning of samples in water negatively affected the mechanical properties of the epoxy adhesive at T0, compared to the specimens that were conditioned in air. This effect can mainly be attributed to the plasticization of the polymer network by water molecules, as a result of the high water absorption of the material (~8.5% mass uptake after 3 months in water).

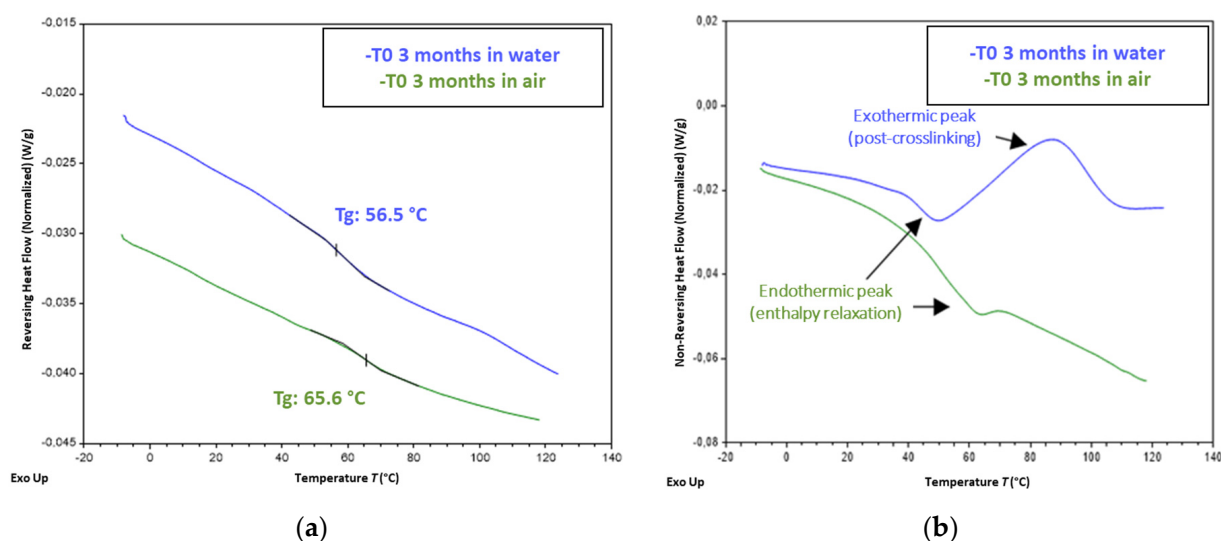
Figure 23. MDSC thermograms obtained for X120 adhesive samples at T0, after preliminary conditioning for 3 months in water or in air: (a) reversing and (b) non-reversing heat flow signals.

MDSC analyses (see the experimental protocol in Section 2.3.2) were also performed on samples at T0, and on samples aged for 8 months under F/T, I/D, and NA conditions. Figure 23 compares the MDSC thermograms obtained for adhesive samples at T0, after preliminary conditioning in water for 3 months (that reproduces the curing schedule of concrete prisms instrumented with bonded DOFS cables) or after conditioning in water for the same period. The glass transitions were clearly detected as jumps in the reversing heat flow signal (Figure 23a), which enabled the determination of T_g values in the range of 56 °C for the adhesive conditioned in water, and 65 °C for the adhesive conditioned in air. In addition, the non-reversing heat flow component (Figure 23b) displayed a large exothermic peak for the adhesive conditioned in water, reflecting post-crosslinking of the polymer during the test, due to the presence of residual monomers that react upon heating. Meanwhile, this phenomenon was not observed for the adhesive conditioned in air. These features suggest that the adhesive conditioned in water is not fully cured at T0, whereas the material stored in air has almost completed its polymerization process. Such differences in both T_g and mechanical properties at T0 as a function of the preliminary conditioning treatment of the adhesive samples (in water or in air) may therefore result from the plasticization of the epoxy network by the absorbed water, as already mentioned, but also from differences in the polymerization kinetics.

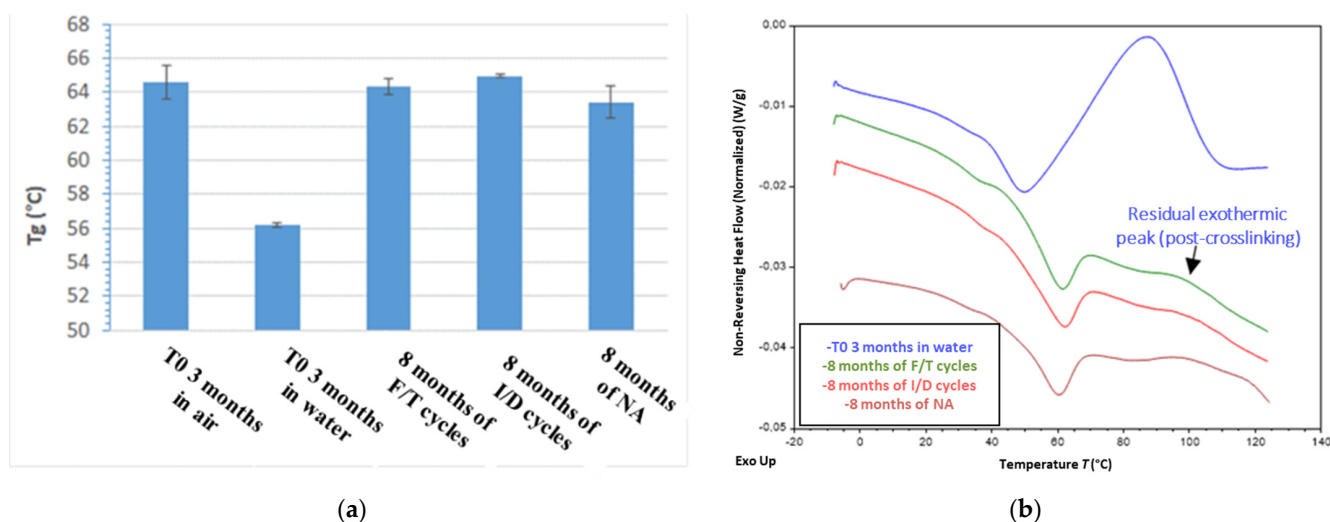
Figure 24. MDSC analyses of X120 adhesive samples exposed for 8 months to F/T, I/D and NA conditions: (a) T_g values and (b) non-reversing Heat flow thermograms.

- Exposures to F/T, I/D and NA conditions led to the desorption of a large part of the water that was initially present at T0 in the control X120 adhesive (previously conditioned in water),
- Such exposures also favored the cross-linking process of the adhesive during the ageing period, but without reaching complete polymerization of the epoxy network. This phenomenon also explains the observed increase in mechanical properties of aged adhesive samples compared to the unaged control sample at T0 (conditioned in water), and the fact that these properties remain slightly lower than those of the dry adhesive at T0 (sample conditioned in air).

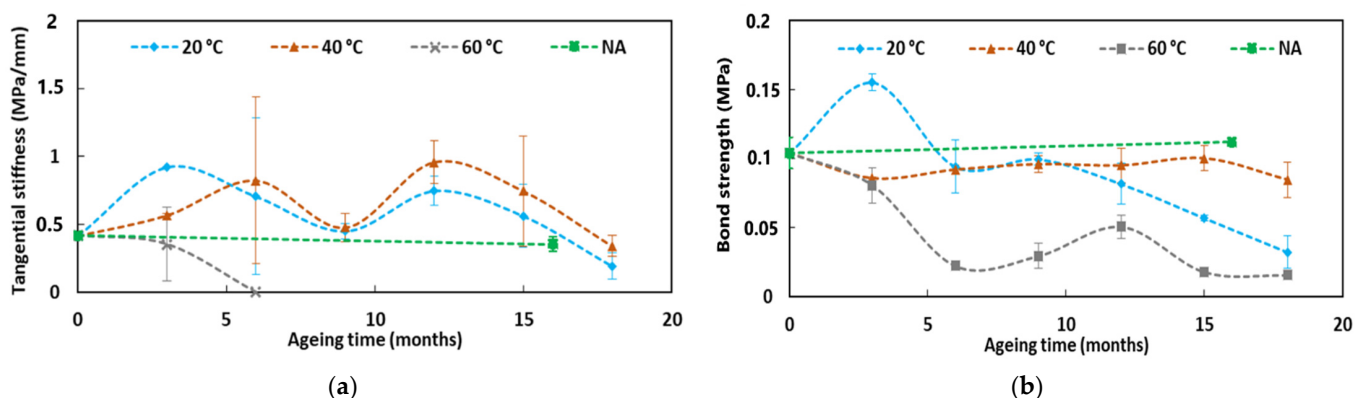
Figure 25. Evolutions of the coating/concrete bond properties during ageing in the alkaline solution at different temperatures or under NA condition: (a) tangential stiffness and (b) bond strength.

- Under NA conditions and considering the large dispersion of experimental data, no significant evolution of the coating/concrete bond properties was observed after 16 months of exposure. This result shows that NA, which reproduces actual service conditions in an outdoor environment, does not constitute an aggressive environment for the embedded DOFS cable. In addition, it suggests that immersion in the alkaline solution at 60 °C is a very harsh condition which is not representative of the actual service environment of an embedded FO instrumentation. Nevertheless, additional experiments involving long-term exposure to NA conditions would be necessary to support this conclusion.

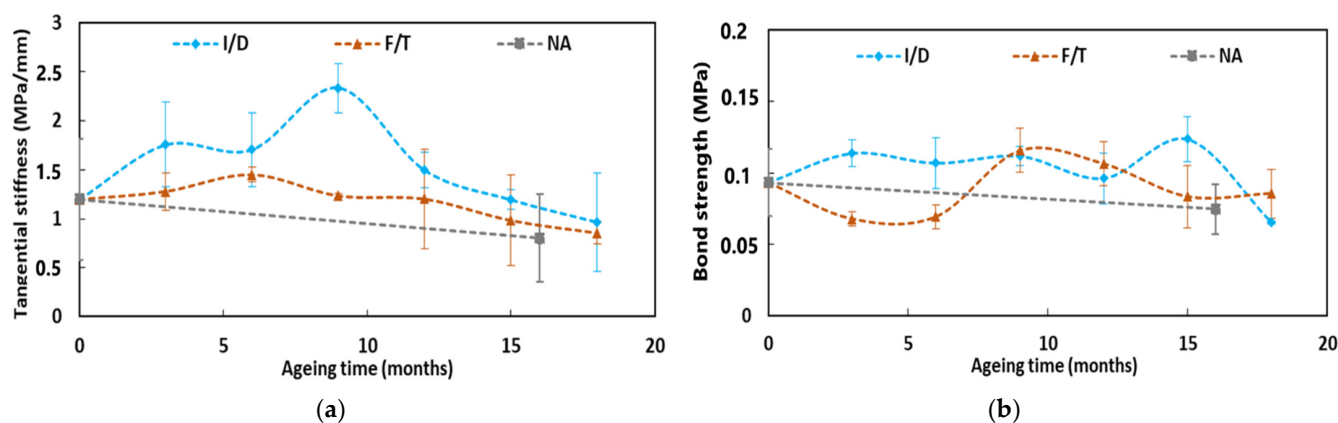
Figure 26. Evolutions of the coating/adhesive bond properties during ageing under I/D, F/T and NA exposure conditions: (a) tangential stiffness and (b) bond strength.

These slight decreases do not seem to be correlated with the changes in the mechanical properties of the X120 adhesive during ageing, which show the opposite trend. Indeed, it was previously reported that the Young's modulus of the adhesive increases with ageing due to desorption of the specimens and the continuation of the cross-linking process.
