Environmental Durability of an Optical Fiber Cable Intended for Distributed Strain Measurements in Concrete Structures

Ismail Alj, Marc Quiertant, Aghiad Khadour, Quentin Grando, Karim Benzarti. Environmental Durability of an Optical Fiber Cable Intended for Distributed Strain Measurements in Concrete Structures. *Sensors*, 2022, 1 (22), 43 p. <10.3390/s22010141>. <hal-03519473>

Abstract: The present study investigates the environmental durability of a distributed optical fiber sensing (DOFS) cable on the market, commonly used for distributed strain measurements in reinforced concrete structures. An extensive experimental program was conducted on different types of specimens (including samples of bare DOFS cable and plain concrete specimens instrumented with this DOFS cable) that were exposed to accelerated and natural ageing (NA) conditions for different periods of up to 18 months. The instrumentation of both concrete specimens consisted of DOFS cables embedded at the center of the specimens and bonded at the concrete surface, as these two configurations are commonly deployed in the field. In these configurations, the alkalinity of the surrounding cement medium and the outdoor c

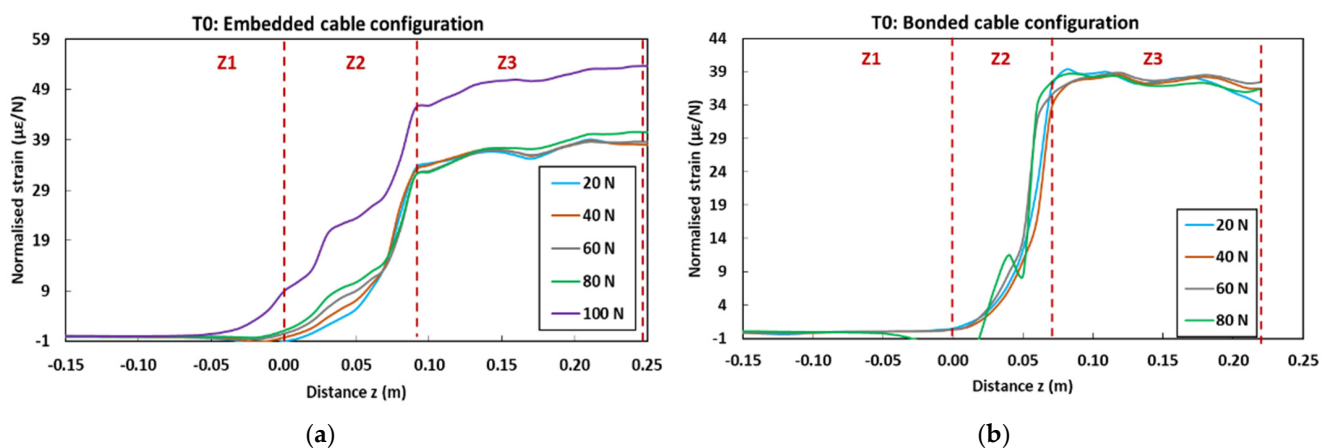
Figure 27. Strain profiles recorded at T0 (initial state before ageing) during the pull-out tests on control concrete specimens instrumented with (a) embedded and (b) bonded DOFS cables.

Overall, the strain profiles recorded at various load levels become superimposed once normalized. Nevertheless, the application of high load levels induces significant damage to the system, and hence alters the normalized strain profiles. For instance, at 100 N for the embedded cable configuration (Figure 27a), a loss of adhesion occurs at the coating/OF interface, leading to the enlargement of zone Z2; in addition, a large increase in the normalized strain value is observed in zone Z3, due to substantial decohesion at the coating/steel wire interface.

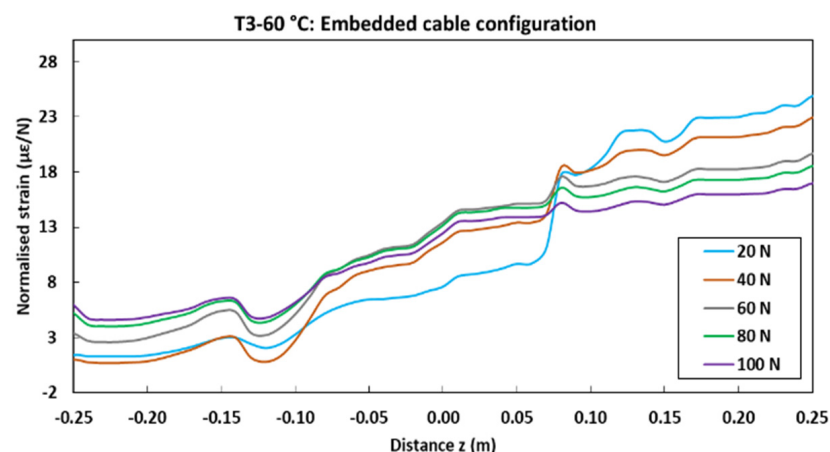
Figure 28. Strain profiles recorded during the pull-out tests on concrete specimens instrumented with embedded DOFS cables after 9 months of immersion (T3) in the alkaline solution at 60 °C.

Figure 28 displays the normalized strain profiles recorded during pull-out tests performed on concrete specimens with embedded DOFS cables after 9 months of immersion in the alkaline solution at 60 °C. A comparison of this graph with the initial strain profile (Figure 27a) clearly demonstrates the impact of these harsh ageing conditions on the strain transfer process between the OF and the host concrete. Indeed, it becomes difficult to identify the different zones (Z1, Z1 and Z3) along the measurement line after ageing, as the load transfer becomes almost uniform over the entire cable length. This phenomenon can be mainly attributed to the slip of the OF within the cable coating, resulting from the degradation of the bond properties at internal interfaces caused by the penetration of the alkaline solution into the cable (cf. Section 3.2.2). The loss of bond properties at the concrete/coating interface that was observed beyond 6 months of exposure in this specific condition (cf. Section 3.2.4) may have also contributed to the observed alteration of the strain profiles.
