Environmental Durability of an Optical Fiber Cable Intended for Distributed Strain Measurements in Concrete Structures

Article

Abstract: The present study investigates the environmental durability of a distributed optical fiber sensing (DOFS) cable on the market, commonly used for distributed strain measurements in reinforced concrete structures. An extensive experimental program was conducted on different types of specimens (including samples of bare DOFS cable and plain concrete specimens instrumented with this DOFS cable) that were exposed to accelerated and natural ageing (NA) conditions for different periods of up to 18 months. The instrumentation of both concrete specimens consisted of DOFS cables embedded at the center of the specimens and bonded at the concrete surface, as these two configurations are commonly deployed in the field. In these configurations, the alkalinity of the surrounding cement medium and the outdoor conditions are the main factors potentially affecting the characteristics of the DOFS component materials and the integrity of the various interfaces, and hence impacting the strain transfer process between the host structure and the core optical fiber (OF

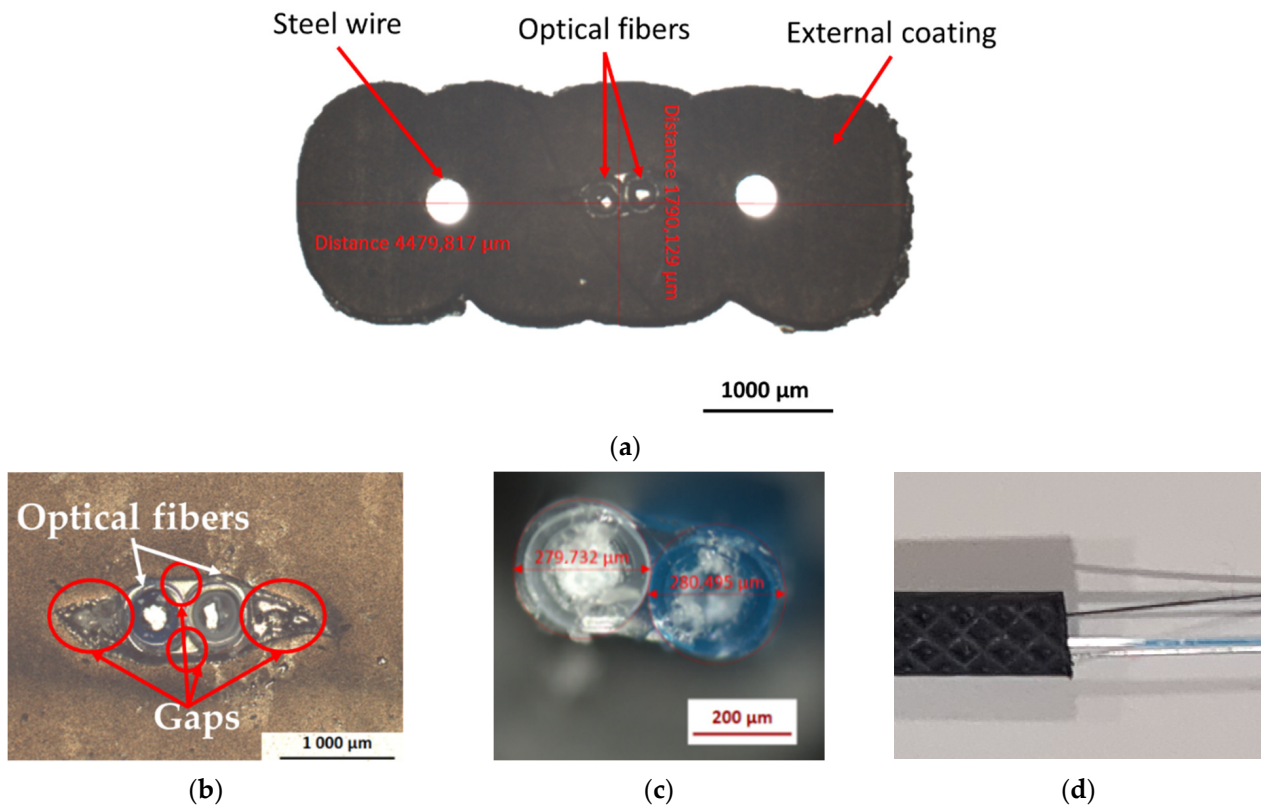
Figure 1. Optical microscope observations of (a) the cross-section of the DOFS cable, (b) the cross-section of the central part of the cable, and (c) the cross-section of the two central OFs; (d) picture showing the external surface relief of the cable, as well as an uncoated segment.

of the DOFS cable (i.e., the sensing element). Meanwhile, the interfaces between the steel wires and the external coating are sound, and do not present any visible defects.

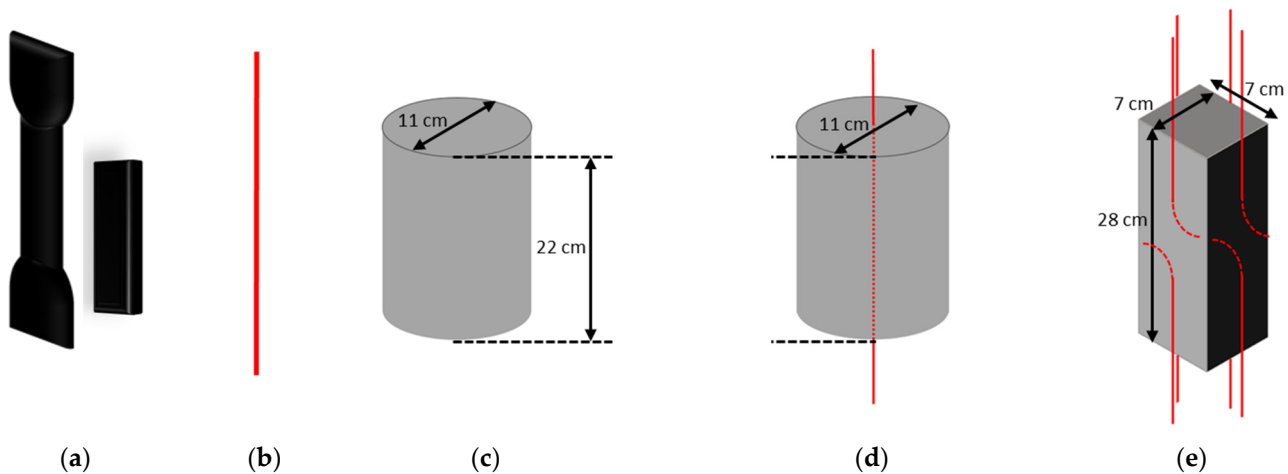
Figure 2. Schematic descriptions of the different specimens: (a) samples of bulk adhesive (b) samples of DOFS cable, (c) concrete cylinders, (d) concrete cylinders with embedded DOFS cables and (e) concrete prisms with DOFS cables bonded on the 4 lateral faces.

The samples of DOFS cable (Figure 2b) were intended for conducting tensile tests on the component materials (external coating and reinforcing steel wires), as well as pull-out tests on internal interfaces (i.e., external coating/OF and external coating/steel reinforcement interfaces). They were also used for the physico-chemical characterizations. The DOFS cable was stripped in order to prepare external coating and steel wire specimens for tensile tests, or partially stripped to prepare specimens intended for external coating/OF and external coating/steel wire pull-out tests.

- Instrumented concrete cylinders (diameter 11 cm, height 22 cm) containing a DOFS cable embedded along the central axis (Figure 2d) were subjected to pull-out tests for determining the bond characteristics of the cable/concrete interface in the embedded cable configuration. Here, again, a 3-month curing period in water at room temperature was applied prior to initial characterizations on control specimens and the conditioning of exposed specimens in their ageing environments (=time T0),

- Instrumented concrete prisms (dimensions $7 \times 7 \times 28 \text{ cm}^3$) bearing DOFS cables bonded on each of the four lateral faces (Figure 2e) were used for pull-out tests to evaluate the bond properties between the bonded cable and the host structure (i.e., at the cable/adhesive or at the adhesive/concrete interfaces, depending on the pull-out failure mode). The cables were bonded a few days after the demolding of the concrete prisms (see the bonding procedure in the next paragraph), and the instrumented prisms were again cured for 3 months in water at an ambient temperature until time T0. It is worth noting that the samples of bulk X120 adhesive introduced previously were also subjected to an immersion period of 3 months, in order have the same history at time T0 compared to the adhesive joints of instrumented concrete prisms.

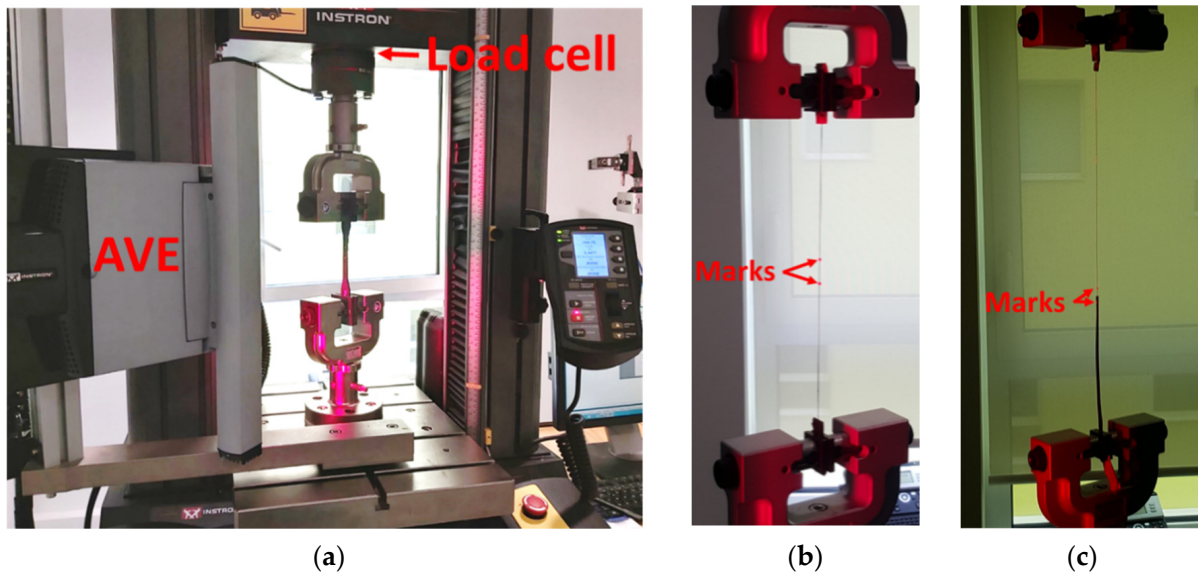
Figure 4. Tensile tests on (a) a dumbbell sample of X120 adhesive and on (b) a steel wire reinforcement (showing the two marks used for AVE monitoring); (c) typical pull-out test setup used to determine the bond properties at the external coating/steel wire interface (showing the two marks used to measure differential displacement between adherents).

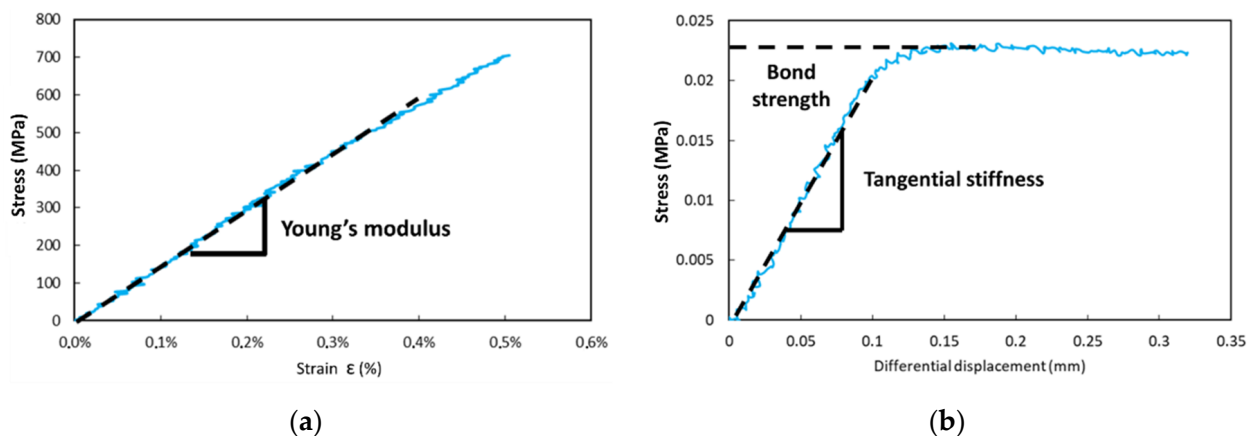
Figure 5. (a) Typical tensile curve for a steel wire reinforcement, and (b) typical pull-out curve for the external coating/OF interface in the initial state (unaged sample).

A typical pull-out curve obtained for the external coating/OF interface is illustrated in Figure 5b. From the slope of the initial linear part of the curve, one can determine a tangential stiffness of the considered interface (in MPa/mm), while the maximum stress value provides the bond strength (in MPa). Results were averaged over a series of 3 tests. It should be mentioned that the preparation of specimens and their clamping in the UTM grips was not easy, and might sometimes have induced slight damage to the samples. Therefore, the results of these pull-out tests should not be considered as absolute quantitative data, but rather as a way to highlight variation trends during ageing.

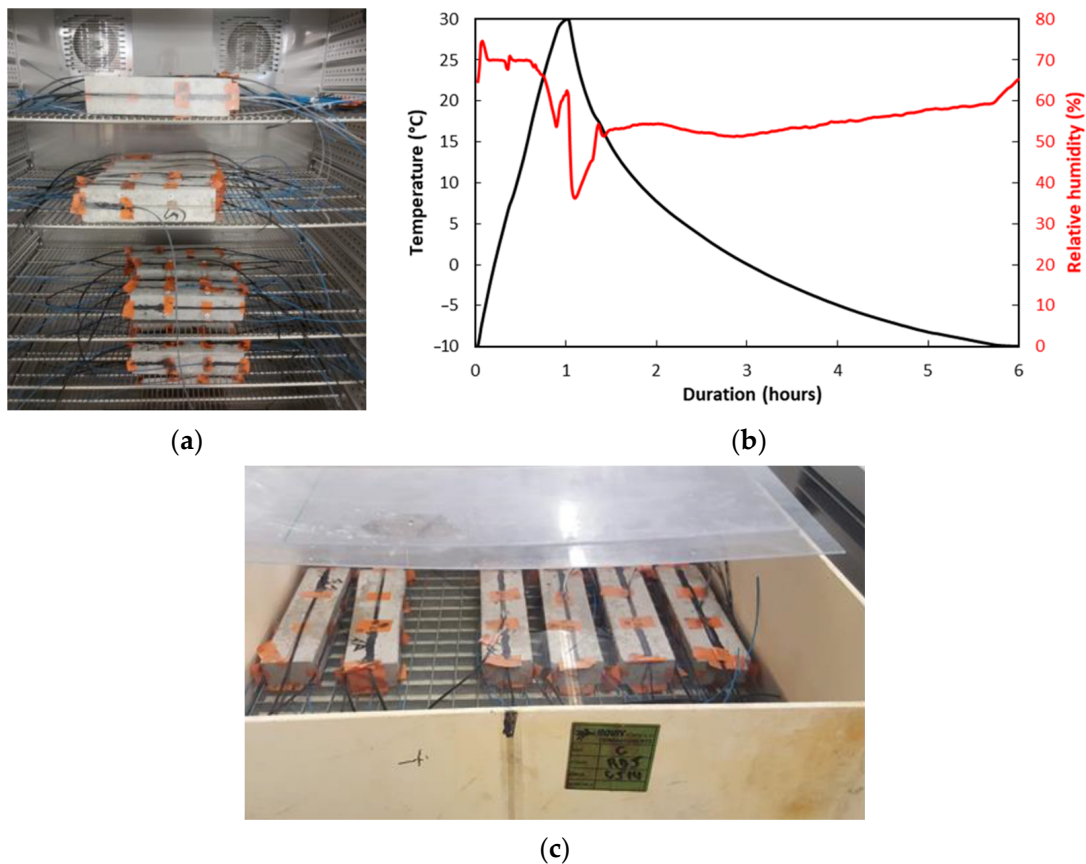
Figure 8. Application of cyclic conditions: (a) specimens subjected to F/T cycling in a climatic chamber and (b) Temperature/RH variations recorded in the chamber over a F/T cycle. (c) Specimens exposed to I/D cycling in a tank.

manner (cycles of 6 h, corresponding to an acceleration rate of 4 compared to daily alternation). Typical temperature/humidity variations recorded during a F/T cycle are displayed in Figure 8b. One can note that a duration of 5 h was necessary to achieve cooling from 30 to -10 °C, as the chamber was not able to maintain a constant cooling rate in the whole domain. In addition, the RH level was only controlled in the heating phase (RH~70%), but could not be regulated during the cooling phase.

The protocol of I/D cycles consisted of alternating a one-week immersion period in a water tank at room temperature with a one-week drying period in ambient air (Figure 8c). Water was renewed in the tank at each cycle, to favor the leaching of concrete. An overall exposure period of 18 months was initially scheduled (as for the other accelerated conditions), but it was finally reduced to 16 months due to the COVID-19 pandemic. Here, again, T0 denotes the starting date of exposure.

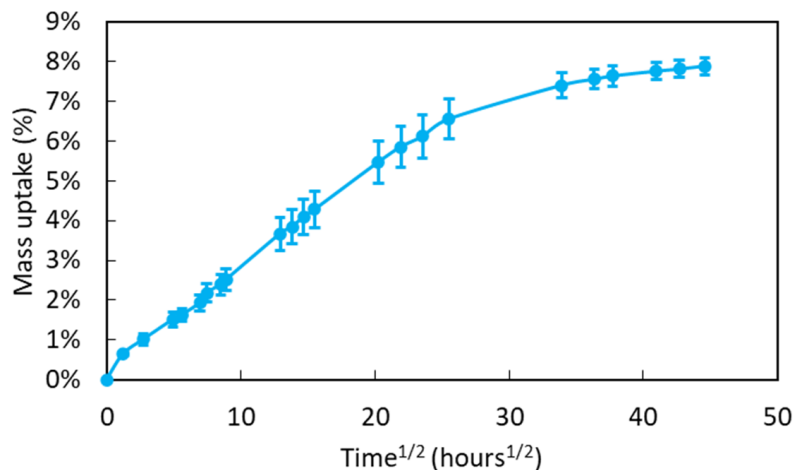
Figure 11. Absorption curve of the bulk adhesive samples immersed in water at 20 °C.

80 days of exposure, the mass uptake is close to 7.8%, and the saturation plateau is not totally reached. From the apparent trend, one can expect an equilibrium water content in the range of 8–8.5%.

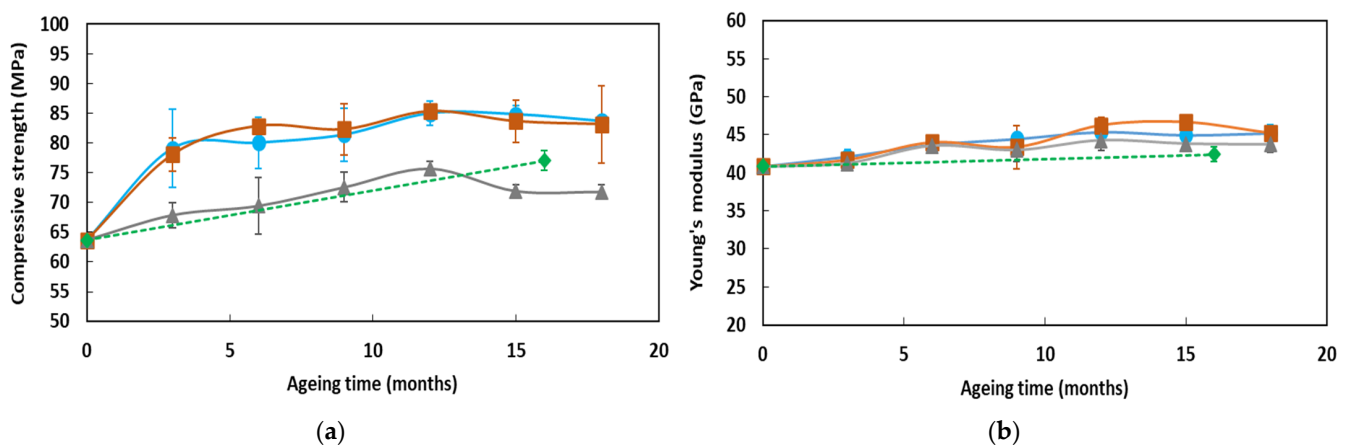
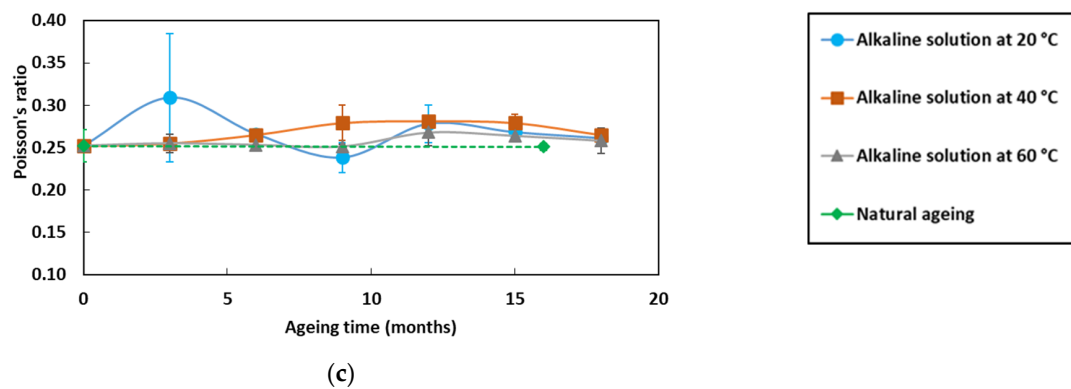
Figure 12. Evolutions of the mechanical characteristics of concrete over exposure in the alkaline and NA environments: (a) compressive strength, (b) Young's modulus and (c) Poisson's ratio.

- Alkaline environments at 20 and 40 °C favor the hydration process of the cementitious matrix and lead to an increase in compressive strength over time [40], up to a maximum value in the range 80–85 MPa. In the solution at 60 °C, and during NA that generally includes periods with low RH levels, the compressive strength also increases over time, but to a lower extent as the maximum values are in the range 70–75 MPa;
- Changes in the Young's modulus and Poisson's ratio during ageing remain limited and seem little dependent on the type of ageing condition. Only a slight increase in Young's modulus is observed over time, while the Poisson's ratio does not vary significantly.

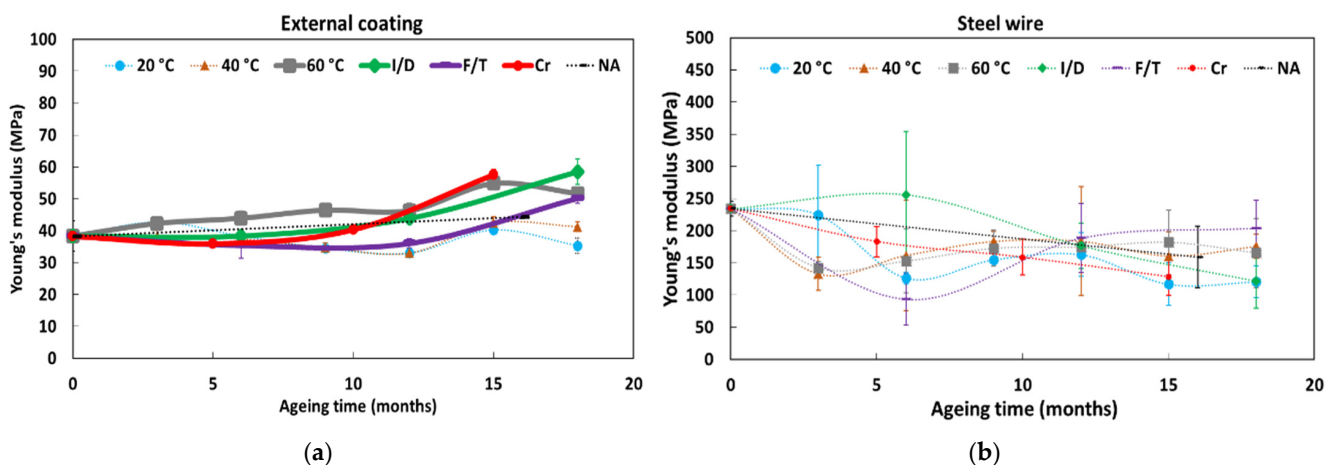
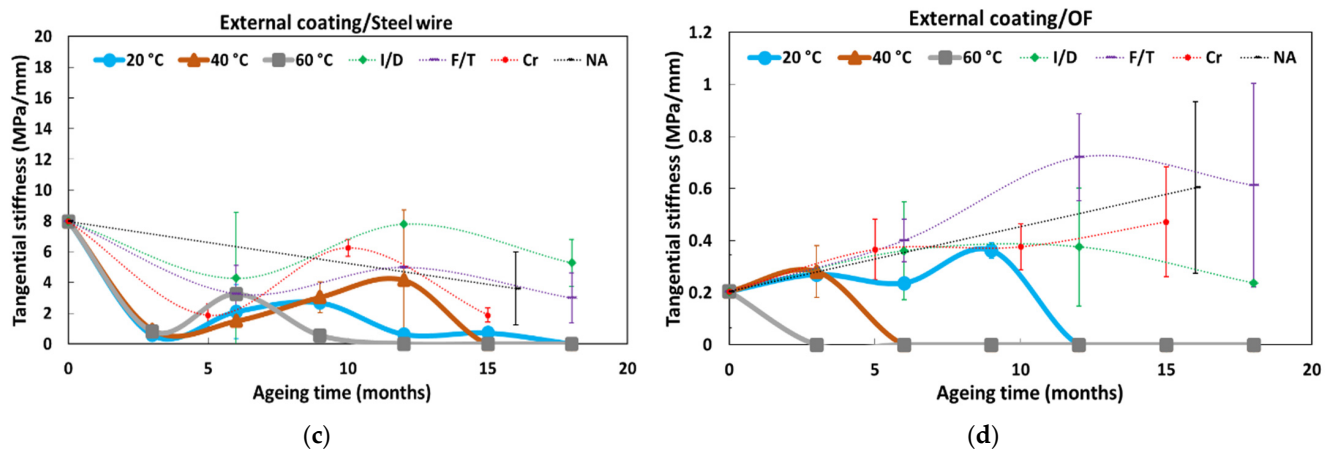
Figure 13. Changes in the mechanical properties of the component materials and internal interfaces of the DOFS cable over exposure in the various ageing environments: tensile Young’s moduli of (a) the cable coating and (b) the steel wire reinforcement; tangential stiffness of the (c) coating/steel wire and (d) coating/OF interfaces.

The numerical values are also reported in Table A1 of Appendix A.

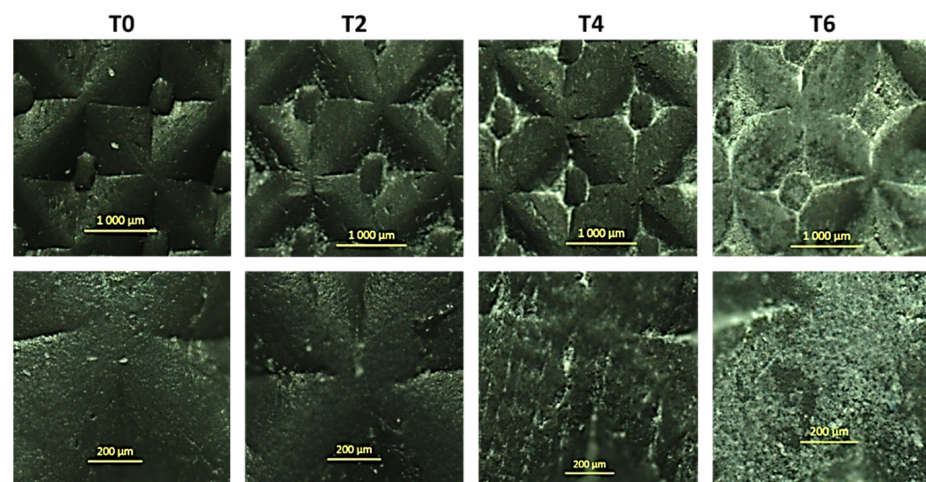
Figure 15. Optical micrographs at different magnifications, of the surface of the DOFS cable in the initial state (T0) and after 6 months (T2), 12 months (T4) and 18 months (T6) of exposure in the alkaline solution at 60 °C.

Observations of the external coating of DOFS cables by optical microscopy did not reveal any significant change in the surface aspect after ageing, except for samples conditioned in the alkaline solution at 60 °C. Figure 15 shows the external surface of the DOFS cable after different exposure periods in this peculiar condition.

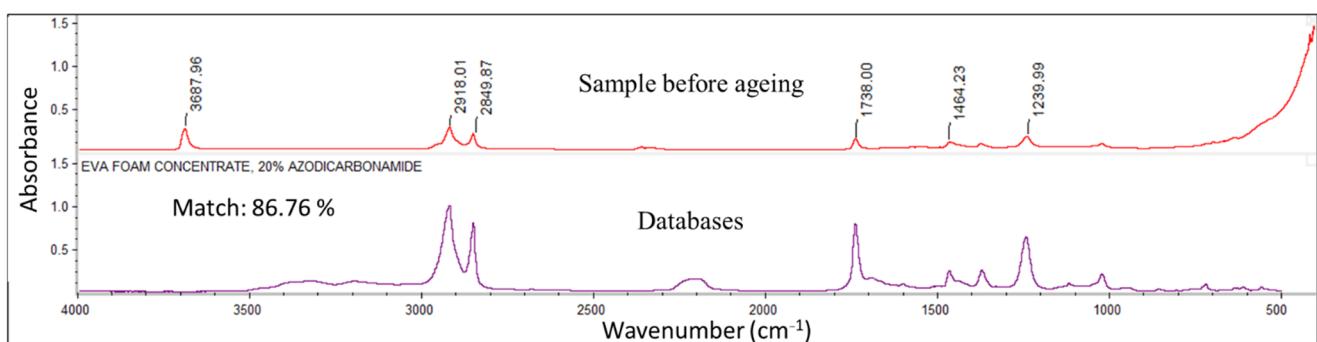
Figure 16. FTIR-ATR spectrum obtained for the external coating of the unaged DOFS cable (at session T0), together with the spectrum from FTIR databases providing the best match.

Figure 16 shows a typical FTIR-ATR spectrum of the surface of the unaged DOFS cable, as well as the spectrum identified from available FTIR databases that provides the best correspondence.

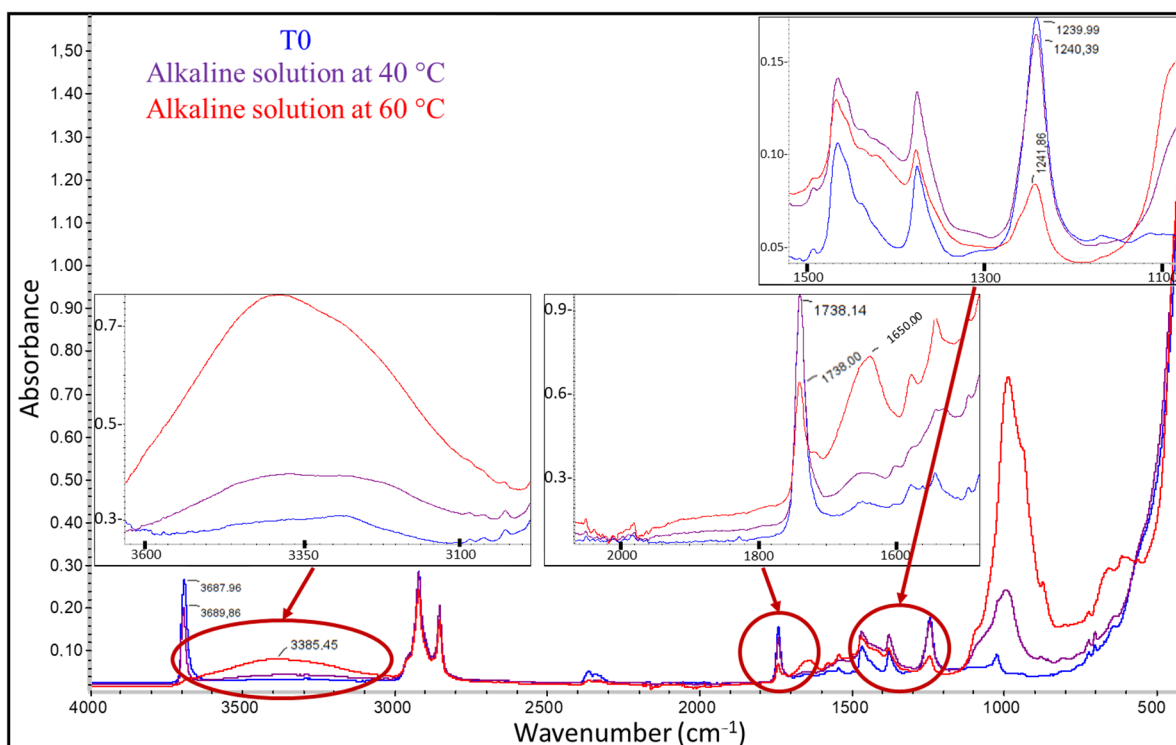
Figure 17. FTIR-ATR spectra obtained for the unaged cable coating (T0) and after 12 months of ageing (T4) in the alkaline solution at 40 and 60 °C.

FTIR analyses were then performed on the external coating of DOFS cables that had been exposed to the various ageing environments. In general, the spectra did not reveal any significant alteration of the chemical structure of the coating after ageing, except for cables immersed in the alkaline solution at 40 and 60 °C. Figure 17 shows the typical FTIR-ATR spectra obtained for the external coating of cables after 12 months exposure (T4) to these two peculiar conditions, as well as the spectrum of the unaged coating for comparison. Zooms corresponding to specific regions of interests of these spectra are also displayed in this figure.

In addition, the FTIR spectra of the aged samples also show the appearance of a broad band in the region of 3000–3600 cm^{-1} whose amplitude increases with the temperature of the alkaline solution. This band may be ascribed to an additional degradation process by hydrolysis of the acetate groups, leading to the formation of hydroxyl groups according to the mechanism described in Figure 18 [44,45]. This decomposition process of acetates would contribute, similarly to thermal degradation, to decreasing the intensity of the peaks at 1738 and 1250 cm^{-1} . Moreover, this hydrolysis phenomenon may also be responsible for the swelling observed for cables aged in the alkaline solution at a high temperature (see Figure 14) [45].

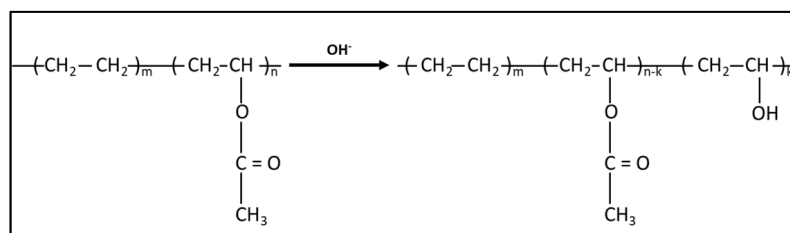
Figure 18. Hydrolysis of EVA copolymers, according to [45].

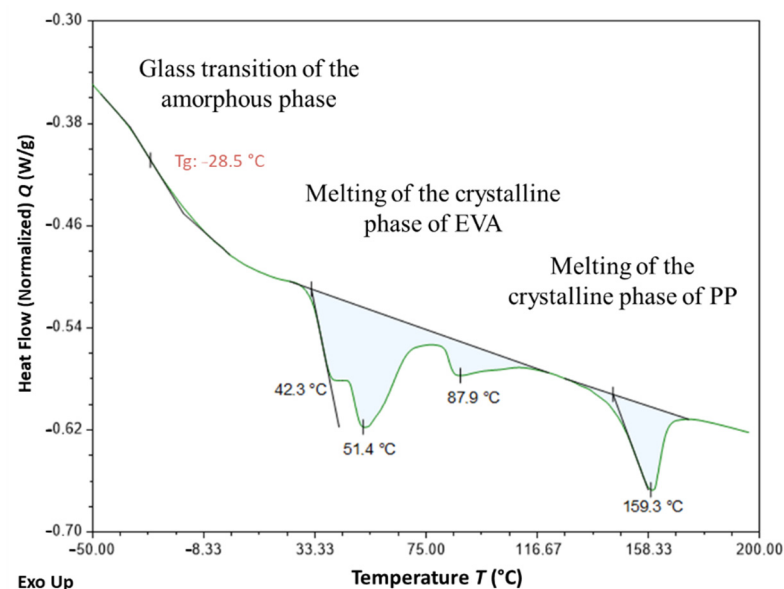
Figure 19. DSC thermogram of the unaged cable coating (T0).

- An enthalpic jump is visible around -30 °C, which can be attributed to the glass transition of the amorphous phase of the EVA copolymer;
- A large endothermic region is observed between -30 and 110 °C, from which three distinct peaks emerge at approximately 40 , 50 and 90 °C. This domain corresponds to the melting temperature range generally reported for the crystalline phase of EVAs [42,43,46]. The presence of multiple peaks reveals the existence of several populations and sizes of crystalline lamellae.
- Another endothermic peak is observed at a higher temperature, around 160 °C, which is not characteristic of the EVA crystal structure. This temperature range is usually associated with the melting of polypropylene (PP), which suggests that the cable coating is actually composed of an EVA/PP copolymer [47].

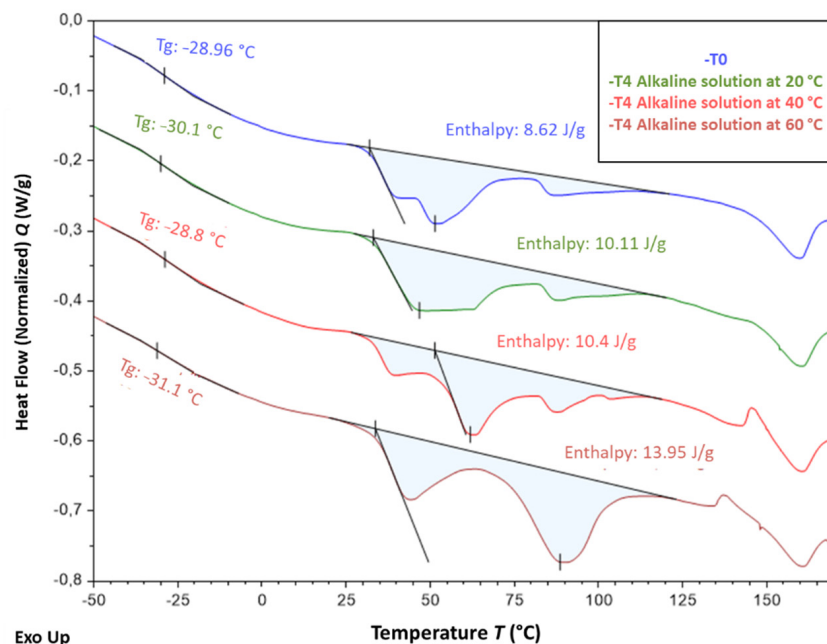
Figure 20. DSC thermograms of the cable coating conditioned for 12 months (T4) in the alkaline solution at different temperatures, and thermogram of the control sample (T0).

It is well known that the mechanical properties of semi-crystalline polymers are mainly controlled by the degree of crystallinity of the material, since crystalline lamellae play a reinforcing role for the amorphous phase. Based on previous DSC results, one can thus assume that the increase in tensile Young's modulus observed after ageing for the bulk coating material (cf. Figure 13) results from an increase in the overall crystallinity degree of the EVA copolymer due to recrystallization processes.

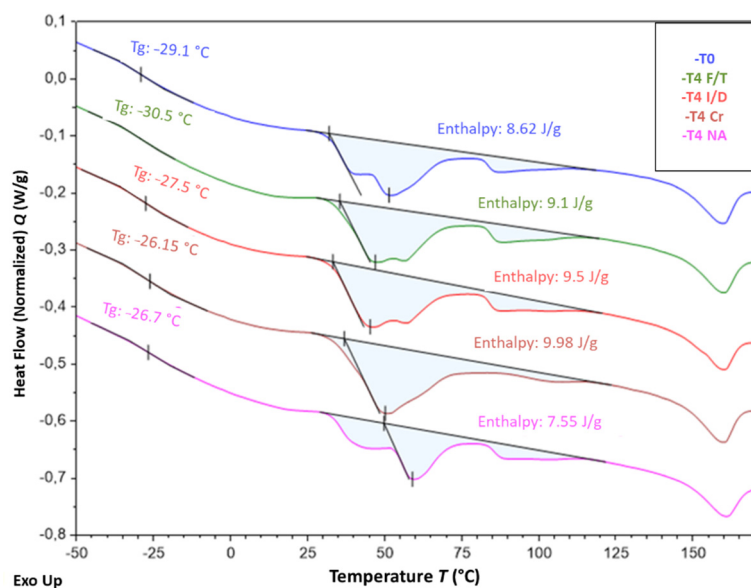
Figure 21. DSC thermograms of the cable coating after 12 months exposure (T4) to F/T, I/D, Cr and NA conditions. The control sample (T0) is also displayed for comparison.

Figure 21 presents the DSC thermograms obtained for samples that were exposed for 12 months to the other ageing environment, i.e., F/T and I/D cycling, as well as Cr and NA conditions. As before, alterations of the melting peaks of aged specimens can be detected on the thermograms, attesting for changes in the lamellae size distribution associated with the crystalline structure of EVA. However, these changes seem less important than those observed after ageing in the alkaline solution at a high temperature. In the case of NA condition, such transformations of the crystal structure are generally activated by photo-oxidation [46].

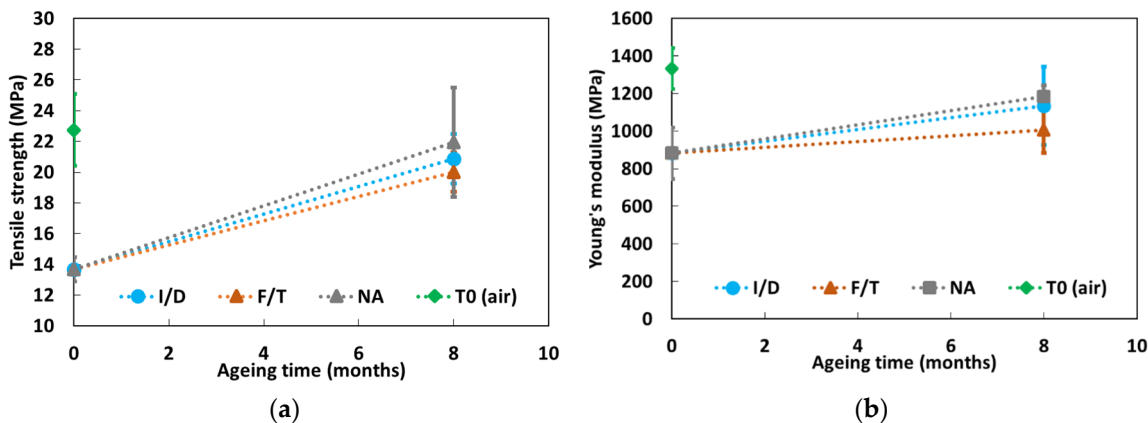
Figure 22. Values of (a) the tensile strength and (b) Young’s modulus of the X120 adhesive before and after exposure to I/D, F/T and NA conditions for a period of 8 months (T3). The initial state corresponds to preliminary conditioning in water (or in air) for 3 months.

As previously discussed in Section 3.1.3, the preliminary conditioning of samples in water negatively affected the mechanical properties of the epoxy adhesive at T0, compared to the specimens that were conditioned in air. This effect can mainly be attributed to the plasticization of the polymer network by water molecules, as a result of the high water absorption of the material (~8.5% mass uptake after 3 months in water).

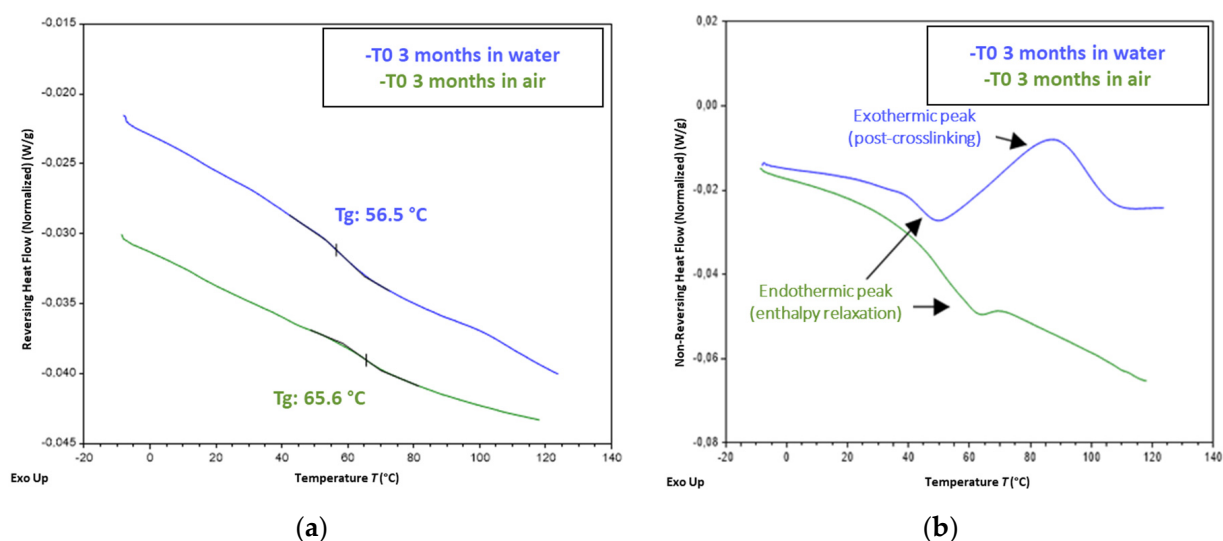
Figure 23. MDSC thermograms obtained for X120 adhesive samples at T0, after preliminary conditioning for 3 months in water or in air: (a) reversing and (b) non-reversing heat flow signals.

MDSC analyses (see the experimental protocol in Section 2.3.2) were also performed on samples at T0, and on samples aged for 8 months under F/T, I/D, and NA conditions. Figure 23 compares the MDSC thermograms obtained for adhesive samples at T0, after preliminary conditioning in water for 3 months (that reproduces the curing schedule of concrete prisms instrumented with bonded DOFS cables) or after conditioning in water for the same period. The glass transitions were clearly detected as jumps in the reversing heat flow signal (Figure 23a), which enabled the determination of T_g values in the range of 56 °C for the adhesive conditioned in water, and 65 °C for the adhesive conditioned in air. In addition, the non-reversing heat flow component (Figure 23b) displayed a large exothermic peak for the adhesive conditioned in water, reflecting post-crosslinking of the polymer during the test, due to the presence of residual monomers that react upon heating. Meanwhile, this phenomenon was not observed for the adhesive conditioned in air. These features suggest that the adhesive conditioned in water is not fully cured at T0, whereas the material stored in air has almost completed its polymerization process. Such differences in both T_g and mechanical properties at T0 as a function of the preliminary conditioning treatment of the adhesive samples (in water or in air) may therefore result from the plasticization of the epoxy network by the absorbed water, as already mentioned, but also from differences in the polymerization kinetics.

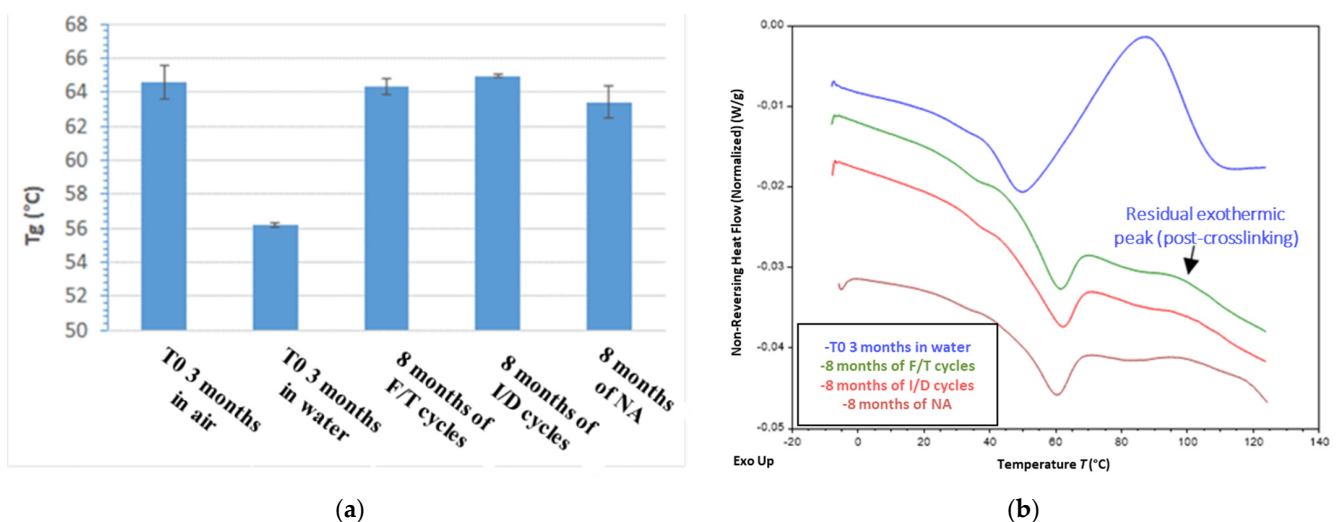
Figure 24. MDSC analyses of X120 adhesive samples exposed for 8 months to F/T, I/D and NA conditions: (a) T_g values and (b) non-reversing Heat flow thermograms.

- Exposures to F/T, I/D and NA conditions led to the desorption of a large part of the water that was initially present at T0 in the control X120 adhesive (previously conditioned in water),
- Such exposures also favored the cross-linking process of the adhesive during the ageing period, but without reaching complete polymerization of the epoxy network. This phenomenon also explains the observed increase in mechanical properties of aged adhesive samples compared to the unaged control sample at T0 (conditioned in water), and the fact that these properties remain slightly lower than those of the dry adhesive at T0 (sample conditioned in air).

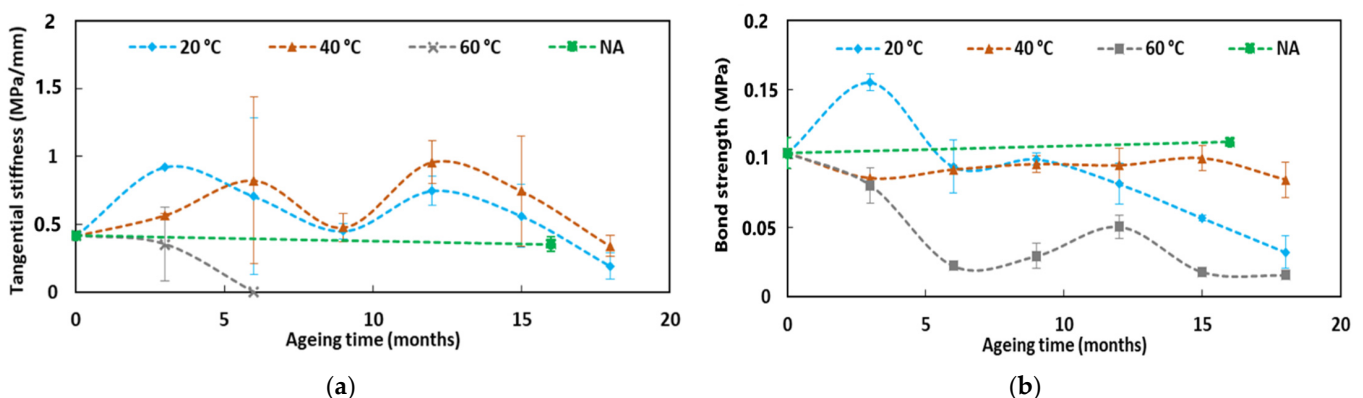
Figure 25. Evolutions of the coating/concrete bond properties during ageing in the alkaline solution at different temperatures or under NA condition: (a) tangential stiffness and (b) bond strength.

- Under NA conditions and considering the large dispersion of experimental data, no significant evolution of the coating/concrete bond properties was observed after 16 months of exposure. This result shows that NA, which reproduces actual service conditions in an outdoor environment, does not constitute an aggressive environment for the embedded DOFS cable. In addition, it suggests that immersion in the alkaline solution at 60 °C is a very harsh condition which is not representative of the actual service environment of an embedded FO instrumentation. Nevertheless, additional experiments involving long-term exposure to NA conditions would be necessary to support this conclusion.

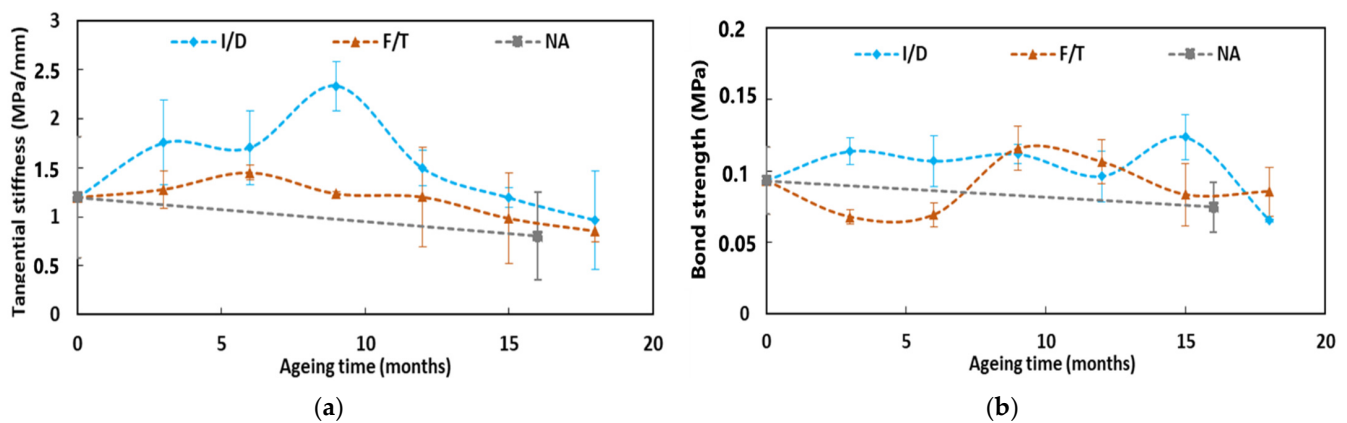
Figure 26. Evolutions of the coating/adhesive bond properties during ageing under I/D, F/T and NA exposure conditions: (a) tangential stiffness and (b) bond strength.

These slight decreases do not seem to be correlated with the changes in the mechanical properties of the X120 adhesive during ageing, which show the opposite trend. Indeed, it was previously reported that the Young's modulus of the adhesive increases with ageing due to desorption of the specimens and the continuation of the cross-linking process.

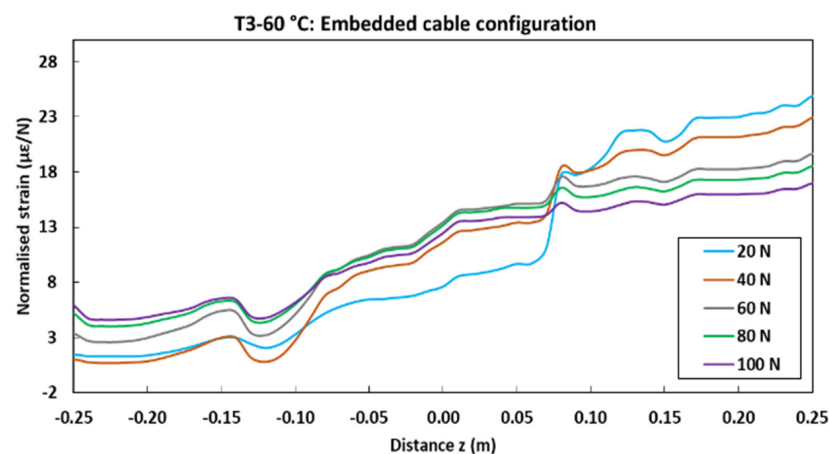
Figure 28. Strain profiles recorded during the pull-out tests on concrete specimens instrumented with embedded DOFS cables after 9 months of immersion (T3) in the alkaline solution at 60 °C.

Figure 28 displays the normalized strain profiles recorded during pull-out tests performed on concrete specimens with embedded DOFS cables after 9 months of immersion in the alkaline solution at 60 °C. A comparison of this graph with the initial strain profile (Figure 27a) clearly demonstrates the impact of these harsh ageing conditions on the strain transfer process between the OF and the host concrete. Indeed, it becomes difficult to identify the different zones (Z1, Z1 and Z3) along the measurement line after ageing, as the load transfer becomes almost uniform over the entire cable length. This phenomenon can be mainly attributed to the slip of the OF within the cable coating, resulting from the degradation of the bond properties at internal interfaces caused by the penetration of the alkaline solution into the cable (cf. Section 3.2.2). The loss of bond properties at the concrete/coating interface that was observed beyond 6 months of exposure in this specific condition (cf. Section 3.2.4) may have also contributed to the observed alteration of the strain profiles.
