Effect of Water Vapor on the Spallation of Thermal Barrier Coating Systems During Laboratory Cyclic Oxidation Testing

Abstract The effect of water and water vapor on the lifetime of Ni-based superalloy samples coated with a typical thermal barrier coating system— β -(Ni,Pt)Al bond coat and yttria stabilized zirconia (YSZ) top coat deposited by electron beam physical vapor deposition (EB-PVD) was studied. Samples were thermally cycled to 1,150 °C and subjected to a water-drop test in order to elucidate the effect of water vapor on thermal barrier coating (TBC) spallation. It was shown that the addition of water promotes spallation of TBC samples after a given number of cycles at 1,150 °C. This threshold was found to be equal to 170 cycles for the present system. Systems based on β -NiAl bond coat or on Pt-rich γ/γ' bond coat were also sensitive to the water-drop test. Moreover, it was shown that water vapor in ambient air after minutes or hours at room temperature, promotes also TBC spallation once the critical number of cycles has been reached. This desktop spalling (DTS) can be prevented by locking up the cycled samples in a dry atmosphere box. These results for TBC systems confi

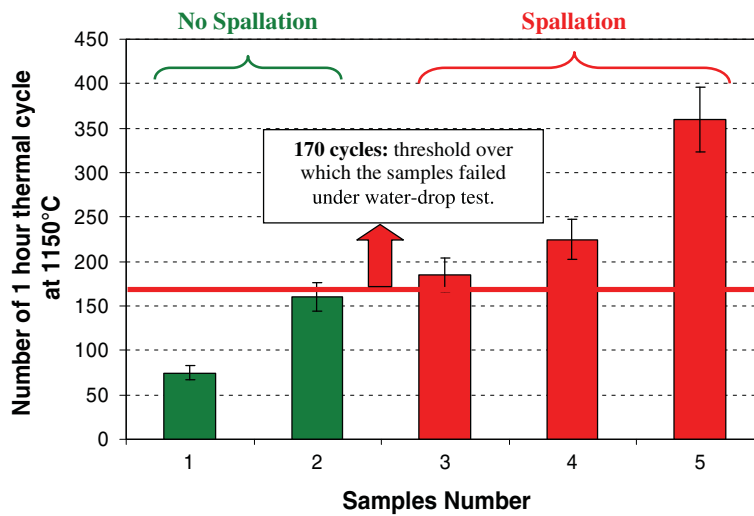
Fig. 3 Results of the second experiment reporting the effect of water-drop testing on samples after 5 durations of thermal cycling. Three specimens were tested for each duration

Table 1 and Fig. 3 report the effect of water-drop testing on samples after five thermal cycles durations. Three specimens were tested for each duration. They all demonstrate the same behavior during the water-drop test carried out a few seconds

after cooling the specimens to room temperature. The first thing noted was that no spallation was observed right after the removal of the specimens from the furnace. When a water-drop was applied to specimens, spallation occurred systematically for the samples subjected to 185, 225 and 360 cycles. On the contrary, samples did not fail after 75 and 160 cycles. This shows that there is a critical threshold above which the samples fail consistently during the water-drop test (Fig. 3). It is noted, however, that the samples which did not fail during oxidation cycles above this limit are in a tenuous state, since they would fail immediately in contact of a water drop. The threshold was found to be about 170 one hour cycles at 1,150 °C (Fig. 3). This existence of a critical threshold is in good agreement with the data from Smialek et al. [2, 5] on alumina forming alloys.
