**BOND / Structural Bonding**

- Study of the adhesion mechanisms in a titanium - composite bonded joint with consideration of environmental aging

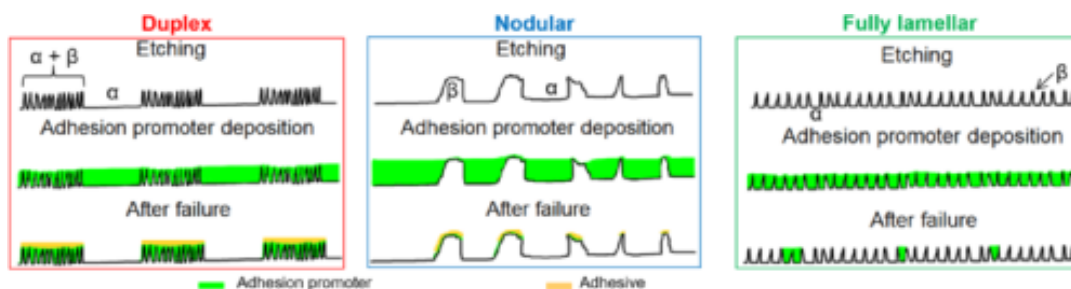
Failure mechanism of TA6V microstructures

In the aeronautical field, mass reduction of structures is a major objective. Among the wide range of possible solutions, structural bonding can be used. Hybrid bonded joints involving a thin titanium cover sheet on a lighter composite bulk appear to be a good alternative to reduce structure's weight without losing mechanical properties. In this particular type of bonded parts, titanium alloys adhesion properties are usually enhanced by chemical surface treatment and adherence promoters. Some studies have shown that in the case of the  $\alpha + \beta$  titanium Ti-6Al-4V alloy, an alkaline etching treatment leads to a selective dissolution of  $\alpha$ -phase [1]. Surface roughness and chemistry are modified, allowing good bonding properties. As for adhesive bonding, phenolic primer and epoxy adhesive seem to be standard practice. These are the solutions used in the present study. To characterize the joint properties, Thick Adherend Shear Testing (TAST) is proposed. Although nominally pure shear, this test shows failure initiation at the interface from both edges of the adhesive joint, due to development of a non-zero normal edge stress (mode I component). By shifting the load axis in the normal direction, a bending moment is created which allows increasing normal stresses at one of the two edges. Thus, failure close to the titanium-adhesive interface can be initiated from only one side, increasing sensitivity to surface microstructure modifications or to surface treatment parameters. Thus, this study focuses on the impact of surface treatment parameters upon adhesion properties. Microstructures of titanium alloy and environmental impact were also investigated. Surfaces were characterized before and after etching, and after failure, by scanning electron microscopy and X-ray Photoelectron spectroscopy, leading to a slightly Ti-microstructure dependent failure mechanism (Figure 1).
