Investigation of Fatigue Behavior of Three Dimensional Interlock Composites by Time-Lapse Micro-Computed Tomography

Christophe Cruanes, Keerthi Krishna Parvathaneni, Dmytro Vasiukov and Chung Hae Park *

IMT Nord Europe, Institut Mines-Télécom, Université de Lille, Centre for Materials and Processes, F-59000 Lille, France; ccruanes@gmail.com (C.C.); krishna.klume@gmail.com (K.K.P.); dmytro.vasiukov@imt-nord-europe.fr (D.V.)

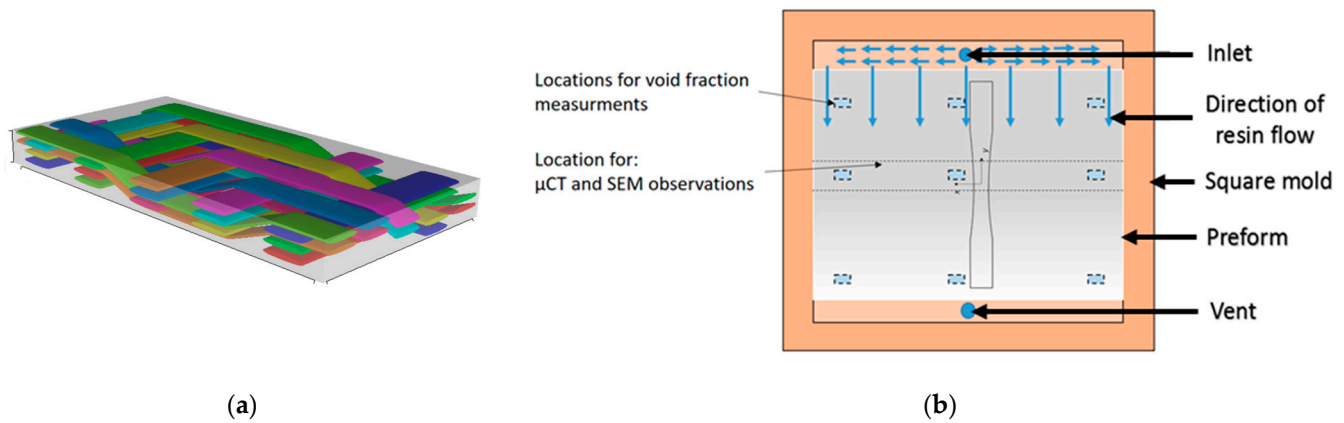
Figure 1. Manufacturing of composite plate: (a) textile architecture and (b) scheme of resin transfer molding manufacturing process with the position of specimen extraction for tensile fatigue tests.

could be filled from an edge, resulting in a rectilinear flow front. The schematic of the manufacturing strategy is shown in Figure 1b.

A rectangular preform was placed in the mold. The resin injected through the resin inlet rapidly filled the empty cavity between the preform and the mold wall. Then, the resin impregnated the preform progressively from the empty cavity, while maintaining a rectilinear flow. In Figure 1b, the nine locations of the extraction of specimens for void volume fraction measurement are illustrated. Mechanical test specimens were extracted as shown in Figure 1b so that the direction of resin flow corresponded with the resin flow direction.

Following the standards specified by ASTM D 3171-99, a burn-off test was conducted in nine locations (Figure 1b) to measure the fiber volume fraction and the total void volume fraction, which is the sum of intrayarn and interyarn void volume fractions. The intrayarn void volume fraction was estimated by optical observation after post-processing of SEM images.

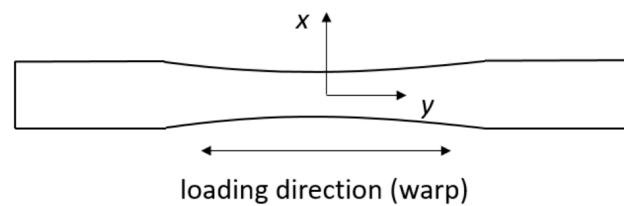
Figure 2. The specimen used for the fatigue tests and the axis used for the μ CT (z in the thickness direction).

After the injection of resin into preform, the composite plates were submitted to curing at room temperature for 18 h and de-molded at room temperature. Then, to achieve sufficiently high green strength of the resin, the composite plates were placed in an oven with a constant temperature of $50 \text{ }^\circ\text{C}$ for 16 h. Subsequently, the specimens with a dumbbell shape were cut off from the composite plates as shown in Figure 2. The specimens had a varying cross-section whose width was decreased from 28 mm at the tips to 18 mm at the mid-length, to minimize the stress concentration effects near the grips and increase the probability of the damage localization in the middle zone of the specimen. Therefore, the region of interest would be limited at the central zone of the specimen.

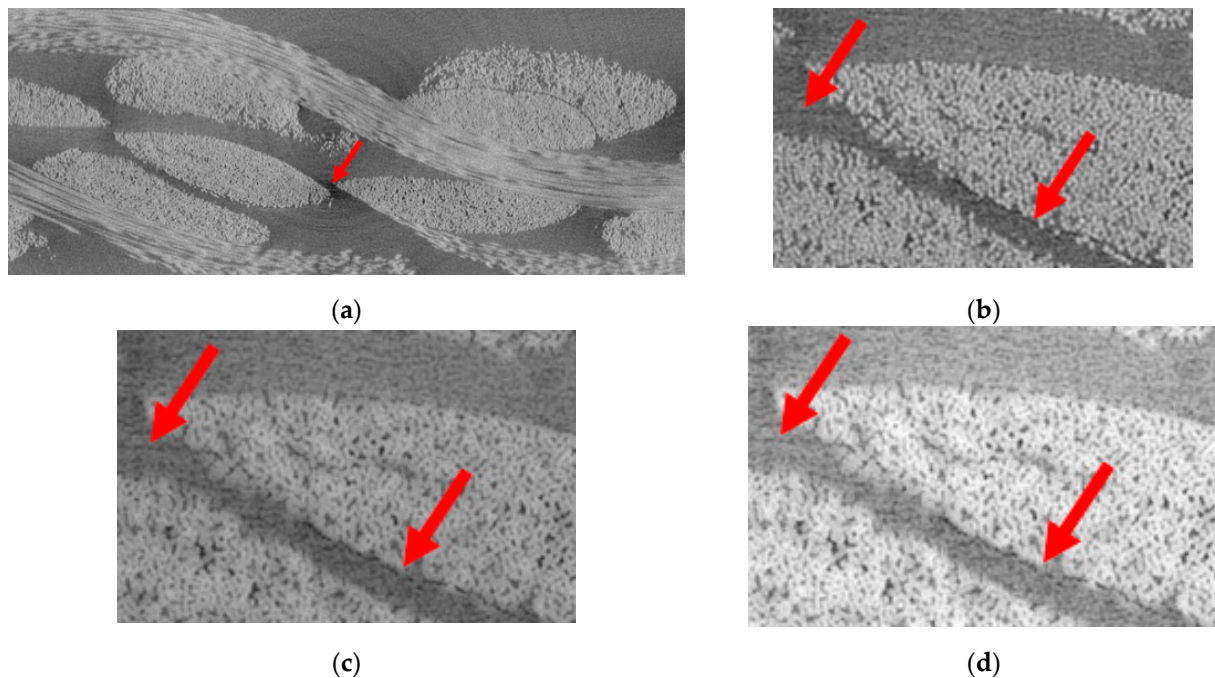
Figure 3. μ CT image post-processing example: (a) raw image with dark areas in the matrix that are artifacts; (b) zoom in an area where two cracks are present; (c) filtering of the noise outliers; and (d) contrast adjustment.

In the images obtained from the μ CT measurements, the matrix was in a dark color and the grey level was the same for both the cracks and for the voids (see the red arrow in Figure 3a). This can be explained by the low number of images taken for each acquisition and the significant contrast between the matrix and the fibers. Consequently, in the absence of a contrast liquid, it was difficult to observe the cracks in the early stages of crack propagation. The solution adopted in this study was to work on the digital images using Fiji software to enhance the contrast in the images and to make the cracks more visible. Therefore, two operations were carried out (Figure 3b–d). Firstly, it was possible to limit the noise caused by the brightest pixels that were associated with the glass fibers by using the “Remove outliers” function. Secondly, the contrast was adjusted to better detect the cracks (see the red arrows in Figure 3d).

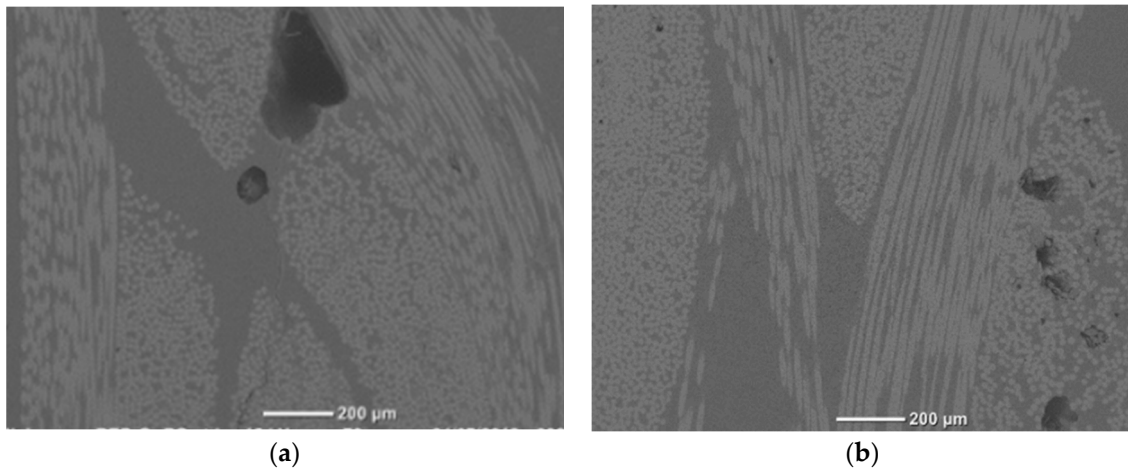
Figure 4. SEM images of voids: (a) interyarn voids in Case A; (b) intrayarn voids in Case B.

From the SEM image analysis, it was found that for Case A, where the injection pressure was low, most of voids were located in the matrix zone between the yarns

(i.e., interyarn voids) even if there were some voids inside the fiber yarns (Figure 4a). Conversely, for Case B, where the high injection pressure was adopted, many voids were located inside the fiber yarns (i.e., intrayarn voids), as shown in Figure 4b. This trend was observed for most of specimens of each case even if it was difficult to precisely measure the intrayarn void volume fraction and the interyarn void volume fraction separately. It should also be mentioned that the interyarn voids were generally spherical whereas the intrayarn voids were mostly cylindrical.

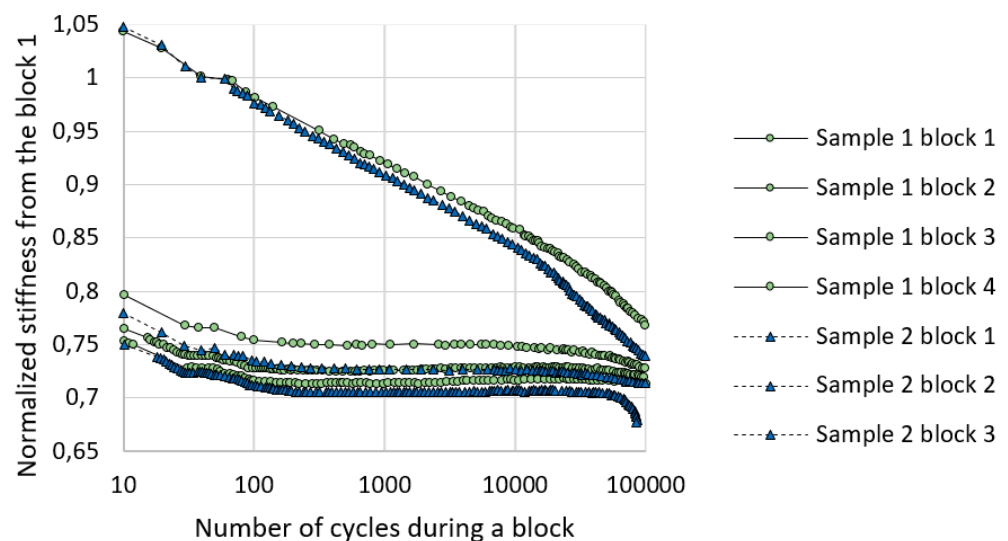
Figure 5. Evolution of the normalized stiffness during each block.

Figure 5 shows the evolution of the normalized stiffness (normalized with the value of the stiffness at 50 cycles in the first block). We can observe that as the number of blocks undergone by the specimen increased, the curve started at a lower value, indicating that each block accumulated more damage in the specimen. It can also be observed that the behavior changed between the first block and the others as the slope decreased significantly.

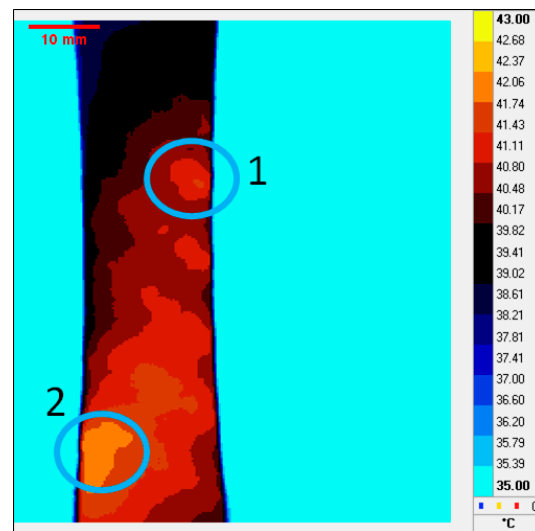
Figure 6. An example of a thermal map for a random block with locations of the hot spots.

Figure 6 shows the localization of hot spots during the blocks. It appears that there were two hot spots, i.e., the first one in the upper part of the sample and the second one symmetrically placed in the lower part. Their positions were chosen as the regions of interest (ROI) for the μ CT measurements.

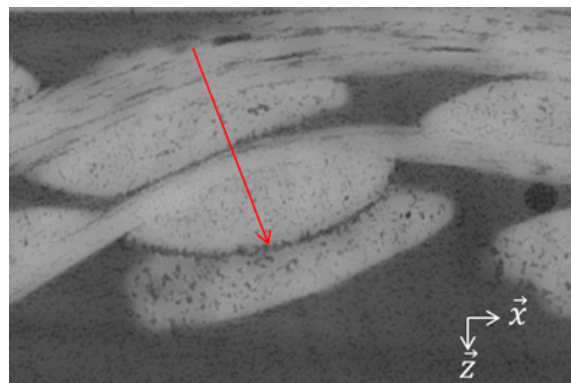
Figure 7. μ CT showing initiation of cracks by debonding between warp yarns. Time-lapse after 10^5 cycles. See the area of contact between two warp yarns.

During the first block of fatigue, the specimen exhibited a hot spot located around 10 mm below its center. The volume investigated during the μ CT measurement was centered on this location. Figure 7 shows two adjacent warp yarns compacted by the weft yarns. It should be noted that the quantity of matrix at the contact surface between these two adjacent warp yarns was very low (even if not completely zero) and the crack was initiated at this zone by inducing the debonding between the warp yarns.

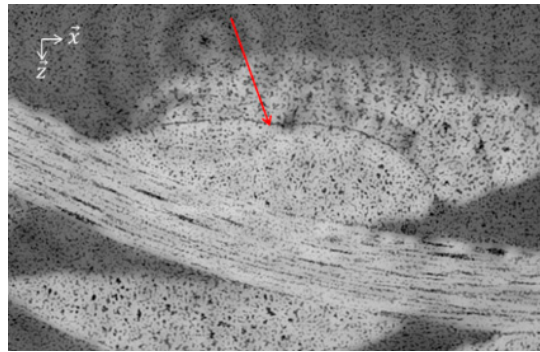
Figure 8. μ CT showing propagation along the warp yarns and multiple initiations of cracks from debonding. Time-lapse after 2×10^5 cycles. Cracks are found in the area of contact of two warp yarns.

We can see several locations of crack initiation at the contact surface between the two warp yarns, where the amount of matrix was the lowest (Figure 8).

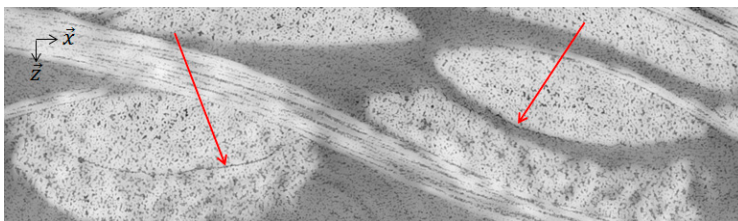
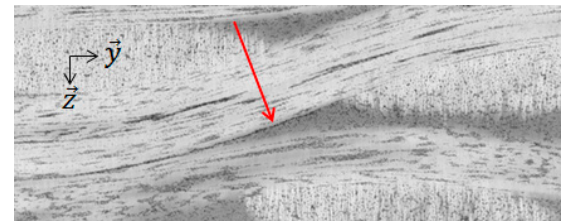
Figure 9. μ CT images show cracks propagating to coalesce along the weft yarn in the center of the thickness. Time-lapse after 3×10^5 cycles. (a) Cracks between the neighboring warp yarns. (b) Cracks joining the weft yarn.

Figure 9a shows that the cracks propagated along the contact surface between the warp yarns at a high angle with respect to the loading direction (i.e., transverse to the loading direction). Then, it appears that the cracks propagated through the matrix to join the weft yarn (Figure 9b) and went around it. The multiple cracks tended to join one another as they were following the same path of propagation. The propagation path was located at the center of the specimen in the thickness direction.

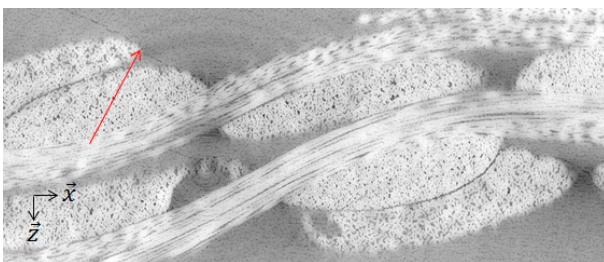
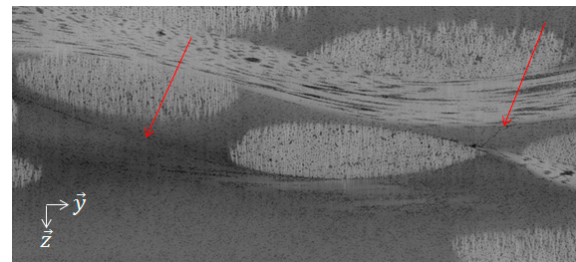
Figure 10. μ CT images show cracks propagating to coalesce along the weft yarn in the center of the thickness. Time-lapse after 3×10^5 cycles. (a) View in the x-z plane. (b) View in the y-z plane (see Figure 2 for the axis definition).

Figure 10 shows that many cracks joined while the propagation path was around the specimen center in the thickness direction. It is also observable that when the crack came closer to the surface, it sometimes branched towards it (Figure 11). This can be observed on the infrared measurements as the cracks increased the self-heating in this region.

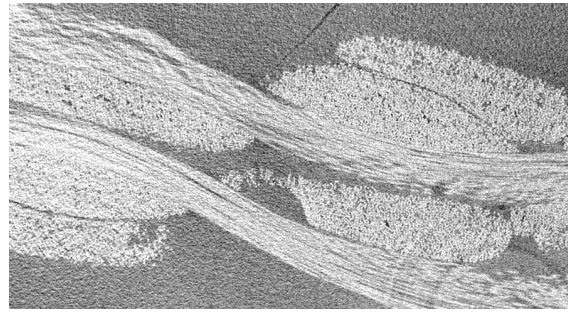
Figure 11. μ CT image of crack branching toward the surface of the sample.

It can be observed that if the path of crack propagation is close to the specimen surface, the crack can propagate toward the surface. This happens, however, only if the crack has seen at least one cycle of propagation on the steps, as mentioned previously.

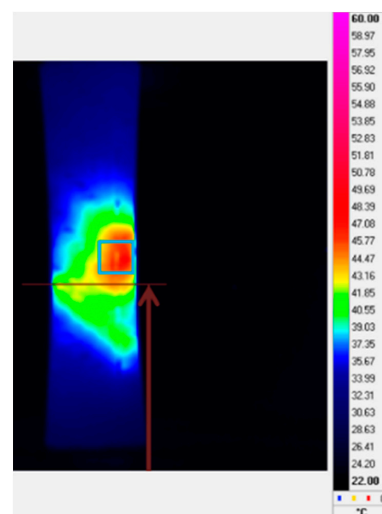
Figure 12. Location of the plane in which the SEM observations were carried out (brown line). The blue square shows where the failure of the sample will occur later in the test.

On the other hand, it was possible to perform scanning electron microscope (SEM) observations after the end of constant amplitude tests. The area observed was located approximately 1 cm away from the zone of the specimen rupture (Figure 12). It should be kept in mind that it would be inappropriate to be closer than 1 cm because the zone at the very vicinity of a rupture is usually significantly damaged, mainly by a catastrophic crack propagation, which is not representative of the damage mechanism occurring during the fatigue tests.

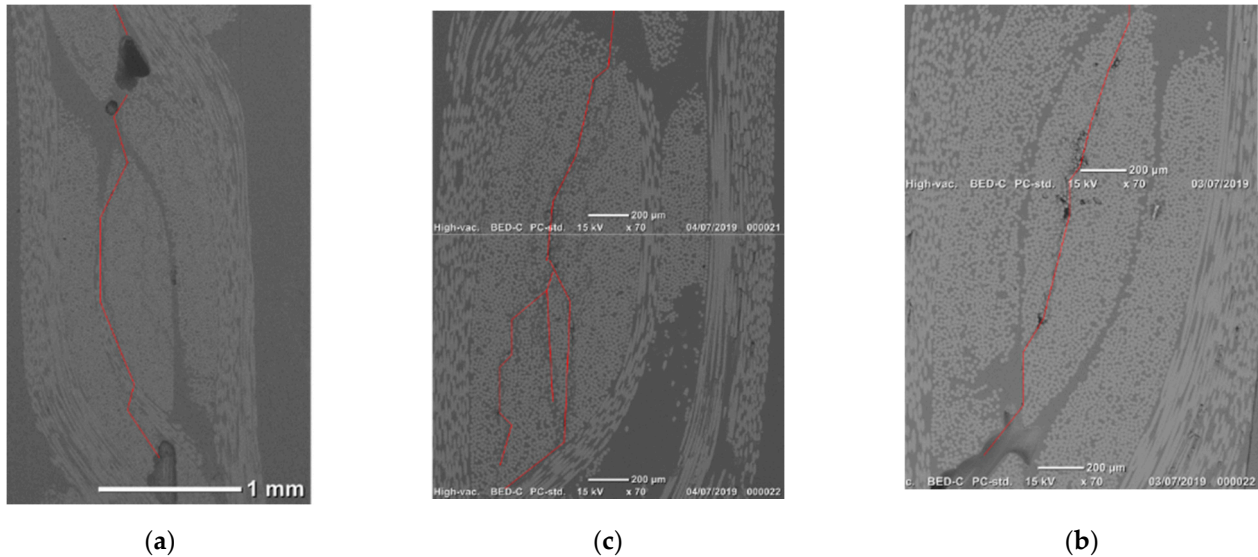
Figure 13. Micrographs in samples with fatigue lives of (a) 8.9×10^5 cycles, (b) 0.9×10^5 cycles, and (c) 0.3×10^5 cycles. The plane of observation is the same $(\vec{x}; \vec{z})$. The cracks are highlighted by a red line.

Figure 13 shows SEM views in the $(\vec{x}; \vec{z})$ plane for samples with different fatigue cycles (from 0.3×10^5 cycles to 8.9×10^5 cycles). In every case, the cracks show a similar behavior as that of Case A specimen. In addition, a new feature can be observed for the Case B specimen. When the crack was located at the contact surface of two warp yarns, its propagation went through one of the yarns.

- When the crack goes through a yarn, it is likely to be caused by the presence of voids in the yarn. In Figure 13c, we can see that the path of the crack propagation was driven by the voids. Even if voids are not observed in other cases, they are likely to be present inside the yarn but not in the observed plane.
- Because the crack propagation through the yarns is observable in almost all of the micrographic images, it is possible to assume that this happened multiple times in a given sample.

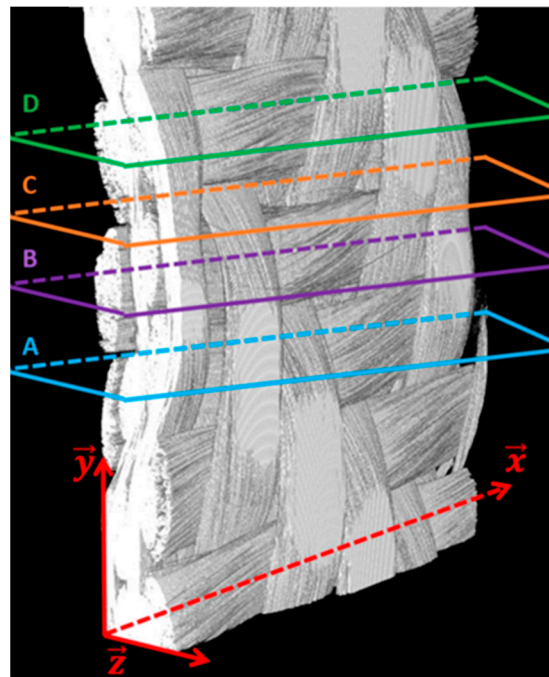
Figure 14. Projection in the $(\vec{y}; \vec{z})$ plane. The four steps of the propagation of a crack in a 3D interlock are depicted. The resolution of the μ CT images is as follows: one pixel represents a surface of $5 \times 5 \times 5 \mu\text{m}^3$. This figure illustrates how the images A, B, C and D are located on the 3D model.

From the μ CT images, different cross-sections (Figure 14) were extracted after each block (as defined in Section 2.2) to obtain 2D images (Figure 15). In Figure 15, the yarns are denoted according to their orientation in the fabric, i.e., “Y + number” for warp yarns and “Y + letter” for weft yarns.

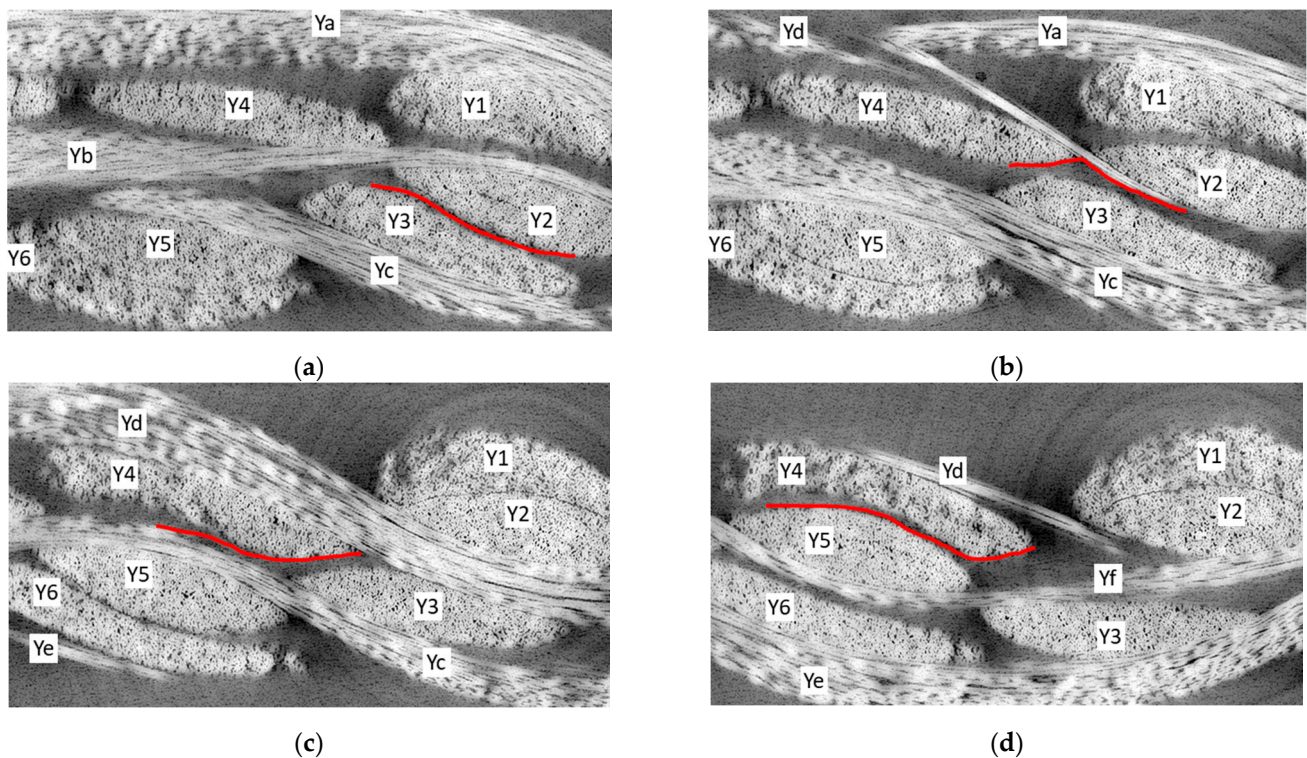
Figure 15. Schematic showing the steps of propagation of the crack(s): (a) Step A, (b) Step B, (c) Step C, (d) Step D.

- Step A (Figure 15a): A crack is initiated at the contact surface of the yarns Y2 and Y3, where the volume of the matrix is very small or almost zero. Because of the high shear stress in the matrix located at the contact surface between the adjacent yarns, debonding occurs, leading to the creation of a crack. The crack then propagates along the warp yarn Y2 that exhibits a higher angle with respect to the loading direction or in the transverse direction to the loading.

- Step B (Figure 15b): While approaching the weft yarn Yd, the crack starts to propagate into the matrix and reaches the surface of the weft yarn, which is closer to the center of the specimen (i.e., Yd in this case). Subsequently, it propagates around Yd, then in the matrix, and reaches another warp yarn (Y4) symmetrically, as aforementioned.

- Step C (Figure 15c): The crack propagates alongside the yarns Y4 and Yc.
- Step D (Figure 15d): The crack reaches the contact area between the yarns Y4 and Y5. It is also possible that another crack is initiated from this zone as the area in step A and the two cracks tend to coalesce.

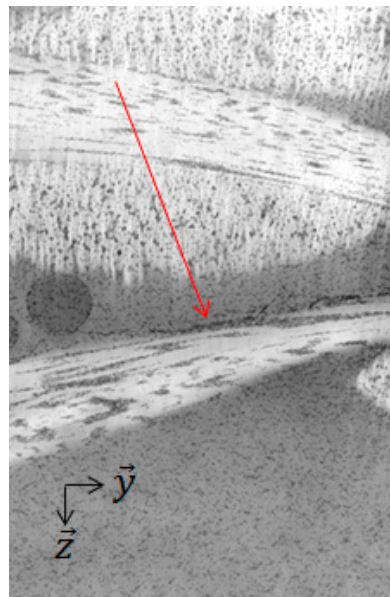
Figure 16. Deviation of the propagation of a crack by a void in the matrix.

The influence of interyarn voids was limited, whereas a slight change in the direction of the crack propagation could sometimes be observed (Figure 16). In general, however, their presence did not have any effect on the propagation of cracks. Gigliotti et al. [25] made the same observations during thermal fatigue tests on 3D interlock composite samples with voids whose volume fraction was equal to that of the specimens investigated in this paper.
