# Research and Measuring Technology Needs to Better Model and Measure Fatigue Crack Development of Thinly Surfaced Asphalt Road Pavements

**Abstract:** The root cause of premature failures in relatively thin (<50 mm) asphalt surfaced roads is often a challenge to solve during forensic investigations in South Africa (SA). This description is based on peer review type discussions with forensic investigations experts as well as published research papers. The areas of ignorance or areas where research effort is needed are identified. These observations serve to identify areas of new knowledge needed in terms of actual verification with measurements, measurement technology, and modeling of the observed phenomena. The main objectives of this discussion paper are to highlight the evolution of distress development in asphalt layers starting from the identification and description of the kind of microcracks, effects of microcracks in the debonding of the asphalt layer from lower layer, and vehicle–pavement interactions (VPI) of moving truck wheels focusing on the thin asphalt layer. Specific reference is made to the need to measure and model the effects of bow waves in front of and next to

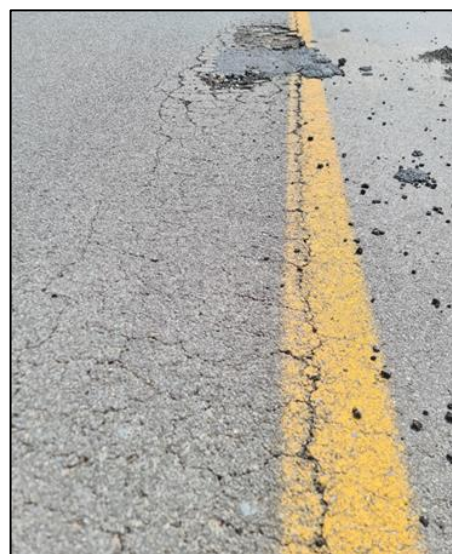
**Figure 2.** The second kind of micro-cracks is visible against the yellow line contrast.

Fines from the base and subbase are pumped upwards to make the microcracks visible by rimming the cracks’ lips with a whitish residue. Due to the influence of water intrusion, these cracks also tend to rapidly develop longitudinally and often into the so-called chicken net or early map cracking, or irregular crocodile type cracks shown in Figure 2 [4]. In this image, it is clear that the crack of the second kind is more visible against the yellow line (on the edge of the outer wheel path) versus the larger extent of chicken wire or map type cracks now clearly observable in the wheel path next to the yellow line. Several cases indicated that the transverse cracking was followed by ladder cracking and then followed by irregular cracking or map cracking or chicken net cracking or described as early irregular crocodile pattern as shown in Figure 3 [4].
