# Research and Measuring Technology Needs to Better Model and Measure Fatigue Crack Development of Thinly Surfaced Asphalt Road Pavements

**Abstract:** The root cause of premature failures in relatively thin (<50 mm) asphalt surfaced roads is often a challenge to solve during forensic investigations in South Africa (SA). This description is based on peer review type discussions with forensic investigations experts as well as published research papers. The areas of ignorance or areas where research effort is needed are identified. These observations serve to identify areas of new knowledge needed in terms of actual verification with measurements, measurement technology, and modeling of the observed phenomena. The main objectives of this discussion paper are to highlight the evolution of distress development in asphalt layers starting from the identification and description of the kind of microcracks, effects of microcracks in the debonding of the asphalt layer from lower layer, and vehicle–pavement interactions (VPI) of moving truck wheels focusing on the thin asphalt layer. Specific reference is made to the need to measure and model the effects of bow waves in front of and next to

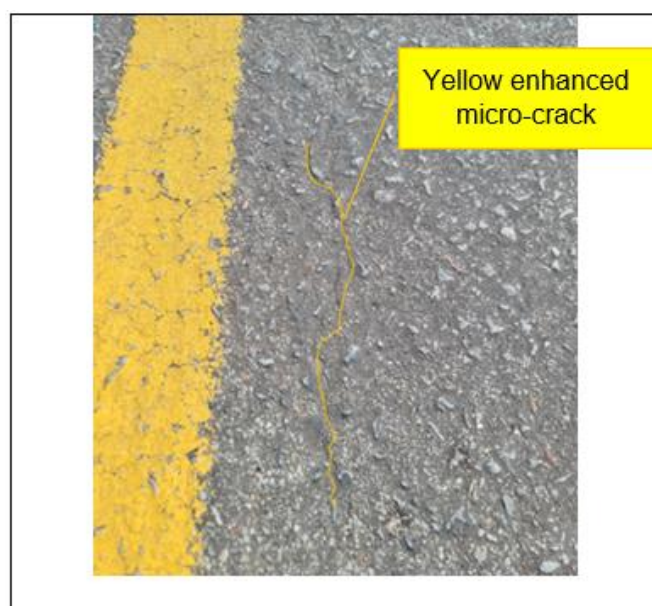
The early signs of crack development are often overlooked as they tend to be less visible in the early stages. See the illustration in Figure 1 where the microcrack is highlighted in yellow next to the normal yellow line to identify its presence.

**Figure 1.** First kind fine hairline/micro cracks on the surface (barely visible).

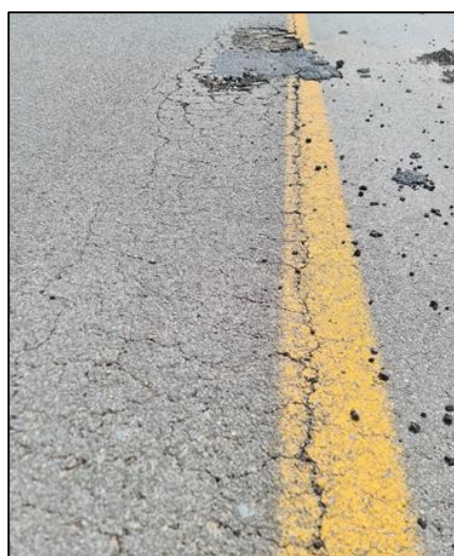
Fines from the base and subbase are pumped upwards to make the microcracks visible by rimming the cracks’ lips with a whitish residue. Due to the influence of water intrusion, these cracks also tend to rapidly develop longitudinally and often into the so-called chicken net or early map cracking, or irregular crocodile type cracks shown in Figure 2 [4]. In this image, it is clear that the crack of the second kind is more visible against the yellow line (on the edge of the outer wheel path) versus the larger extent of chicken wire or map type cracks now clearly observable in the wheel path next to the yellow line. Several cases indicated that the transverse cracking was followed by ladder cracking and then followed by irregular cracking or map cracking or chicken net cracking or described as early irregular crocodile pattern as shown in Figure 3 [4].

**Figure 2.** The second kind of micro-cracks is visible against the yellow line contrast.

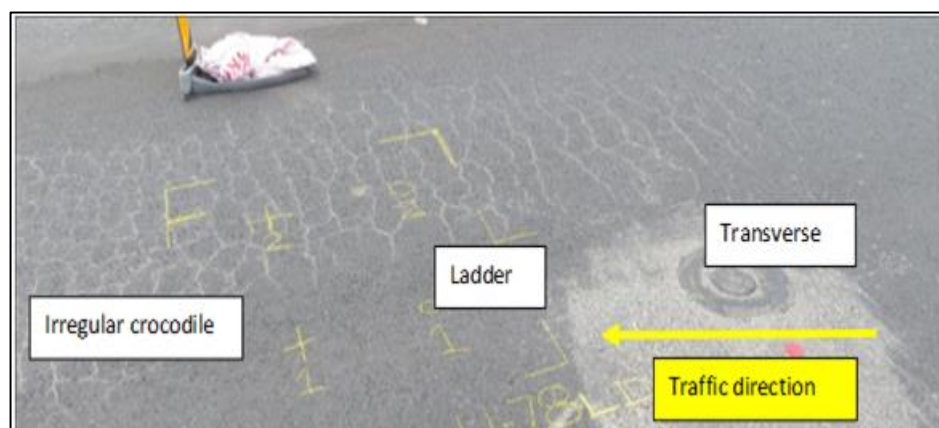
**Figure 3.** Changes in the pattern of cracks of the second kind.

standing waves in water are highly dampened on the asphalt surface, but they cause significant flexing in the longitudinal as well as transverse directions next to the wheel. Under traffic loading, this relatively softened top of the base layer (i.e., weak interlayer) causes even more flexing of the asphalt surfacing loose layer due to downwards and upwards flexing added to the normal structural flexing behavior of road pavements. See Figure 8 where the phenomenon is illustrated for the front bow wave. [4]. This additional flexing accelerates the traffic associated fatigue crack development exponentially and may explain why longitudinal or transverse cracking is often followed by ladder-type cracks (of the second type and observable) as shown in Figure 3.

awareness that the transverse flexing between and along the sides of the moving wheel significantly contribute to observed crack development patterns. This helps to explain how such transverse flexing contributes to such exponential crack progression along the tire sides literally morphs into the irregular map type cracking (chicken net) or the start of real crocodile crack patterns in a relatively short time as illustrated in Figure 3.

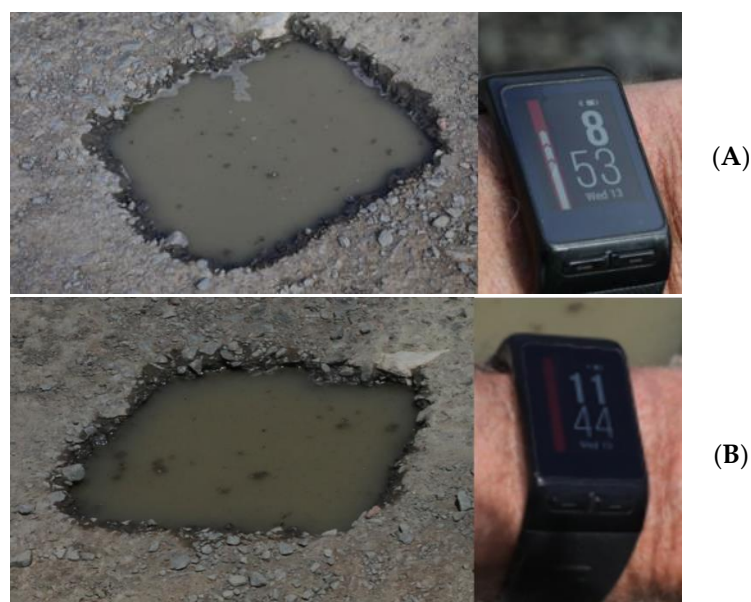
Well-published and peer-reviewed research state that a good quality unbound base (G1, engineered granular material), [9] is in effect impermeable. Basic visual proof of such impermeability of a good quality base is illustrated in Figure 4. It shows the water level in a tests hole after 8 h showing no penetration on its own. Such good quality aggregate bases have a clean mosaic surface finish due to a proper slushing and brooming protocol. However, if the surface of the base was not properly cleaned after slushing it have a slushed interlayer (of fines). If the crushed stone base material does not meet the low Plasticity Index (PI) requirements for a G1, it is now a lubrication interlayer. This leads to rapid debonding of the asphalt layer with clear premature fatigue failure of the asphalt surfacing. Typically, base materials such as G3, G4, and G5 have more relaxed PI requirements and thus the sensitivity to such lubricated interlayers are more pronounced [9].

**Figure 4.** Low permeability demonstration of well compacted and slushed crushed stone base: (A) onset and (B) after a period. (A) Water level at start at 8:53. The sample hole was filled with water. Immediate seepage of moisture was visible at the surface (approximately 20–40 mm), but then becomes standing. (B) No significant reduction in the water level was visible over a period of three hours and was observed even over a period of 8 h.

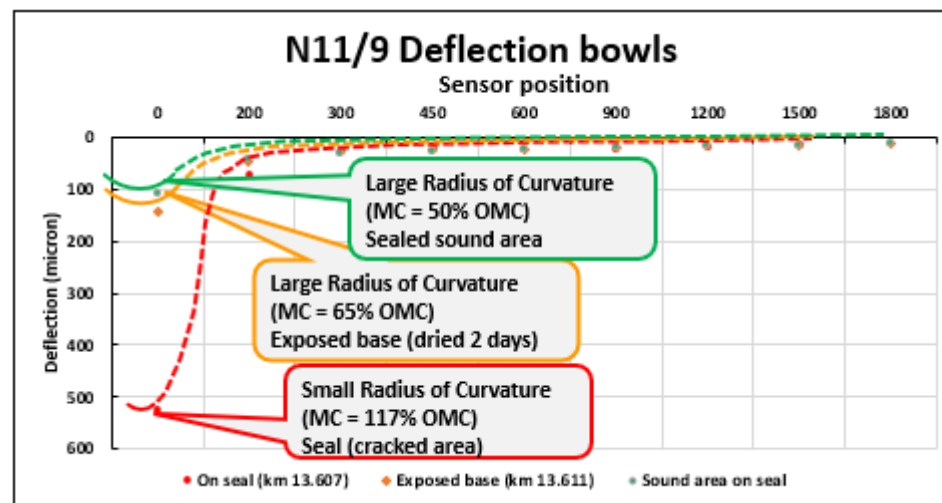
Moisture entering the pavement system, as described above via a cracked asphalt surfacing, can soften the top of the granular or stabilized base material if the quality is less than specified [2,8]. Typically, if the base layer is a lower quality or has lower compaction density, the ingress is quicker and possibly also deeper than merely 20 mm to 40 mm of the top of the base. The top of the base literally becomes soft due to the water ingress in the rainy season. This effect can be measured, even though indirectly, with the Falling Weight Deflectometer (FWD). In Figure 5, the deflection bowl shape shows a distinct increase in the positive curvature portion for a case where the top of the base, and possibly depending on the period of water exposure, has become soft as indicated by the moisture content (MC) referenced against the Optimum Moisture Content (OMC) [4].

Figure 5. Influence of moisture content on base top softening and measured in terms of Radius of Curvature (RoC).

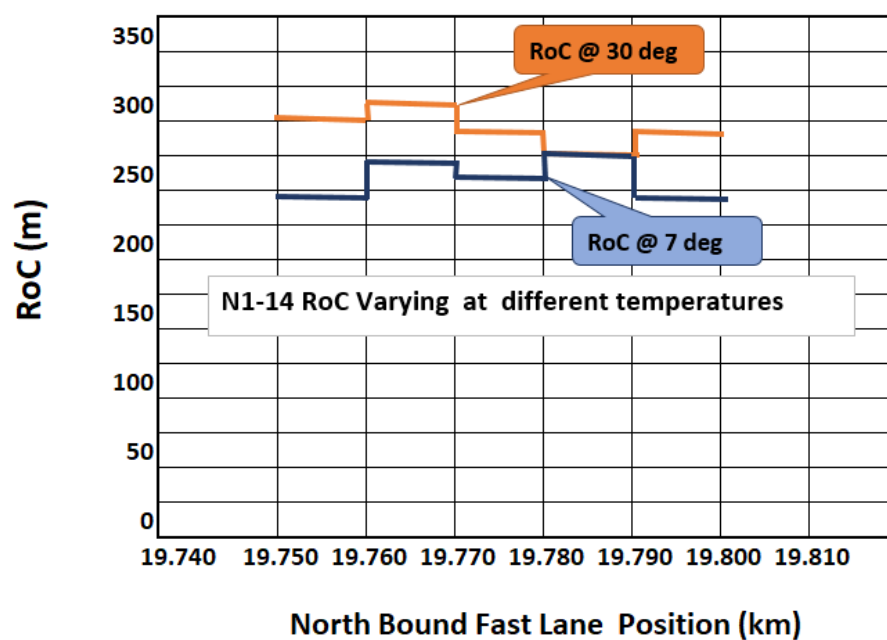
The Radius of Curvature (RoC) [10,11] which can be calculated from the positive curvature portion of the elastic deflection bowl now becomes smaller than in the dry condition. Other examples of softening the top of the base have also been observed in the field where cracks on the shoulders can also, similarly, influence the RoC. The softening of the top of the base due to such softening means the thin asphalt layer now flexes much deeper and therefore bottom-up fatigue cracking ensues much earlier. Temperature can also have a significant effect on the RoC. In Figure 6 [4], the RoC derived from the Traffic Speed Deflectometer (TSD) [10] reading on the same stretch of road at two different temperatures (7 °C and 30 °C) at different times of the day are shown to vary. Figure 6 clearly shows higher RoC at relatively colder temperatures and lower RoCs at relatively higher temperatures, therefore relatively higher flexing.

Figure 6. Variance in RoC at different times of the day and associated different temperatures [4].

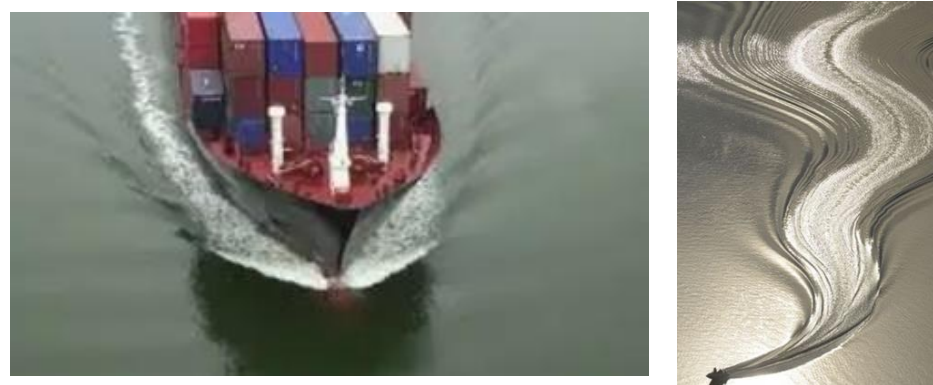
The rolling wheel on the de-bonded asphalt layer is analogous to “bow waves” radiating in front and more important to the sides of boats as illustrated in Figure 7. Such

**Figure 7.** Bow waves alongside and in front of boat and standing wave behind fast-moving boat on the right.

The Stress in Motion (SIM) measuring equipment [18,19] has highlighted the effect of tire inflation pressure coupled to wheel loading for a variety of tire types as illustrated in Figure 10. It tends to also illustrate the transverse edge effects due to variance in tire load and pressure. SIM measurements have also shown that as much as 30% of static free-rolling wheel load transfer into a horizontal force [19]. This has direct implications for bow wave influence on longitudinal strain development due to sharp flexing longitudinally as well as transversely, therefore similar to the standing waves illustrated in the boat bow waves shown in Figure 7 before [17].

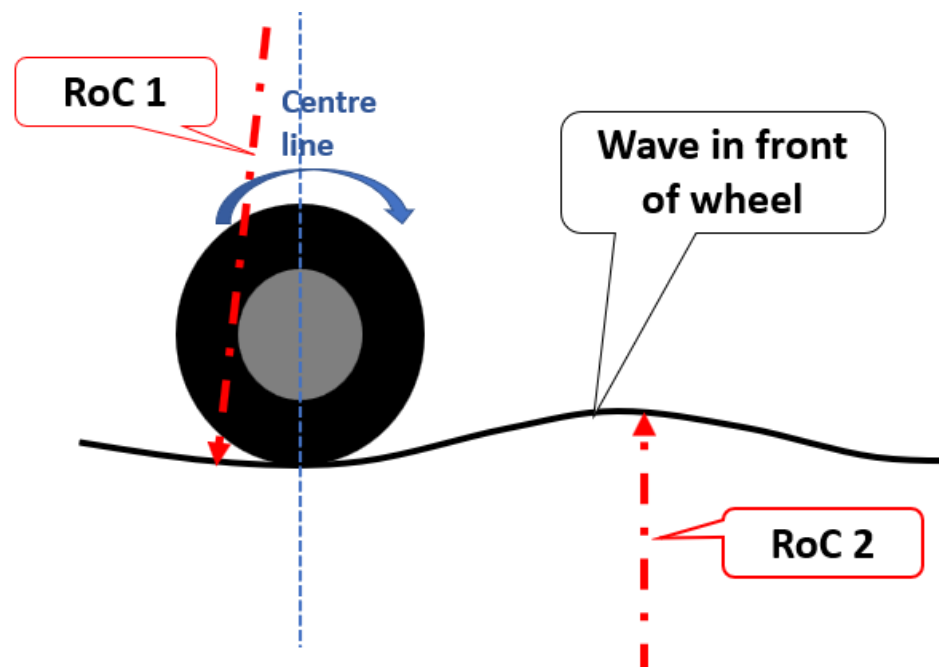
#### Longitudinal cross-section (X-axis)

**Figure 8.** Positive and negative curvature with tire loading on the surface [4]. Redrawn with permission of Author of conference paper.

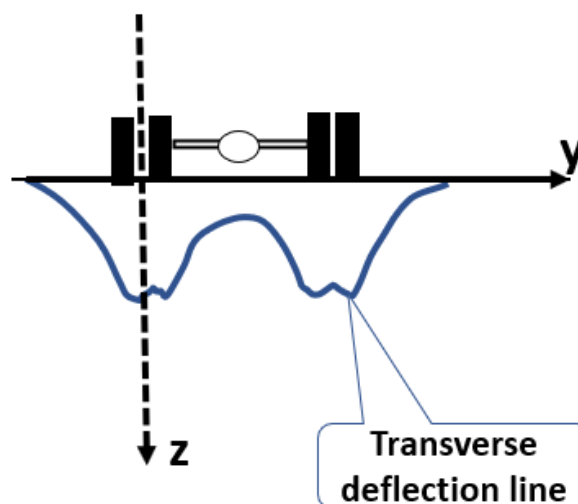
It has long been known that there is also an upwards ‘pinching’ between the dual wheels under such circumstances as illustrated in Figure 9 in the transverse direction as originally determined with the mechanical Dehlen Curvature meter [11]. Improved digital measuring technology just never pursued this significant observation. There is now new

### Typical shape of transverse deflection influence line under single rear axle dual wheel truck configuration

**Figure 9.** Transverse direction “pinching” between tires illustrated in association with longitudinal deflection (Partial redrawn from original Dehlen 1962).

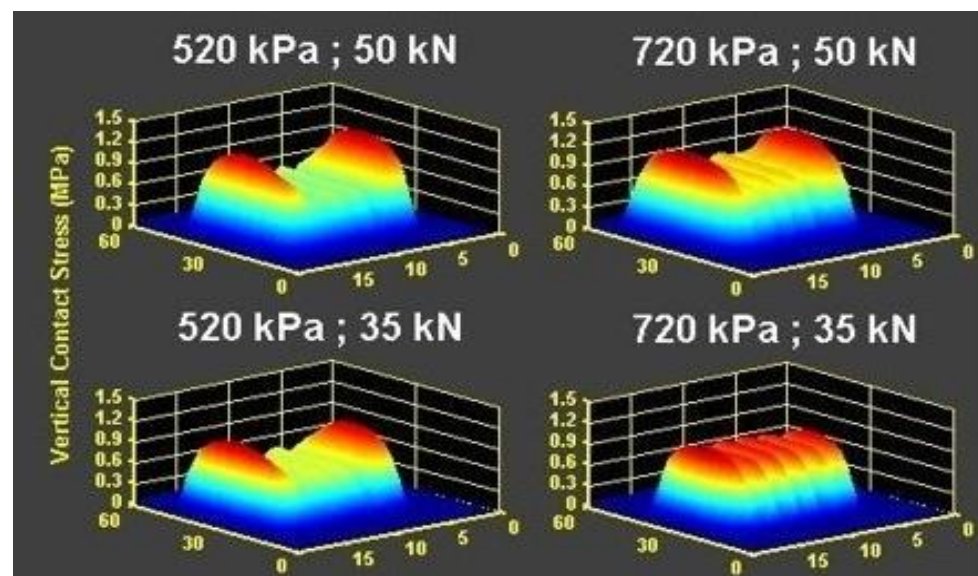
**Figure 10.** Illustration of capability of SIM measurement of variance in vertical contact stress across tire with variance in tire inflation pressure (kPa) and tire loading (kN).
