## Mechanical and fire tests on thermal breaks attached to concrete supports

A. Ben Larbi, M. Couchaux, C. Thauvoye, C. Sautot

A. Ben Larbi, M. Couchaux, C. Thauvoye, C. Sautot. Mechanical and fire tests on thermal breaks attached to concrete supports. *Journal of Constructional Steel Research*, 2022, 190, pp.107114. 10.1016/j.jcsr.2021.107114 . hal-03719692

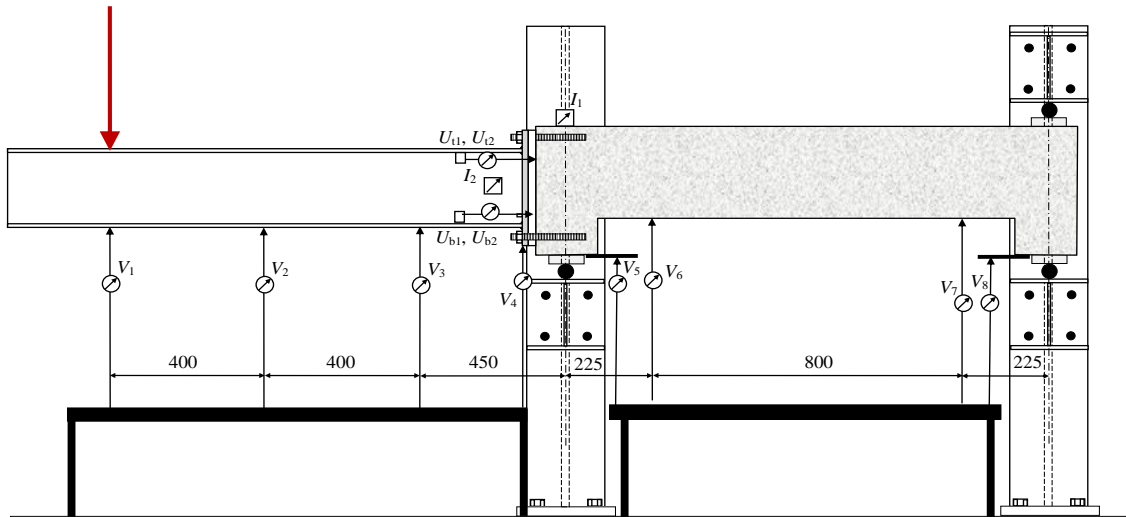
211 Displacement transducers (LVDT) were positioned to measure the displacements at different  
212 locations of the test specimen as shown in Figure 3. Displacement sensors ( $V_1$  to  $V_8$  and  $U_1$  to  
213  $U_4$ ) allowed a complementary estimation of the rotation. Finally, four displacement sensors  
214 placed horizontally were used to evaluate the crushing of the thermal insulation ( $U_{b1}$  and  $U_{b2}$ ),  
215 and the elongation of the tensile part of the connection ( $U_{t1}$  and  $U_{t2}$ ). An inclinometer,  $I_2$ , was  
216 positioned on the beam web at half the beam height from the connection and another one on the  
217 concrete slab,  $I_1$ .

**Figure 3** – Displacement transducers and inclinometers (dimensions in mm)

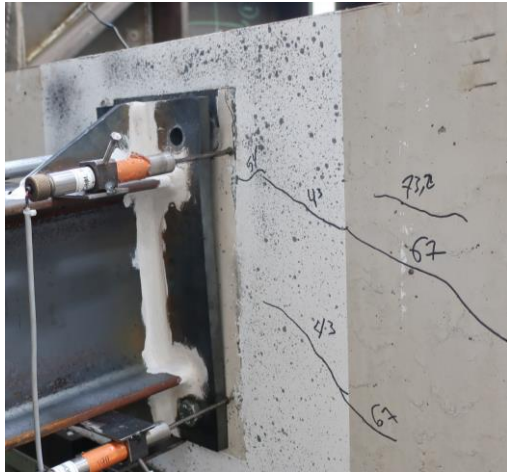
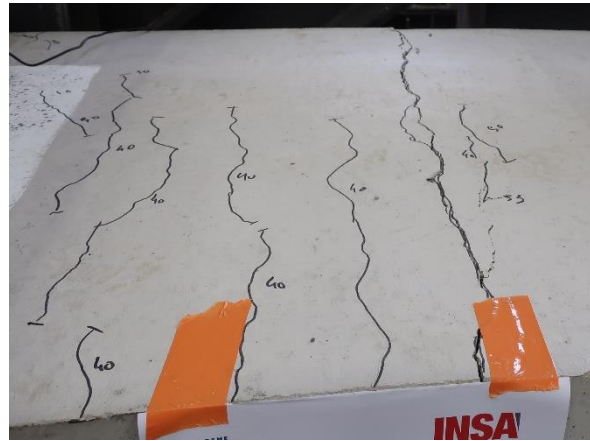
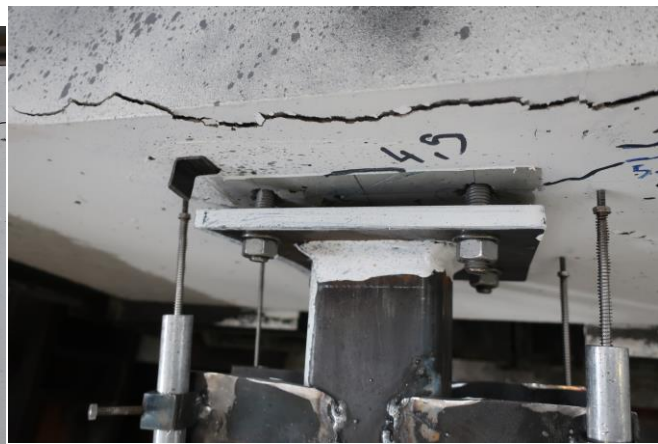
a) Lintel cracking

b) Slab reinforcement rupture

c) Concrete edge failure

d) Concrete cone failure/anchor sliding

**Figure 5. Concrete lintel and slab cracking and failure**

258 On the contrary, when the concrete slab was not sufficiently reinforced (using only steel  
 259 reinforcing mesh ST 25C), the final failure was caused by rupture of reinforcement of the ST 25  
 260 C mesh (see Figure 5-b). The bending resistance of the connection was greater than the capacity  
 261 of the slab in bending. For post-installed chemical fasteners (connections PB-4 and RTPB-4-P),  
 262 concrete edge failure is obtained and the addition of intermediate insulating layer does not affect  
 263 significantly the result. For post-installed mechanical fastener (PB-5 and RTPB-5-P1), the  
 264 failure corresponds to anchor bolt sliding and finally concrete cone failure.

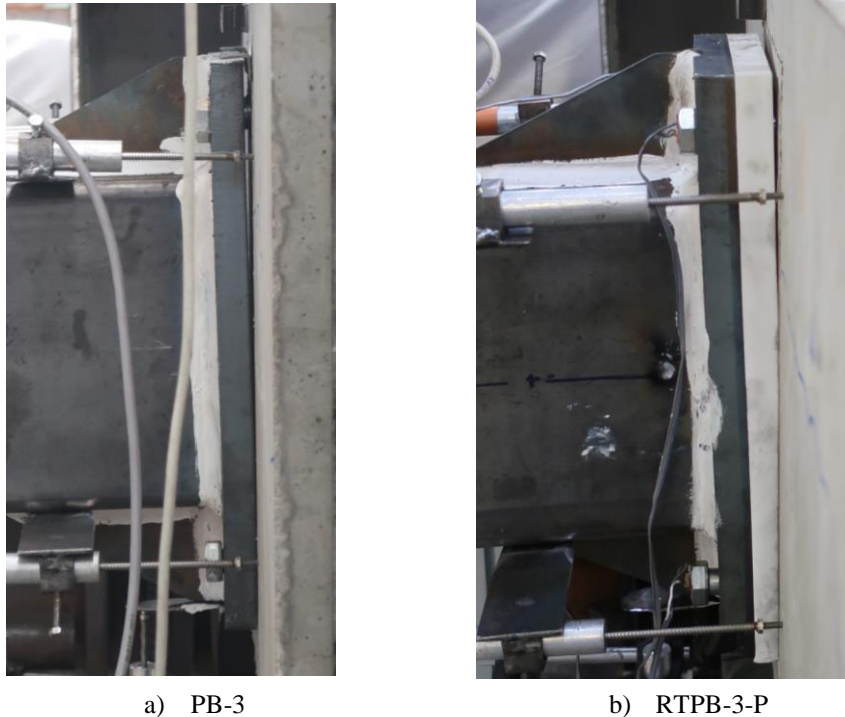
**Figure 8** – Deformed shape of specimens PB-3 and RTPB-3-P at failure

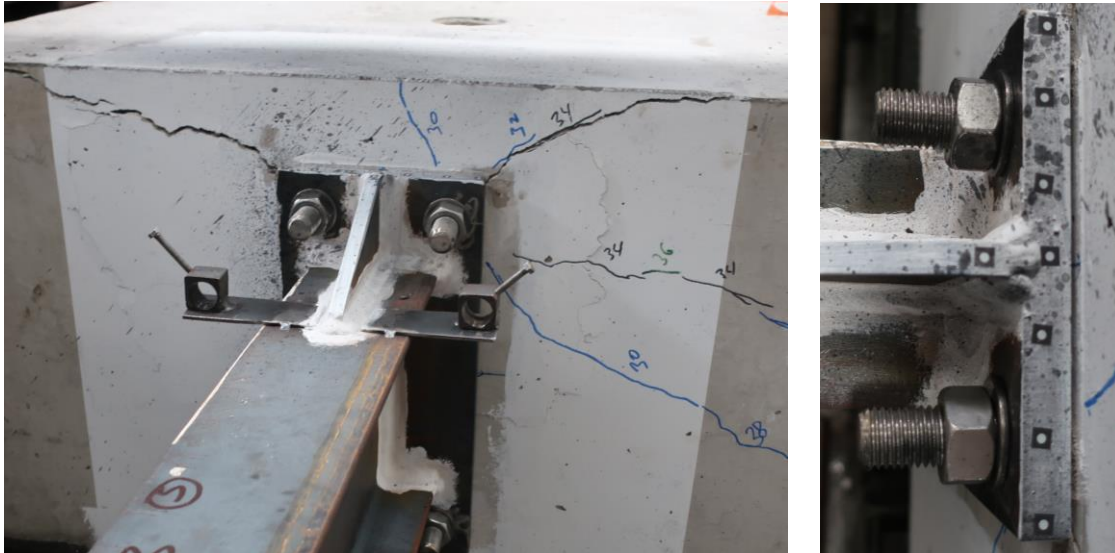
a) PB-4

b) RTPB-4-P

**Figure 9** – Specimens PB-4 and RTPB-4-P at failure

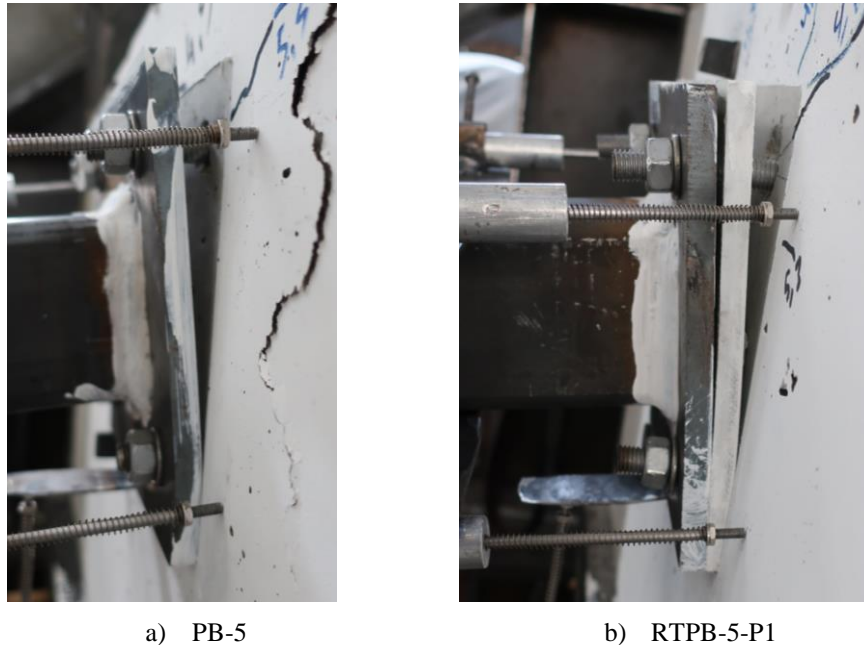
340 The failure mode of connections PB-5 and RTPB-5-P1 starts by anchor sliding in the tensile  
341 area and is followed by the concrete cone failure (see Figure 10). Prying effects did not develop  
342 for the two specimens due to the flexibility of the mechanical fastener. Nevertheless, the **failure**  
343 **pattern** is quite different, hence a yield line parallel to the tube develops in the compression area  
344 to accommodate the rotation of the connection for PB-5. For the connection with intermediate  
345 layer, this rotation is ensured by the PVC crushing in compression, the end-plate deformation is  
346 reduced. The concrete lintel started to crack for a bending moment around 4-4,5 kNm. The  
347 addition of the PVC layer does not impact the secant rotational stiffness as well as the plastic

**Figure 10** – *Specimens PB-5 and RTPB-5-P1 at failure*

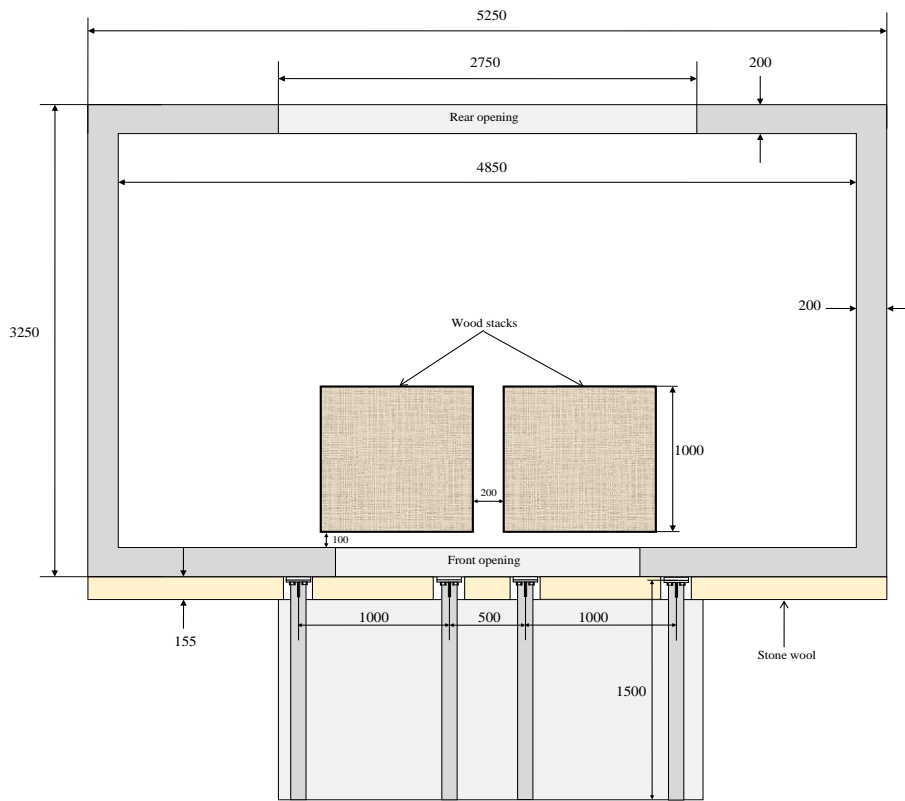
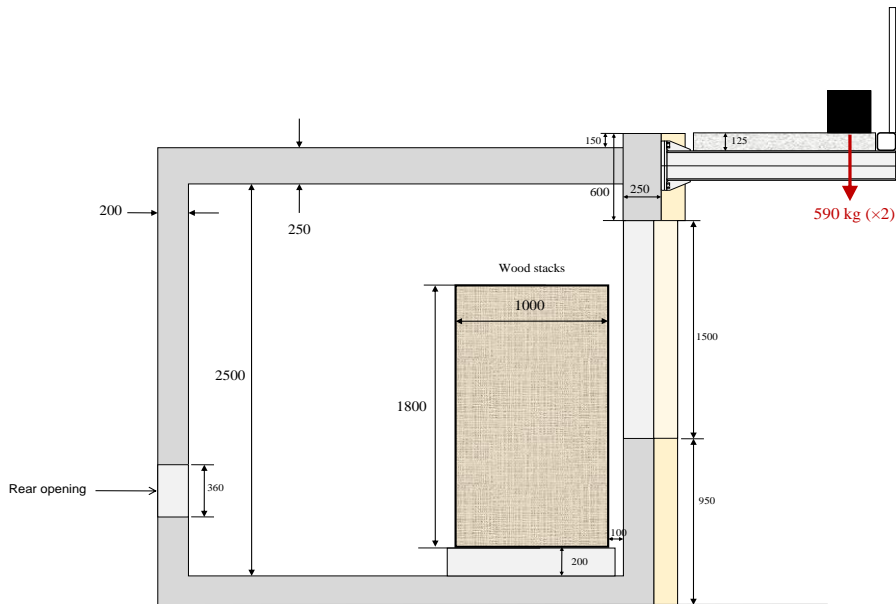
a) Plan view

b) Lateral view

**Figure 11.** Plan and lateral view of the test set-up (dimensions in mm)

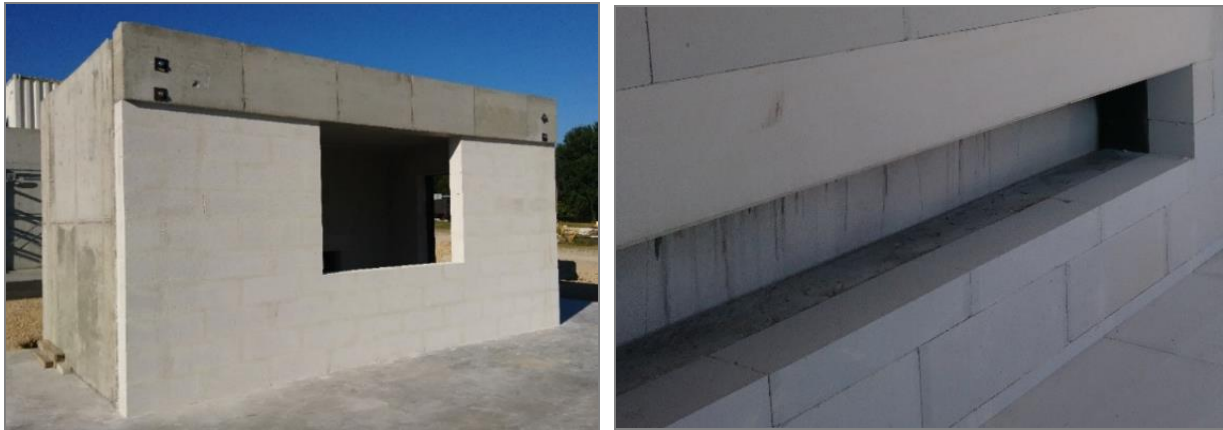
416 thickness, with a lintel of 600 mm high. The front face had one opening of dimensions  
 417 2000×1500 mm, located at 950 mm from the ground (see Figure 12-a).

**Figure 12.** Test furnace before implementation of balconies

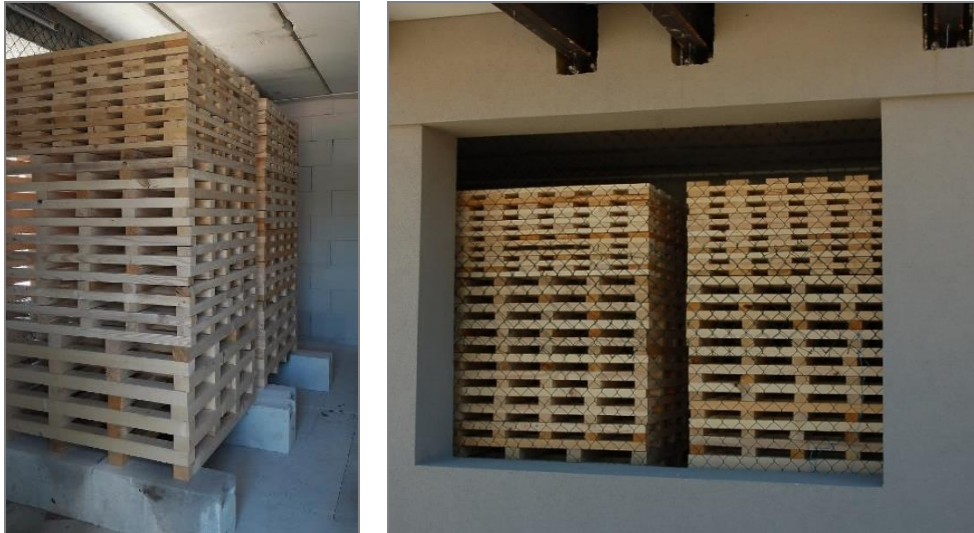
423 The fire load in the furnace consists of two wood stacks of 300 kg composed in the same way as  
424 for a LEPiR II test. This is also consistent with recommendations in the European Standard EN  
425 1991-1-2 [19] and the French national annex [20]. Cribs are made of softwood with density  $480$   
426  $\pm 50$  kg/m<sup>3</sup> and moisture content between 9% and 15%. Each crib consists in 3 stacked piles.  
427 For each crib, the total dimensions are 1000×1000×1800 mm. The cribs are located at 100 mm  
428 from the front wall, 200 mm above the ground and at a distance of 200 mm from each other (see  
429 Figure 13).

**Figure 13.** Wood stacks

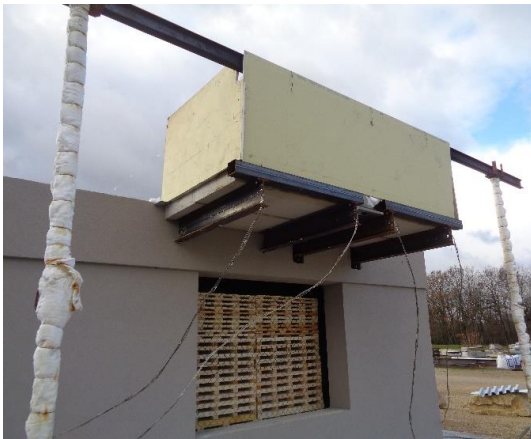
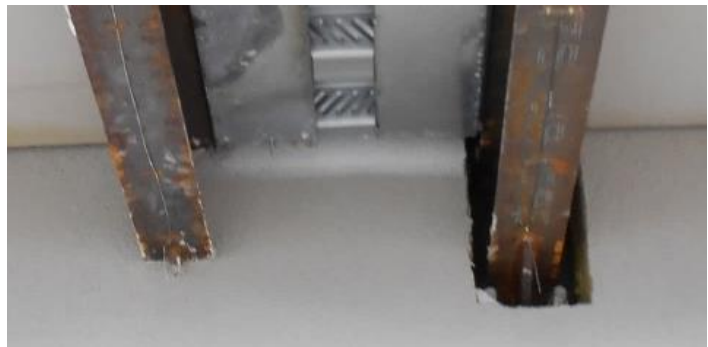
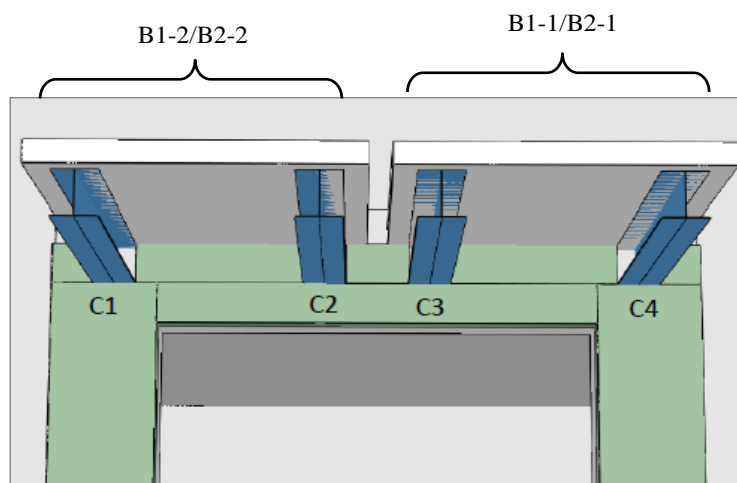
449 The balcony without thermal break, balcony B1-1, constitutes the reference case and is  
 450 representative of a balcony commonly used in practice. Then two configurations have been  
 451 tested without the addition of external insulation around the connection (right beam in Figure  
 452 14-b).

**Figure 14. Balconies and test cell before fire test**

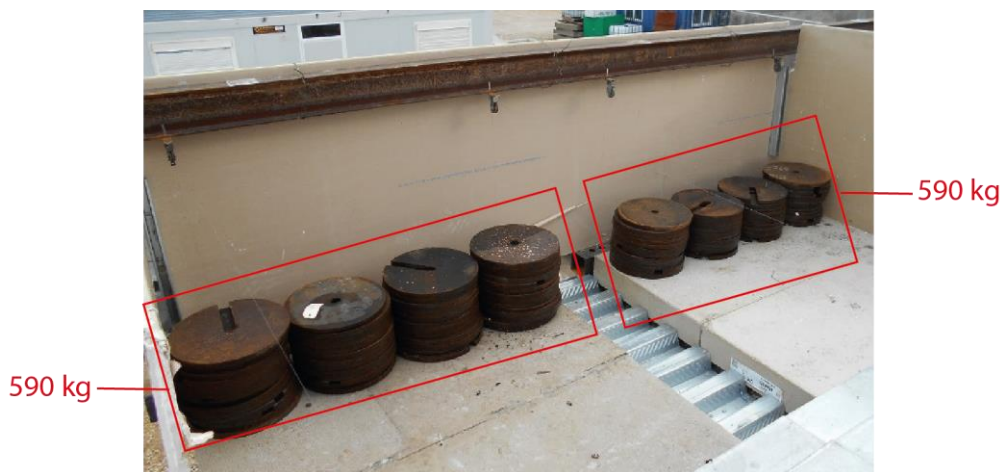
460 The load applied on each balcony was close to 590 kg and distributed on the upper face of  
461 the cellular concrete slab at the end of the consoles (see Figure 15). **This position is conservative**  
462 **as the connection bending moment is overestimated comparatively to a uniformly distributed**  
463 **load. This load have been designed considering the fire combination  $G + \Psi_1 Q$ , with  $\Psi_1 = 0,5$ .** The  
464 total mass per unit area of a balcony, equal to 475 kg/m<sup>2</sup>, is thus equivalent to a permanent load  
465 ( $G$ ) of 300 kg/m<sup>2</sup> and live loads of 350 kg/m<sup>2</sup> ( $Q$ ) according to EN 1991-1-1 [17], in the fire  
466 combination  $G + \Psi_1 Q$ . This loading is typical of balconies with a common concrete slab.

468 **Figure 15.** Load applied on the slab of balconies

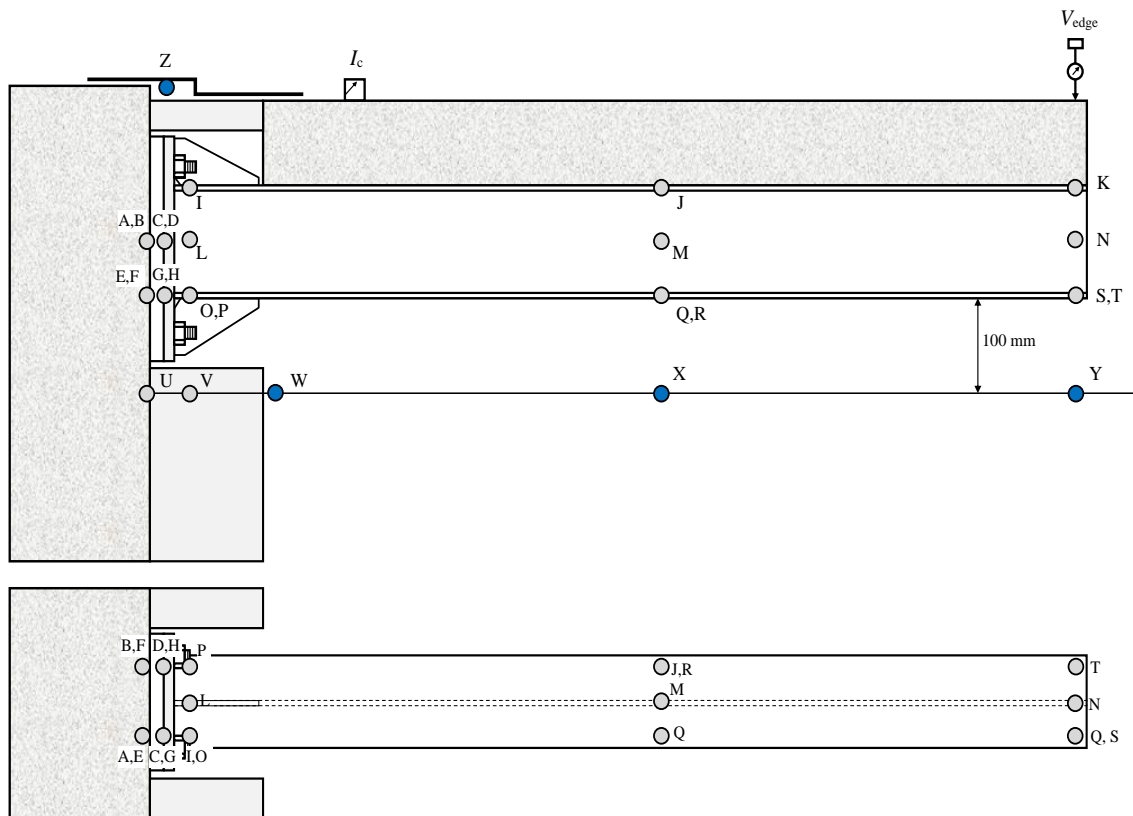
474 The temperature of beam web/flange is measured by thermocouples I to T. In addition, the  
 475 objective being to study the behavior of the thermal break, thermocouples (from A to H) have  
 476 been positioned to measure the temperature at the lintel/layer interface, and layer/end-plate  
 477 interface. By the end, thermocouples U and V were placed to measure the external insulation  
 478 temperature. In the following, beams were labelled C1 to C4 (see Figure 14-c). Beams C3 and  
 479 C4 corresponds to balconies B1-1/B2-1, C1 and C2 to balconies B1-2/B2-2. In addition, a gauge  
 480 heat flux was positioned at 3 m in front of the opening, and a video camera recorded the tests.

481 The mechanical behavior of balconies during the fire tests was also a key aspect and  
 482 particularly the response of the connections. Vertical displacement at the top of the beams,  $V_{edge}$ ,  
 483 was measured, as well as the rotation of the connection with an inclinometer,  $I_c$ .

Figure 16. Thermocouples and displacement positions

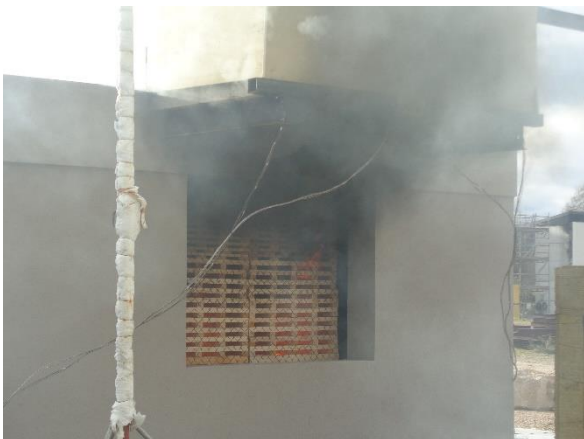
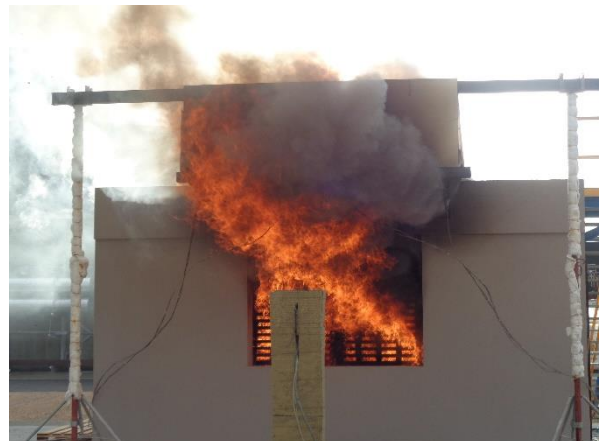
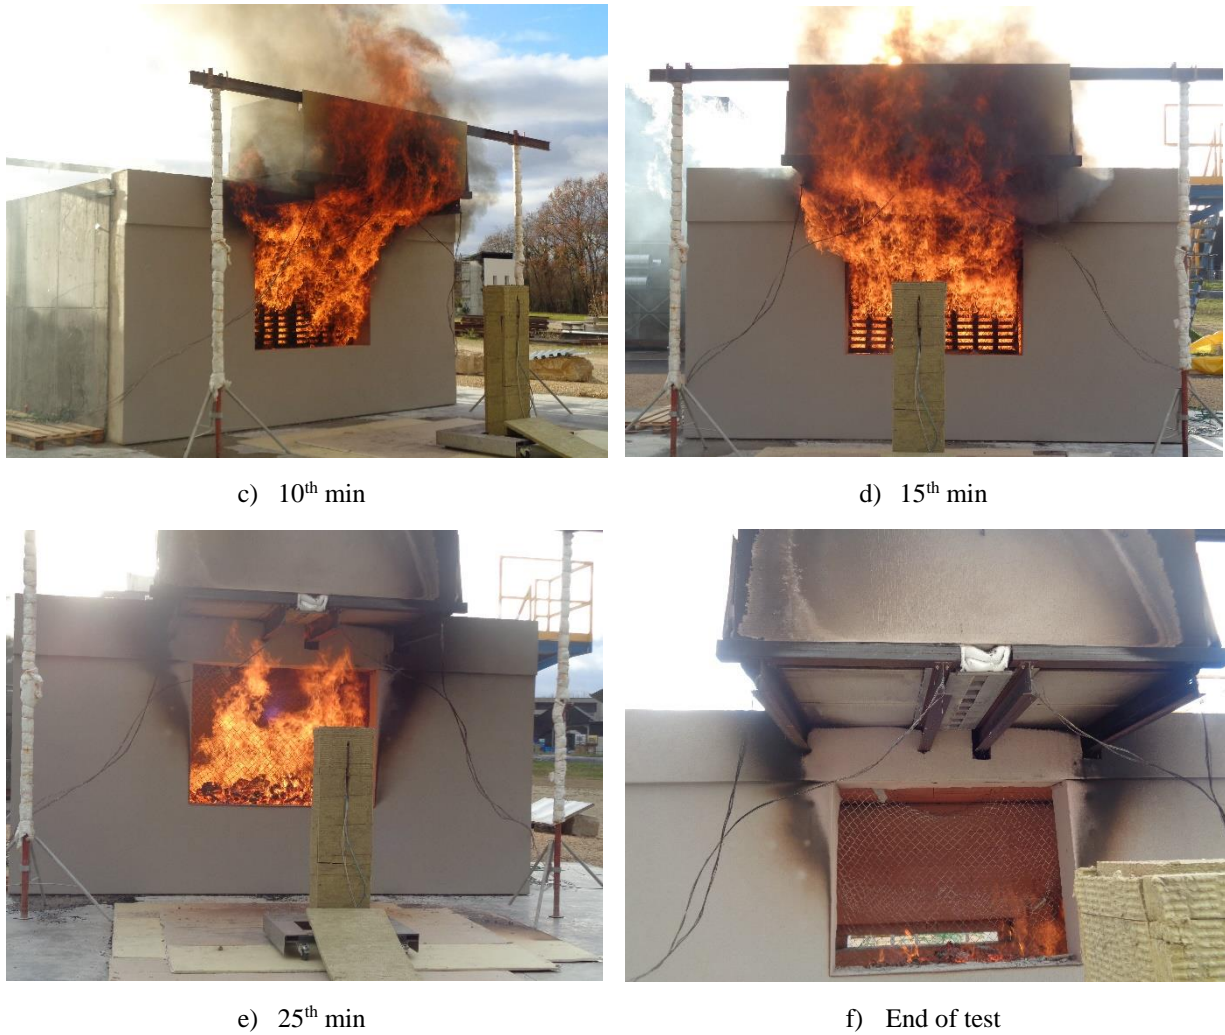
- 488 • Fuel tanks placed under the wood stacks ignited the fire.
- 489 • Smoke exits through the opening of the facade one minute after ignition (see Figure 17-  
490 a).
- 491 • After 5 minutes, the first external flames appeared (see Figure 17-b).
- 492 • At 10 minutes, the fire fully developed and the flames reached their maximum length  
493 left the opening with an angle of 45° (see Figure 17-c). Thus, these flames directly  
494 impact half of the console.
- 495 • From 15 minutes, the fire gradually decreases, and the stacks begin to collapse (see  
496 Figure 17-d).
- 497 • At 25 minutes, the wood stacks collapsed and no flame was visible outside (see Figure  
498 17-e). Hot gases continue to escape through the opening of the facade, and the  
499 temperature under the balcony remains high for another 20 minutes.

**Figure 17.** Flame development during test n°2

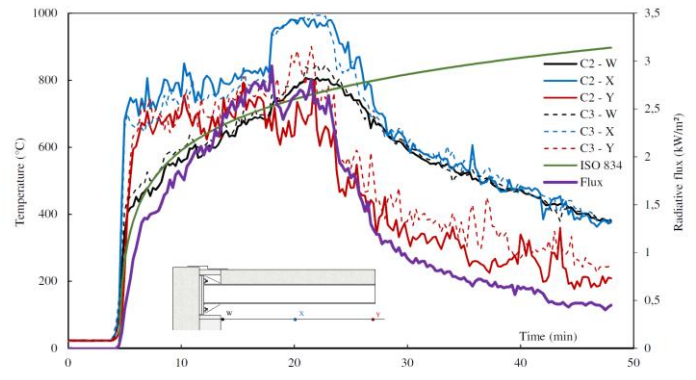
515 In the first part of tests, gas temperature close to the facade (Tc W) is lower than at mid-  
516 range and at the extremity (Tc X and Y). This phenomenon is due to the flame tilting through  
517 the opening (see Figure 19). At 18 minutes, a sharply increase of the temperature is measured  
518 up to 25 minutes for the two tests and particularly test n°1. This phenomenon may be due to the  
519 collapse of the wood stacks which causes momentarily a greater heat release, and therefore  
520 higher temperatures under the consoles C2 and C3. The temperature in the external insulation of  
521 the facade above the opening increases progressively during the test. It reaches 600 °C in the  
522 heart of the external insulation (thermocouple Tc V), but only 100 °C at the interface between  
523 the insulation and the concrete support (Tc U). These measures highlight the importance of  
524 external insulation and its proper implementation around beams, even in case of exceptional fire

**Figure 18.** Gas temperature of flames through the opening ( $T_c$  W, X, Y)

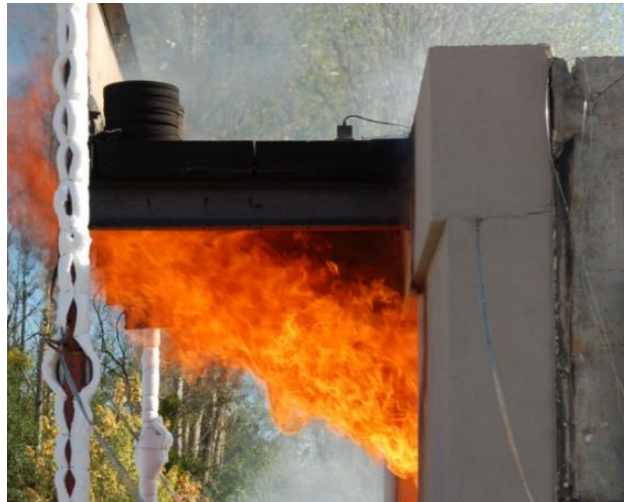
**Figure 19.** Flames through the opening (test n°1 – 17 min)

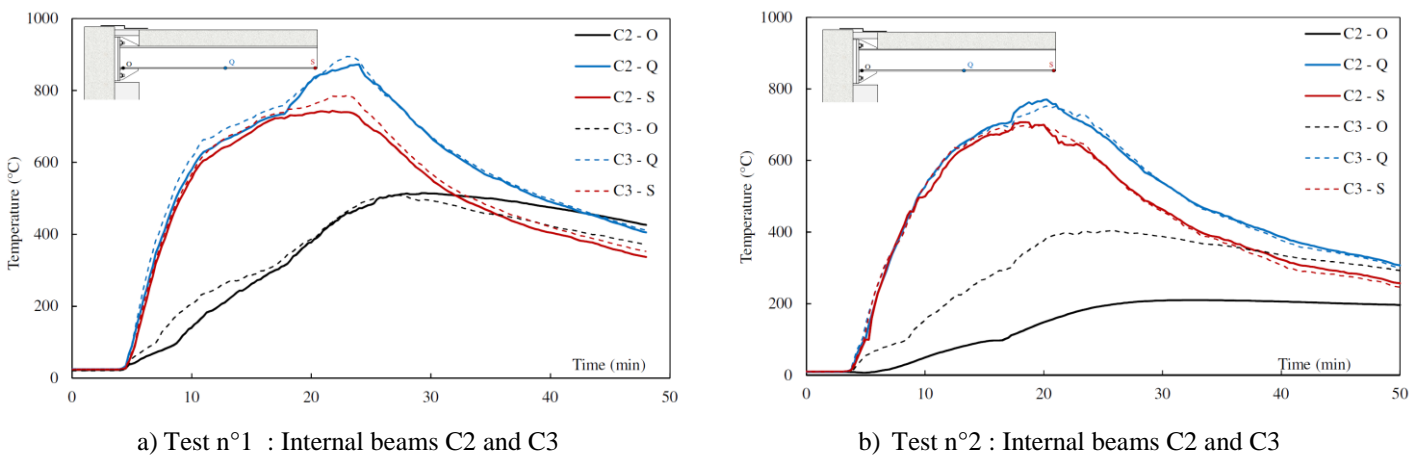
531 700-900°C (Tc Q, S). The highest temperature is at mid-range (Tc Q). At mid-range and at the  
 532 extremity, the steel temperatures follow the gas temperature (see Figure 20). The maximum  
 533 temperature of the end-plate connections (Tc O) was around 500 °C when they were exposed to  
 534 flames and only 200°C for the end-plate connections protected by the additional external  
 535 insulation (Test n°2, beam C2 in Figure 20-b).

536 The temperatures were homogenous through the steel beam section. Web and lower flange  
 537 temperatures were very close, the temperature of the upper flange is slightly lower  
 538 (approximately 100°C) because the concrete slab slows the heating.

539 **Figure 20.** Lower flange temperature at facade (Tc O), mid-range (Tc Q) and extremity (Tc S)

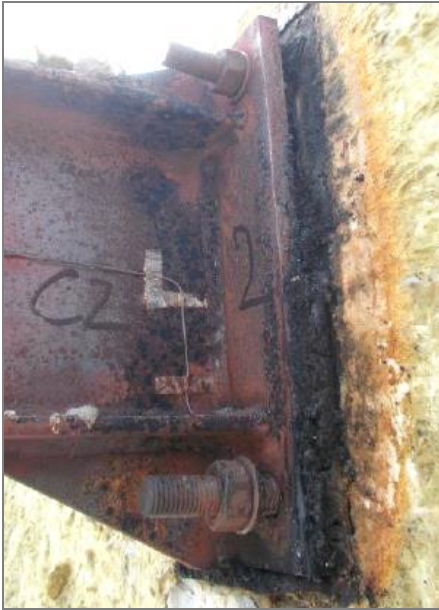
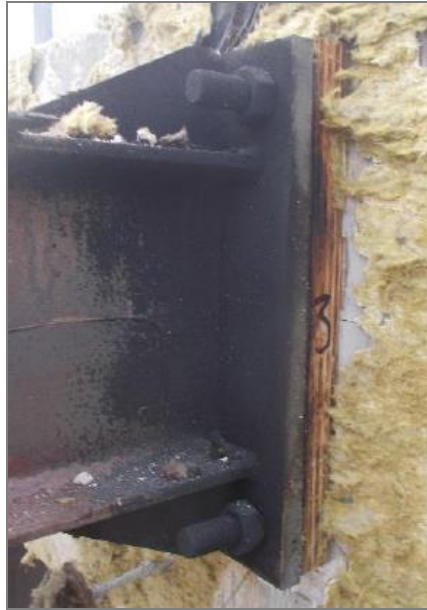
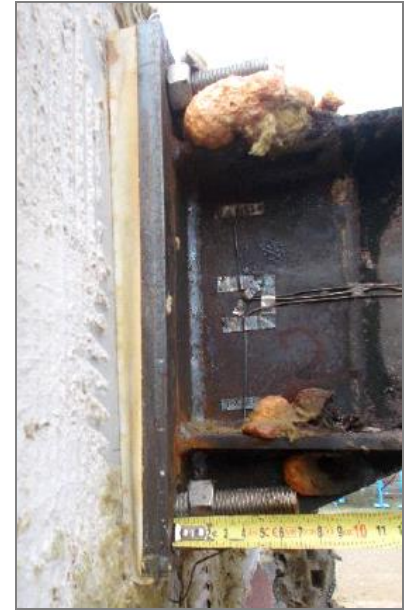
575 The plywood layer started to burn (see Figure 23-c) but only at the interface between the  
 576 end-plate and the layer (see Figure 22-b). This layer keep its thickness and the maximal  
 577 displacement at the top of the balcony does not exceed 43,4 mm. This balcony was the less  
 578 impacted by the fire despite the absence of additional external insulation around the connection.

**Figure 22.** *Connections after fire test*

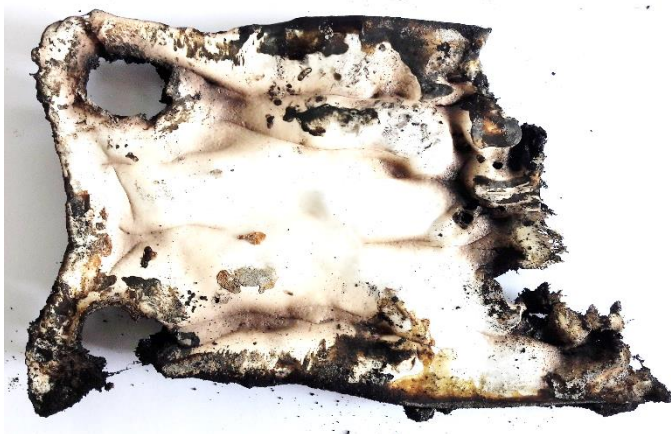
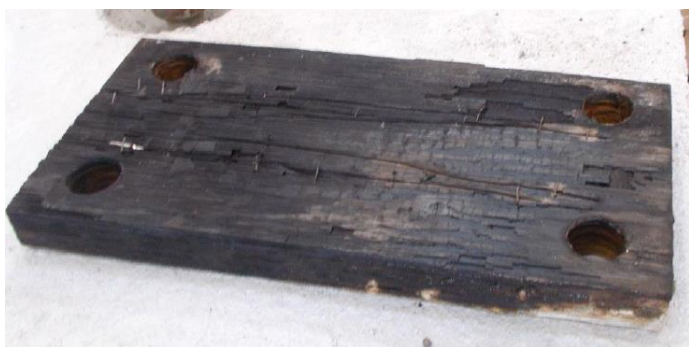
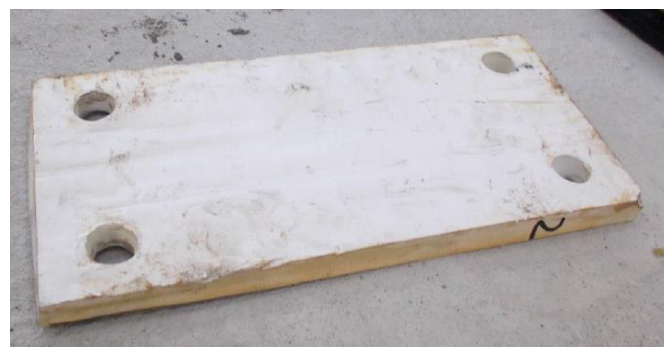
579 For balcony B2-2 with PVC and additional external insulation, the PVC did not burn (see  
580 Figure 23-d) but its thickness decrease in the compressive area (see Figure 22-c) due to a  
581 reduction of its mechanical properties at high temperatures (around 160 °C). The nut of bottom  
582 anchor bolts is no more in contact with the end-plate. This reduction of the PVC thickness in the  
583 compressive area also induce a global rotation of the connection and maximal displacement of  
584 the edge of the balcony of 58 mm. A similar displacement has been obtained for balcony B1-1  
585 without thermal break and additional external insulation around the connection. A thermal break  
586 using PVC and additional external insulation is able to develop a fire behaviour close to that of  
587 a conventional connection (without intermediate layer and additional external insulation). The  
588 solution with plywood layer but without additional external insulation permit to draw the same

**Figure 23.** *Intermediate layer after fire test*

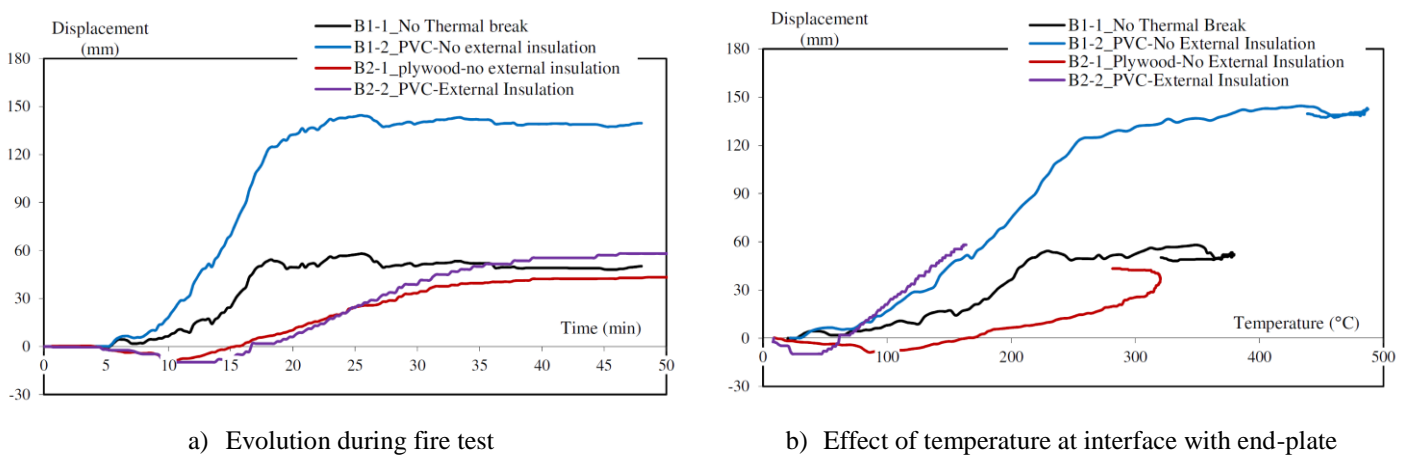
590 The evolution of the displacement measured at the top of the balcony is presented in Figure  
 591 24-a. In addition, this displacement is given in Figure 24-b in function of the temperature  
 592 measured at the interface between the end-plate and the layer or concrete for B1-1. Except for  
 593 balcony B1-2, with PVC and no external insulation, the maximal displacement is around 40-60  
 594 mm. For balconies without thermal break, B1-1, and PVC but without additional external  
 595 insulation, B1-2, the increase of the displacement is quite fast and tends to an asymptote after  
 596 20-25 min. For the two other balconies, the increase of the displacement is slower as well as the  
 597 temperature at the interface between the layer and the end-plate (see Figure 21). We can clearly  
 598 observe with Figure 24-b that for the two first specimens, the displacement is stabilized for a  
 599 temperature of 200-300 °C. When the temperature decrease, the displacement is not modified.

600 On the contrary for plywood, temperatures greater than 300° do not affect strongly the  
 601 displacement. The displacement continues to increase even after the temperature decrease  
 602 because of the plywood burning. For balconies with PVC and additional external insulation, the  
 603 temperature is lower than 200 °C and the combustion didn't start as well as major rotation of the  
 604 connection. Nevertheless, the displacement-temperature curves obtained in presence of PVC  
 605 layer with and without additional external insulation are almost parallel (see Figure 24-b).

**Figure 24.** Vertical displacement of the edge of the balcony

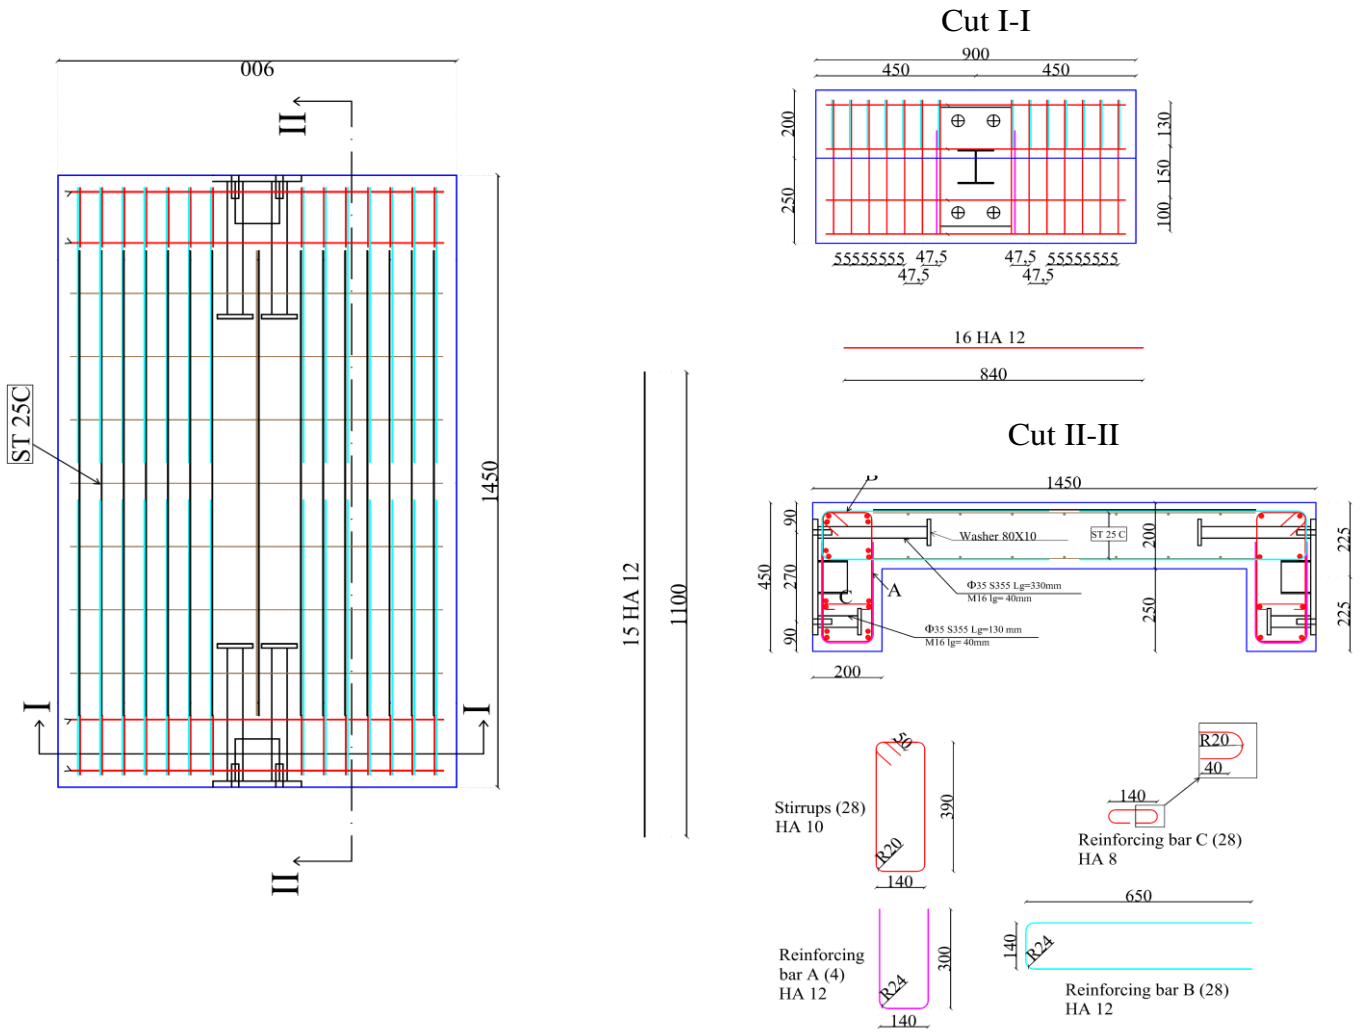
Figure A.1. Reinforcement of concrete Block B1
