# First step in the PROCRAFT Project on WWII Aircraft Heritage: Investigation and Conservation of the Aluminium Alloys

## Abstract

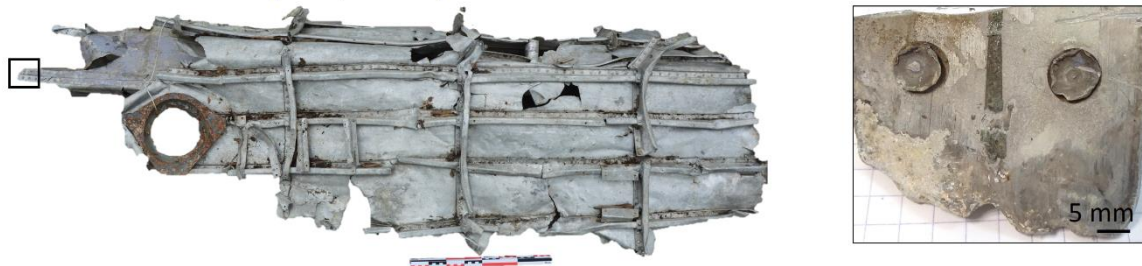
a) Rolled and extruded parts, atmospheric environment

Most the artefacts suffered from corrosion due to their long burial in the ground or sea or to their prolonged abandonment in the open air. Figure 2 shows representative artefacts and the typically encountered alterations. Generally, Al-cladded products were more robust to burial or environmental conditions. This was demonstrated by the Dornier 217 fuselage (Figure 2a), which was left for decades in a chasm in the Pyrenees. However, as shown for the Junkers 88 (Figure 2b), the remnants of which had been used on a farm as the roof of a poultry house, the loss of material provided observable evidence that the Al cladding was no longer effective. On extruded profiles exposed to atmospheric conditions such as those of the Dewoitine D.338 (Figure 2c), the anodisation and paints originally present had significantly degraded. Pitting and intergranular corrosion could have quickly led to exfoliation corrosion, as previously reported (Brunet et al. 2019). In forged products, once the protection is lost, intergranular corrosion occurs, as has been observed in other wrought products. On artefacts recovered from the sea (Figure 2d), corrosion can be severe and the corrosion products often develop a blue colouring (Rocca et al. 2021).

**Figure 2. (left) Photographs of the artefacts. (right) Optical microscopy images of the alterations in the aircraft: (a) Dornier 217 fuselage (Al cladded), (b) Junkers 88 engine cowl (Al cladded), (c)**
