First step in the PROCRAFT Project on WWII Aircraft Heritage: Investigation and Conservation of the Aluminium Alloys

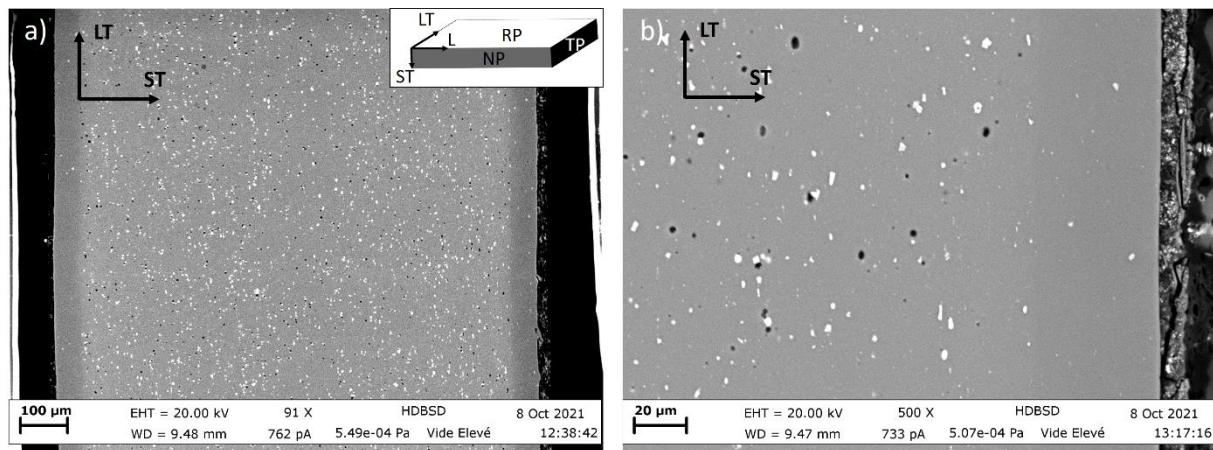
Figure 1. SEM-BE images of a plate from a Messerschmitt Bf109, evidencing Al cladding: (a) full view, (b) close-up view. Insert: main spatial directions and defined planes of the rolled products

Nonetheless, Al cladding was largely found on rolled products, especially fuselage skin and plates. Figure 1 shows an example of an Al-cladded plate in cross-section. For plates of ~1 mm thickness, the cladding layer is typically between 50 and 100 µm. Al cladding was systematically employed in German and American aircraft parts, but not always in French aircraft parts. Several plates of the Dewoitine D.520 (1940) had not been cladded whereas plates of the D.338, an earlier aircraft (1937) from the same manufacturer, had Vedal. It may have been the case that corrosion protection was chosen according to the expected durability of the aircraft. Thus, Vedal was used to protect civil aircraft (such as D.338), expected to be in use for many years, while short-life fighters (such as D.520) had no cladding at all. Among the plates recovered on British and Italian aircraft, no cladding was found but they were also strongly altered and difficult to assess.

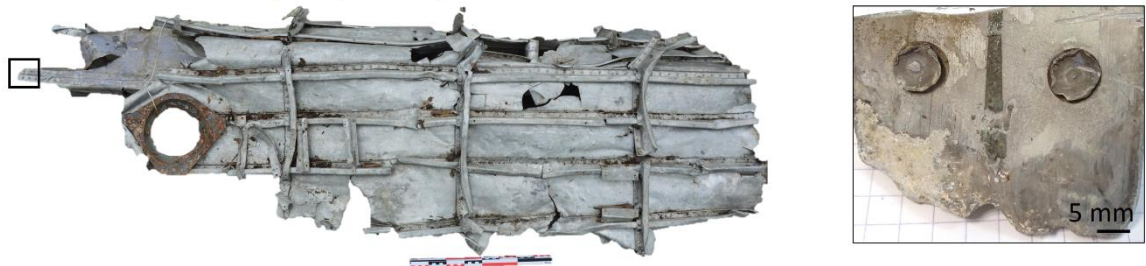
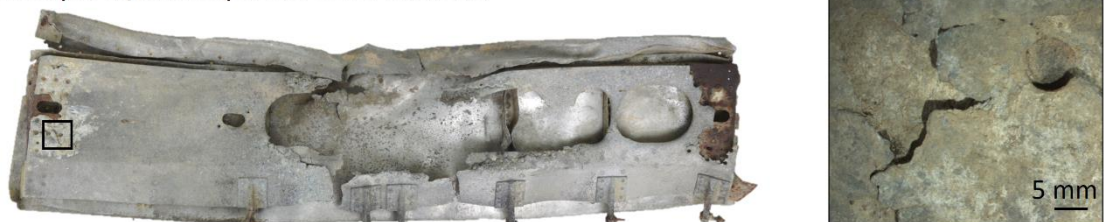
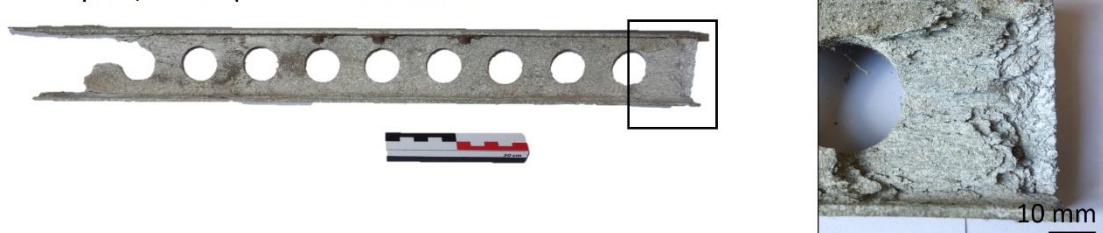
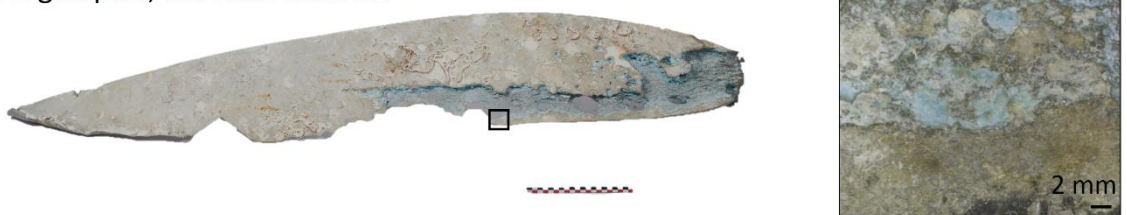
Figure 2. (left) Photographs of the artefacts. (right) Optical microscopy images of the alterations in the aircraft: (a) Dornier 217 fuselage (Al cladded), (b) Junkers 88 engine cowl (Al cladded), (c)

Dewoitine D338 stringer (anodised), (d) propeller blade recovered from the sea near Brest (Britany)

Most the artefacts suffered from corrosion due to their long burial in the ground or sea or to their prolonged abandonment in the open air. Figure 2 shows representative artefacts and the typically encountered alterations. Generally, Al-cladded products were more robust to burial or environmental conditions. This was demonstrated by the Dornier 217 fuselage (Figure 2a), which was left for decades in a chasm in the Pyrenees. However, as shown for the Junkers 88 (Figure 2b), the remnants of which had been used on a farm as the roof of a poultry house, the loss of material provided observable evidence that the Al cladding was no longer effective. On extruded profiles exposed to atmospheric conditions such as those of the Dewoitine D.338 (Figure 2c), the anodisation and paints originally present had significantly degraded. Pitting and intergranular corrosion could have quickly led to exfoliation corrosion, as previously reported (Brunet et al. 2019). In forged products, once the protection is lost, intergranular corrosion occurs, as has been observed in other wrought products. On artefacts recovered from the sea (Figure 2d), corrosion can be severe and the corrosion products often develop a blue colouring (Rocca et al. 2021).

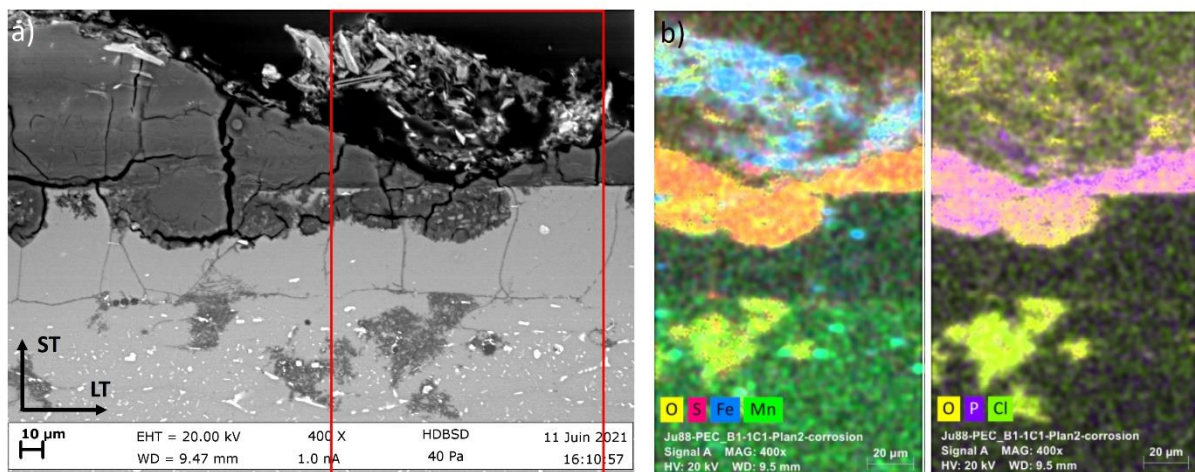
Figure 3. SEM-BE image and EDS maps of a cross-section (transverse plane) of the Junkers 88 (plate 1)

Figure 3 shows the SEM-BE images of the cladded Junkers 88 plate 1 in cross-section (transverse plane) and the corresponding EDS mapping. As shown by the latter (Figure 3b), the concretions (exogenous elements) include localised iron corrosion products. Under the concretions, thick aluminium corrosion products are present on the surface, while on the inner structure pits with elements such as sulfur and phosphorus are seen. Chlorine was also detected within the localised corrosion products. All of these elements indicate interactions with soil anions. Chlorides are the most aggressive species as they can induce the breakdown of the passive layer, leading to pit formation (localised corrosion).

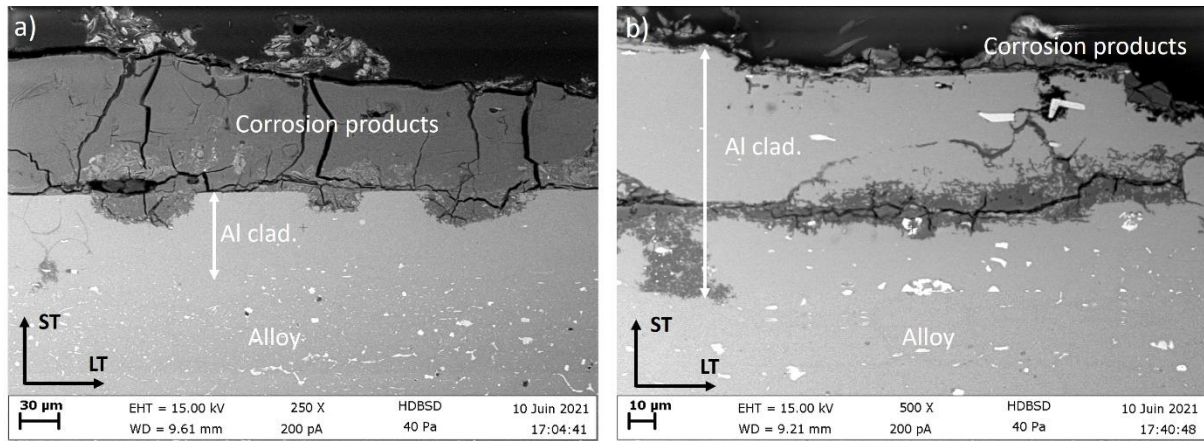
Figure 4. SEM-BE images of a cross-section (transverse plane) of the Junkers 88 (plate 1): (a) pitting corrosion starting on the Al cladding layer and (b) corrosion progressing within the Al-clad layer

An image of the pits within the Al cladding is provided in Figure 4, including evidence of the evolution of the corrosion attack inside the Al-cladded plate (Figure 4b). Localised corrosion developed laterally along the surface, within the cladding. The depth of the corrosion

corresponds to the end of copper diffusion – the result of the hot rolling process – inside the aluminium cladding. The resistance of Al cladding to corrosion was discussed in detail by Walton et al. (1953). Pure Al cladding provides good electrochemical protection, even in an aggressive natural environment. It also confers cathodic protection of the core alloy, such that corrosion will penetrate only as far as the core alloy or diffusion zone. Exposure of the Al cladding to the atmospheric environment (cycles of humidity) results in the formation of corrosion products such as aluminium hydroxides and/or sulfates. When present in large amounts, they induce cracks in the Al cladding layer, lifting it in some places and reaching the bulk alloy in others.

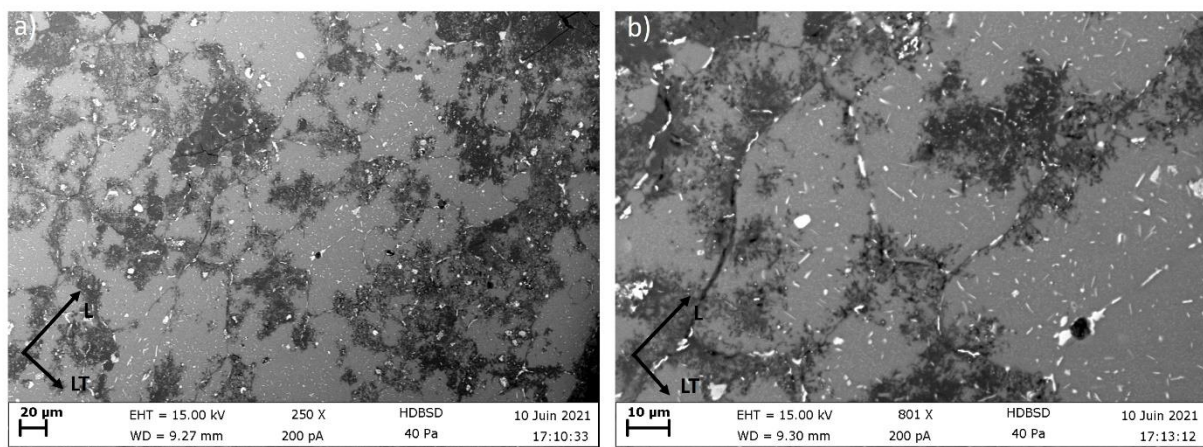
Figure 5. SEM-BE images of the Junkers 88 (plate 1, rolling plane): (a) general view, (b) close-up showing nano-size precipitates within the grains

In Figure 5, the corrosion has reached the bulk alloy, resulting in both intergranular and intragranular corrosion. The latter develops in the presence of humidity and is triggered by the intermetallic precipitates located mainly at the grain boundaries and by nano-size precipitates inside the grains (Figure 5b). These precipitates suggest exposure to heat, either while the aircraft was in use (proximity to the engine) or during the fire that occurred after the crash.
