Experimental study of the influence of the relative humidity of leaves and their link to adhesion losses in the wheel-rail contact

Samy Guidoum^{1,2,*}, Pierrick Merino¹, Aurélien Saulot¹, Yves Berthier¹, and Sylvain Hervieu²

Abstract. Every autumn, low levels of wheel-rail contact adhesion caused by leaves on the railhead surface are reported by train drivers. These incidents cause problems for the safety and regularity of rail traffic and occur predominantly at the beginning and end of the day when high humidity levels are achieved. At those moments the air temperature reaches the dew point temperature creating moisture on the railhead and oxides which react chemically with dead leaves found on the railhead surface. This article presents the results of a test campaign performed on a ring-on-disc tribometer with the aim of reproducing and studying the development of a loss of adhesion at an imposed slip rate. This type of tribometer enables a realistic approximation of the tribological circuit of a rail-wheel contact. Several samples of pollution responsible for adhesion losses were collected on the French railway network during fall and reproduced in a laboratory on a tribomete

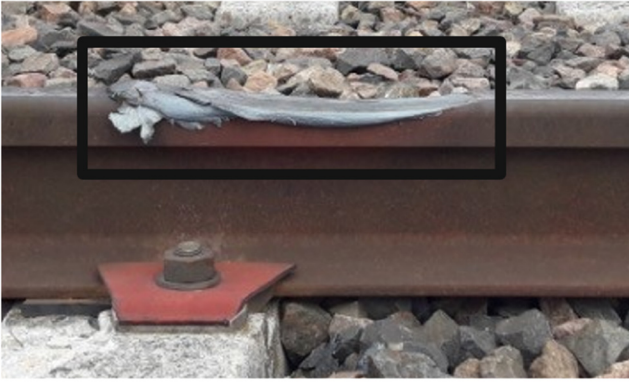
Fig. 1. Rail damage due to wheel-slip event in France; the squared area is the result of damage to the rails caused by train wheels.

The use of train transportation systems is becoming increasingly popular each year in France and are probably the most sustainable means of mass transportation available today. In autumn, security and regularity issues concern several rail networks because of the mixture of contaminants on the head of rails. Therefore, when a braking train rolls on polluted rails, the braking forces cannot be fully transmitted due to the reduction of the contact's adhesion and will lead the railway traffic to miss a signal or a station. In addition, when an accelerating train rolls on polluted rails, the traction forces generated by the engines to the contact will, once again, not be fully transmitted and will be the source of wheel-slipping events. This type of incident can damage both wheels and rails (Fig. 1).

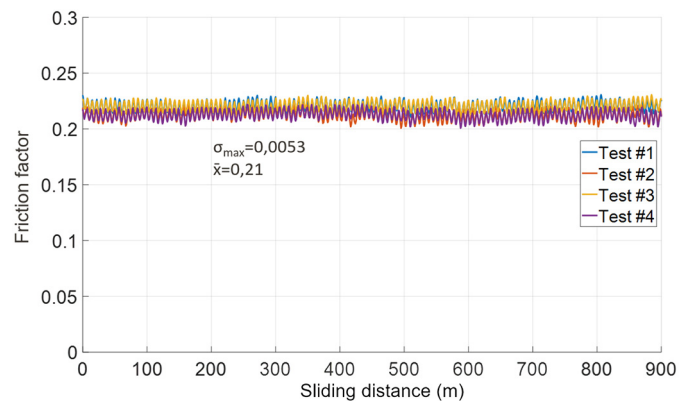
Fig. 9. Repeatability of a series of tests performed under a slip rate of 0.5% with an R260 disc and ring, average: 0.21, maximum standard deviation: 0.0053.

The repeatability of the data obtained after several test campaigns performed by Merino [12] with a corroded ring and R260 steel grade discs on the disc-on-ring tribometer used to study wheel–rail adhesion is justified in Figure 9. A friction factor $\mu = 0.2 \pm 0.0053$ was obtained after four tests were conducted under the same conditions. The aim of this study was to understand the mechanism of creation of a mechanical white etching layer responsible for rail defects.

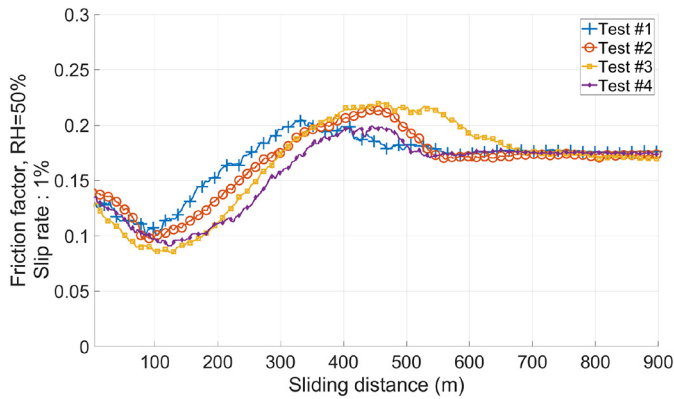
Fig. 10. Repeatability of a series of tests performed with leaves under a slip rate of 1% and a RH of 50%, average: 0.17, and maximum standard deviation: 0.031.

In Figure 10, the difference between the friction factor values can be explained by variations of the ambient temperature when the tests were performed. Tests #1 and #2 occurred in winter with an ambient temperature of 15 °C and a RH of 51%. Test #3 was conducted in the summer with an ambient temperature of 25 °C and a RH

of 54%. Test number #4 was performed in the fall with an ambient temperature of approximately 20 °C and an RH of 47%. The different curves show similar trends at the beginning and end of each test. These variations are mentioned in Section 3.1.3. The main differences resulting from the repeatability of the tests occurred in the middle of the tests and are justified here by the variations of the measured RH of approximately 7% [47%; 54%].

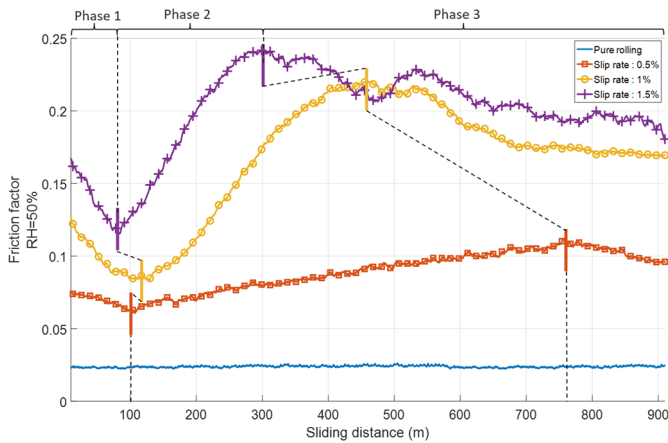
Fig. 12. Friction factor as a function of the sliding distance travelled on Triboring tribometer, plane leaves $RH = 50\%$. Highlights of the different phases. Phase 1 extends from the beginning of the test to the point where the minimum friction factor is obtained, phase 2 extends to the point where the maximum friction factor is measured, and phase 3 extends to the point where a stabilized friction factor is obtained (corresponding to the end of a test).

Figure 12 shows the variation of the friction factor with plain leaves ingested by the contact with a RH of approximately 50% and for the same slip rates described in this section. The data obtained from a pure-rolling test with and without leaves provided an average friction factor of 0.024 ± 0.002 . These low values are due to the pure-rolling conditions, associated with almost no tangential force. The increase of the imposed slip rate indicates different evolutions of the friction factor. Indeed, for the three values of imposed slip rates, the friction factor evolves according to three main phases. It decreases until reaching a minimum during the first 100 m, on average (Fig. 12 phase 1). The values obtained do not allow the transmission of all the forces in the contact. Under these slip rates, the mobilizable friction is at most equal to 0.24 in the case of a slip rate equal to 1.5%. It may also be no greater than 0.11 for a slip rate of 0.5%. The latter is below the friction factor threshold of 0.2 sufficient to allow a train to move forward [31]. This same factor increases in an almost linear progression to reach values higher than the initial ones (Fig. 12 phase 2). The maximum adhesion is reached. Finally, in the last phase, the friction factor stabilizes and tends towards a constant value (Fig. 12, phase 3).

The variations of the friction factor plotted on Figure 12 do not have the same kinetics and depend on the slip rate. At the end of the tests and for all the conditions studied, the friction factor remains on the same order of magnitude as that obtained at the end of the reference tests (Fig. 11). Similar trends were observed for other RH values (Fig. 14a, and b). Comparing the stabilized friction factor values for each of the tests at the end of phase #3 with the results of the reference tests (Fig. 11) allows one to determine whether the parts in contact were still contaminated by leaves. For a given slip rate, as the RH increases, the stabilized friction factor (i.e. at the end of each test) tends towards similar values as the references tests. These values are summarized in Figure 15.

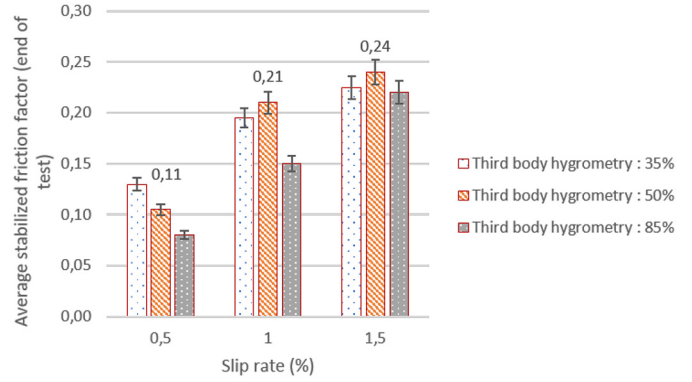
Fig. 15. Average stabilized friction factor (and standard deviation) obtained at the end of the tests performed with various slip rates and RH values of the third bodies.

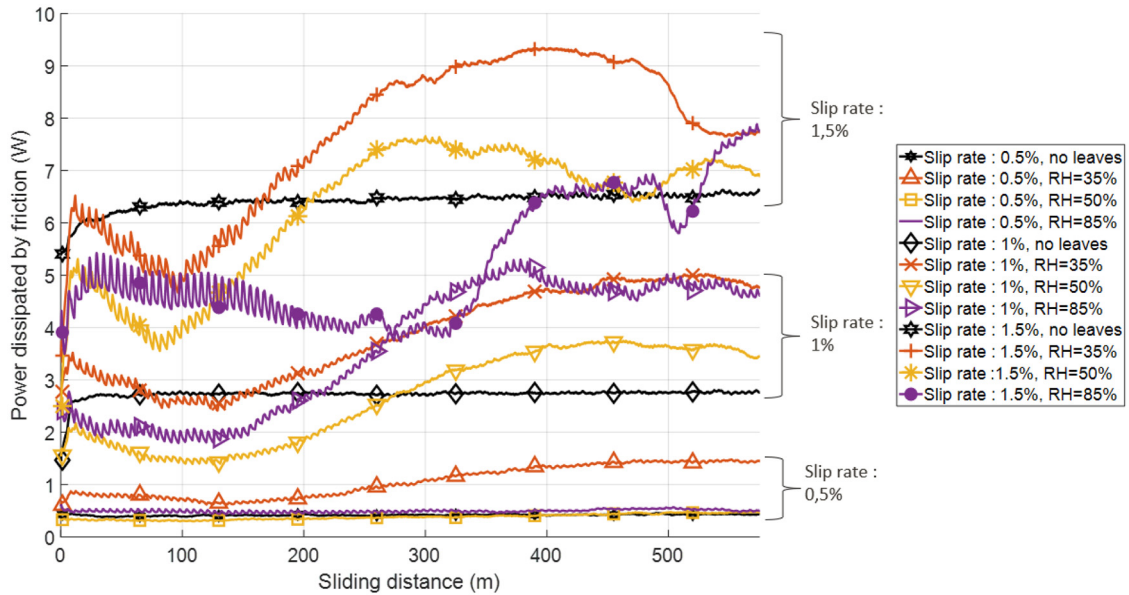
Fig. 16. Power dissipated by friction, all RH and slip rates (tests described in Tab. 4).

For pure rolling contact conditions (Figs. 16 and 17), the power dissipated by friction P_f defined by equation (2) does not include the solid deformations and the associated adhesion phenomena. Consequently, the real sliding speed measured is not zero because of these two aspects, thus justifying that the power dissipated by friction computed from the measured quantities is not nil. The equation giving P_f is thus particularly adapted to the study of the adhesion of the wheel-rail contact under rolling and sliding conditions and can thus be used to carry out the parametric study presented.

For a slip rate of 0.5%, the power dissipated by friction for all the regions only differs by less than 10% for RH values of approximately 50% and 85% when compared to a test done without leaves. In contrast, for a RH of

35%, the power dissipated varies by a factor of +2 when compared to a test done without leaves in region #1 and by a factor of 2.6 on average in region #2.

The power dissipated by friction data shown in Figure 16 highlights the links between RH, the slip rate, and friction variations. Indeed, as P_f reflects the physico-chemical and mechanical transformations of the third bodies obtained during the tests, the processing of the friction data through an energy quantity highlights the instantaneous capacity of the third bodies to be solicited regarding adhesion. In this case, the increase in the slip rate associated with the decrease in RH provides the greatest differences between the power dissipated by friction with or without leaves in the contact. In contrast, the decrease of the slip rate associated with a RH higher than 35% provides the lowest differences between the power dissipated by friction with or without leaves for all the regions defined. These first results translate the ability of the third body to mobilize through power dissipation friction in the contact. In these cases, a slip rate of 1% and 1.5% coupled with a RH below 35% are linked with a higher ability of the third body to increase friction in the contact. Interestingly, the main difference between a RH of leaves of 35% and 85% lies in the difference of the quantity of water initially available in the external third body

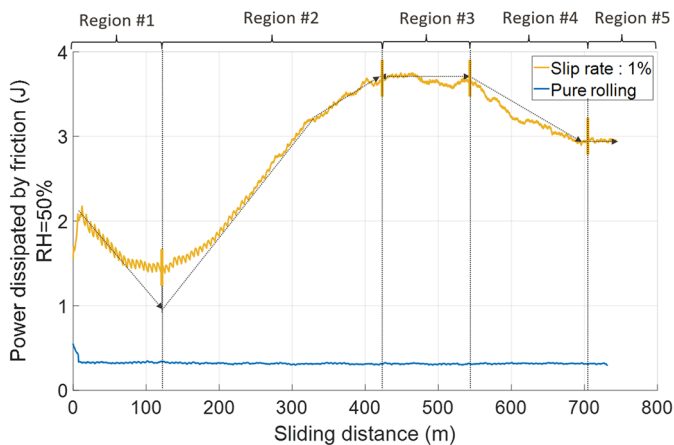
Fig. 18. Power dissipated by friction, slip rate : 1%, RH = 50%, highlight of the regions definitions.

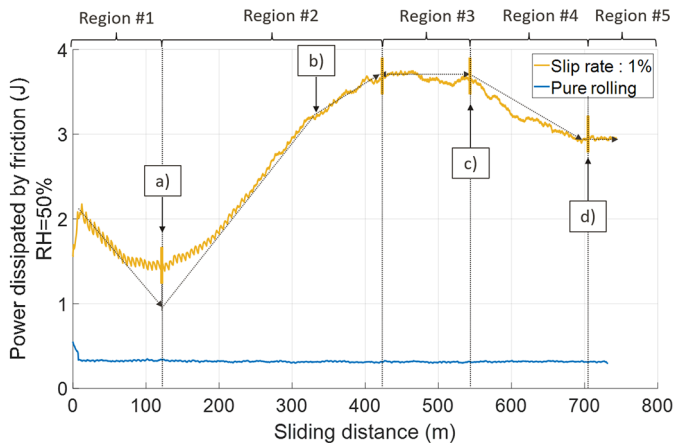
Fig. 22. Power dissipated by friction, slip rate: 1%, RH = 50%. A region is defined when the variations of the measured quantities are decreasing, constant, or increasing. The slopes plotted in this Figure define an inflection point between regions #1 and #5. Pictures of the surfaces of the disc were taken at the instants a) to d) and can be seen in Figure 21. The point a) corresponds to the minimum of adhesion reached, and points b) and c) allow the surface of the disc to be checked before and after reaching a maximum of adhesion. Point c) allows the surface of the disc used to be checked when all of the mechanical quantities are stabilized.

is under 0.1, and the capability of the contact to dissipate power by friction is minimal. This means that the capacity of a train to brake is reduced. The layer of the formed third body fails to be stable and does not stick to the disc surface. It then becomes hooked onto the disc surface and is ejected from the contact during a cycle. These variations are also reflected through the occurrence of oscillations of measured quantities, whose amplitudes are maximal in region #1 and decrease at the end of the second region.

In **region #3**, the drying-up and accumulation of third-body particles enable the maximum friction factor and frictional power dissipation to be reached. This is reflected by the stabilization of the computed power dissipated by friction. It is possible to think that the presence of iron oxides on a third body particle taken at this moment and analyzed by SEM-EDS contributes (Figs. 6, 7, and Tab. 3) to the mechanical stabilization of this black colored layer (Fig. 21, b and c). The layer formed does not evolve any further from a colorimetric viewpoint in this region. It also reflects the stability of the physico-chemical reactions between the different compounds of these third
