## Acoustic signature identification of damage and wear mechanisms in a steel/glass sliding contact

Khouloud Jlaiel, Malik Yahiaoui, Jean-Yves Paris, Jean Denape

Khouloud Jlaiel, Malik Yahiaoui, Jean-Yves Paris, Jean Denape. Acoustic signature identification of damage and wear mechanisms in a steel/glass sliding contact. *Balkantrib* 2020, May 2021, Belgrade, Serbia. pp.135065012110405, 10.1177/13506501211040599 . hal-03757999

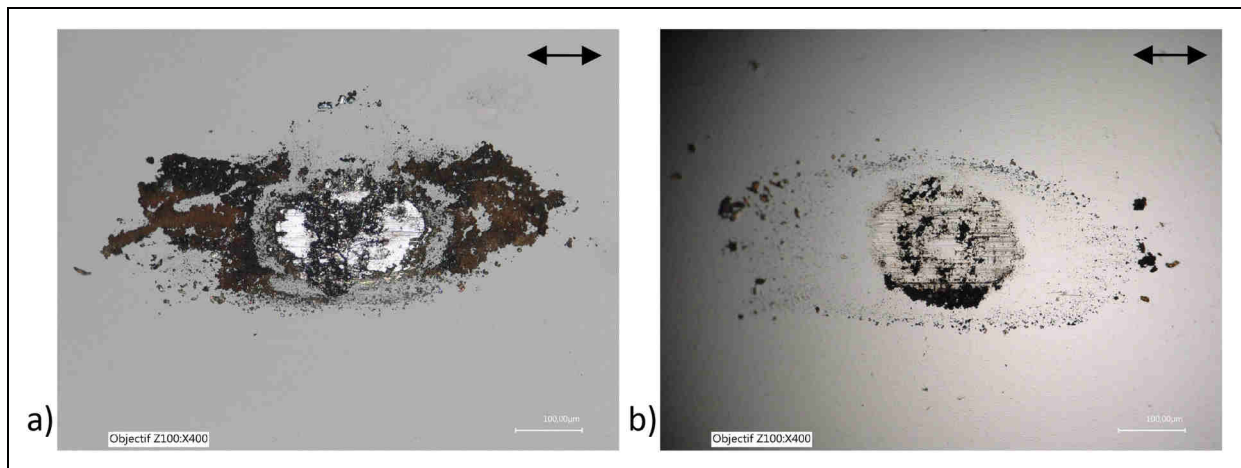
**Figure 2.** Optical microscopy of worn surfaces of (a) soda-lime glass and (b) 100Cr6 steel ball after 1200 cycles ( $F_N = 5$  N,  $\delta = \pm 50$   $\mu\text{m}$ ,  $f = 10$  Hz).  $\leftrightarrow$  Sliding direction.

The worn surfaces of the soda-lime glass and the 100Cr6 steel ball surfaces were observed systematically by optical microscopy without cleaning after 1200 cycles (Figure 2). The wear scar on the flat glass sample shows an expected elliptical shape with the smallest axis corresponding to the diameter of the wear scar on the steel ball (around  $178 \pm 1 \mu\text{m}$ ) and the largest axis oriented in the sliding direction. The central zones of the two worn surfaces have abrasion scratches. In the third body approach, this zone corresponds to the interface generating debris associated with the source flow and the internal flow. Debris is preferentially agglomerated on the soda-lime glass and ejected outside of the contact area, in the displacement direction, representing the wear flow.

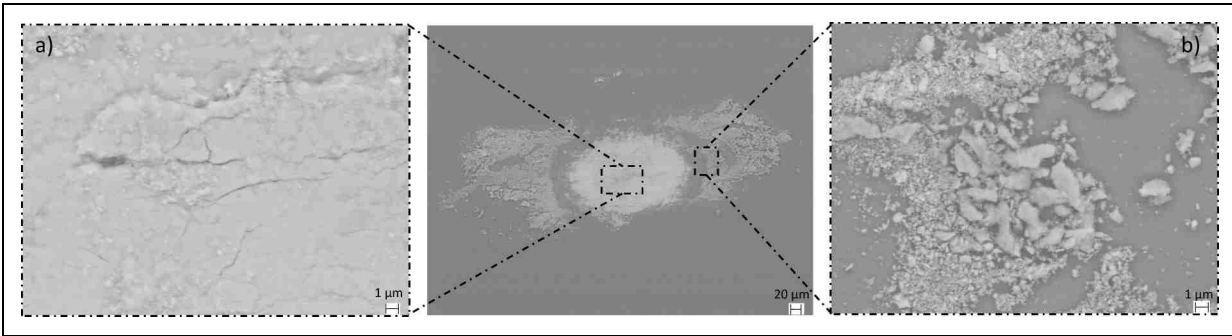
**Figure 3.** Scanning electron microscopy (SEM) observation of the third body (a) in the central wear track and (b) in the external wear track.

Figure 3 shows a typical scanning electron microscopy observation of the third body after separating the

ball and the flat. It is noted that debris is compacted together and adheres to the surface of the soda-lime glass sample to form an adherent interfacial layer. When the contact is opened and the ball is removed, the breakdown of this interfacial layer inevitably occurs as a result of the separation of tensile stress following the end of the tribological test (Figure 3(a)). Outside the wear track, ejected debris is found in fine particles with a diameter of  $1 \pm 0.5$   $\mu\text{m}$  and much larger particles with an average diameter of  $8.5 \pm 0.5$   $\mu\text{m}$  (Figure 3(b)).

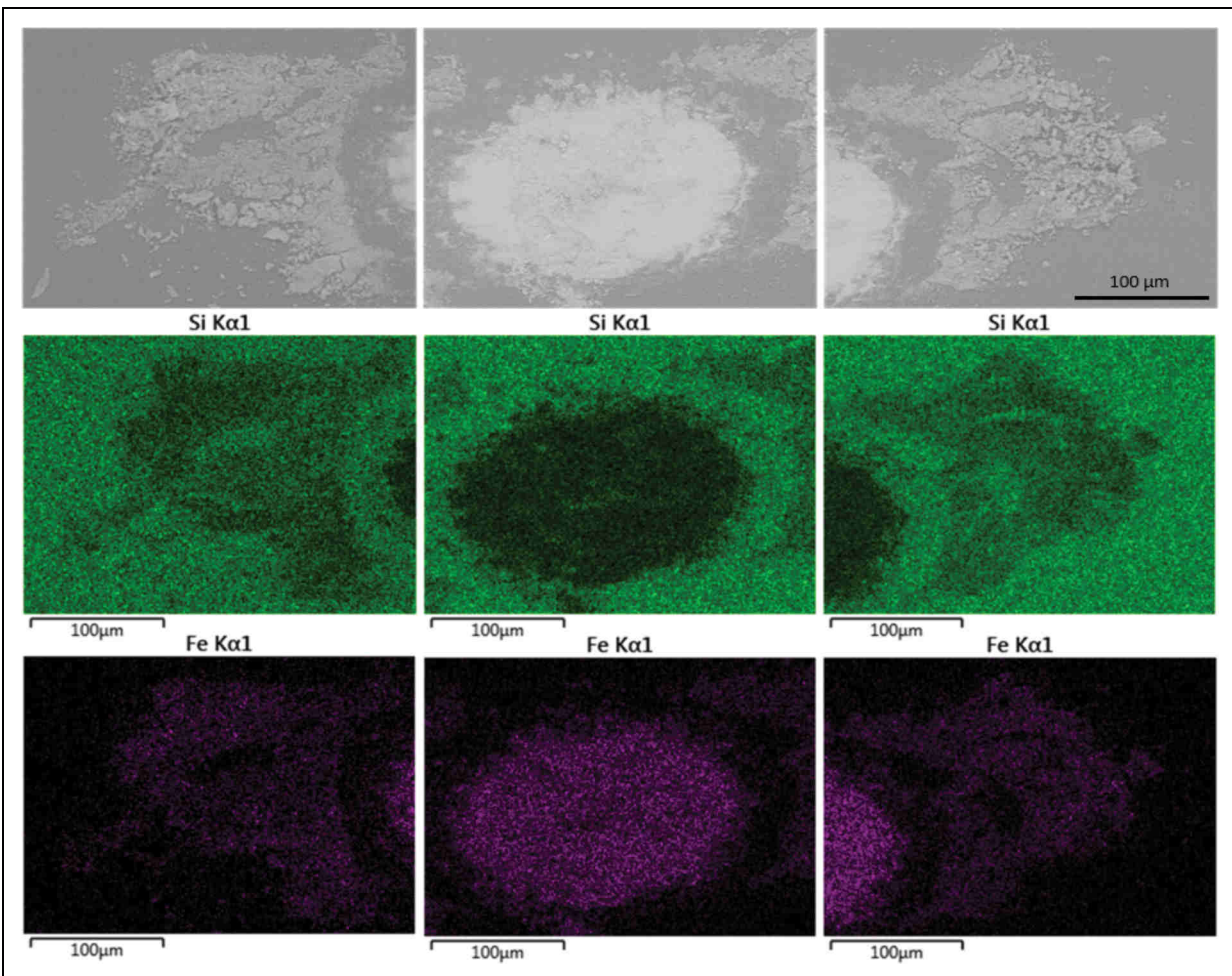
**Figure 4.** SEM observation and EDS analysis (Si and Fe) of the third body. SEM, scanning electron microscopy; EDS, energy dispersive spectroscopy.

The energy dispersive spectroscopy maps show that iron elements were transferred from the ball to the flat (Figure 4). These elements are more numerous in the central wear track than in the external wear track.

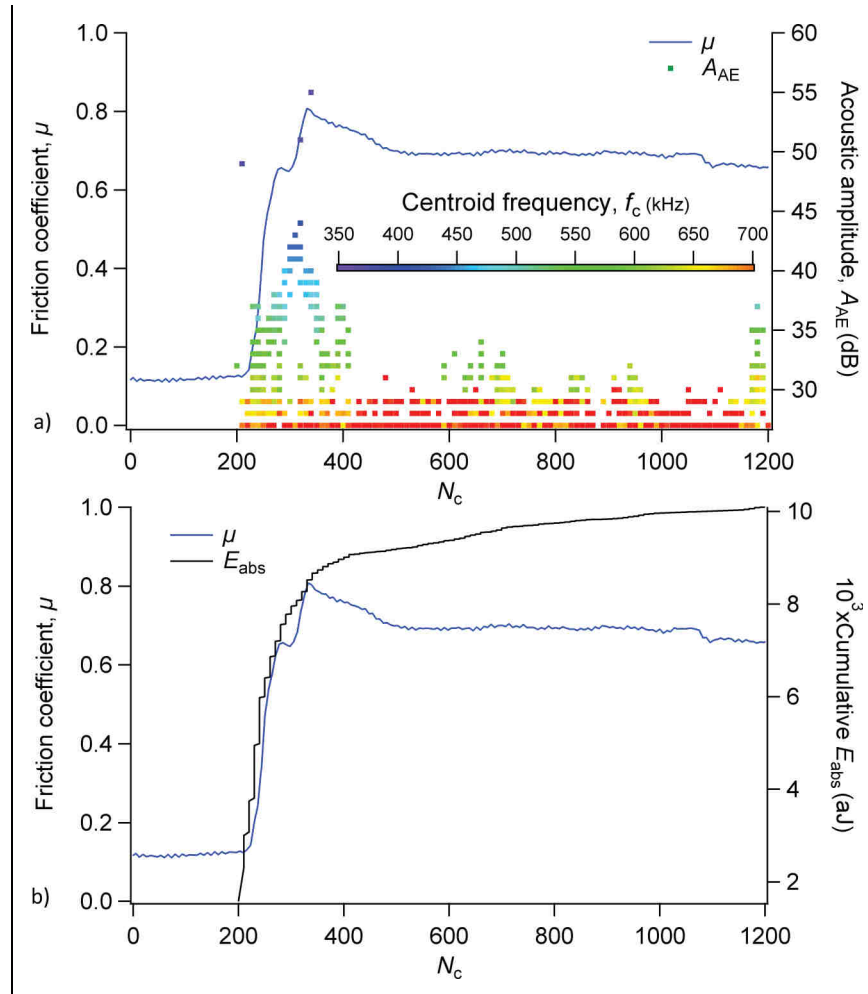
**Figure 5.** Evolution of (a) acoustic amplitude and (b) cumulative absolute energy during testing.

Figure 5 presents the variations of the amplitude, the centroid frequency, and the cumulative absolute energy during the friction test. Three distinct stages are identified synchronously with the evolution of the coefficient of friction:

- In the initial stage (until 200 cycles), the coefficient of friction was low and no AE signals were recorded over the experimental AE threshold detection level.
- In the intermediate stage, from 200 cycles until 420 cycles, the coefficient of friction increases abruptly. During this second phase, AE signals (hit) are recorded. They represent about 90% of the total AE energy emitted and are characterized by a wide range of frequencies (360–700 kHz) and amplitude (29–55 dB).

- In the final stage (420 cycles to the end), the coefficient of friction is again relatively stable but high. During this third phase, the AE signals are low in energy (about 10% of the total AE energy emitted) and are characterized also by low amplitudes (29–35 dB), but high frequencies (500–700 kHz), compared with the second stage.

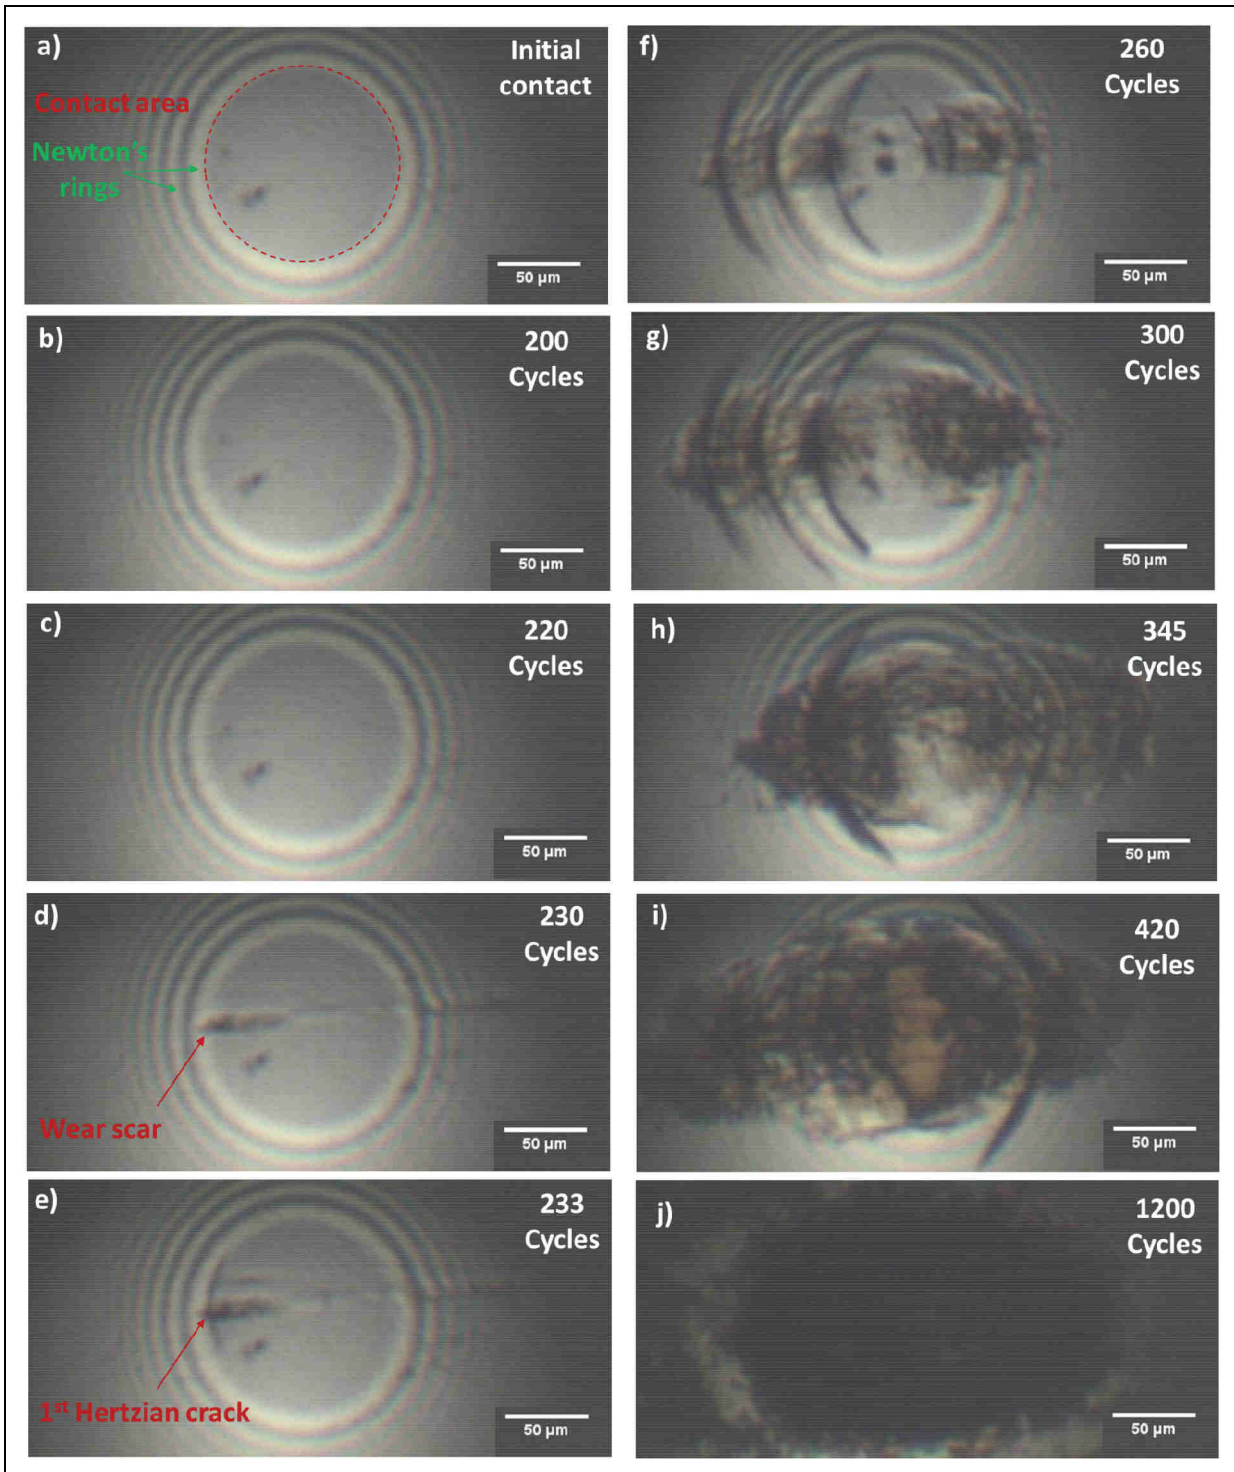
**Figure 7.** Images of the contact area extracted from the video showing the evolution of the damaging process during sliding friction. (a) and (b) in the first stage, from (c) to (h) in the intermediate stage, (i) and (j) in the final stage.

Figure 7(a) shows the initial contact between the ball and the flat under a normal load of 5 N. The central, circular dark area is the contact area. Following Hertz's theory, the radius of this contact area is determined and is about 58  $\mu\text{m}$ , as can be observed. It is formed by elastic deformation. The white rings around this area

also called Newton's rings, corresponding to the optical interference fringes. They are caused by the divergence of the ball away from the glass sample surface.

In the first stage (until 200 cycles), the coefficient of friction remains very low (about 0.12) and no degradation in steel or glass surfaces is observed (Figure 7(b)). So, the accommodation has taken place by shearing in residual natural screens of the first bodies' surfaces. No AE signals were recorded over the experimental AE threshold.

At 220 cycles (Figure 7(c)), after multiple passes, particles are detached from the contact zones of the steel ball. They are transferred to the glass surface by adhesion and generate the source flow  $Q_s$ . These particles are trapped and circulated within the contact zone to initiate the

internal flow  $Q_i$ . A wear scar starts to form in the sliding interface and emits an acoustic amplitude close to 35 dB. Also, the wear scar evolves in terms of length (Figure 7(d)). These observations are in agreement with several studies, which have shown that the AE signals are sensitive to wear debris generation. Gen et al. showed that the AE energy could demonstrate the generation of wear debris, which emits a high-level signal.

At 233 cycles, a first Hertzian crack is observed on the glass sample (Figure 7(e)). The crack has a semicircular shape in which the concave side indicates the sliding direction when it occurred. This type of crack is usually observed on brittle materials such as glasses and ceramics. It originates from the stress distribution in the flat sample, which is induced by the ball displacement. For a sliding ball-on-flat contact, tensile stress appears behind the contact and leads to a fracture. In this stage, the centroid frequency is around 501 kHz. However, the AE amplitude increases to 37 dB, because the strain energy released by cracking is higher than that released by the formation of wear debris.

When the ball moves, the number of cracks increases. Figure 7(f) shows a series of three consecutive cracks at the back of the contact. In addition, with the reciprocal sliding of the ball, cracks can also appear completely or partially in the opposite sliding direction. The cracks are equally spaced (around  $36 \pm 1 \mu\text{m}$ ). This inter-crack spacing is generally related to the coefficient of friction and the fracture toughness of the glass.<sup>16,17</sup> Friction also produces compressive stress in the front of the sliding surface that closes the cracks generated during the previous part of the cycle when the displacement followed the opposite direction, so they are not more visible on the video. Such cracks are visible again when they are re-opened by tension behind the contact when the sliding is once more in the appropriate direction.

Figure 7(g) shows that detached particles continue to progress in terms of width. Their accumulation produces an adherent interfacial bed of powder that reduces the first bodies' surface interactions. A part of the detached particles is also ejected outside the contact zone and creates the wear flow  $Q_w$ .

At 345 cycles (Figure 7(h)), the abrupt increase of the coefficient of friction up to 0.8 is accompanied by the increase of the AE amplitude to 55 dB. This is due to the appearance of the largest Hertzian crack on the glass surface. In this intermediate stage of testing, cracks

In the final stage, starting at 420 cycles (Figure 7(i) and (j)), the coefficient of friction starts to stabilize at 0.68. The adherent interfacial layer continues to grow until it becomes extended to the entire contact area. Newton's rings and also cracks are no more visible. The AE signals are low compared to the second stage. This is similar to Ito et al.<sup>20</sup> results. They showed that in a steady-state stage the accumulation of wear debris between the contacting surfaces leads to relatively low values of AE signals despite a high coefficient of friction.
