Low-cycle fatigue crack initiation and propagation from controlled surface imperfections in nuclear steels

International Journal of Fatigue, 2020, 139 : 105703

Cussac, P., C. Gardin, V. Pelosin, G. Hénaff, L. de Baglion, O. Ancelet, and S. Courtin

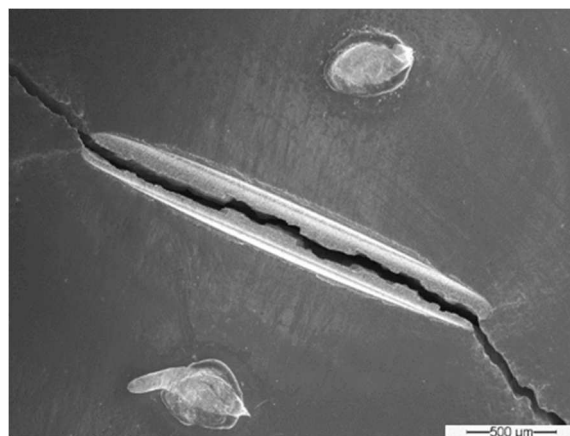
Figure 4 - Initiation and propagation of a crack from a surface imperfection at $\Delta\epsilon_t/2 = 0.6\%$ (18MND5)

In fatigue tests carried out on specimens containing a surface imperfection, the initiation of the main crack systematically occurred from this imperfection. More specifically, whatever the strain level or the imperfection depth and type considered, optical observations carried out during the tests by means of a long focal length microscope, have revealed a systematic initiation in the center and at the root of the defects. These zones correspond to the maximum surface imperfection depth and are associated with a significant deformation concentration. An example of a crack initiated at an imperfection root is shown in figure 4.
