## Effect of end milling, grinding and tartaric-sulfuric anodizing on the fatigue behavior of AA7050 alloy

Foued Abroug, Etienne Pessard, Guénaël Germain, Franck Morel

Foued Abroug, Etienne Pessard, Guénaël Germain, Franck Morel. Effect of end milling, grinding and tartaric-sulfuric anodizing on the fatigue behavior of AA7050 alloy. *International Journal of Advanced Manufacturing Technology*, 2022, 122 (9-10), pp.3903-3922. 10.1007/s00170-022-10124-3 . hal-03801227

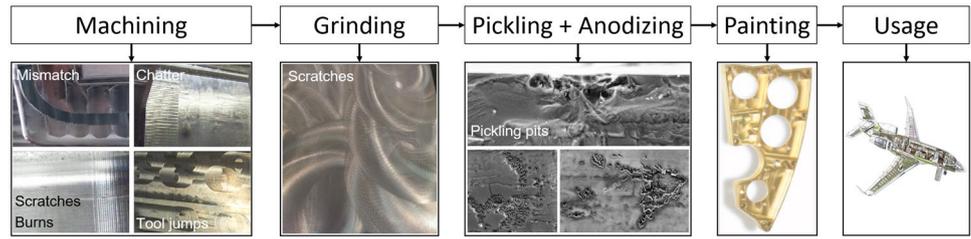
**Fig. 1** Steps of aircraft aluminum components manufacturing

of its topography and could introduce pits during the pickling process [11, 12]. The anodization does not systematically succeed in filling these pits with the alumina layer. According to the literature [4, 11, 13], the surface treatment often reduces the fatigue strength of the component, this is the case for studies using chromic and sulfuric anodizing treatments. Some studies, on the other hand, show that tartaric-sulfuric anodizing (TSA) preserves the high cycle fatigue strength of the parts [13, 14], but studies on the HCF of the TSA process remain rare in the literature [15]. The chronology of the operations that AA7050 aircraft components undergo is presented in Fig. 1.

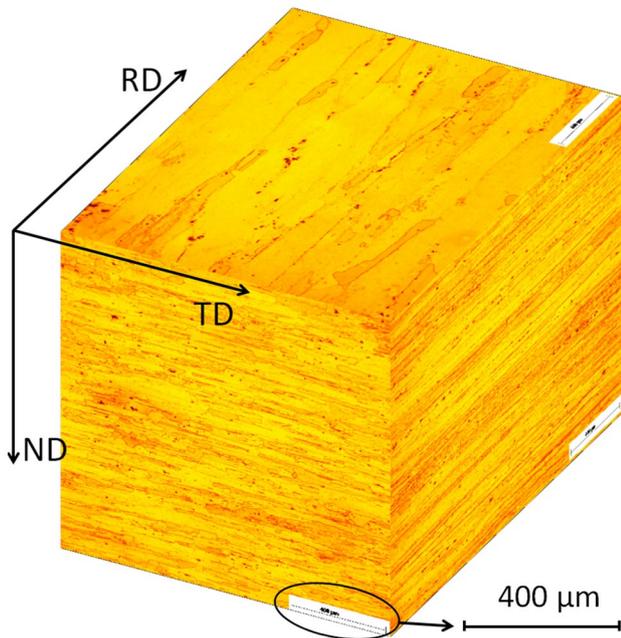
**Fig. 2** Microstructure of the AA7050-T7451 alloy (RD = Rolling Direction 0°, TD = Transverse Direction 90°, ND = Normal Direction)

The investigated material is a 30 mm thick rolled sheet of AA 7050 Aluminum alloy (Al Zn6CuMgZr) intended for aeronautical applications. The chemical composition of the AA7050-T7451 alloy (in Wt%) is: 6.027 Zn, 2.221 Cu, 1.847 Mg, 0.102 Zr, 0.039 Ti, 0.038 Si, 0.095 Fe, 0.01 Mn. The microstructure of the sheet used is shown in Fig. 2. The rolling

process generated a high degree of recrystallization. The areas of consolidation of recrystallized and non-recrystallized grains can be up to a few millimeters in length. The range of grain sizes is between 5 and 300  $\mu\text{m}$  in the rolling and the transverse directions, and between 5 and 50  $\mu\text{m}$  in the depth direction (see Fig. 2). Intermetallic particles, mainly located at the grain boundaries and in the recrystallized grains, are also present. For the AA7050 alloy, the majority of these particles, whose size can be up to 20  $\mu\text{m}$  in length, are of type  $\text{Mg}_2\text{Si}$  and  $\text{Al}_7\text{Cu}_2\text{Fe}$ . Particles of  $\text{MgZn}_2$  and  $\text{AlCuZn}$  are also present in the structure (see Fig. 3). These brittle particles are known to be at the origin of the initiation of fatigue cracks in aluminum alloys [17, 18].

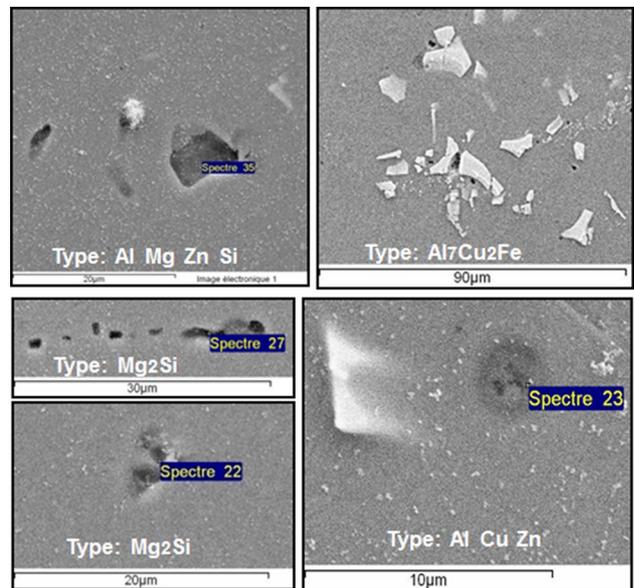
**Fig. 3** Al<sub>7</sub>Cu<sub>2</sub>Fe, Al Mg Zn Si and Mg<sub>2</sub>Si type intermetallic particles at the surface of the AA7050 alloy

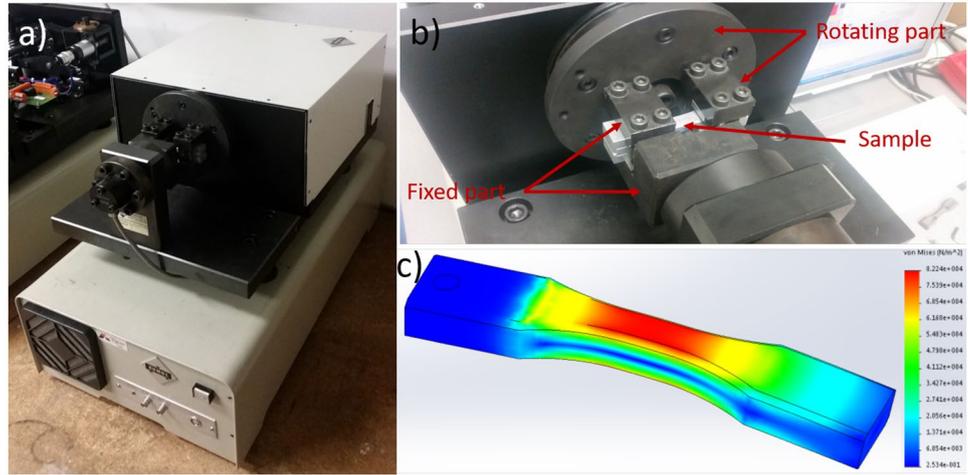
**Fig. 4** a) Rumul Cracktronic fatigue test machine, b) a zoomed view on the loading zone and c) stress distribution resulting from plane bending

Fatigue tests have been carried out on a Rumul Cracktronic, resonant fatigue testing machine (see Fig. 4) under the following conditions:

- Fully reversed plane bending load ( $R = -1$ ).
- Test frequency :  $\approx 75$  Hz.
- Ambient temperature and pressure, ambient air.
- Stopping criterion: frequency drop of 0.70 Hz corresponding to the presence of a crack on the specimen (crack larger than 5 mm), or  $2 \times 10^6$  cycles reached.

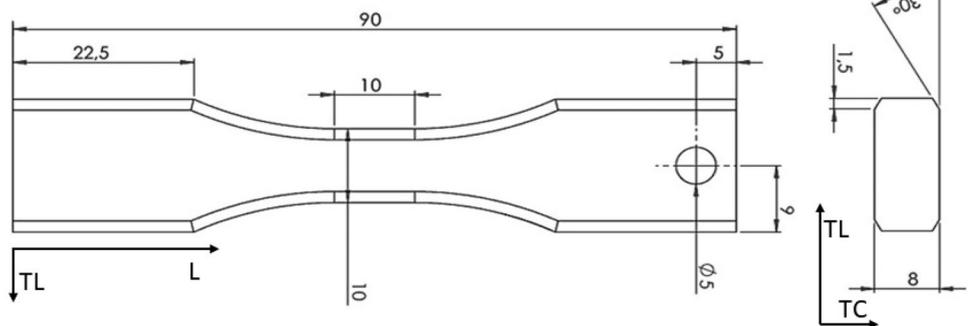
**Fig. 5** Geometry of plane bending sample

of the specimen is shown in Fig. 5. All specimens are taken from the middle of the sheet with the loading axis parallel to the rolling direction. A 30° chamfer is machined on the specimen edges to avoid crack initiation at the edges.

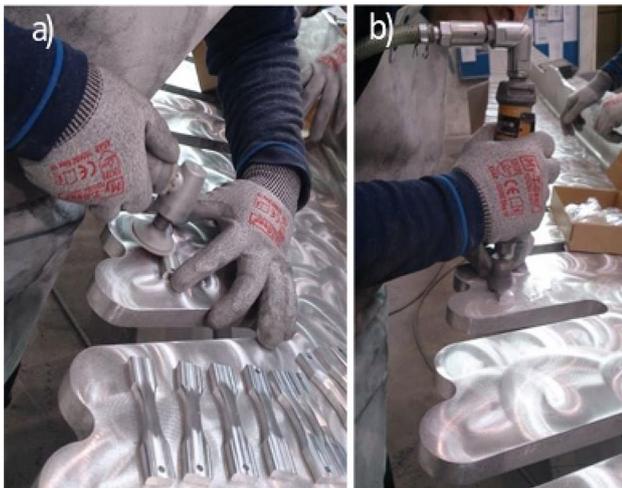
**Fig. 6** Grinding steps by industrial means, **a** vibrating grinder and **b** straight grinder with a grit 40 and grit 80 sandpaper respectively**Table 2** TSA surface treatment sequence of the AA7050-T7451 alloy

In addition, a grinded batch was prepared by industrial means, in the same conditions as the industrial components. This batch, noted G3.8 (Fig. 6a), represents the

industrial surface condition obtained after grinding of a milled surface defect. The specimens were manually grinded using first a vibrating grinder with 40 grit sandpaper, followed by a second step with a straight grinder with 80 grit sandpaper (average grain size of the order of  $400 \mu\text{m}$  and  $200 \mu\text{m}$  respectively) (see Fig. 6). The abrasive paper was changed at the beginning of grinding.

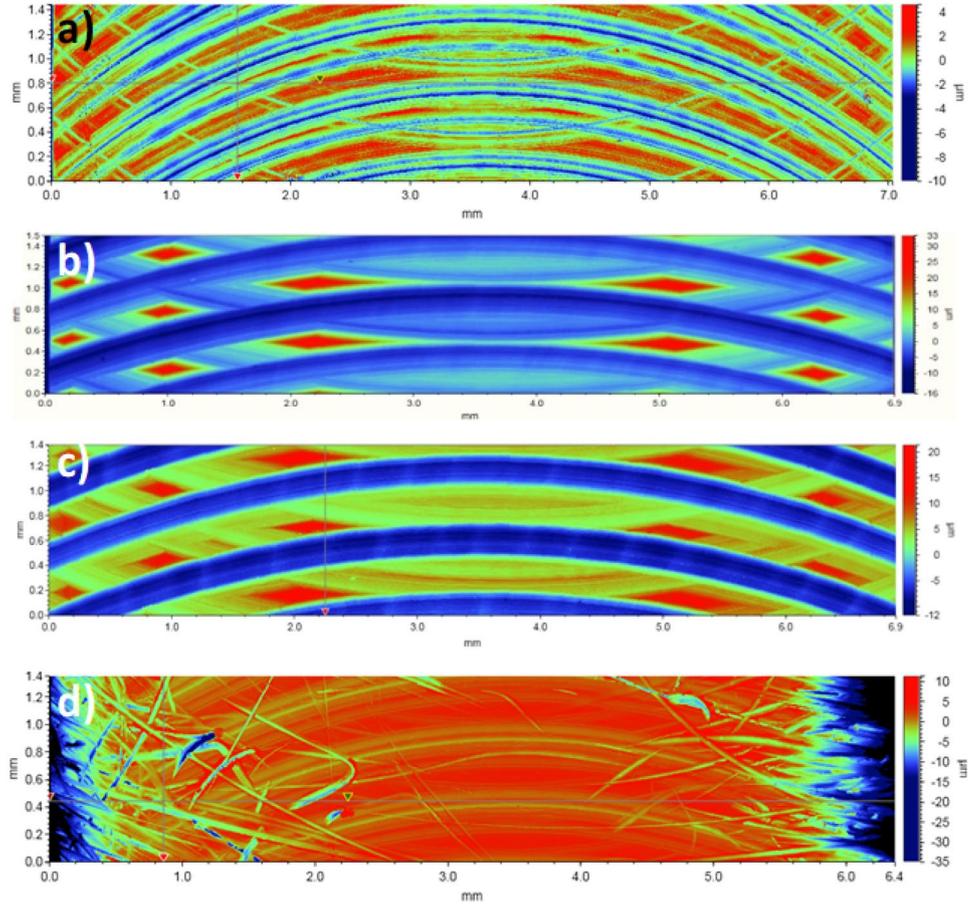
**Fig. 7** Surface topography of milled and grinded specimens

The different surface states were scanned and analyzed using the Bruker Contour GT-K0-X optical profilometer. The surface topologies are shown in Figs. 7 and 8. A large difference is observed between the M1.1, M4.2 and the M5.5 surface states. The high feed rate values for the M4.2 and M5.5 batches generate a tool path leaving areas of high altitude and generates high roughness, both on the total surface (parameter  $Sa$  shown in Table 4) and over high peak lines (parameter  $Ra_{max}$  shown in Table 4 and profiles shown in Fig. 11). Figure 7 also shows the grinded surface scan where the profile is mostly chaotic with scratches crossing the width of the specimen. However, the all-over surface roughness does not seem as affected as by the presence of high peaks on the M4.2 and the M5.5 surface states. As for

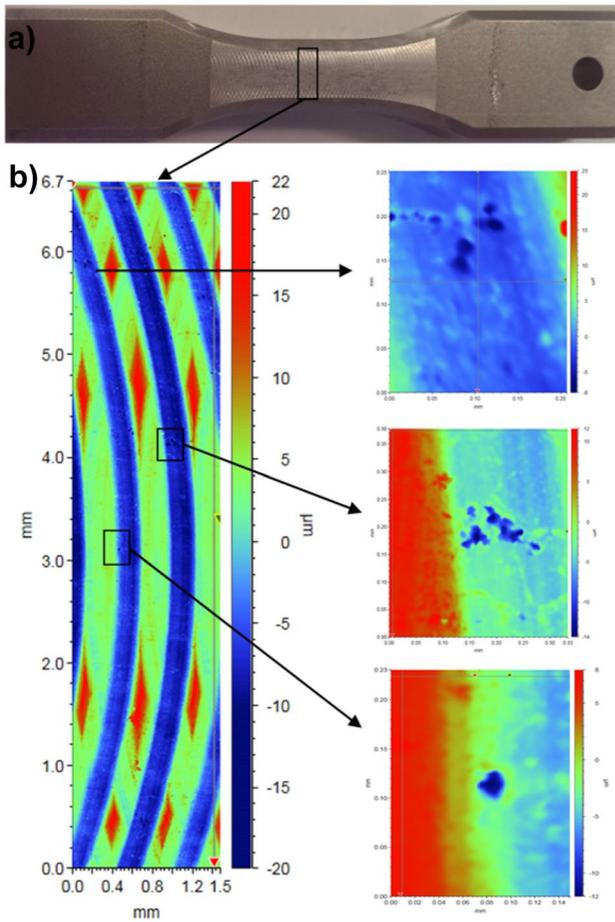
**Fig. 8** M5.4-TSA **a** specimen and **b** 3D surface scan with a zoom over local pits

the chemical process, Fig. 8 shows an example of a specimen from the M5.4-TSA batch post-anodizing surface treatment. The 3D scans show that the surface topology is only slightly affected on a macroscopic scale. However, on a more local scale, pits can be observed at the surface and at the bottom of the milling grooves.

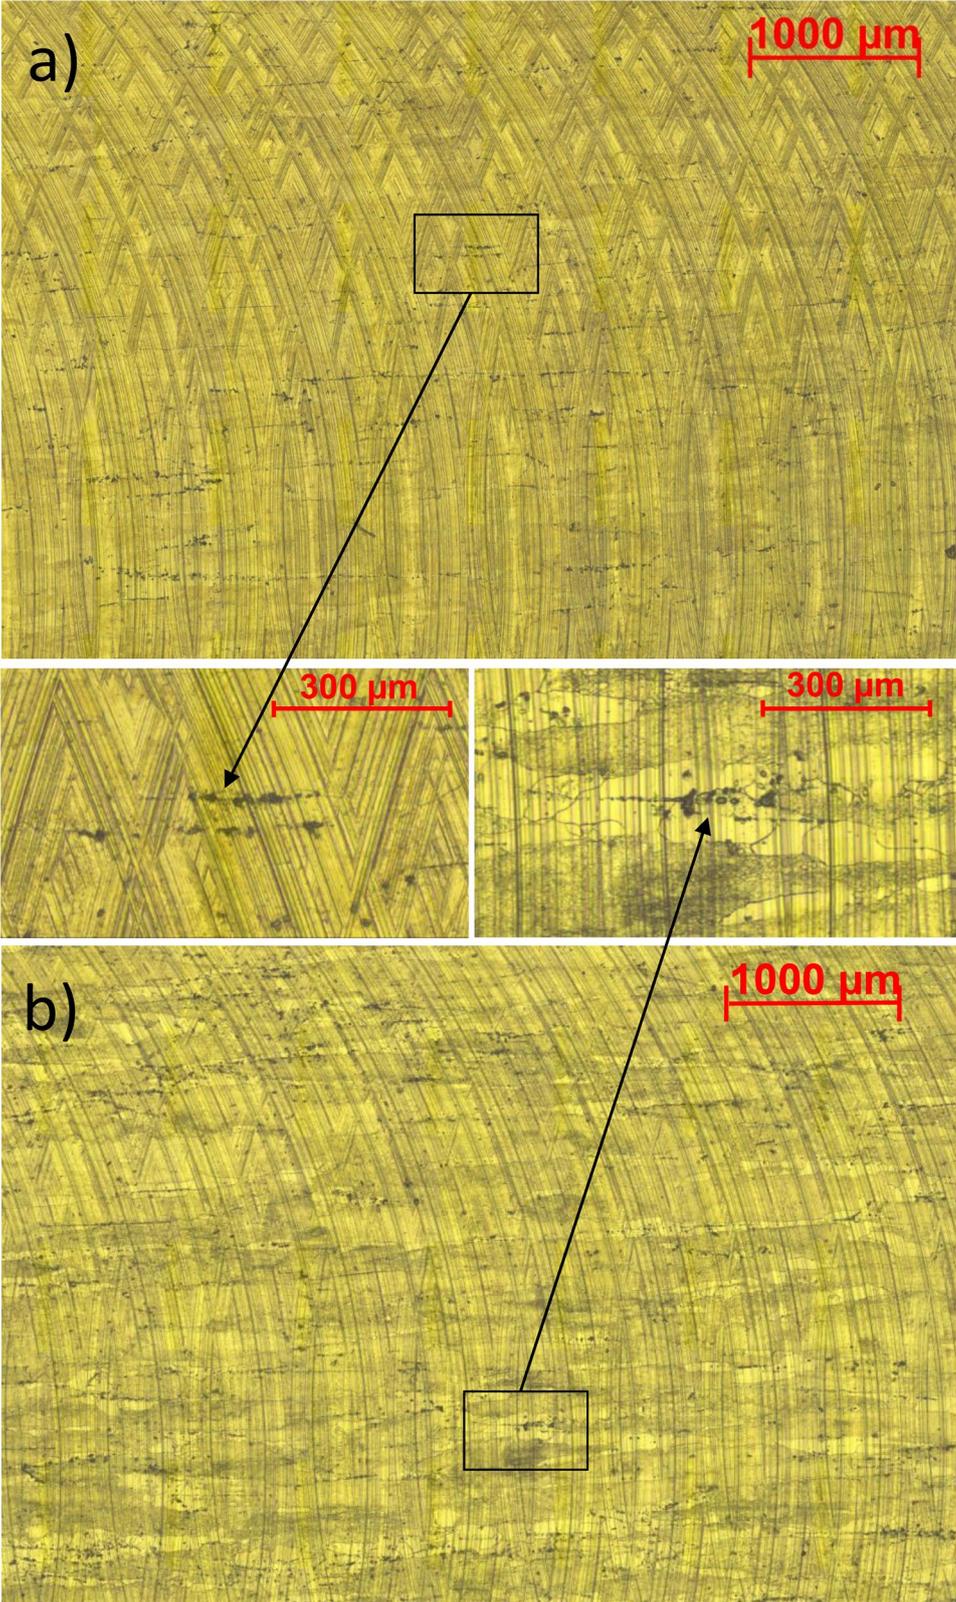
**Fig. 9** Surface state after **a** pickling and **b** TSA anodizing

(see Fig. 9), the surface roughness  $Sa$  before and after surface treatment remain very similar.  $Sa$  values go from  $1.1 \mu\text{m}$  to  $0.9 \mu\text{m}$  for the M0.9-TSA batch and from  $5.5 \mu\text{m}$  to  $5.4 \mu\text{m}$  for the M5.4-TSA batch.

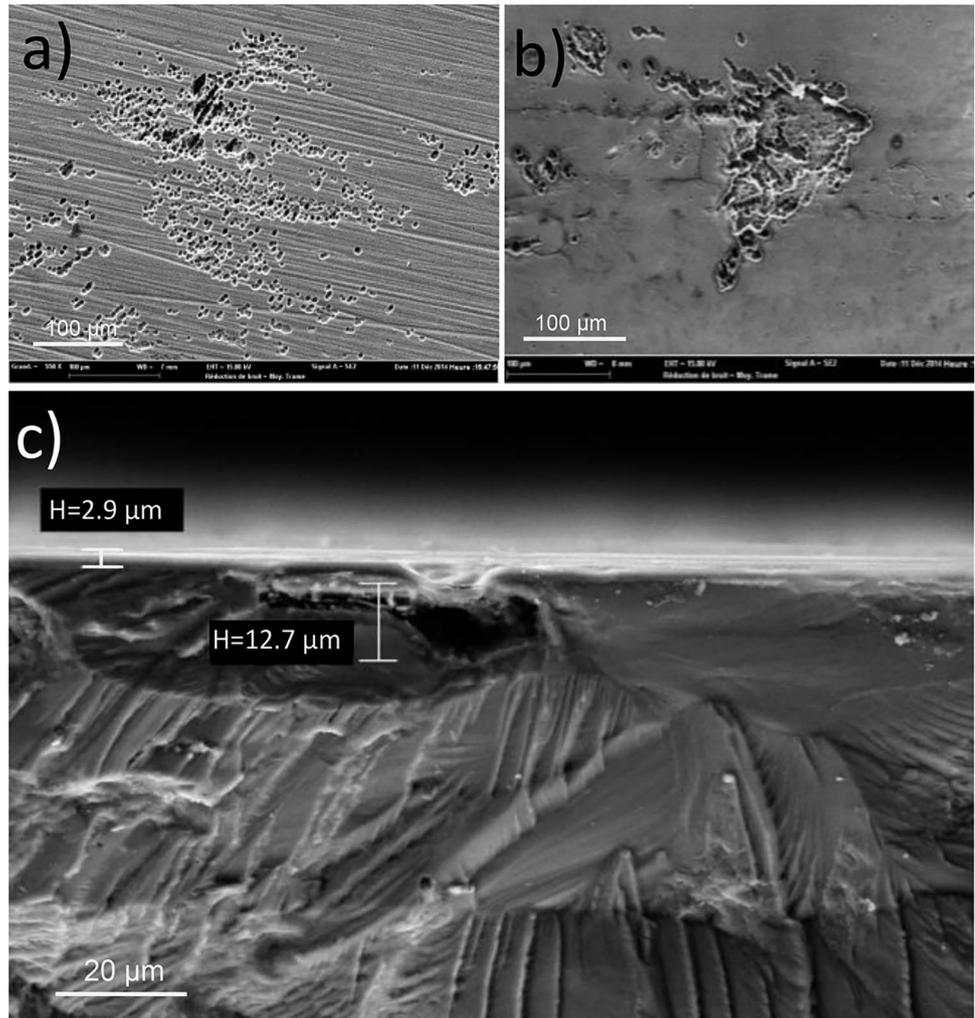
**Fig. 10** SEM observations of surface defect groups of **a** a pickled, **b** an anodized specimen and **c** (fractography of a specimen with a TSA anodizing layer of around  $3\ \mu\text{m}$ )

For the anodized specimens, optical microscope and SEM observations were made after each step of the surface treatment process. The anodic layer has a thickness of between 2 and 3  $\mu m$  (Fig. 10c). After pickling, pits are created and are located at the grain boundaries and within the recrystallized grains (Fig. 10a). These pits can reach widths of the order of 15  $\mu m$  and depths of the order of 15  $\mu m$  (Fig. 10c). Networks of small pits can be observed and are of length of the order of 300  $\mu m$  (Fig. 10a). After anodizing, the anodic layer completely covers the pickling pits. No decohesion zone between the substrate and the anodized layer was detected. The TSA does not seem to affect the size of the pits created during the pickling process (see Fig. 9). Figure 9 shows that the milling grooves are still visible on the surface after the pickling and anodizing processes.

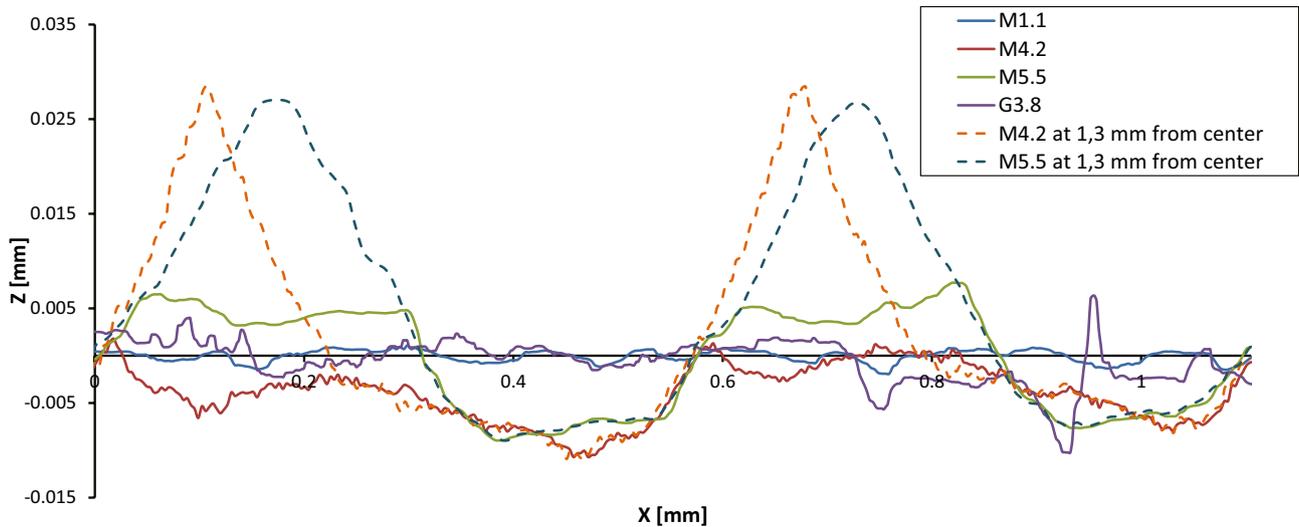
**Fig. 11** 2D roughness profiles for the milled and grinded batches

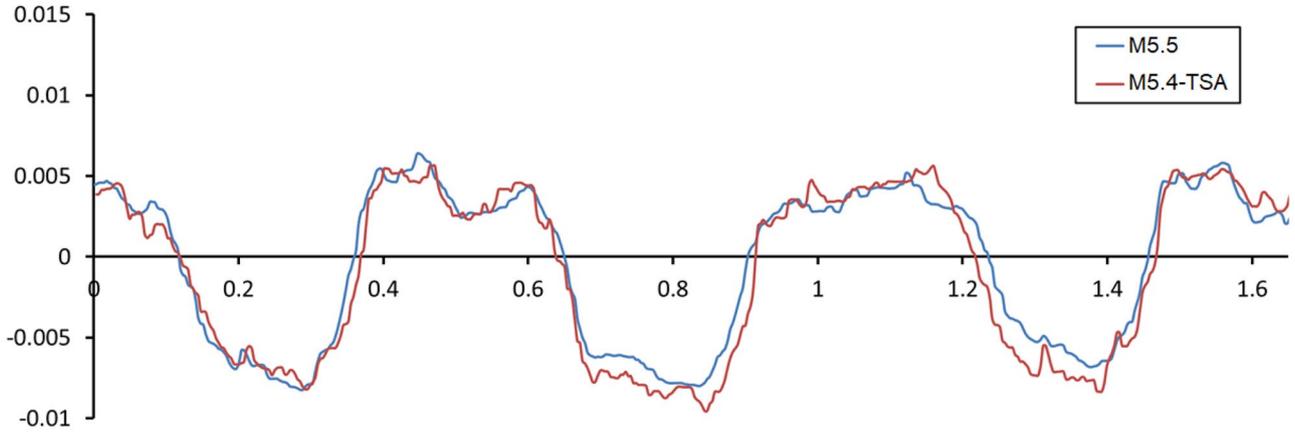
Fig. 12 The impact of TSA anodizing on surface roughness profile (M5.5 batch before and M5.4-TSA batch after surface treatment)

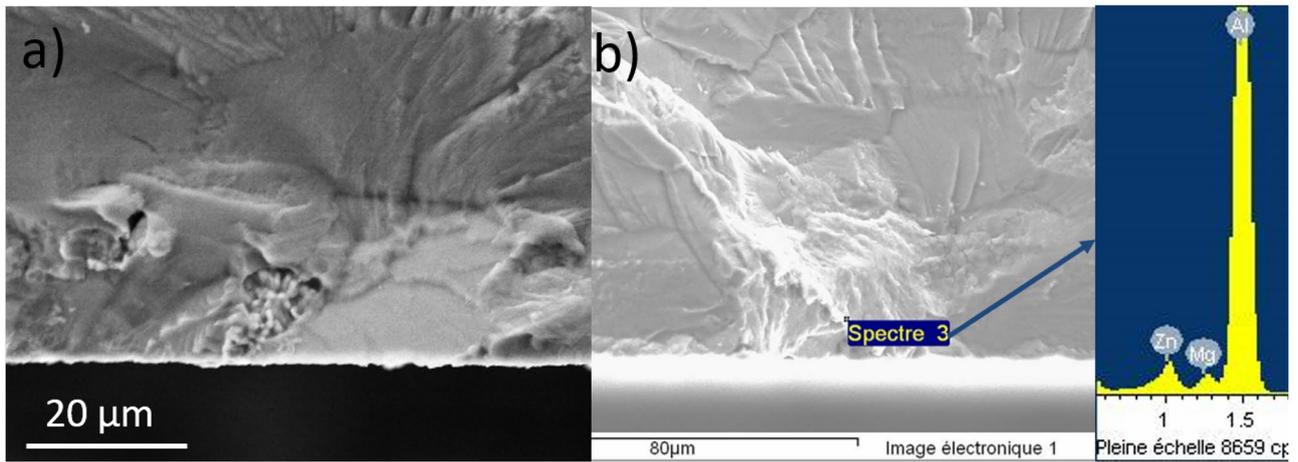
**Fig. 13** Fractographic analysis of the P0 surface state: crack initiation at **a** an  $Al_7Cu_2Fe$  type particle, **b** no particles but presence of Mg, Al and Zn elements

As shown in Fig. 13, for 66% of the tested specimens crack initiation is clearly located at the intermetallic particles. EDX analysis of these particles shows that they are either  $Mg_2Si$  or  $Al_7Cu_2Fe$  particles. For the rest of the cases, cracks initiate from areas without visible particle, but rich with Mg and Zn as identified via EDX analyses (Fig. 13b). According to [21], the high concentration of these elements may indicate the presence of nanometric precipitates of  $MgZn_2$ , which may be at the origin of the crack initiation. The two mechanisms (particles or areas rich in additive elements) coexist at low and high loading levels.

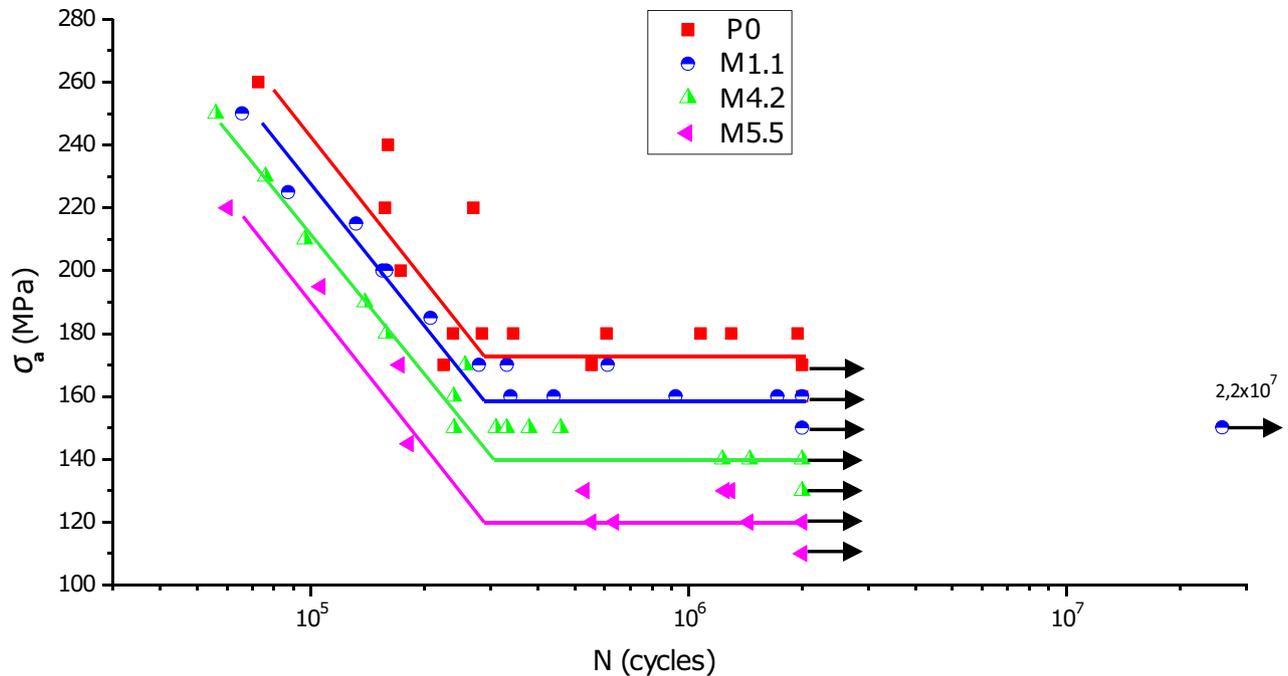
**Fig. 14** S-N curves of different surface states obtained by polishing and end milling

MPa compared to the P0 reference state. The average fatigue limit of the M4.2 state shows a greater decrease and reaches 141 MPa. The fatigue decrease is the most pronounced for the M5.5 Batch (-55 MPa) compared to the reference state P0. The associated standard deviation for all milled surface states remains low, of the order of 5.3 MPa (see Table 5). The S-N curves of the polished and milled batches are shown in Fig. 14.

The slope of the S-N curves for the polished and milled batches are similar. In addition, observation of the S-N curves for the different batches shows that the fatigue strength seems constant over a large number of cycles, which suggests the existence of a fatigue limit asymptote. To verify this hypothesis, a specimen of the M1.1 batch was loaded at 150 MPa (a loading step below the fatigue limit determined by the StairCase method) for a very large number of cycles. For this specimen, the test was stopped at  $2.2 \cdot 10^7$  cycles and no cracks were observed. This test validates the concept of

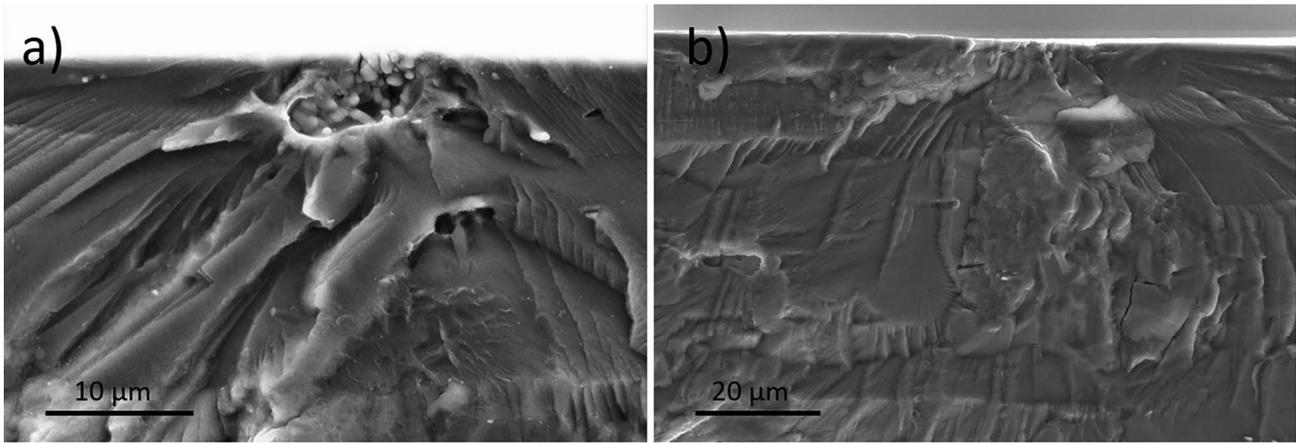
Fig. 15 M1.1 state: crack initiation from **a** a particle and **b** without an observable particle

As for the damage mechanisms, the principally observed crack initiation mechanism for the M1.1 surface state is the initiation at the intermetallic particles. This is observed at high and low cycles domains. At high stress amplitude loading level, multiple crack initiation sites are observed. This result agrees with the observations made by [22] on an AA7050 alloy. Only one of the 15 tested specimens did not have a particle at the initiation site at a high cycle level (Fig. 15b).

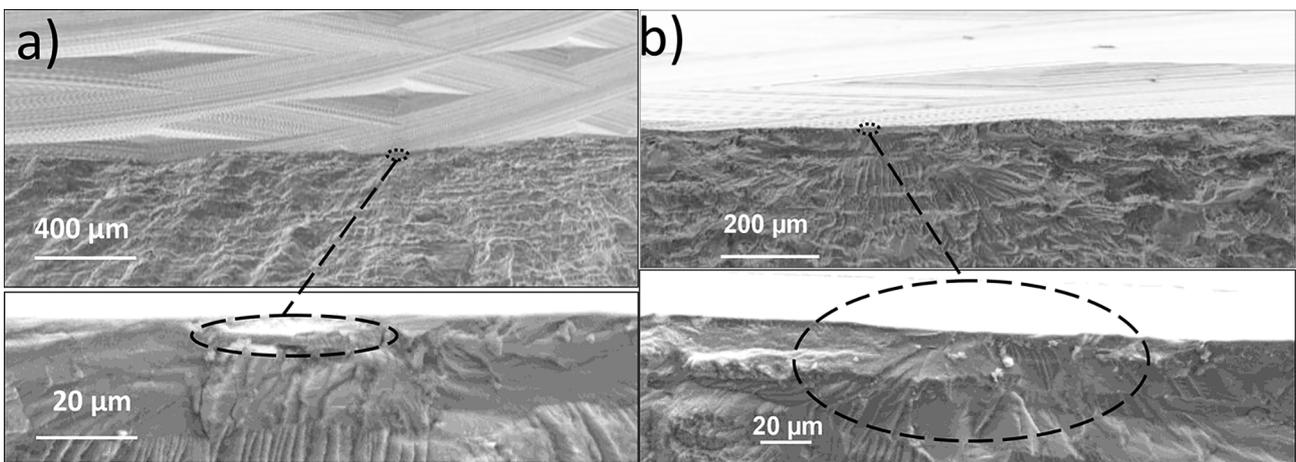
Fig. 16 M4.2 state: crack initiation from **a** a particle and **b** without an observable particle

In the case of the M4.2 surface state, two damage mechanisms are present depending on the loading level. Intermetallic particles are present at the crack initiation sites at a low stress amplitude (or number of cycles higher than  $3.10^5$  cycles) (Fig. 16a). However, no particle could be observed at the crack initiation sites at high stress amplitudes (or low number of cycles) (Fig. 16b). It should be noted that, at high stress amplitude, some specimens show multiple crack initiation sites without intermetallic particles.

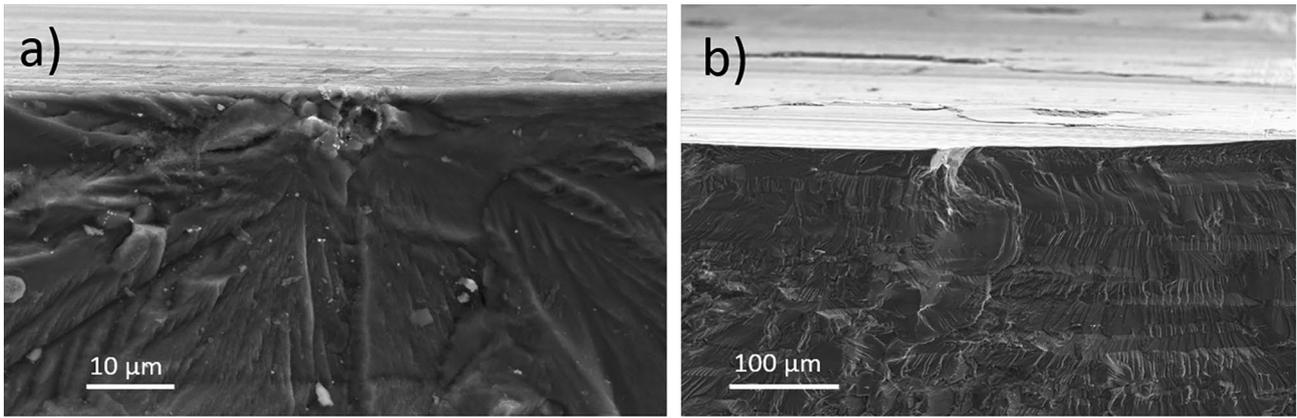
Fig. 17 M5.5 state: crack initiation from **a** a particle and **b** without an observable particle

For the M5.5 state, SEM fractographic observations led to the conclusion that in the majority of cases, crack initiation occurs from an intermetallic particle (Fig. 17a), at high and low level stress amplitudes (or low and high number of cycles). Of the ten observed specimens, two do not have particles at the crack initiation site (an example is given in Fig. 17b). For these two specimens, the crack initiated at the area of the highest roughness (and highest peaks) on the surface. Both mechanisms occur at low and high number of cycles.

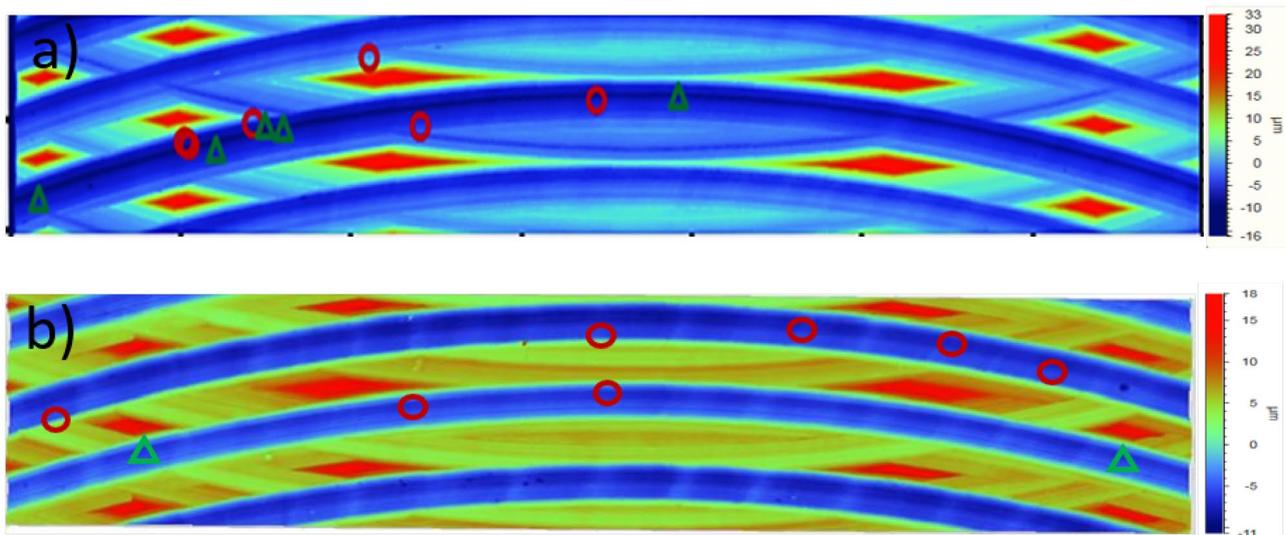
Fig. 18 Crack initiation positions for specimens of **a** M4.2 and **b** M5.5 states. The red circles represent crack initiations from an intermetallic particle, whereas the green triangles represent crack initiations without an observable particle

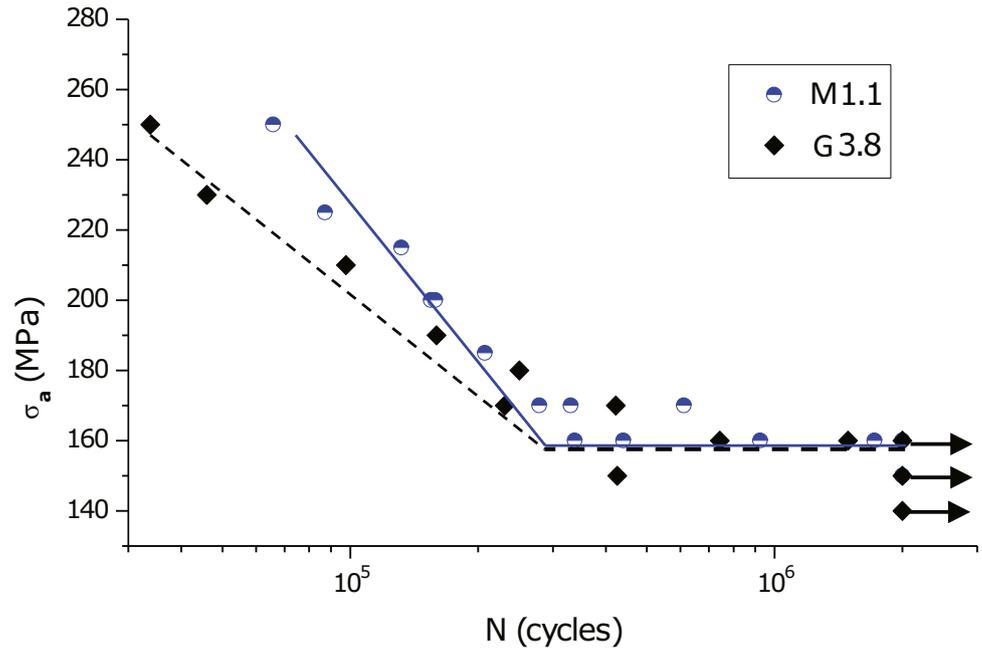
**Fig. 19** S-N curves of the end milled M1.1 and the grinded G3.8 configurations

For the grinded surface state G3.8, the fatigue strength is 157 MPa (see Fig. 19) and is very similar to the M1.1 milled

state in the high cycles domain. However, the S-N curve of these two configurations seems to differ in the low cycles domain for which the grinded state has a slightly reduced fatigue life. It seems that the grinding scratches are more

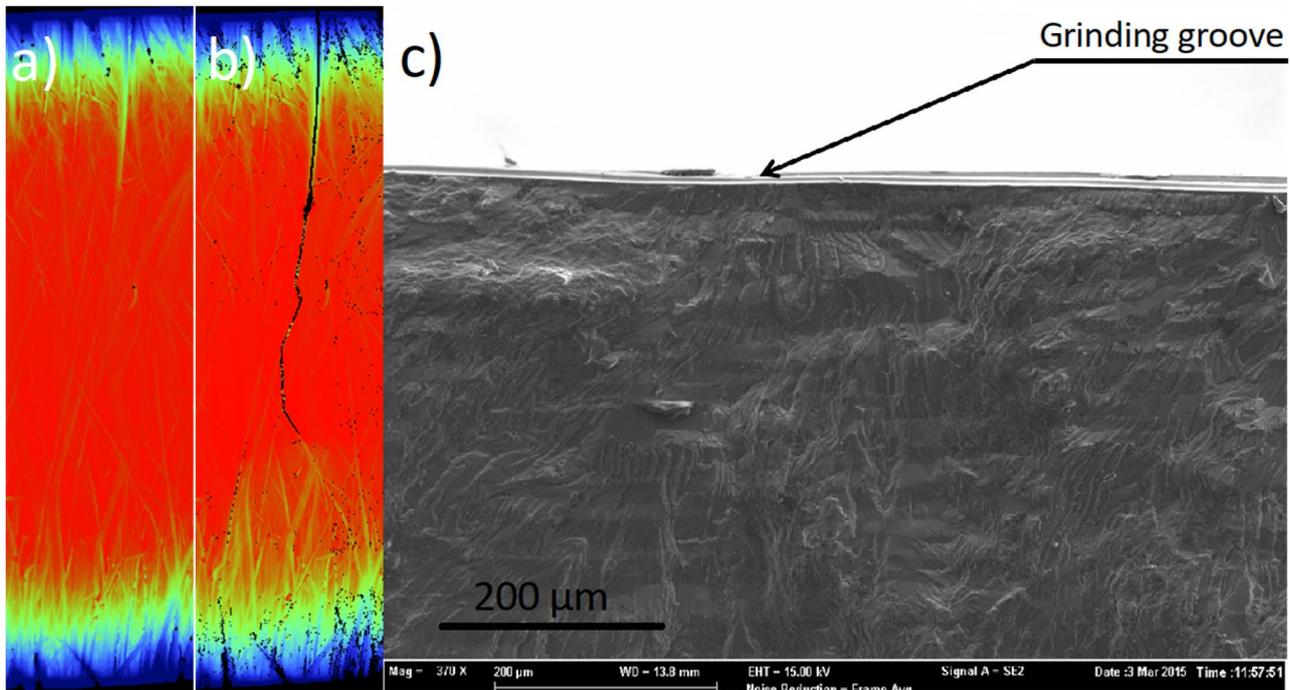
**Fig. 20** Crack initiation from grinding scratch: surface scan of the grinded face **a** before and **b** after cracking and **c** a SEM fractographic observation of the initiation site

For the grinded G3.8 batch, cracks initiate from the surface grinding scratches. These scratches can be up to  $10\ \mu\text{m}$  in depth and several millimeters in length (Fig. 20). In 6 out of 8 cases, no intermetallic particles are observed at the initiation site. At high stress amplitudes, multiple crack sites were identified. In some cases, crack initiation occurs at the corner of the specimen due to the scratch's harmfulness (2 out of 8 observed cases).

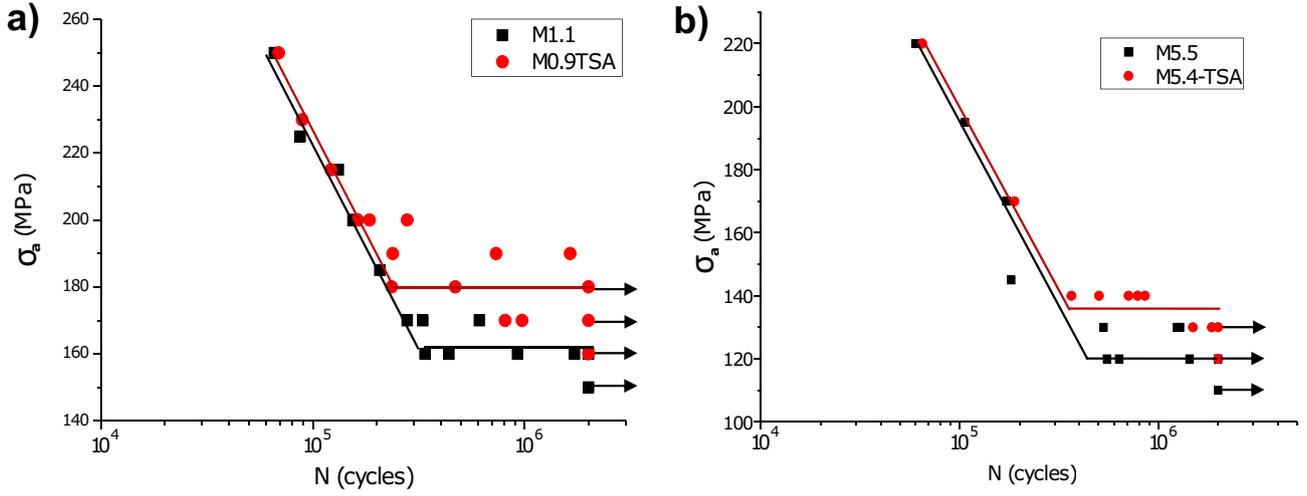
Fig. 21 S-N curves showing the influence of TSA on the fatigue strength: **a** M0.9-TSA batch and **b** M5.4-TSA batch

Surprisingly, the fatigue resistance is enhanced for the two anodized surface states. A gain of 15 MPa in the fatigue strength is observed for both the 0.9-TSA and 5.4-TSA batches, compared to the same batches without the surface treatment. Figure 21 presents the S-N curves for the two surface states before and after surface treatment. This surprising result is in agreement with the few results of the literature addressing this issue [13, 14], where the tartaric-sulfuric treatment was found to preserve fatigue strength.

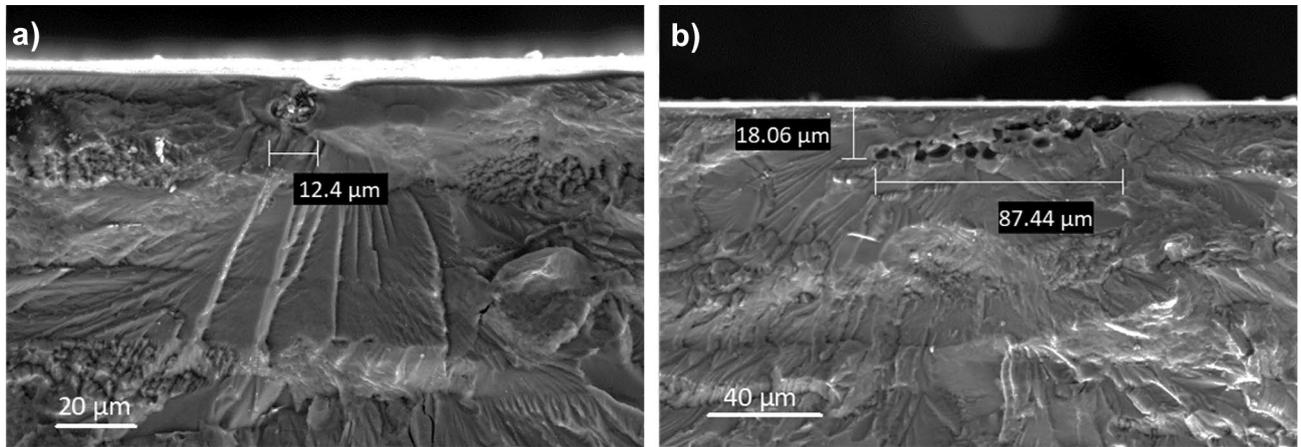
Fig. 22 M0.9-TSA: crack initiation from pickling pits

As for the damage mechanisms for the anodized surface states, SEM observations of the M0.9-TSA surface state show that the crack initiation sites are located at the pickling pits. As shown in Fig. 22, these pits are of different sizes and shapes and can achieve lengths of approximately  $88 \mu m$  (i.e., pit clusters in Fig. 22b) and depths around  $30 \mu m$ . For the M5.4-TSA batch, crack initiation always occurs

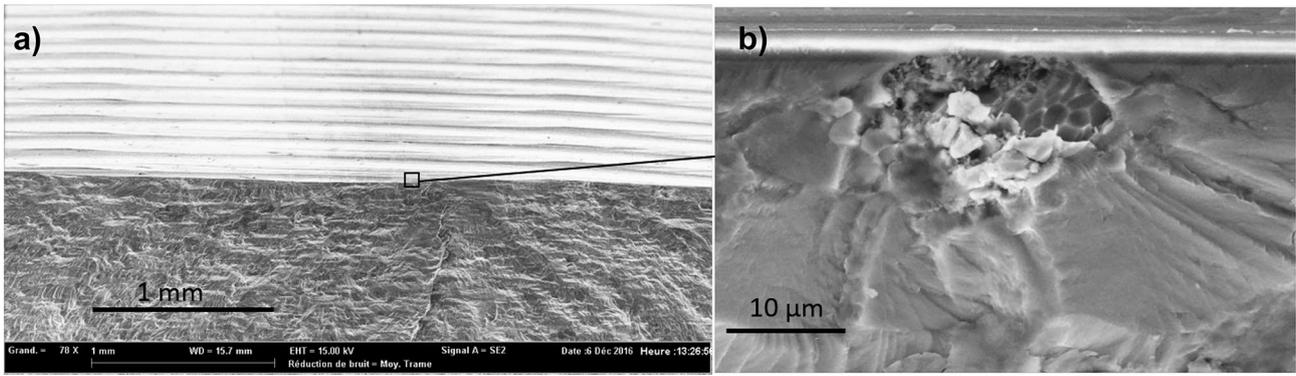
Fig. 23 M5.4-TSA : crack initiation from a pickling pit

from a defect, either at pickling pits at the extreme surface for 50% of cases (see Fig. 23), or at intermetallic particle a few micrometers below the surface (see Fig. 24). Note that the pits are generated due the dissolution of the aluminum in the intermetallic particles during the pickling operation [11].

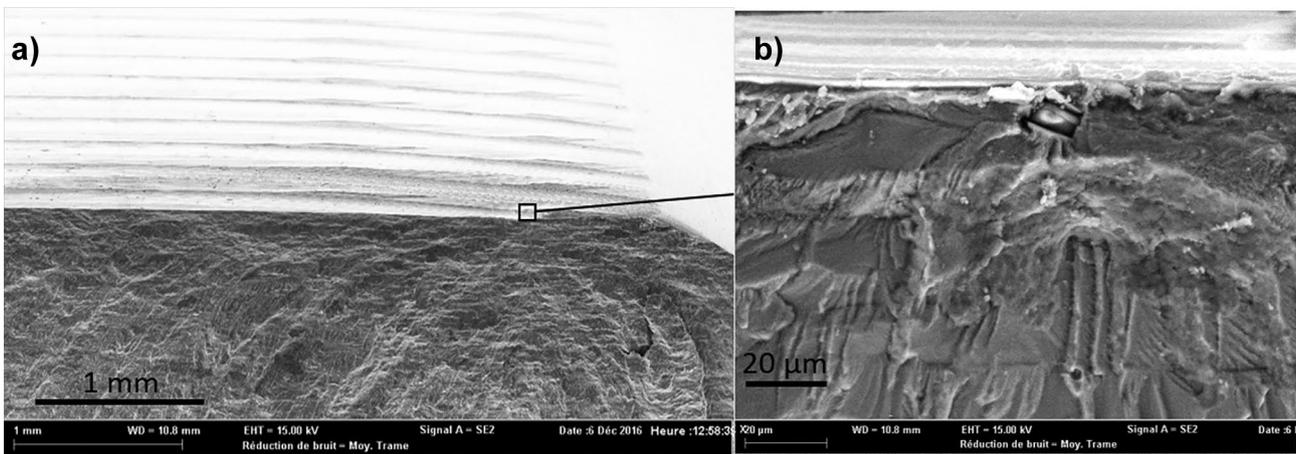
Fig. 24 M5.4-TSA : crack initiation from an intermetallic particle

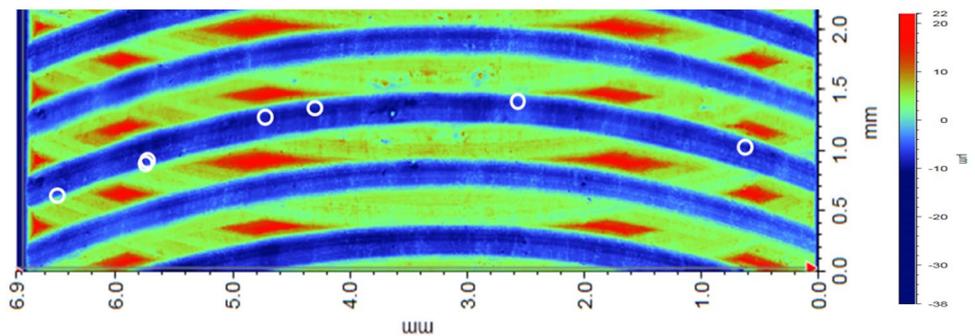
Fig. 25 M5.4-TSA: positions of the crack initiation sites at the bottom of milling grooves

As seen in Fig. 25, the position of the crack initiation sites are randomly located at the bottom of the milling grooves. The stress concentration generated by these grooves, and moreover by the presence of a defect (pitting or particle) controls the crack initiation for the anodized batches.

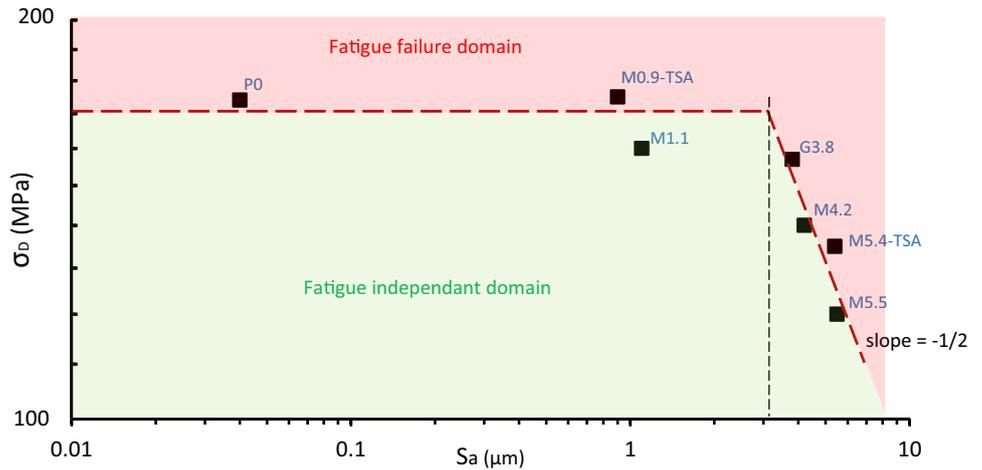
**Fig. 26** Kitagawa-Takahashi type diagram, expressed in terms of the parameter  $S_a$  that highlights the existence two damage mechanism regions

$Sa$  value. Above the critical value of  $Sa$  of  $3 \mu m$ , the fatigue strength has higher sensitivity to the surface roughness. Note that for the 2 batches with anodized surface states M0.9-TSA and M5.4-TSA, the link between fatigue strength and the surface roughness  $Sa$  (Fig. 26) seems to follow the same trend as the batches without the surface treatment.

link the milling conditions to the surface roughness and hence to the fatigue strengths shown in Fig. 26. For the simulations, only the macro geometrical aspects are considered. Other aspects such as residual stresses or microstructural effects are not considered, as their effect on the fatigue

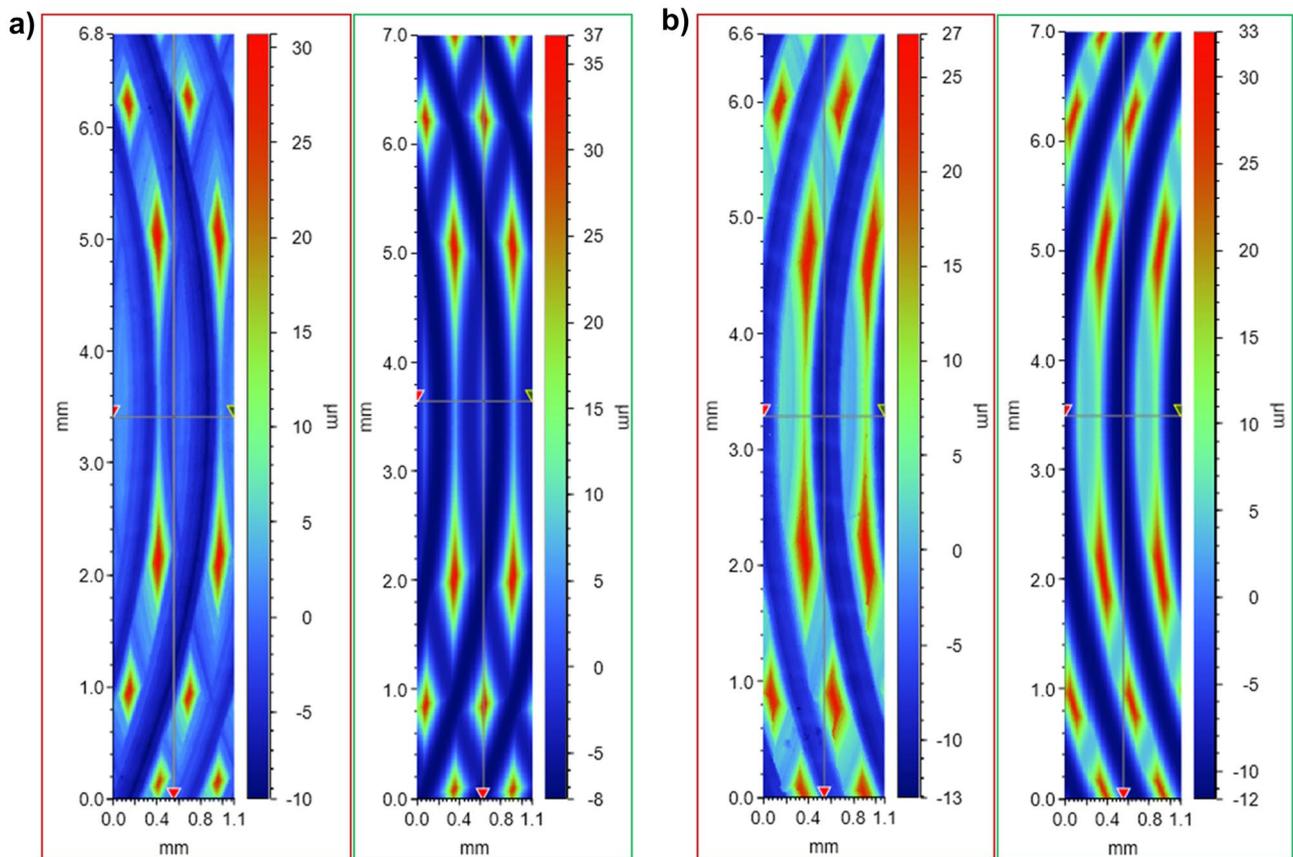
**Fig. 27** Comparison between 3D profiles of **a** the M4.2 and **b** the M5.5 surface states (red frame) and the simulated surface states (green frame)

Two configurations are tested, the first represents a slightly tilted tool and is used to reproduce the M4.2 surface state (tilt angle of  $0.014^\circ$ ) (see Table 1). The second configuration has a tilt of  $0.05^\circ$  in order to reproduce the M5.5 surface state. When considering a tool diameter of  $\varnothing 20$  mm, a slight tilt is capable of greatly modifying the surface state. Figure 27 shows 3D comparison between the real and
