## Effect of end milling, grinding and tartaric-sulfuric anodizing on the fatigue behavior of AA7050 alloy

Foued Abroug, Etienne Pessard, Guénaël Germain, Franck Morel

Foued Abroug, Etienne Pessard, Guénaël Germain, Franck Morel. Effect of end milling, grinding and tartaric-sulfuric anodizing on the fatigue behavior of AA7050 alloy. *International Journal of Advanced Manufacturing Technology*, 2022, 122 (9-10), pp.3903-3922. 10.1007/s00170-022-10124-3 . hal-03801227

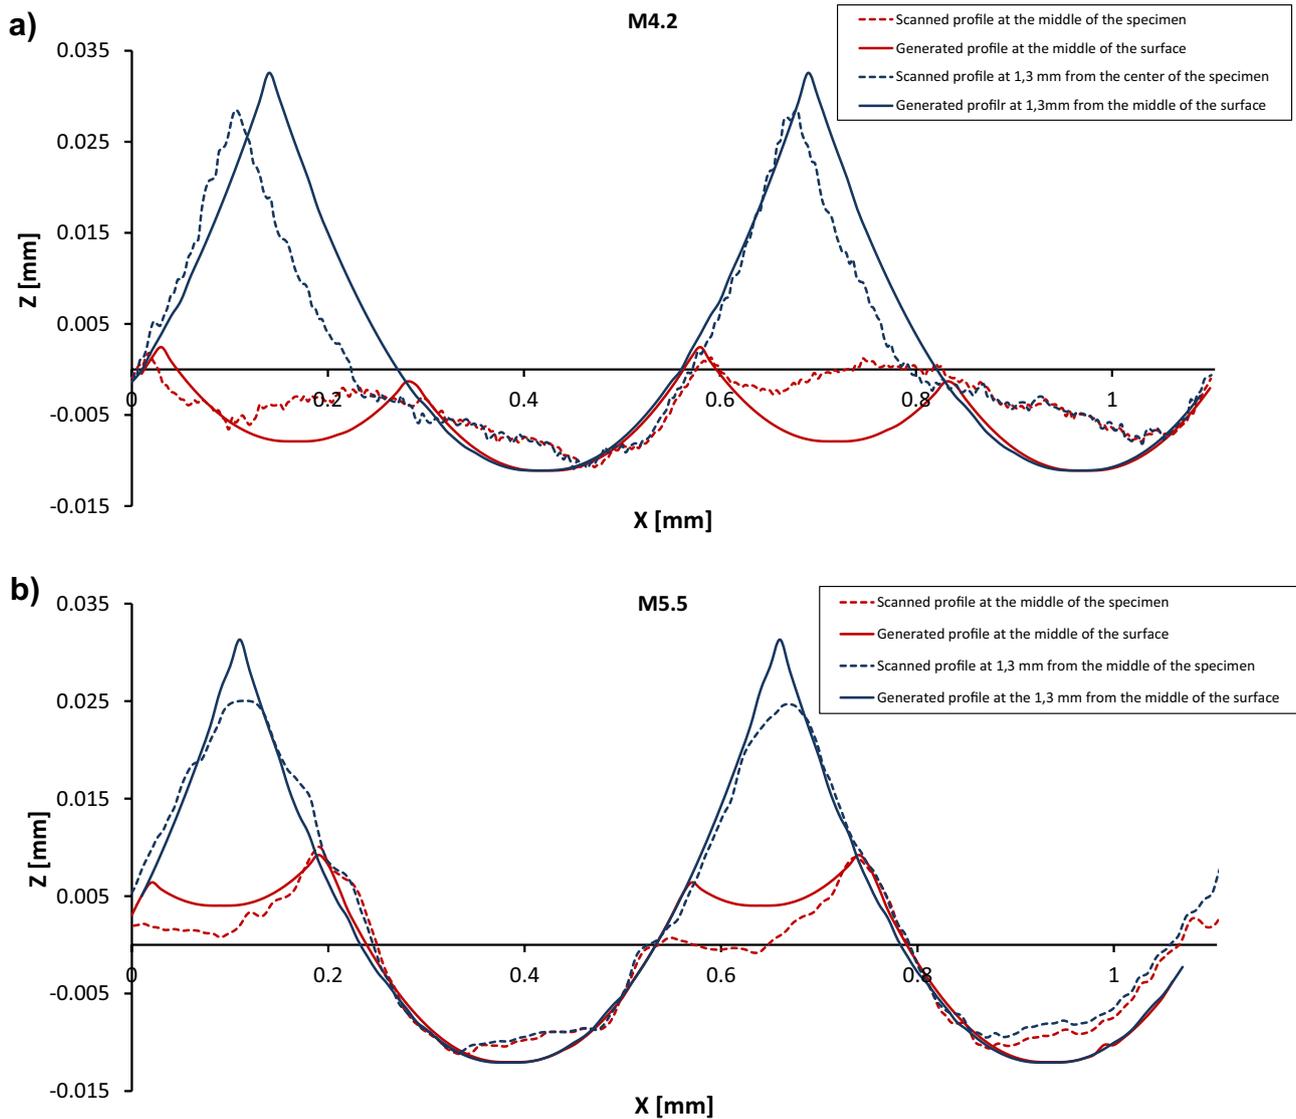
Fig. 28 Comparison between 2D roughness profiles of **a** the M4.2 and **b** the M5.5 surface states and the simulated roughness profiles

simulated surface states, while Fig. 28 presents 2D roughness profiles taken at different positions of the generated surface states for these two tilt configurations. The altitude at the bottom of the milling marks varies from one groove to another due to the tool/part tilt. The altitude difference between the peaks and the bottoms of the grooves is up to  $47 \mu\text{m}$  for the simulated roughness profiles. It can be seen

that the generated surfaces successfully describe the global surface geometries. However, differences due to irregularities at a lower scale can be observed between the experimental and numerical roughness profiles. Figure 28 shows that the numerical profiles have greater depth and height when compared to the real profiles at different positions (i.e., at 0.7 mm along the x axis for the M4.2 batch). This difference results in much higher predicted surface roughness values
